Accident with Apache during night flight training
near Rossum, 12 December 2007

The Hague, January 2009 (M2007DE1212-08)

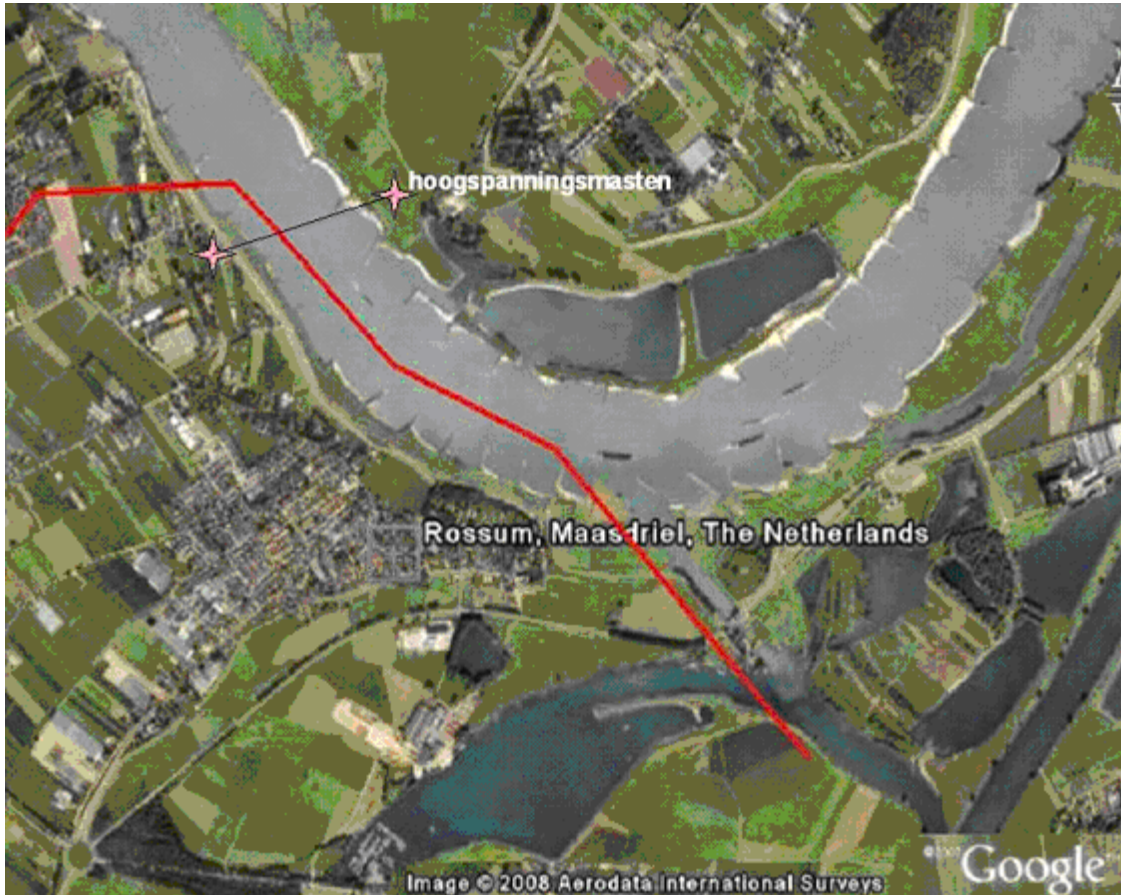
Figure 5: flight path immediately before and immediately after the collision with the power lines

and the front seater had a great deal more experience, the back seater handed over control to the front seater. Although no system failures were detected (cockpit alert system) that could indicate reduced airworthiness, the front seater decided that the helicopter must have been damaged to such a degree by the collision that it might not be possible to reach the Gilze-Rijen safely. He decided to cut short the flight and to look for a suitable location to carry out a precautionary landing. A site was found south of the river Maas at Hedikhuizen. Following a successful precautionary landing, a call was placed to the Gilze-Rijen air base and assistance was requested.

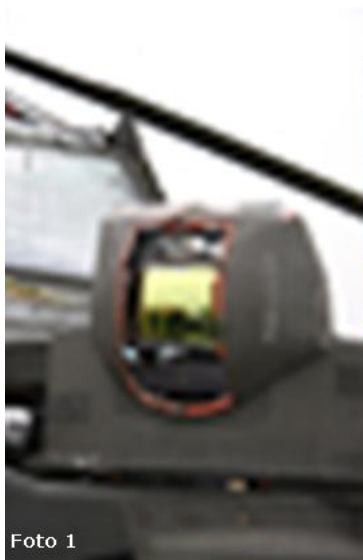
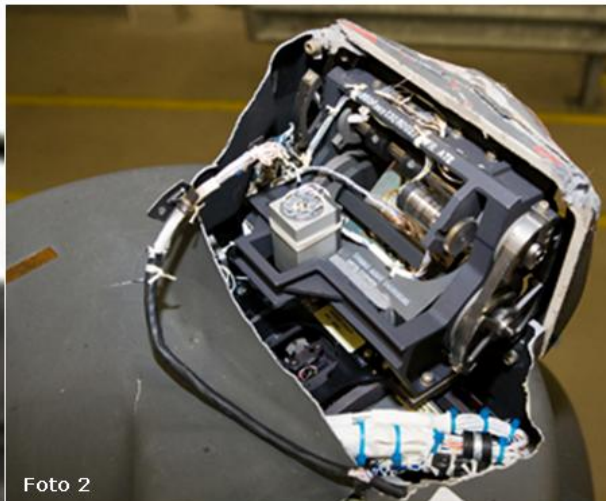
The pilot night vision system⁹¹ (PNVS) is located on the nose of the helicopter. The top of the system was hit, causing a considerable amount of damage. The glass plate had completely disappeared from the front. At the back of the PNVS, the plastic housing had been knocked off (see photos 1 and 2).

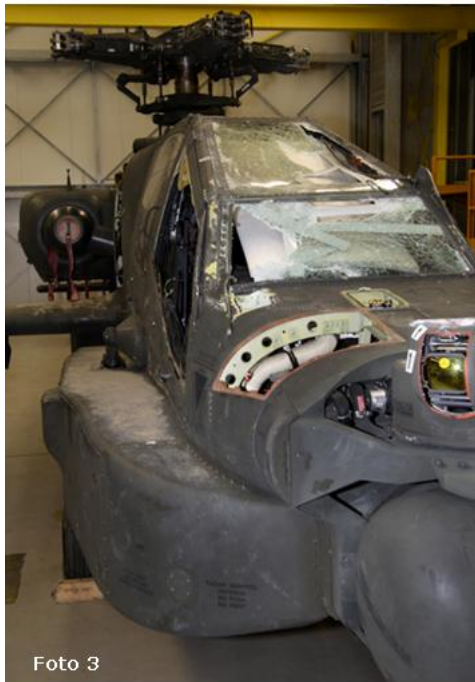
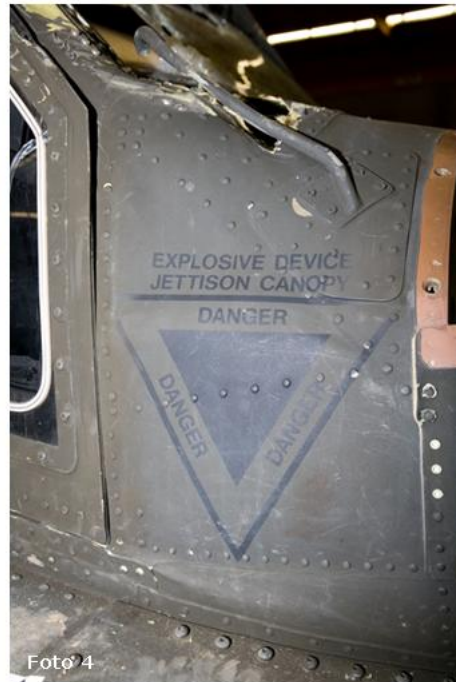
This caused the frame of the nose section to buckle a few centimetres on the right side. The sheet metal work was distorted, and a number of rivets had completely disappeared (see photos 3 and 4).

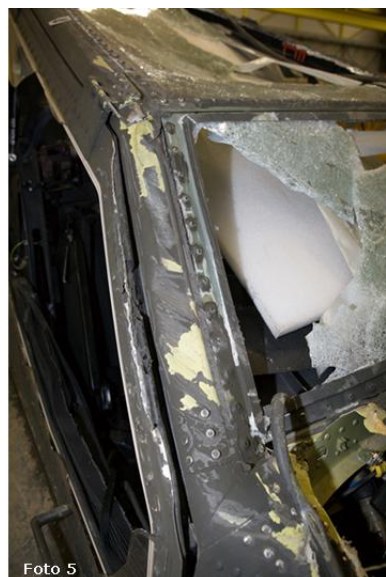
At the CPG station, the stile of the window on the right was pushed right in, shattering the windshield⁹⁴ of both the CPG station (co-pilot) and the PLT station⁹⁵ (pilot). It is also clear to see that the high-voltage power line moved upwards over the cockpit during the collision. The left window stile was hit, however it was not pushed in. The bending of the window stile caused the co-pilot's door (right side) to warp (see photo 5).

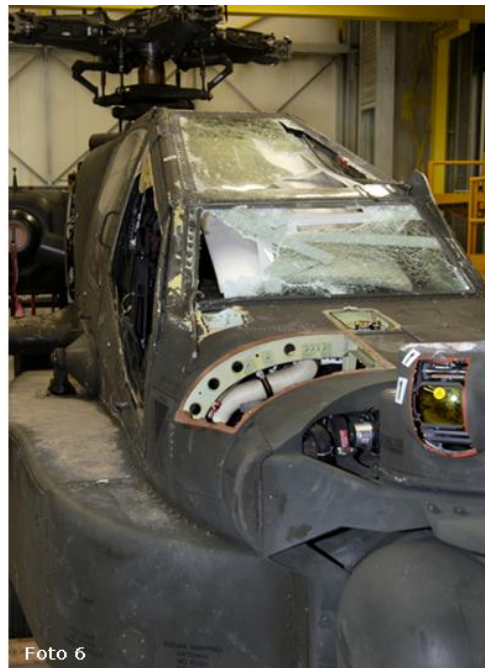
The impact of the high-voltage power line caused both pilots' windows (windshield) at the front to smash into lots of small pieces. The window in the front cockpit door was completely removed. The door buckled and material from the front frame was largely pulled away (see photos 5 and 6).

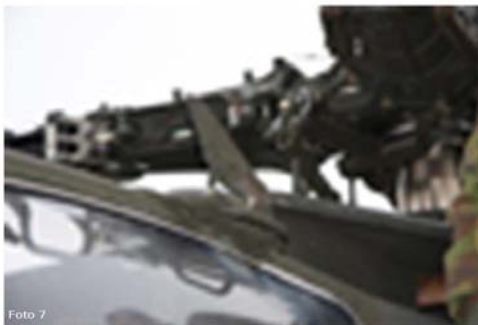
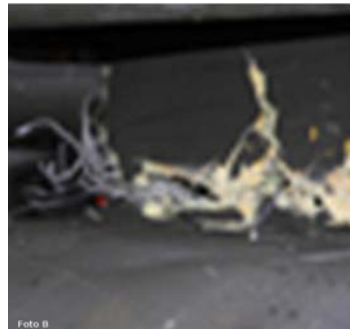
The cable cutter is situated immediately to the left behind the cockpit. No damage to the CC has been identified as yet. The panel known as the dog-house⁹⁶, which starts immediately behind the cockpit, sustained a considerable amount of damage as a result of the incident. One of the causes of this damage was debris, which was found in a number of places, including part of the helicopter known as the cat-walk⁹⁷. The debris mainly consisted of small pieces of hard foam, glass and some fragments of synthetic resin fibre. The small pieces of hard foam came from the dog-house panel (source: BOEING, see photos 7 and 8).

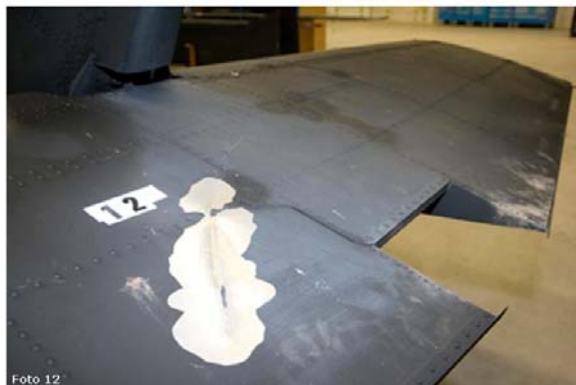
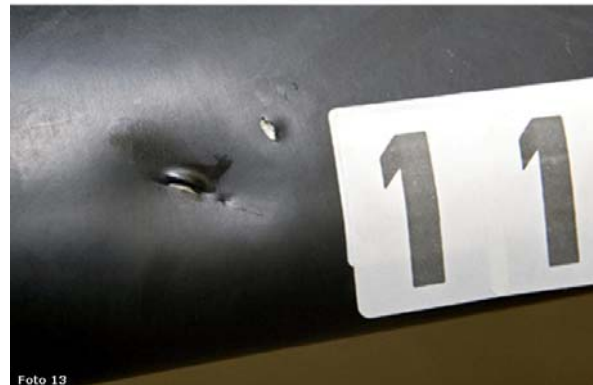
There was damage to the top of the horizontal stabilator in the form of a minor dent measuring around 25 cm in length behind the centre of the helicopter's tail. There was also minor damage to the top right. On the front left, there was a heavy-impact dent measuring a few centimetres in depth (see photos 12 and 13).

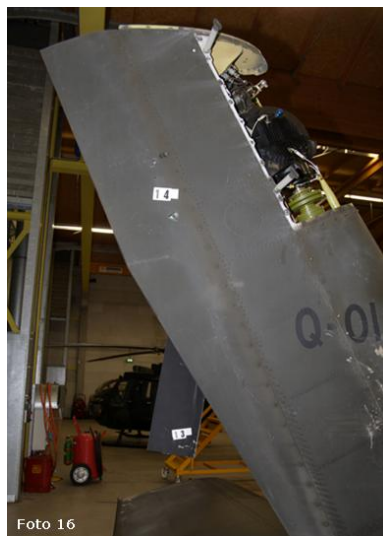
The vertical tail boom starts at the back of the helicopter at the end of the tail. A protective hood is mounted along the entire length of the back of this vertical tail boom. There were a number of small holes in the top part of the hood, on both the left and the right (see photo 16).

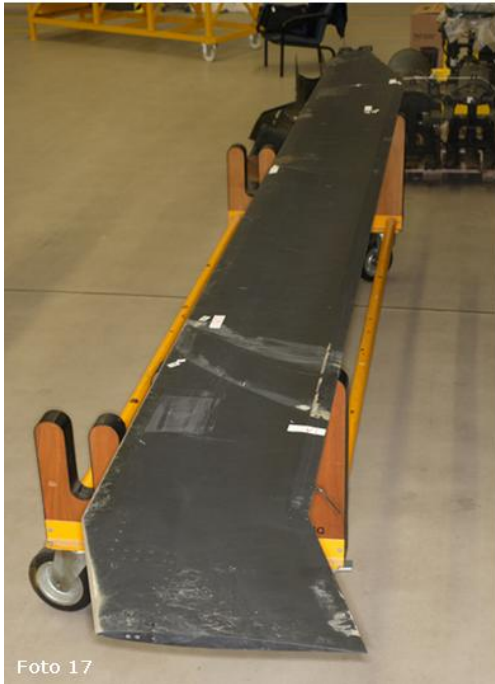
Trailing Edge (T.E.)¹⁰² damaged at around 1 metre from the tip, 2.5 cm deep and delamination¹⁰³ over an area measuring around 50 cm in length (see photo 17).

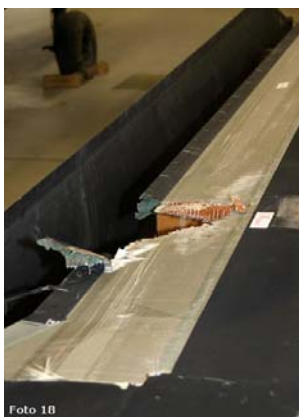
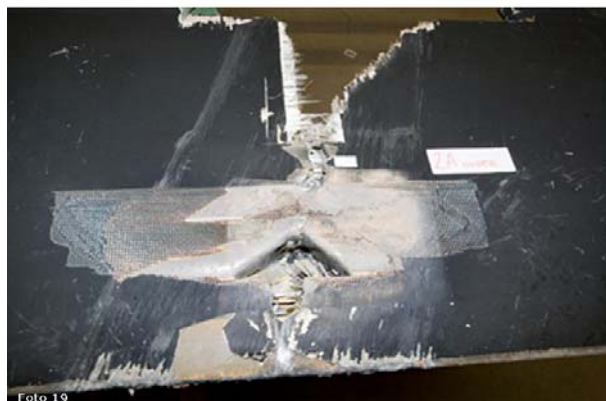
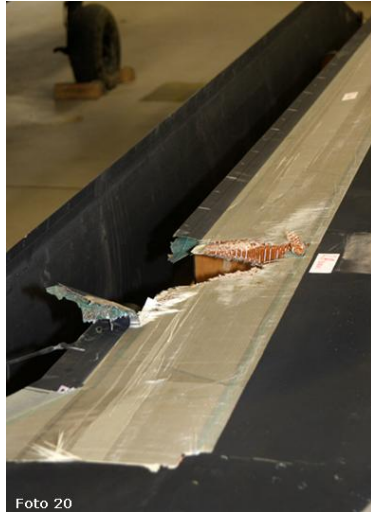
On the top of the blade, the fibreglass reinforced shell was removed from 50% of the surface area (see photos 18, 19 and 20).

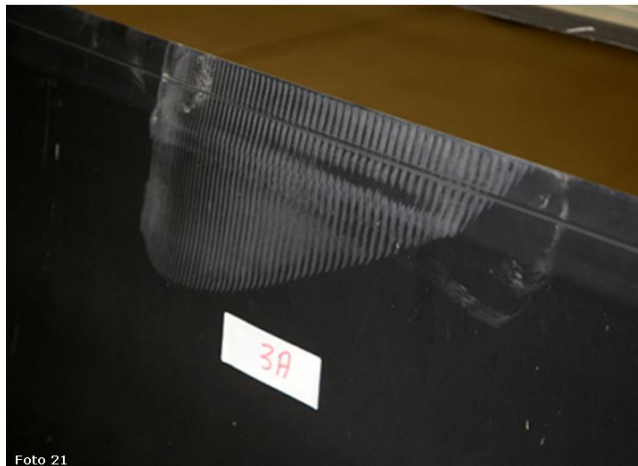
Blade at position no. 3, serial number C10-5715:
It is possible to see an imprint on the underside of the L.E. at a distance of 2 metres from the tip:
10x20 cm (see photo 21).

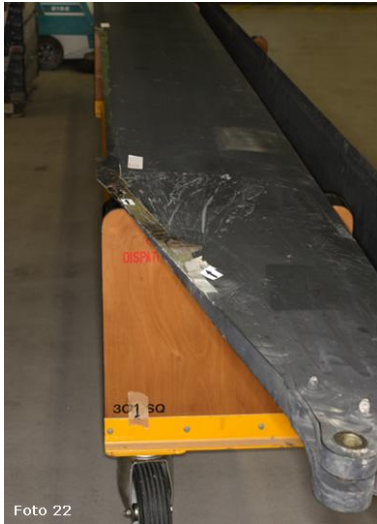
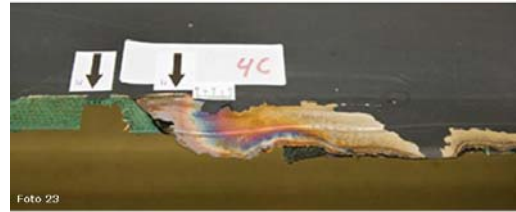
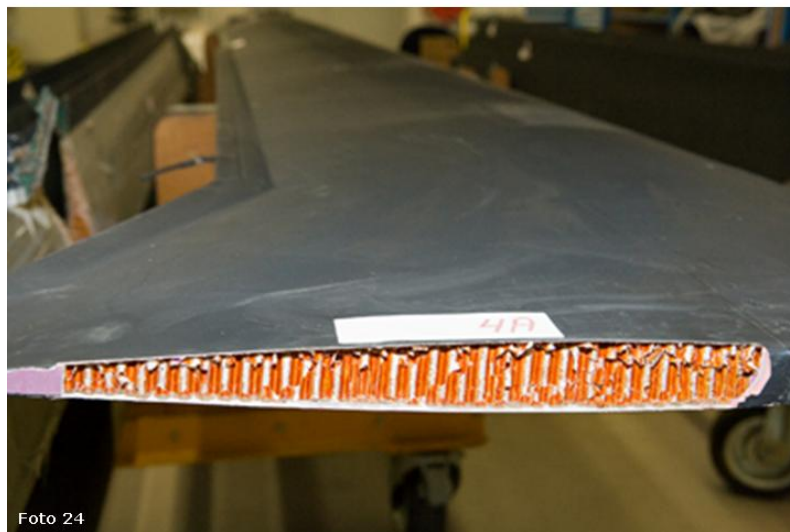
Blade at position no. 4, serial number C10-5701:
Damage to the front frame of the L.E. at a distance of ± 1.2 metres from the tip as a result of
F.O.D.
The entire rear frame had disappeared from an area measuring ± 3 metres in length on the T.E.,
with large burn/singe marks visible in two places.
The base of the blade on the T.E. also had a major singe mark, with delamination of the connection
at the base of the blade. The top layer was missing from the end of the blade (see also photos 22,
23 and 24).

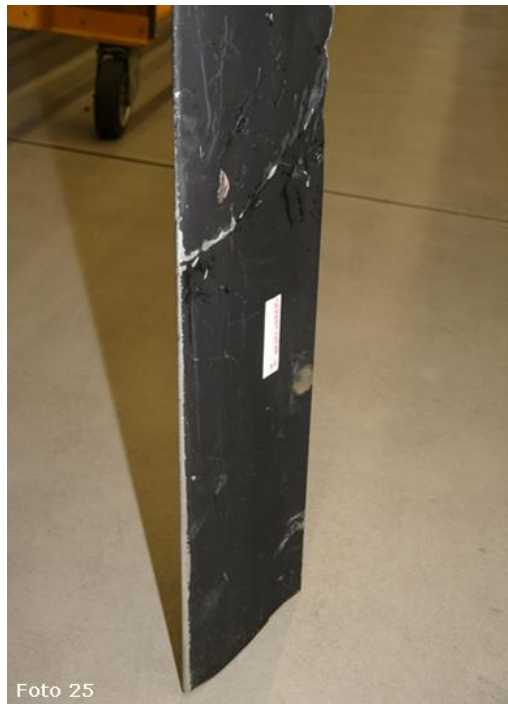
Foto 25

Two large dents can be seen in the rear frame at the same level (see photo 25).

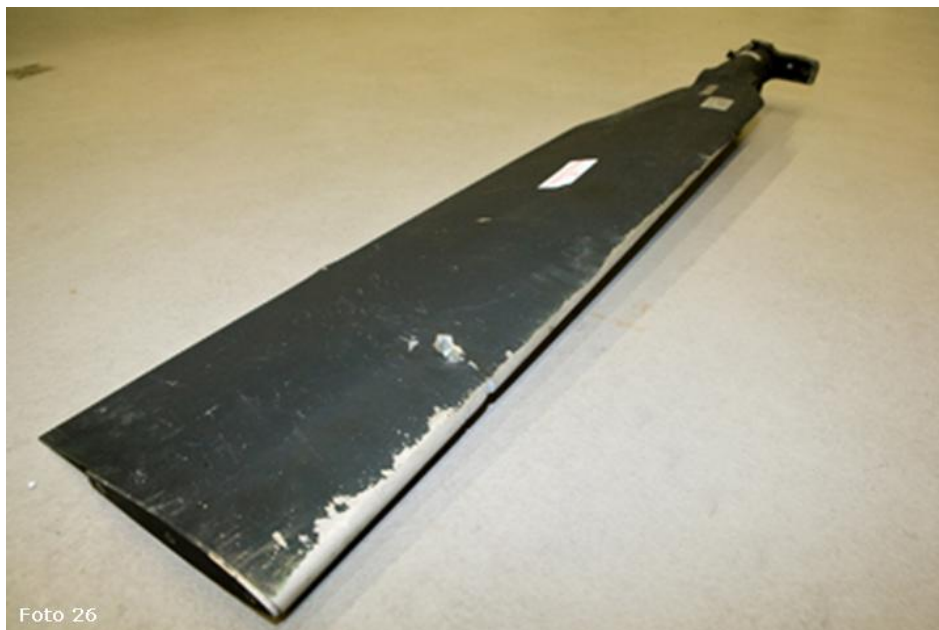
Foto 26

In the front frame at a distance of 15 cm below the tip of the blade two deep impressions: one impression \pm 1 cm and one slightly smaller impression (see photo 26).

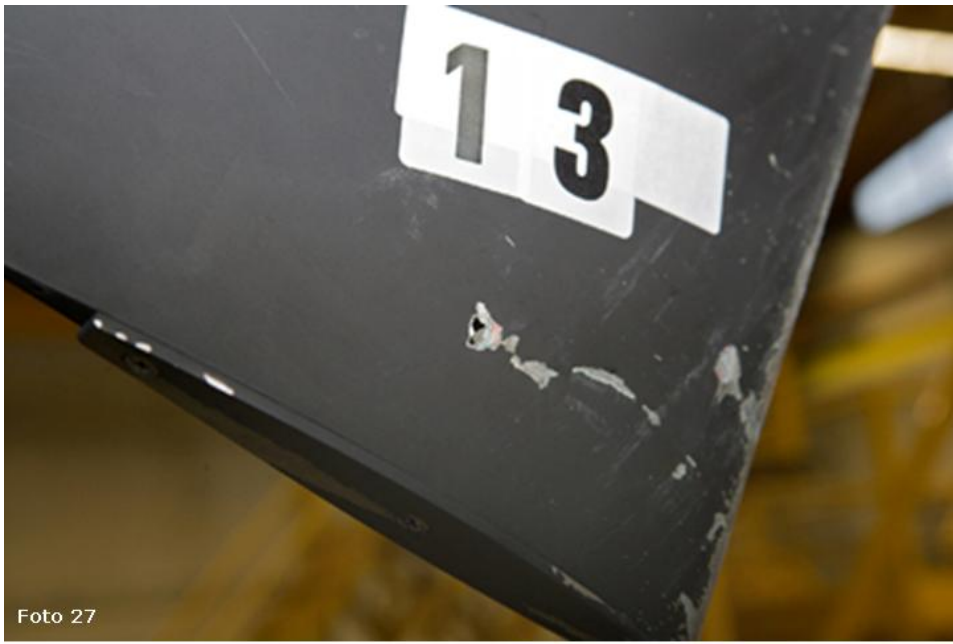
Foto 27

On the underside of the blade (on the inside) at a distance of around 5 cm from the tip there are two small holes in the blade (see photo 27).

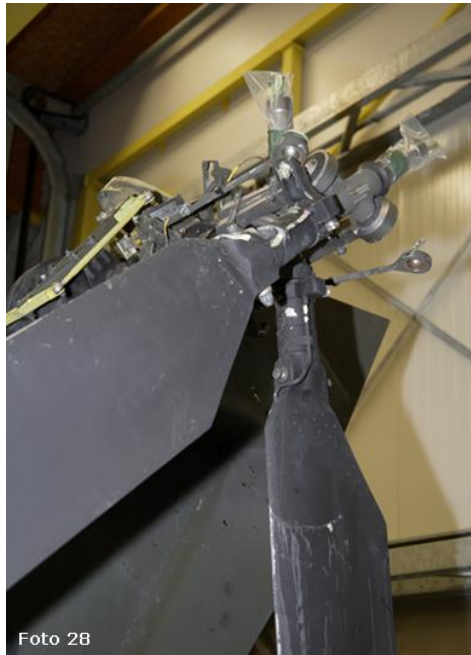
At the base of this tail rotor blade, the wiring (anti-ice wiring) was warped and crushed (see photo 28).

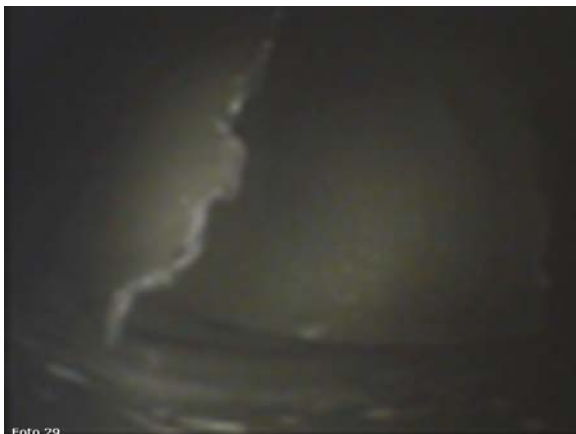
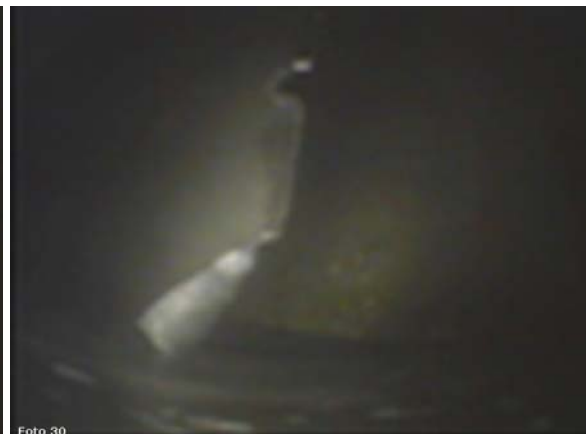
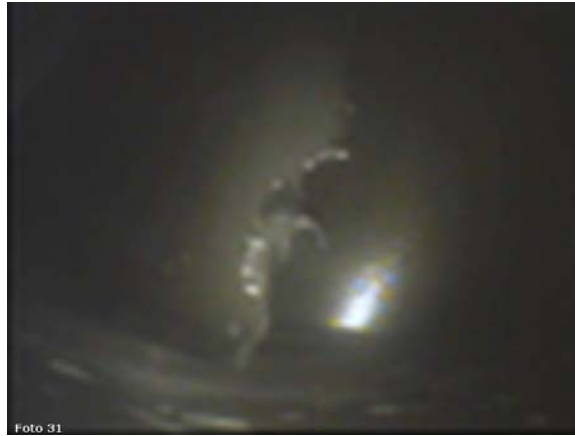
The right engine, serial number ET 306, was damaged by flying debris. This damage can be seen in the first stage of the compressor. In the first stage of the compressor, all of the blades showed severe damage on the front frame (see photos 29, 30 and 31).

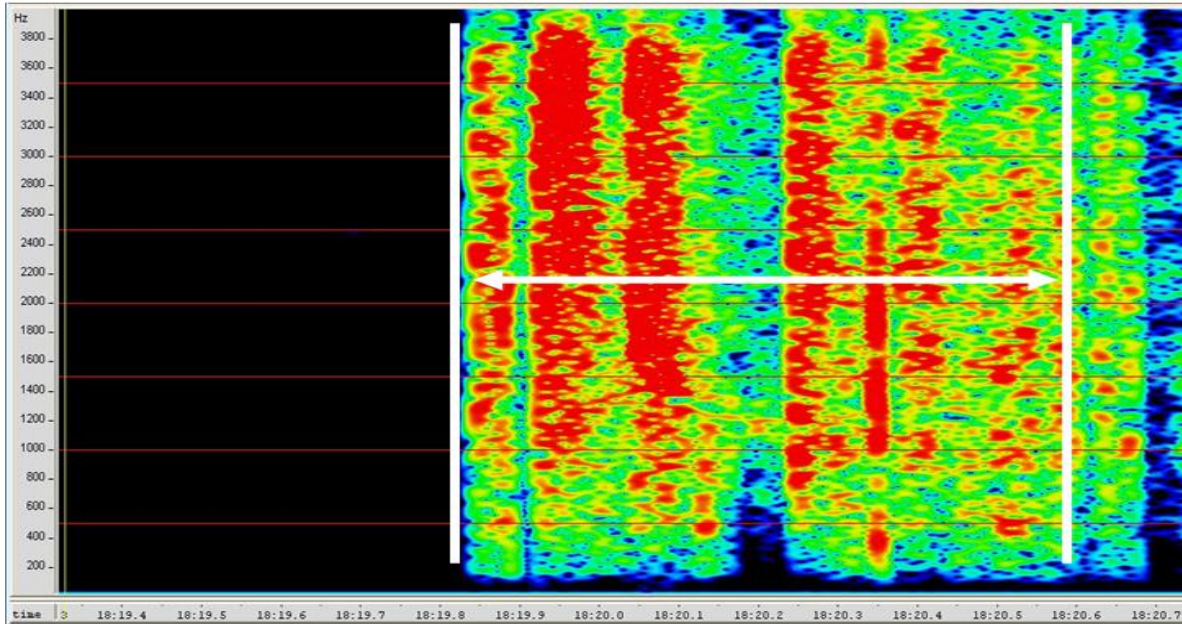
Frequency – Time: spectral analysis of the 'impact noise' recorded at 0:18:19. It is possible to distinguish between six signals with similar frequencies within the total duration of the noise (0.76 sec).

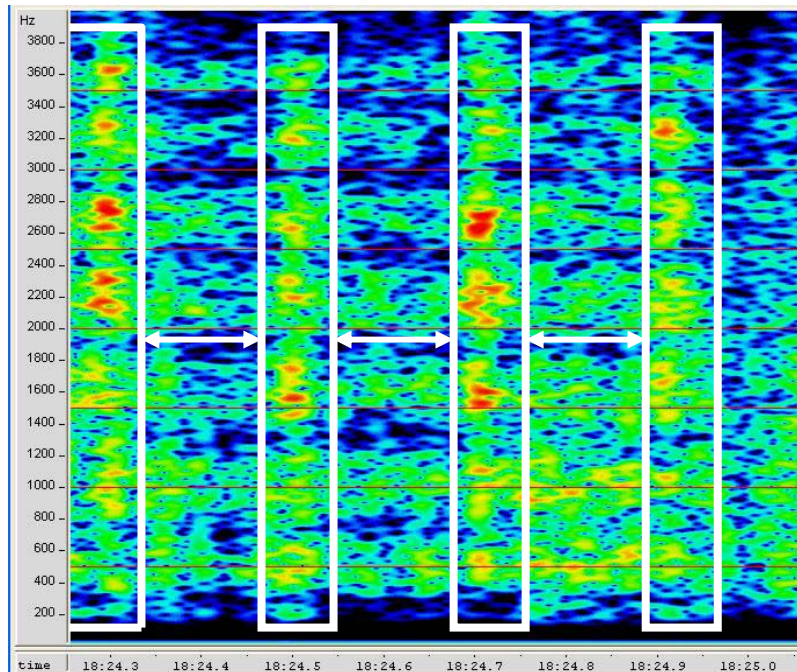
Spectral analysis of the repetitive noise following the power line collision. The time difference between each of the fragments is 0.02 seconds

The repetitive noise with a frequency of approx. 5 Hz corresponds with a rotational speed of 300 revs per minute. A likely explanation for this noise is the impact damage to the main rotor blade, as this rotates at a speed of 296 revs per minute. This type of damage would theoretically produce a repetitive noise at a frequency of 5 Hz. See also Appendix 10: Damage to the helicopter, section 3.1.
