Fire, De Punt, 9 May 2008

Investigation into the deaths of three firefighters
while tackling a fire

The Hague, October 2009

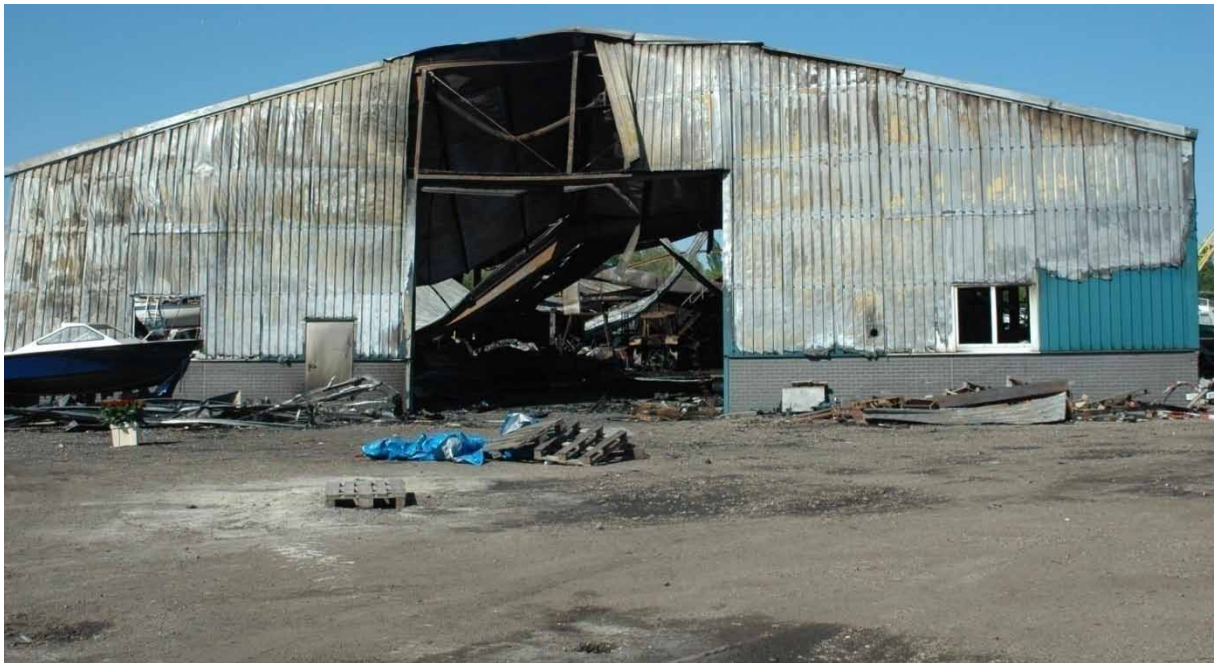
Photograph 2 Front of the shed after the fire. The hole above the door opening was created at the time of the sudden fire spread when part of the front was blown out.

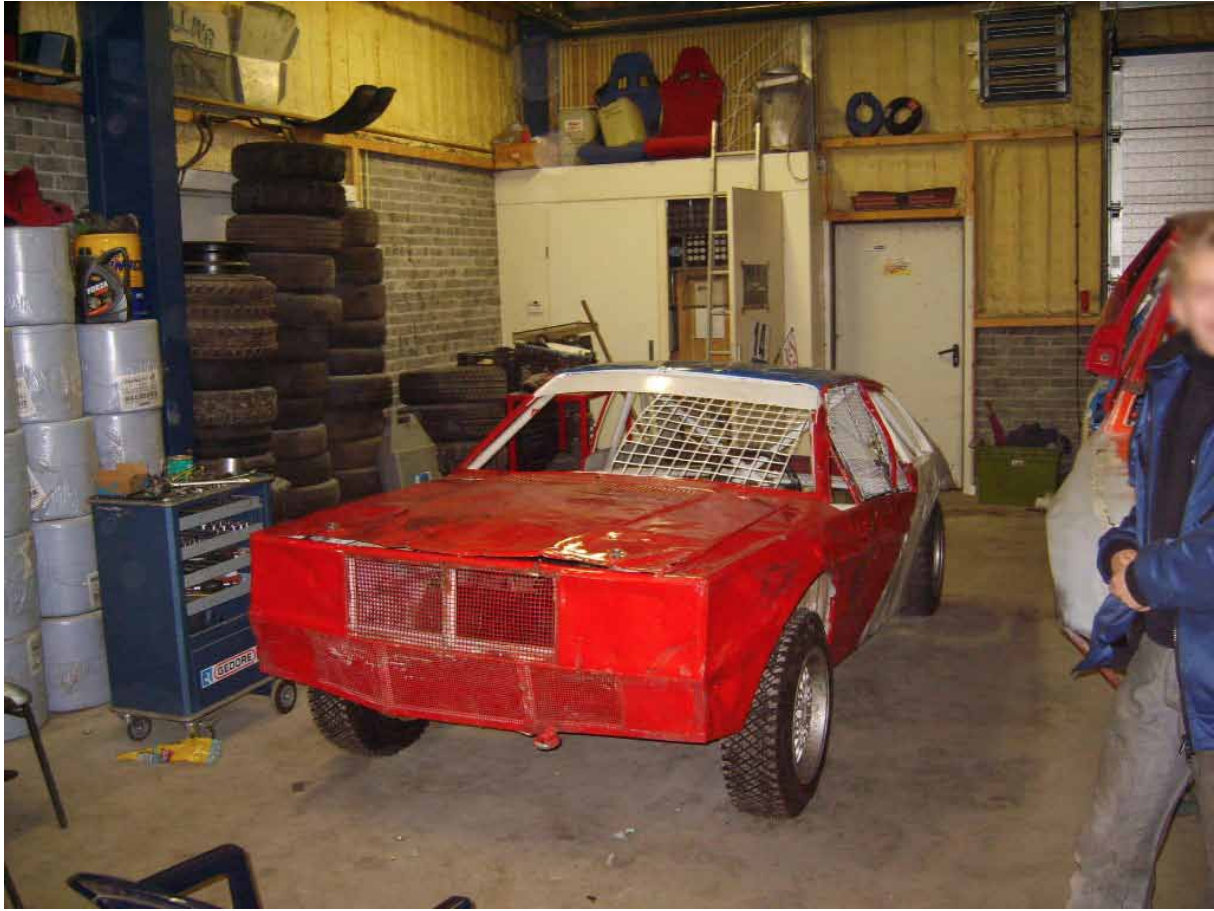
The room at the back on the left-hand side is a storeroom which was also used as a maintenance area for stock cars (see photograph 3). On the left-hand side at the back of this area is a wooden meter cupboard containing safety fuses, an electricity meter and a gas meter. The top section of the outside wall, as well as the ceiling, is thermally insulated with spray polyurethane.

Photograph 3 The inside of the storeroom. On the left-hand side at the back, with the door open, is the meter cupboard where the fire started. The yellowish coating on the higher parts of the walls is exposed polyurethane foam.

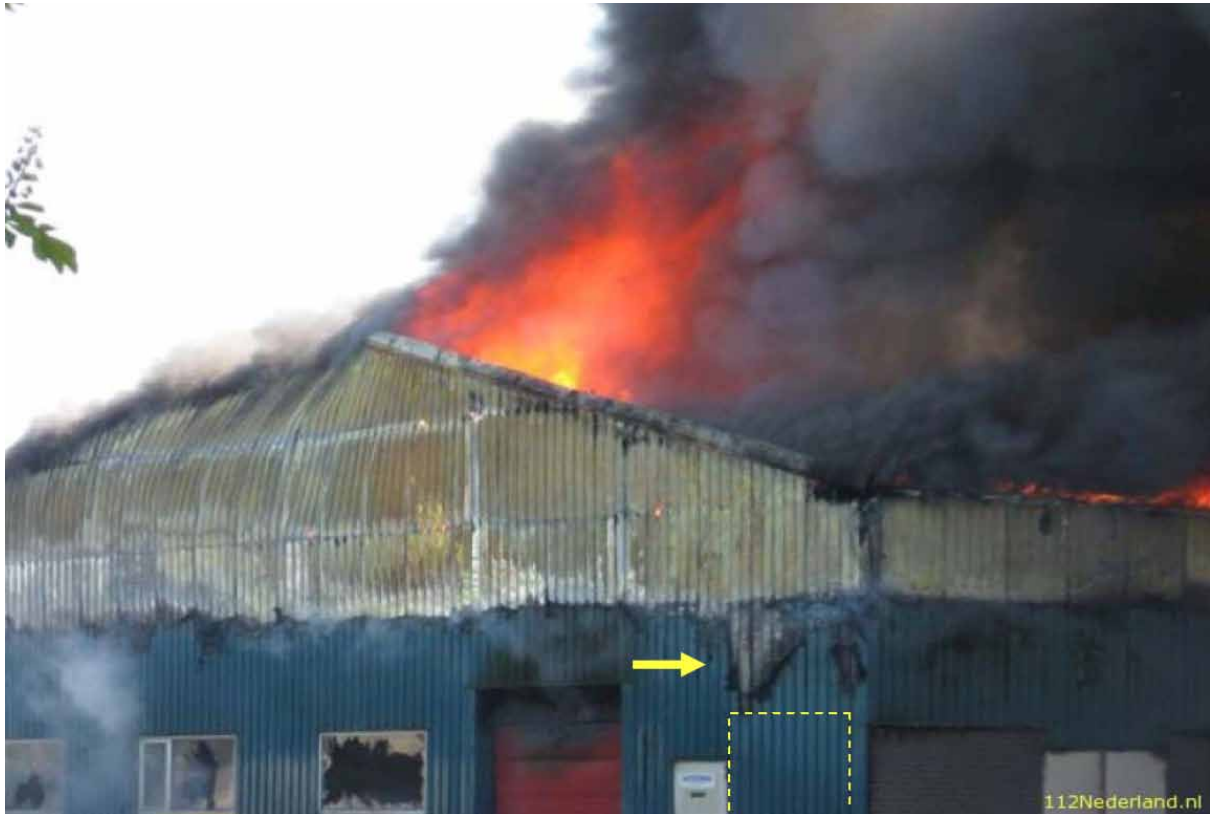
Photograph 4 Back of the shed when the fire was fully ablaze. The yellow arrow is pointing to the 'V' pattern on the outside wall. The yellow dotted line indicates the outline of the meter cupboard located on the other side of the wall.

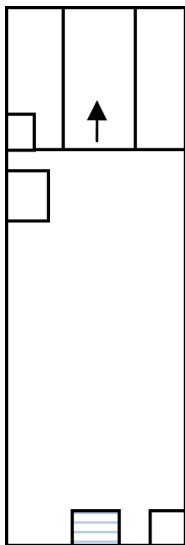
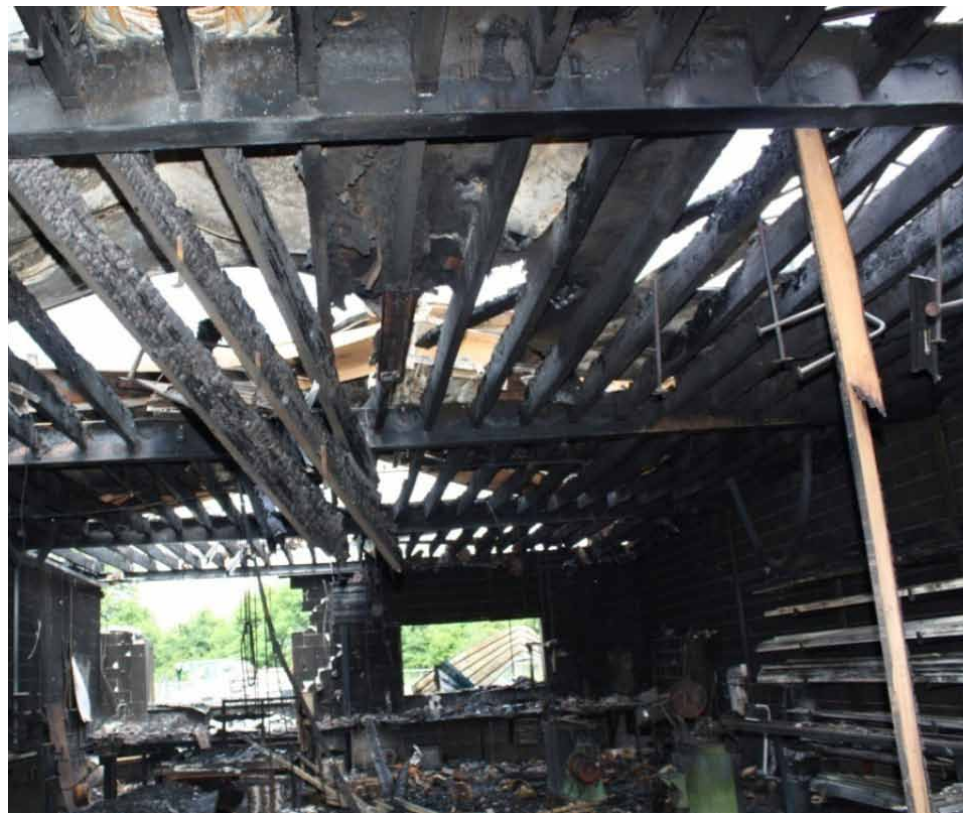
0 shows a view of the wooden cross-beams in the aluminium workshop. The burnt areas can be seen clearly here on the top and the sides of the beams. Generally speaking, there are no burnt areas to be seen on the underside. That indicates that the fire travelled from the ceiling to the workshop and not the other way round.

In addition, various items made of paper and cardboard were found in the area which were still relatively undamaged, such as a wall calendar and a roll of cardboard packaging, for example.

Photograph 5 Aluminium workshop – thermal attack from attic to workshop

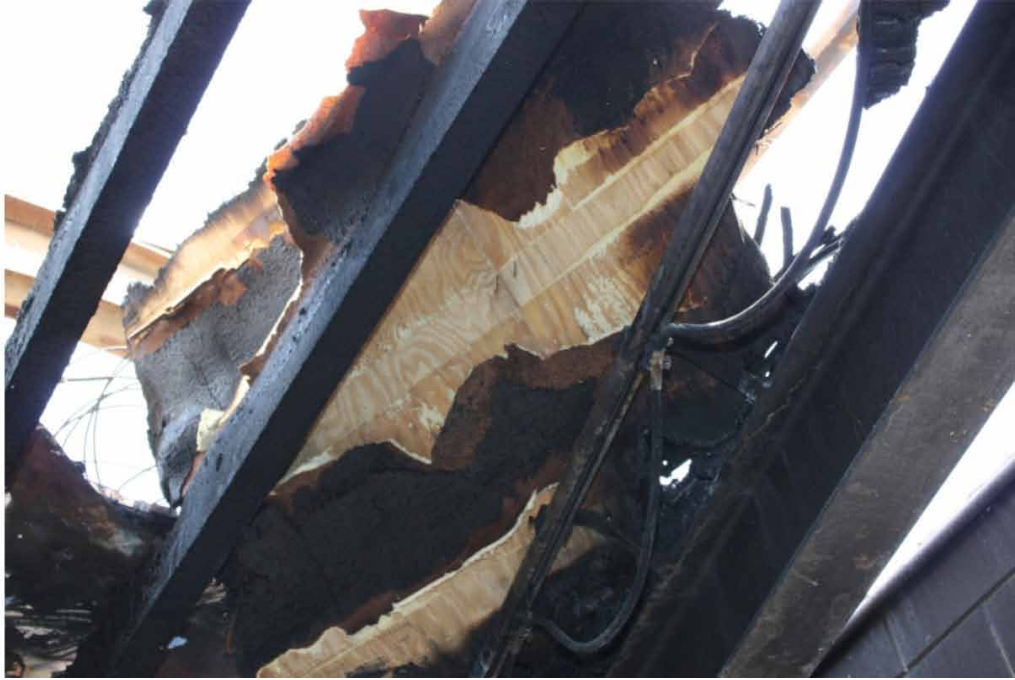
The picture in the engine workshop is the same. Here, even part of the underlayment is still intact here and there which also indicates burning from above (0). Pieces of spray PUR insulation were also found in this workshop.

We also find relatively undamaged cardboard items here (0).

Photograph 6 Engine workshop – thermal attack from attic to workshop

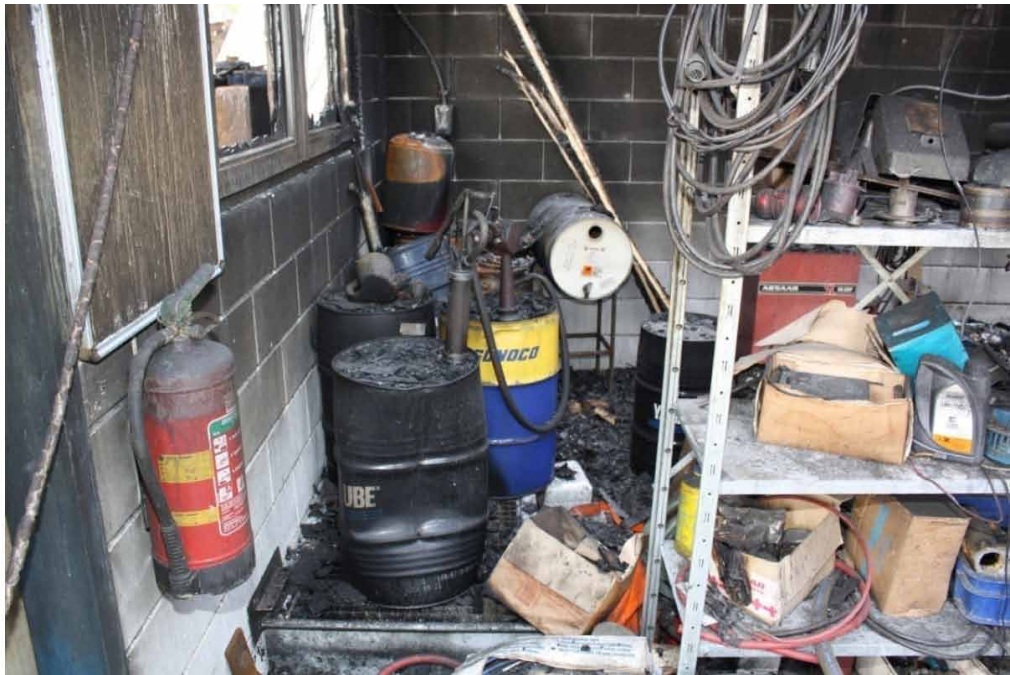
Photograph 7 Engine workshop

Decision: Investigation of the workshops after the fire clearly shows that the fire gained access to the workshops from above – through the underlayment. Therefore, the workshops were not substantially involved in the fire at the time of the explosion and therefore the hypothesis is not retained.
