**Goods train derailment**  
**Amsterdam-Muiderpoort,**  
22 November 2008

The Hague, March 2010 (project number M2008RV1122-01)

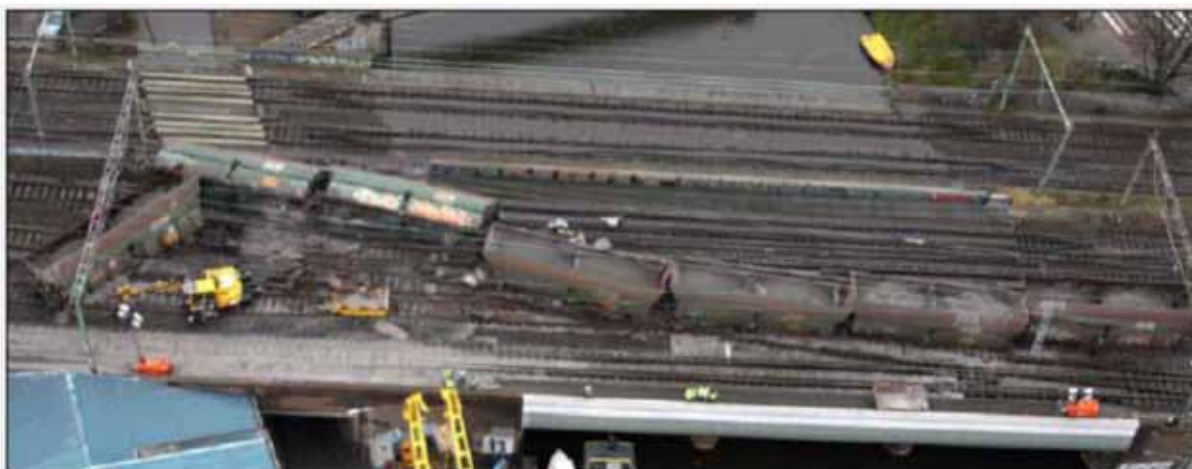
Figure 2: This photo shows the final position of some of the derailed wagons.

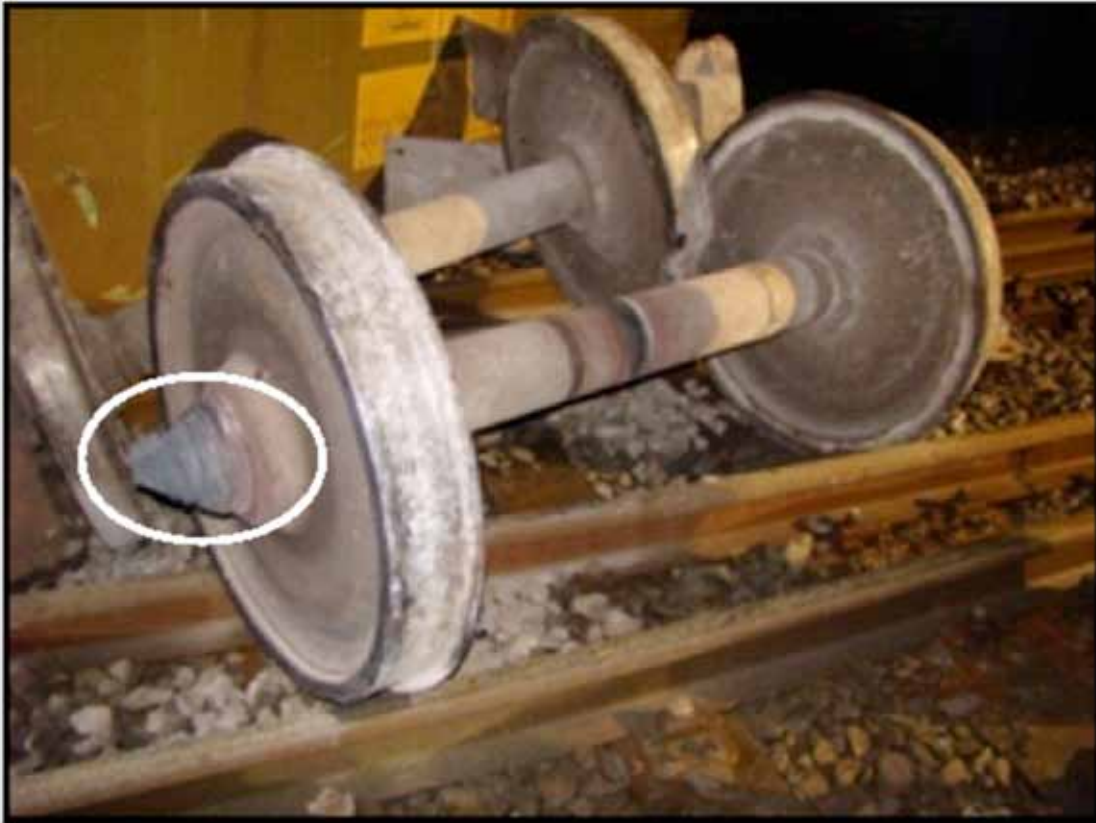
*Figure 8: The second wheel set of the eleventh wagon. The left-hand axle journal has broken off/melted.*

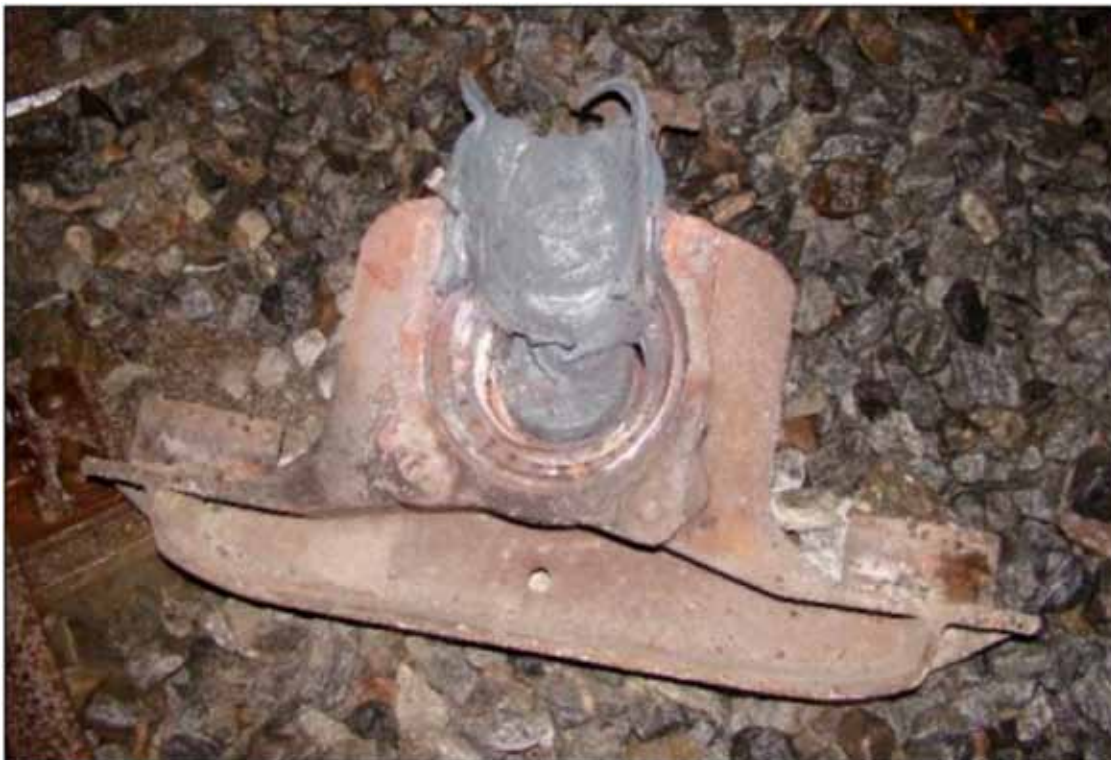
The Board, on the basis of the damage and the marks, concluded that the derailment was caused by an overheating axle box on the eleventh wagon<sup>3</sup> that in turn caused an axle journal to break off. The overheating of the axle box was caused by the seizure of one of the two bearings in the axle box. The Board was unable to reach a definitive conclusion on the cause of the seizure of the bearing due to the damage caused by the overheating. However, it is clear that the bearing cage failed at an early stage of the seizure process. The nature of the damage also excludes a number of potential causes (such as an assembly error, lack of lubrication and overloading).

*Figure 9: the overheated axle box found next to the track at the location of the derailment.*

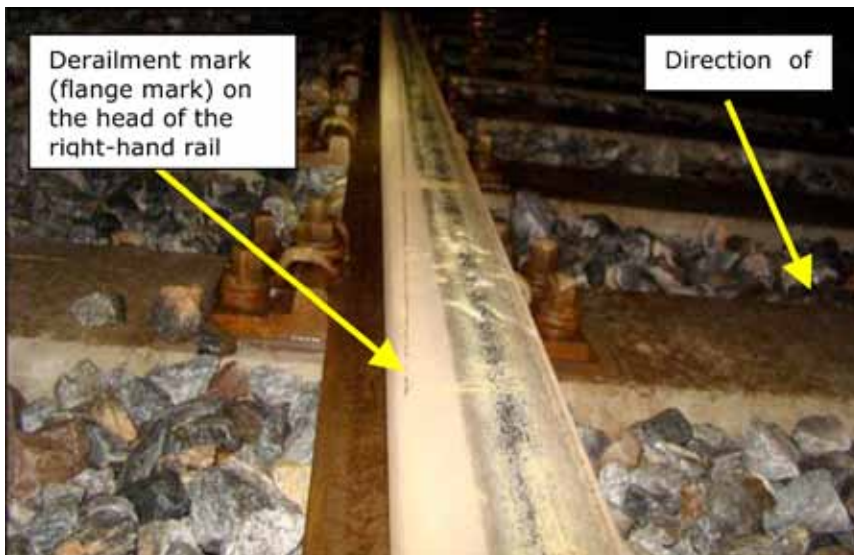
- a) Damage was seen on the right-hand rail of the relevant track (UP) 51 metres past the end of the platform that was indicative of a wheel flange climbing over the head of the rail. The length of these 'derailment marks' were about 15 metres.

Figure 12: This photo shows the derailment marks on the head of the right-hand rail.

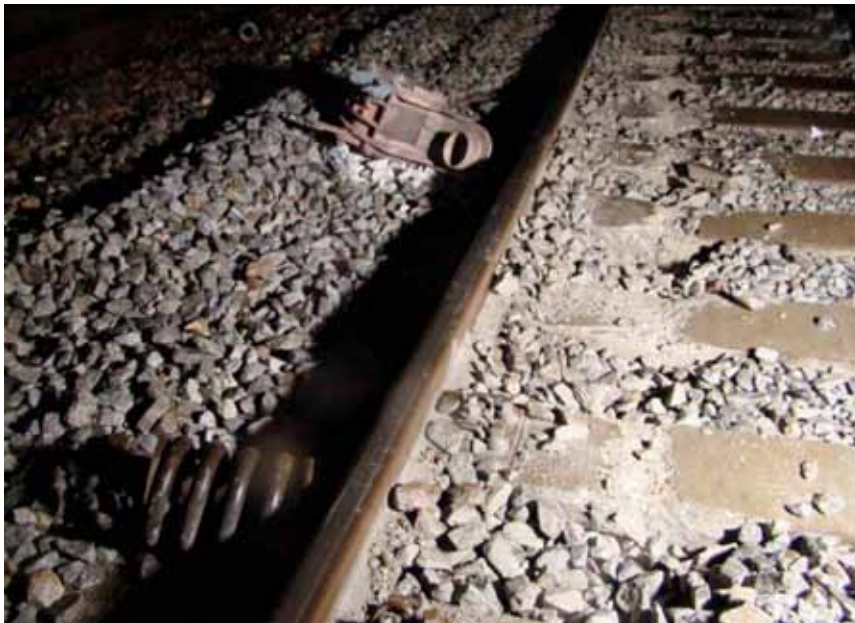
- b) The sleepers immediately following the end of the derailment marks exhibited damage indicating that a wheel set had run alongside the rails.

Figure 13: This photo shows the damage the left-hand wheel of the derailed wheel set caused to the concrete sleepers. The overheated axle box and one of the four springs accompanying the axle box lie next to the rail.

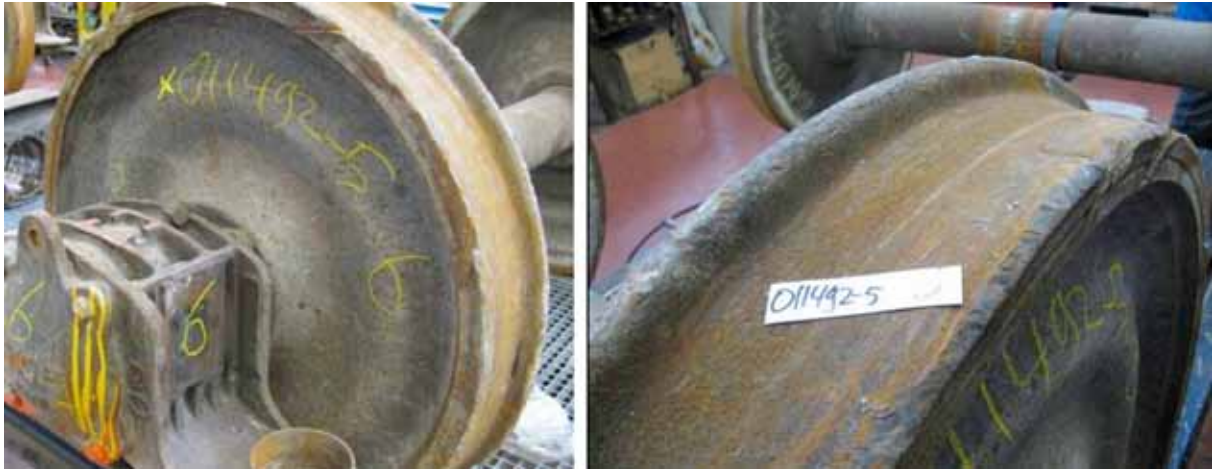
The two wheels of the front wheel set were the only derailed wheels that exhibited severe damage of the flanges and running face of the form that can be expected when wheels run a considerable distance over concrete sleepers (see Figure 14).

Figure 14: These photos show the damage to the wheels of the front wheel set (of the front bogie of the eleventh wagon) caused by the wheel set running over the concrete sleepers.

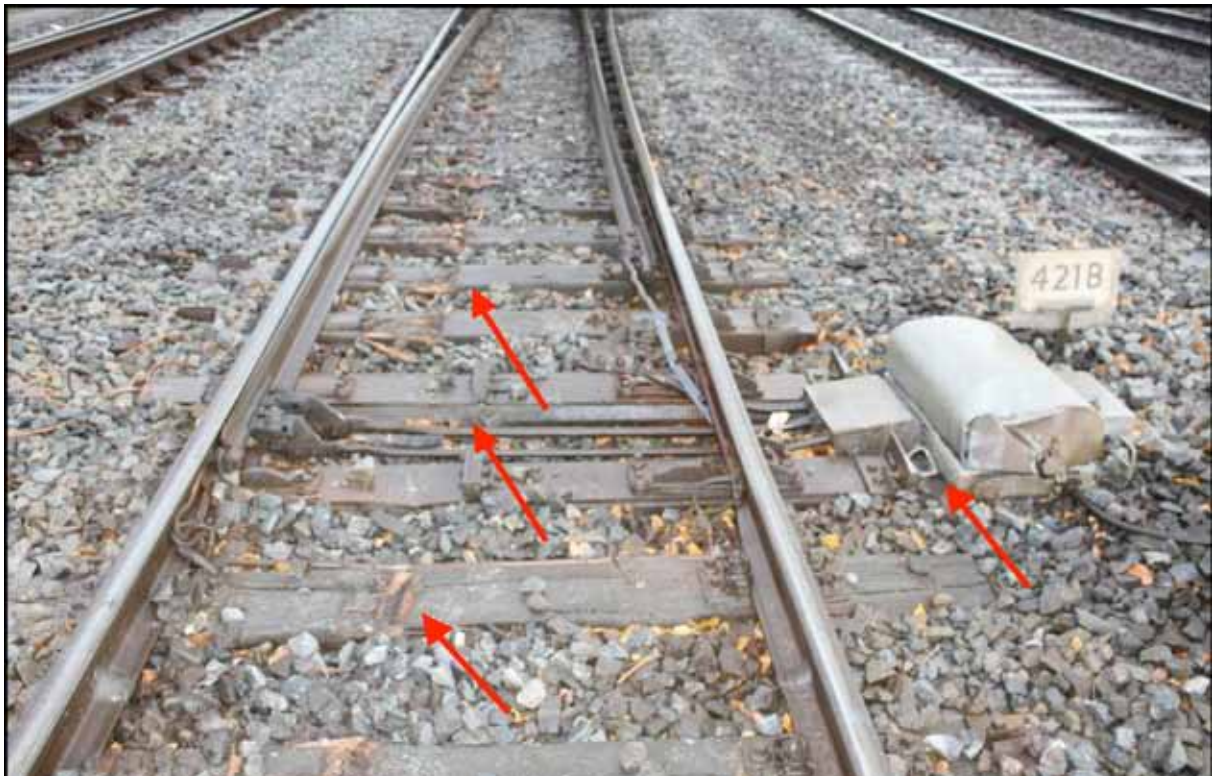
- c) From its findings from the on-site inspection also concludes that:
- the train continued its journey with one derailed wheel set after the actual derailment (see a);
  - that the derailed wheel set damaged a set of points (421-B) about 500 metres further on;
  - that as a result the 'following' wheel sets did not go straight on (as the previous wheel sets had) but turned to the right;
  - that as a result the wagons 11 to 19 inclusive were derailed, whereby the coupling between the twelfth and thirteenth wagon broke and some of the derailed wagons (wagons 11, 12, 14 and 15) toppled over.

Figure 15: This photo shows the damage the derailed wheel set caused to the sleepers and the operating mechanism of the set of points

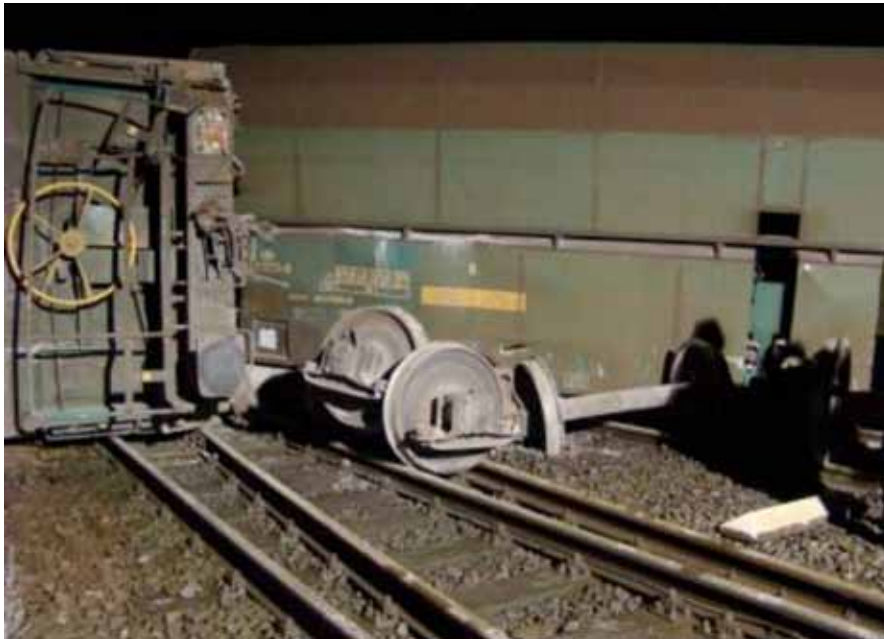
Figure 16: This photo shows some of the derailed wagons and a number of wheel sets that had broken off.

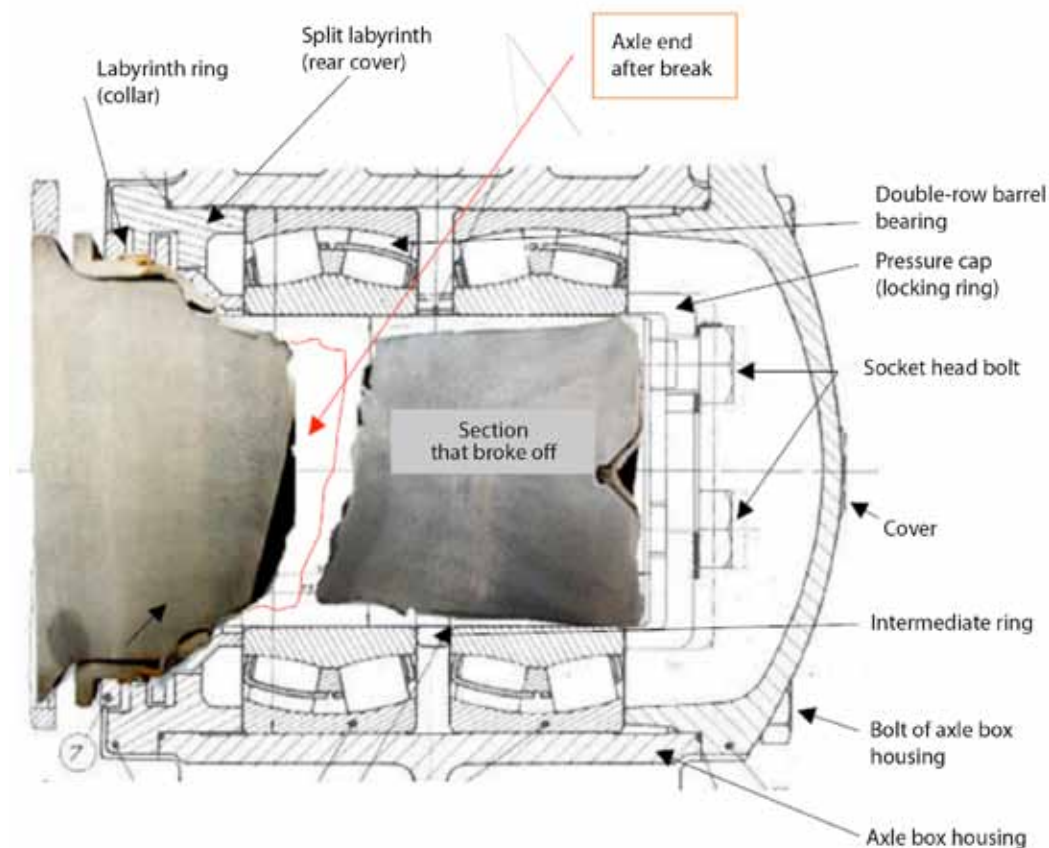
Figure 18: Cross-section of the axle journal and axle box housing. Two double-row barrel bearings are mounted in the axle box housing. The axle journal has broken at the point where it passes through the inner bearing.

The axle journal broke at the point where it passed through the inner bearing. The boring of the inner ring of the outer bearing exhibited clearly-visible erosion: this indicated that the axle journal had rotated in and eroded this bearing. Sections of the inner ring were completely worn away.

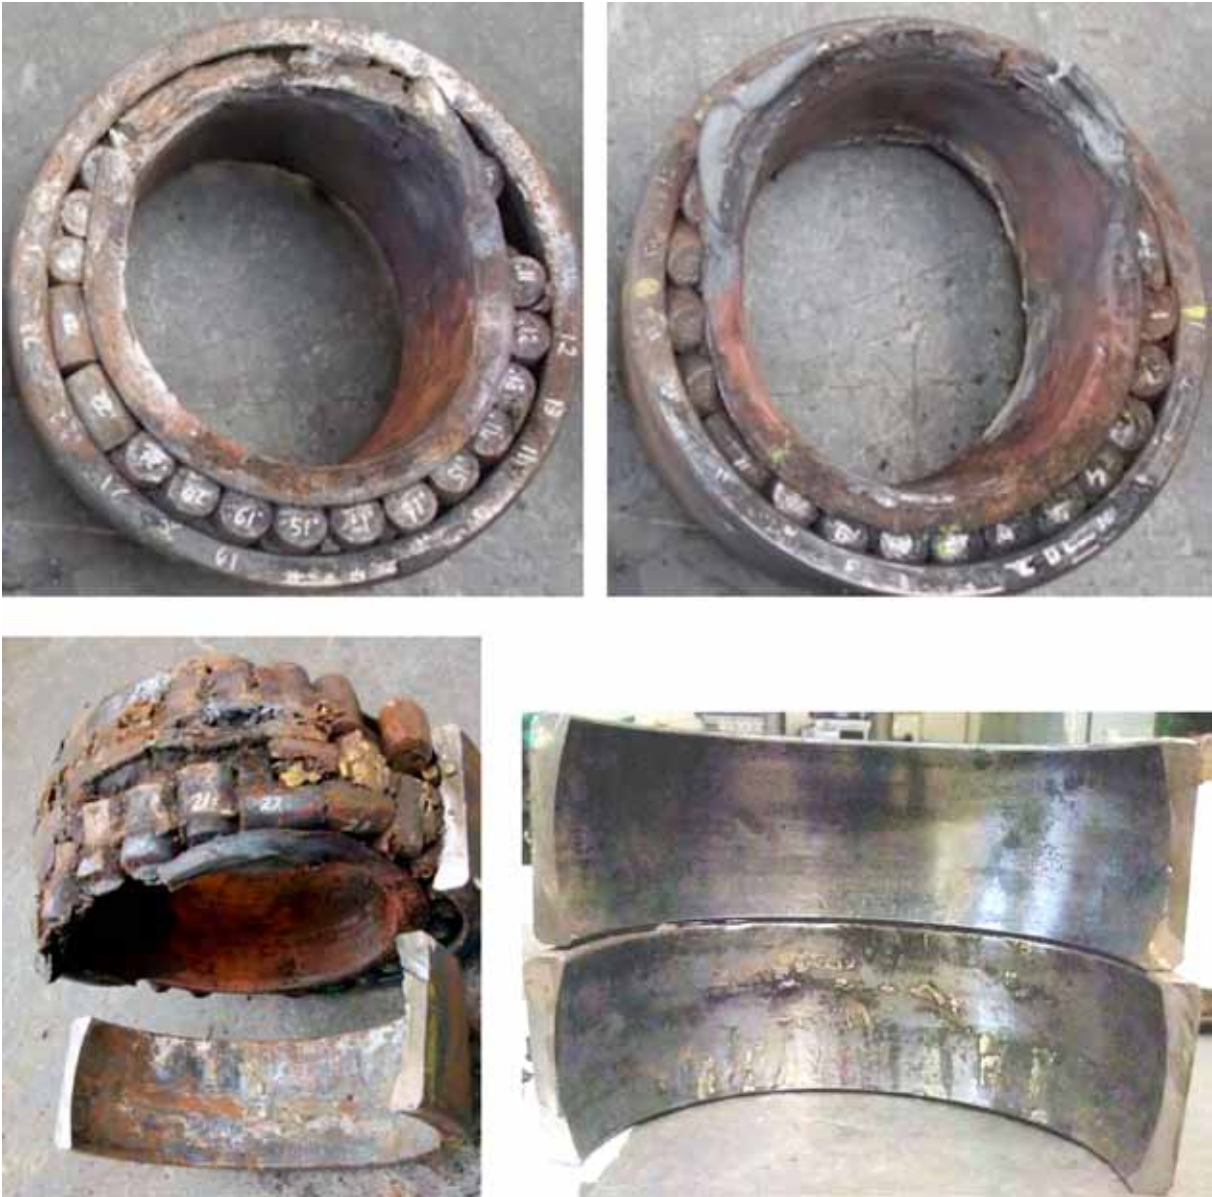
The outer bearing was extremely severely damaged (see photos below).

Figure 19: The outer layer from the overheated axle box. the top left photo shows the outer side, the top right photo the inner side. The bottom left photo was taken once the outer ring had been cut through and partly removed. The bottom right photo shows the raceway of the outer ring after the ring had been cleaned.

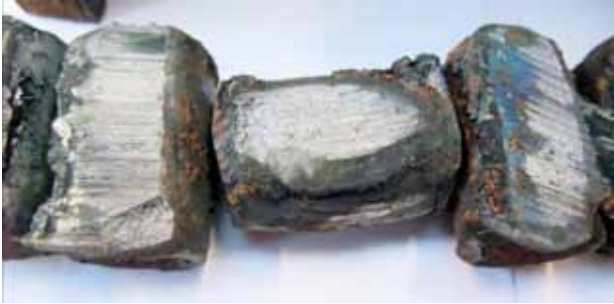
An inspection of the raceways of the inner ring and the outer ring after the bearing had been opened did not reveal a degree of chipping that could have explained the seizure (see Figure 20, bottom right photo). It was also observed that flats had been worn on some of the rollers in the bearing before the rollers had become 'welded' to the inner ring (see Figure 20).

Figure 20: Three rollers from the outer layer: one roller had turned through 90 degrees and flats had worn on all three rollers.

This situation can be explained only by the relevant rollers becoming jammed relative to the outer ring while the inner ring was still rotating. Since one of the rollers had turned through 90 degrees (see Figure 20) at least one cage lip of the bearing cage must already have been broken off at the time the bearing began to seize.

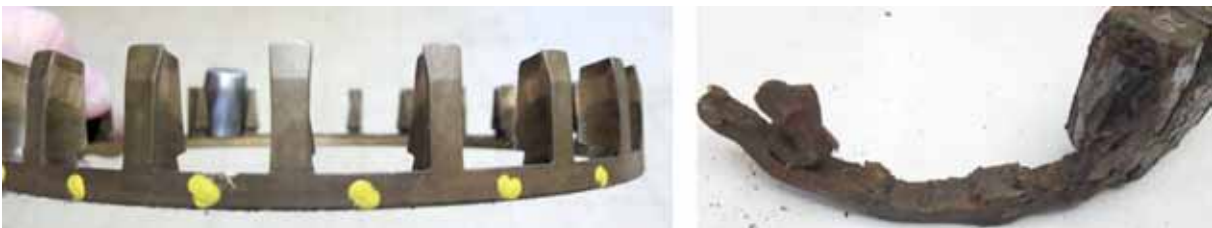
The bearing cage, which was made of brass and was comb-shaped (see left photo in Figure 21), had largely melted. The cage lips had broken off from the remains of the bearing cage (see right photo in Figure 21).

Figure 21: Left: a comb-shaped brass bearing cage of the type used in the relevant bearings. Right: the remains of one of the two bearing cages from the outer bearing mounted in the overheated axle box (with the cage lips broken off).

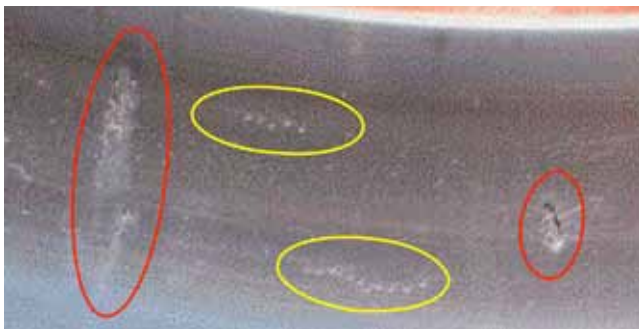
In addition, one of the twenty bearings that were inspected exhibited chipping of the raceway of the outer ring at two locations. The distance between the two locations was equal to the centre-to-centre distance between the rollers. In the opinion of the bearing experts the Board consulted the form and the distance between the chipping indicated that this chipping was probably not caused by current-flow damage but by brinelling<sup>66</sup> or corrosion.

Figure 22: The adjacent photo shows the current-flow damage (circled in yellow) and chipping (circled in red) in the raceway of the outer ring of a bearing from one of the ten other axle boxes that were inspected.

The bearing experts that the Board consulted stated they expected that chipping of this magnitude would have resulted in the failure of the bearing within the remaining period of the overhaul interval (eight years).

3. To Xpedys:  
Evaluate the periodic maintenance of the axle boxes of the series of wagons involved in the Muiderpoort derailment, with due regard for the chipping damage encountered in one of the bearings of the derailed wagons.
4. To Railion and ProRail:  
Carry out an investigation of the current-flow damage to the axle box bearings observed with the wagons involved in the Muiderpoort derailment and make sure that the necessary measures are implemented to prevent this form of damage.

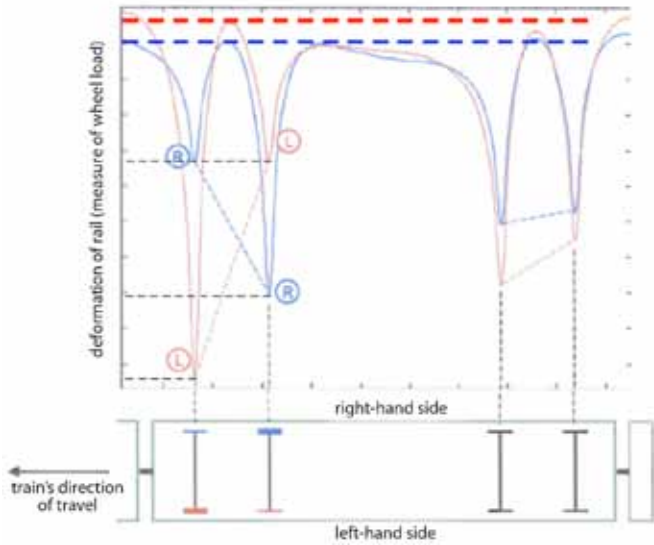
Figure 23: This figure shows the wheel loads of the eleventh wagon as recorded by the QuoVadis-Gotcha station at Tricht. The front bogie exhibits a diagonal difference in the wheel loads.

The anomalous distribution of the wheel loads at Tricht should be viewed in combination with the fact that by the time the train reached Amsterdam-Muiderpoort the left-hand axle box of the rear wheel set of the relevant bogie had overheated to an extent such that the axle journal had eroded its way through the axle box. For this reason the Board concludes that the difference in wheel loads measured at Tricht was due to the fact that at that location and at that time the axle box had eroded through the axle box to an extent such that the axle box had already 'sagged' by an appreciable distance. On the basis of the available information about the dimensions of the relevant parts and the spring stiffness of the primary suspension the wheel unloading measured at Tricht (approximately 40%) is equivalent to the axle box sagging - and the axle journal eroding into the axle box - by a distance of approximately 95 mm. This distance (95 mm) is about half of the total distance (approximately 200 mm) required for the axle journal to erode completely through the axle housing (before the axle journal broke free shortly before reaching the derailment point at Amsterdam-Muiderpoort).

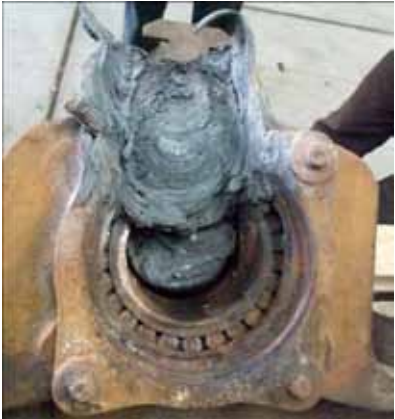
Figure 24: This photo of (the inner side of) the overheated axle box shows that the axle journal erodes its way upwards through the axle box.

In the Board's opinion it is also possible to state that this degree of erosion (approximately 95 mm) of the axle journal through the axle box would have been accompanied by the generation of sufficient heat to raise the temperature of the axle box to a level that could also have been detected by a HotBox detection system at that location and at that time.
