THE DUTCH  
SAFETY BOARD

**Emergency assistance after Turkish Airlines  
aircraft accident, Haarlemmermeer**

25 February 2009

The Hague, July 2010 (project number M2009CH0225-02)

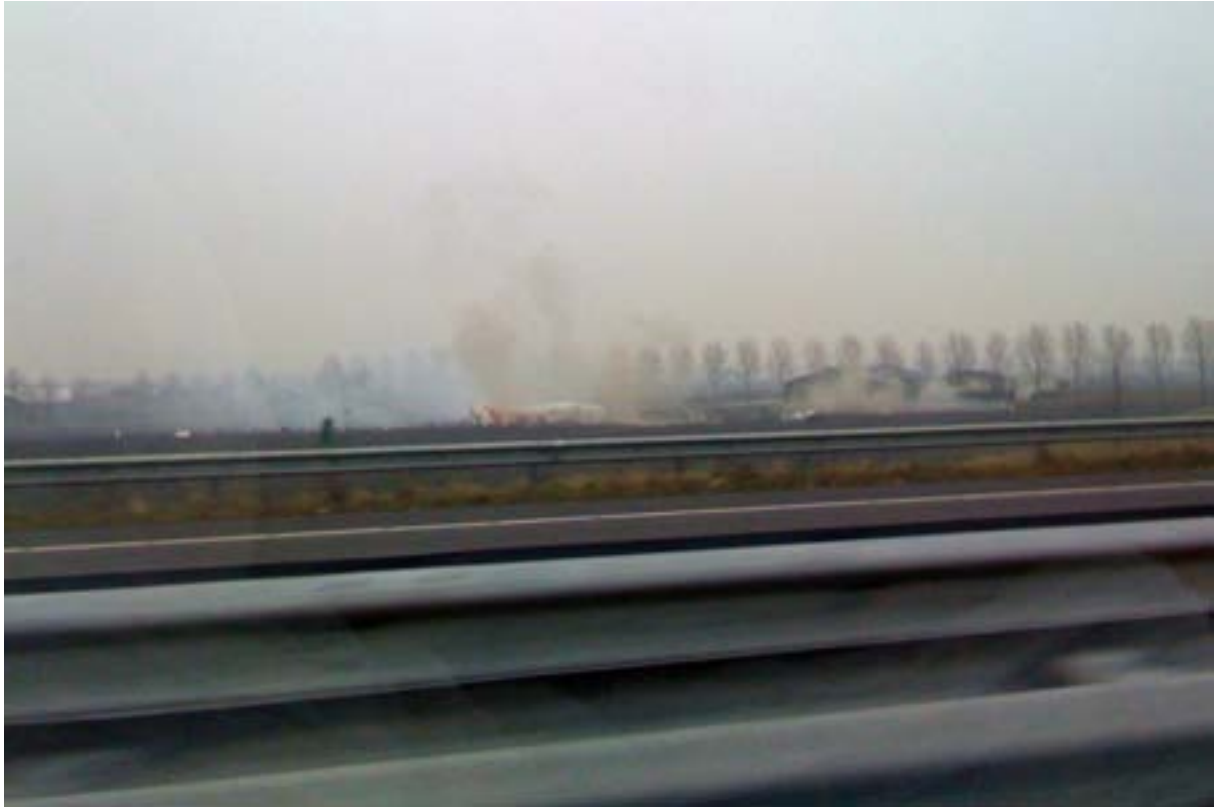
Figure 1: The moment when the aircraft hit the ground, as seen by a motorist driving by on highway A9 (Source: N. Van der Smagt)

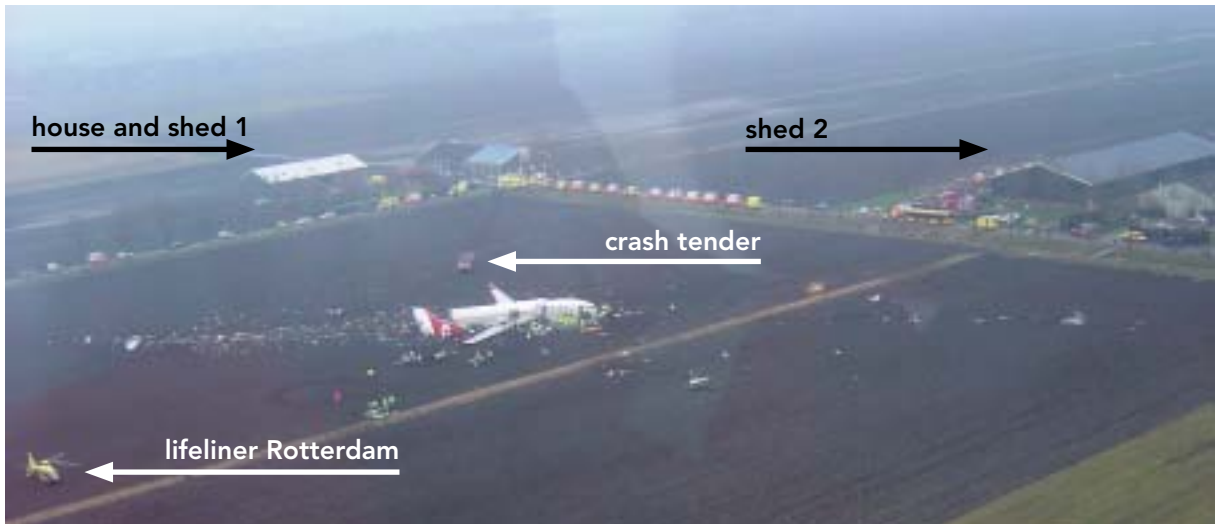
Figure 5: Accident site (Source: Nijmegen trauma helicopter team (MMT) Nijmegen)

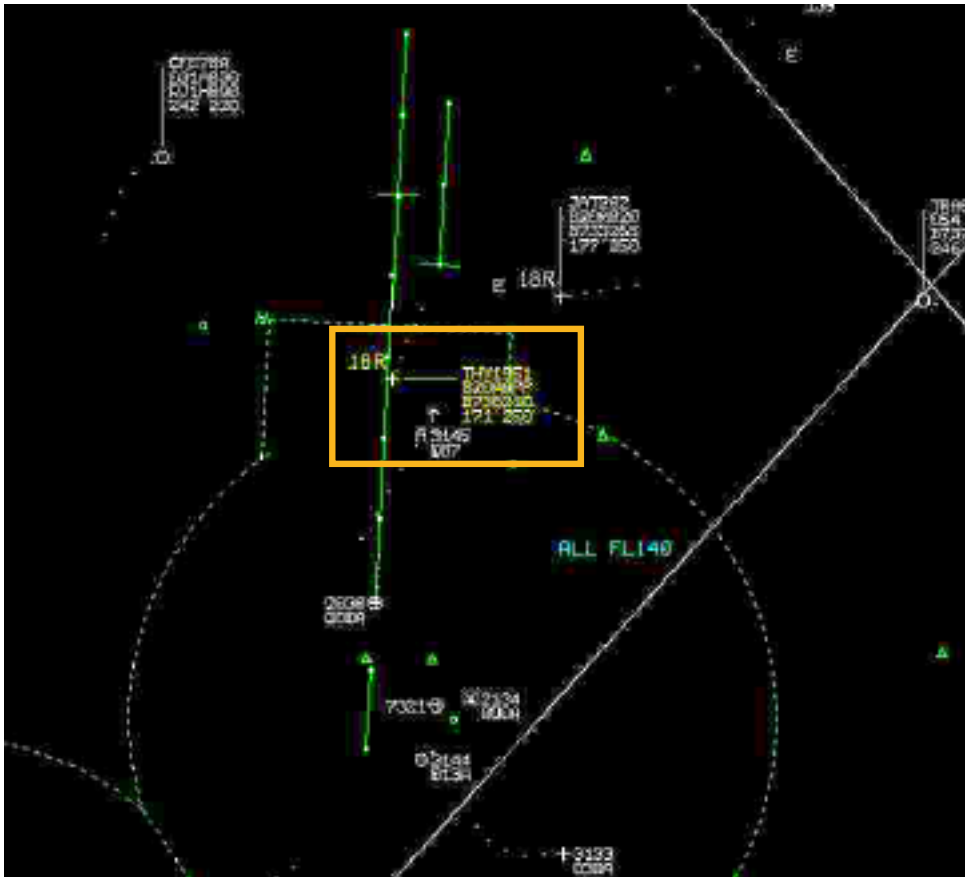
Figure 10: The radar plot on which aircraft TK1951 is still indicated, six miles before the runway.

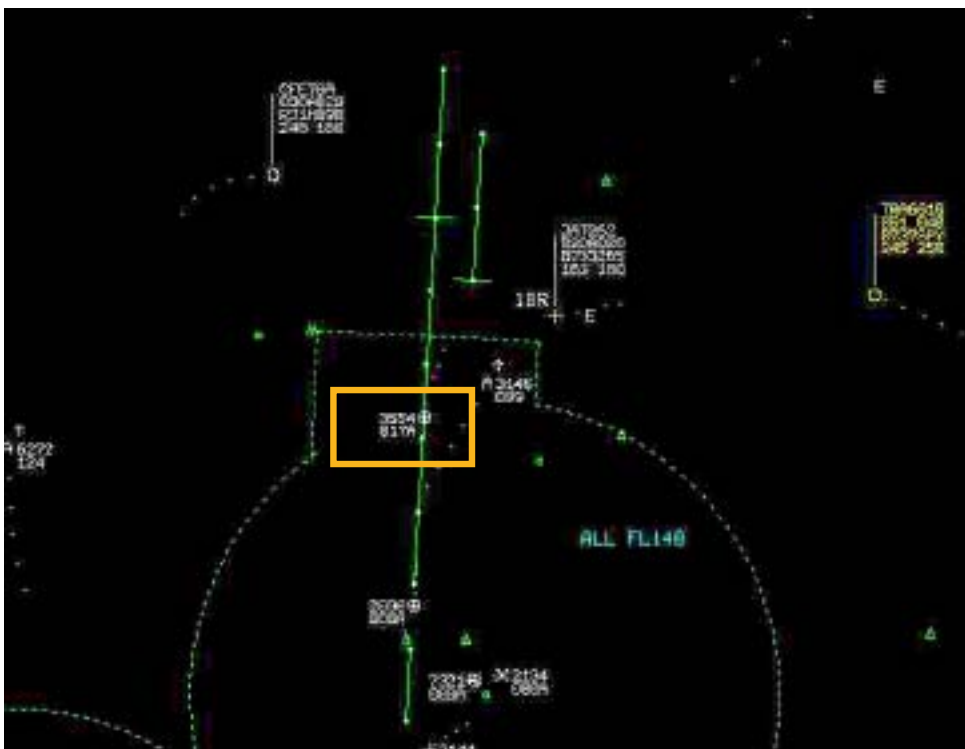
Figure 11: The next radar plot, just before flight TK1951 is no longer visible. After the next screen refresh, the aircraft had disappeared.

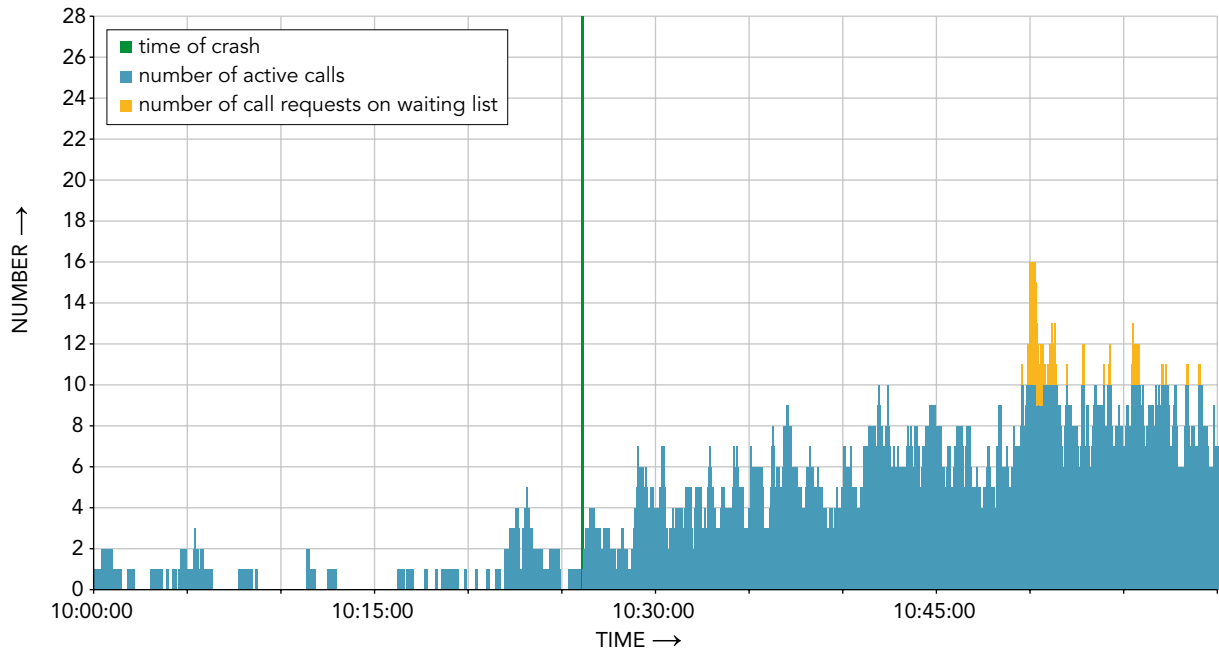
Figure 17: Load Halfweg mast of the C2000 system between 10:00 and 11:00 local time

The figures 17, 18 and 19 show the development of the number of call requests that have been plotted (vertically) based on time (horizontally). The blue bars specify the number of calls that were held at that time. The red bars specify the number of call requests in the queue (the 'busy calls'). The members of the call group in which the call request was placed cannot communicate with each other at that moment in time and must wait until a call channel becomes available. If red peaks cannot be seen, there was, therefore, no queue. The fast changes in the blue and red bars show that the number of current calls and the length of the queue fluctuated highly.<sup>99</sup>

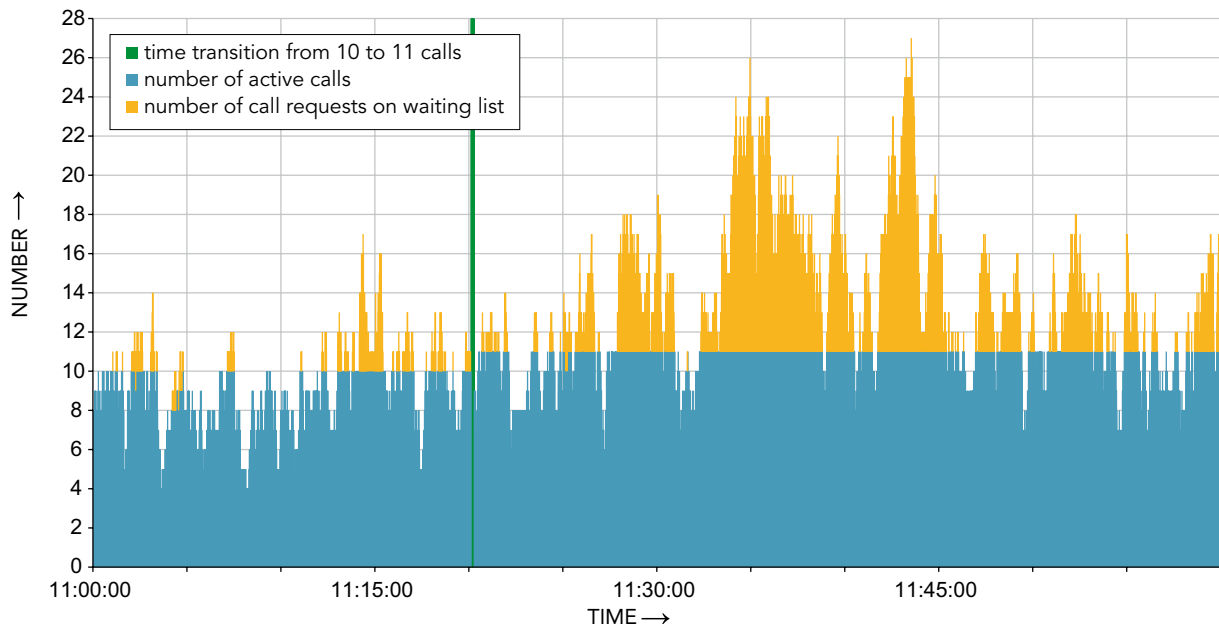
Figure 18: Load Halfweg mast of the C2000 system between 11:00 and 12:00 local time

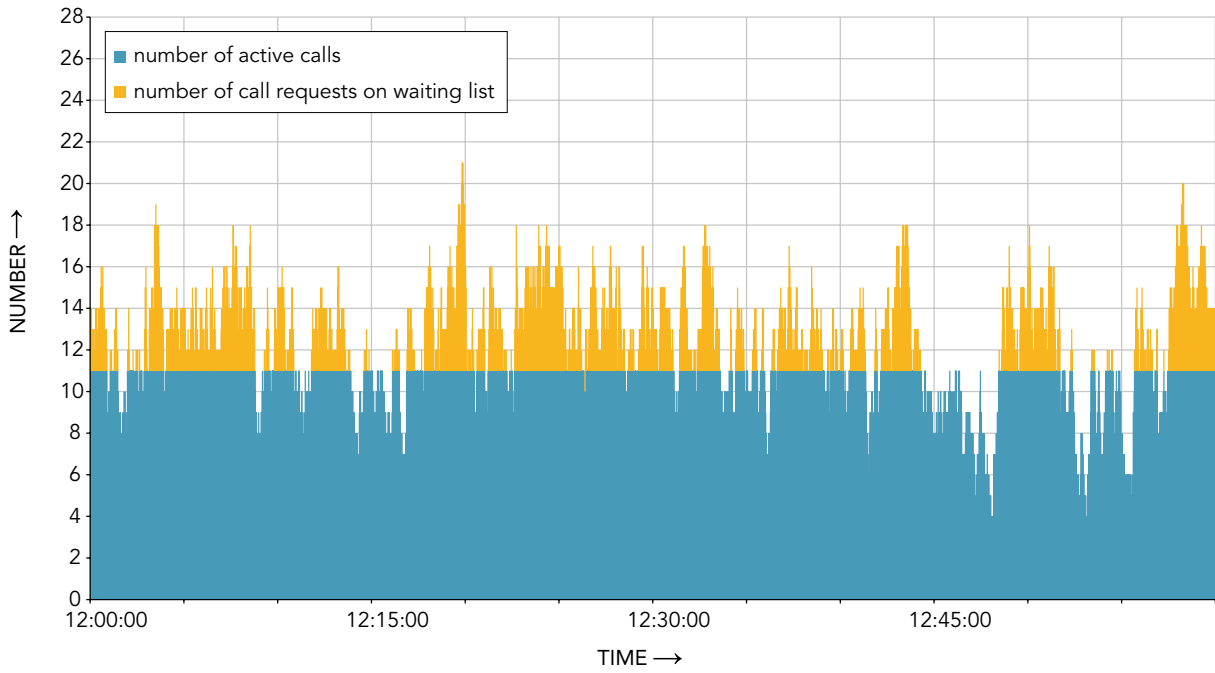
Figure 19: Load Halfweg mast of the C2000 system between 12:00 and 13:00 local time

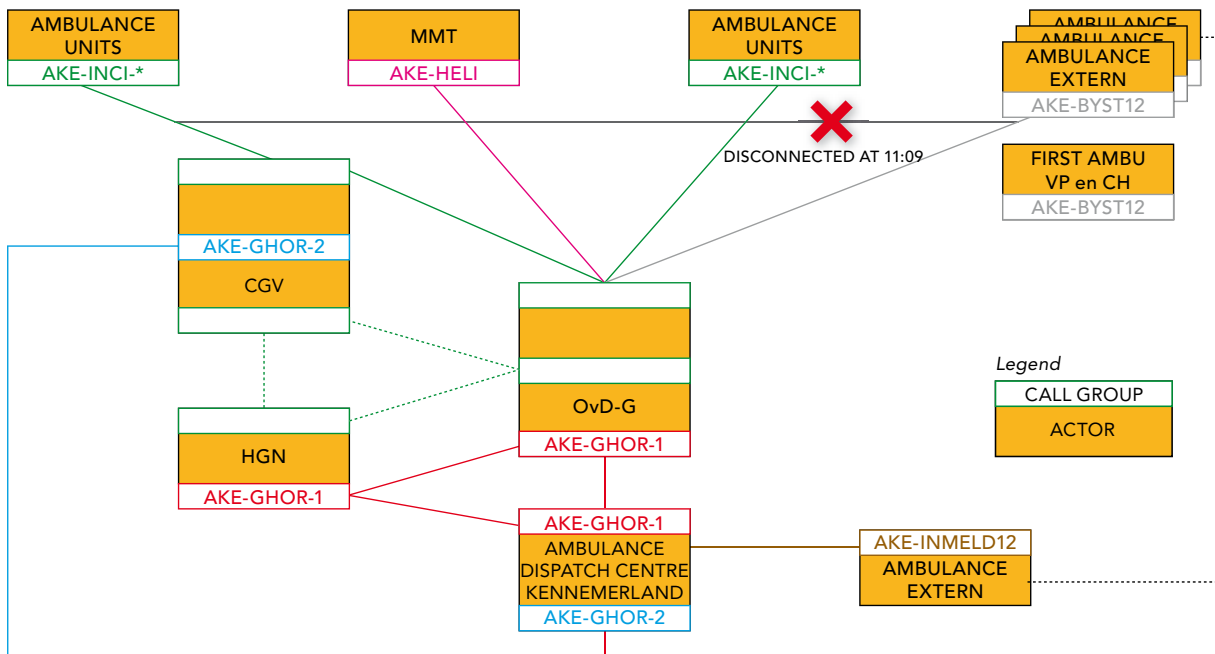
Figure 22: Actual connections on 25 February 2009

The fire brigade of the Kennemerland Safety Region also handled the aircraft accident according to the daily call group structure. This entails that all fire brigade units involved in the handling of the incident are coupled with a single 'incident call group'. From Amsterdam Amstelland, one squad was dispatched. This is an organic support unit which is part of the fire brigade of the Kennemerland Safety Region in accordance with the planning. Because of the heavy load on the Kennemerland control room, the Amsterdam control room was asked to coordinate and supervise the deployment of this squad from the Amsterdam control room. After a short time, the fire brigade of the Kennemerland Safety Region placed a connection command vehicle containing an operator at the site of the accident. The connection command vehicle served as a link between the control room and the field by passing along pooled information, often by telephone. This reduced the load on the Halfweg mast.<sup>104</sup>

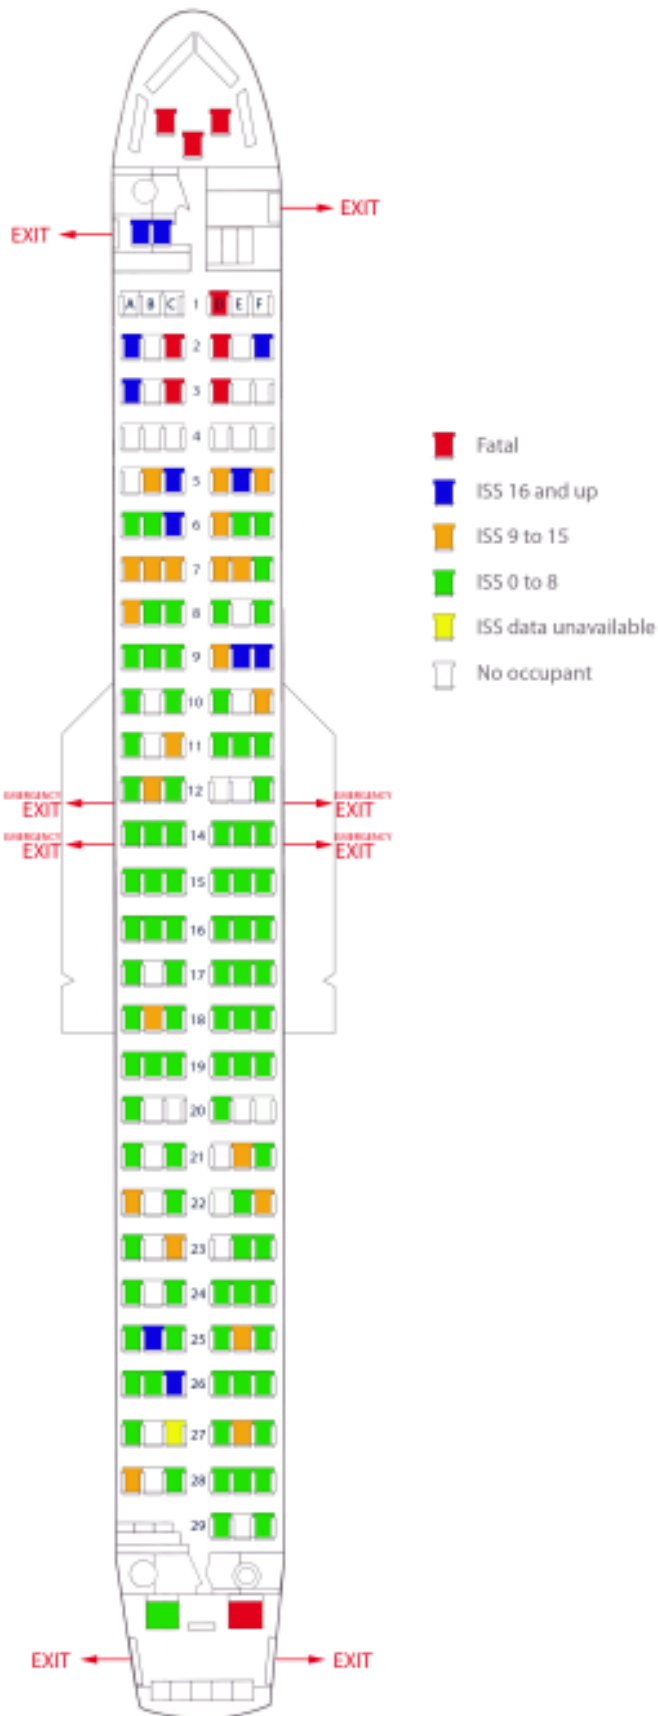
Figure 23: Gravity of injuries to passengers by seating position according to ISS scale  
Please note that not all of the occupants were interviewed or returned the questionnaires. Therefore, it is possible that a few positions in this figure do not coincide with the factual situation.

Many of the wounded had several injuries. The international custom in such cases is to use the ISS scale (Injury Severity Score) instead of the AIS scale. For the three areas of the body where the most serious AIS injuries have occurred, this scale applies the sum of the square of the maximum AIS value in that area.<sup>137</sup> The following table indicates the ISS codes, with the relevant gravity of the injury.
