**Investigation into the cause of the
fast ferry Voskhod 605 accident
on 18 October 2003
in Amsterdam**

The Hague, May 2005

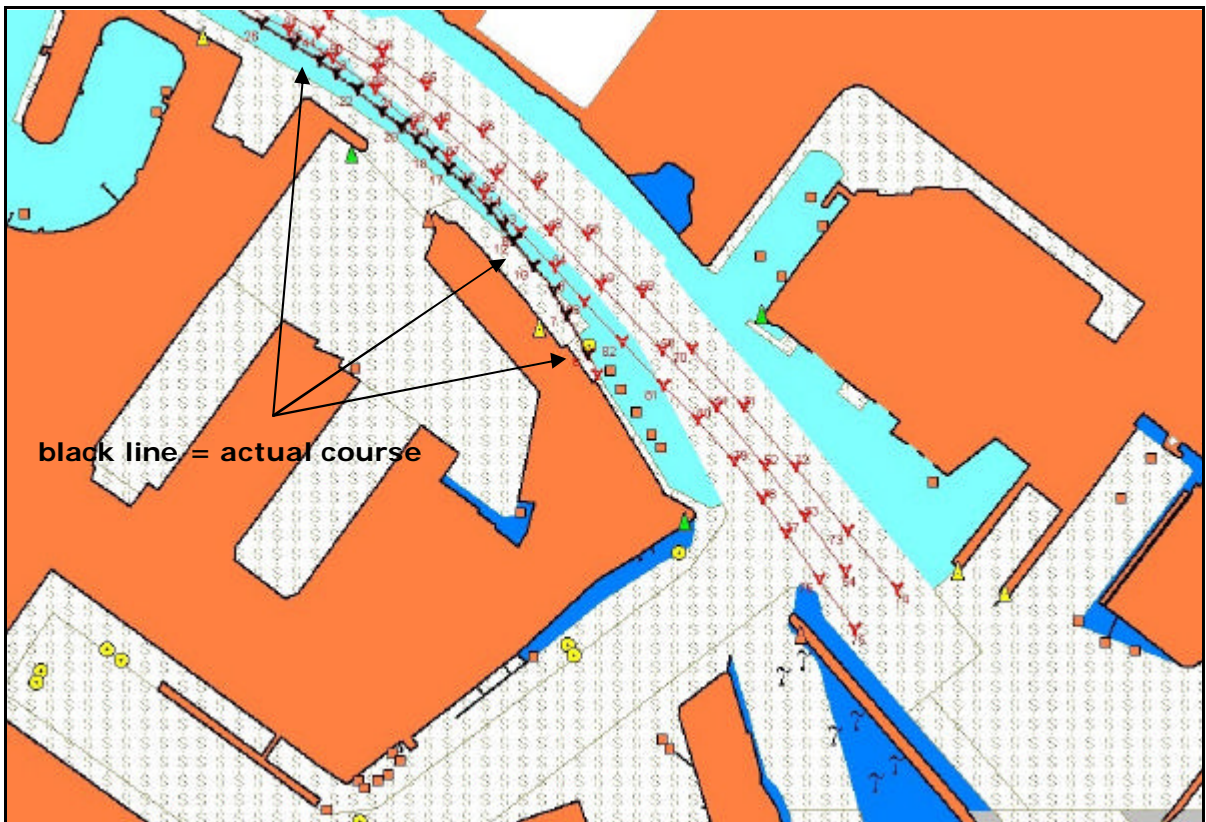
Figure 1b: Course of the Voskhod 605 prior to the accident¹

¹ The black line is a reconstruction of the distance covered on the basis of the positions recorded in the installed Global Positioning System. NB: the symbols in the line bear no relation to velocity, distance covered or GPS point of measurement. The other red track lines bear no relation to the accident.

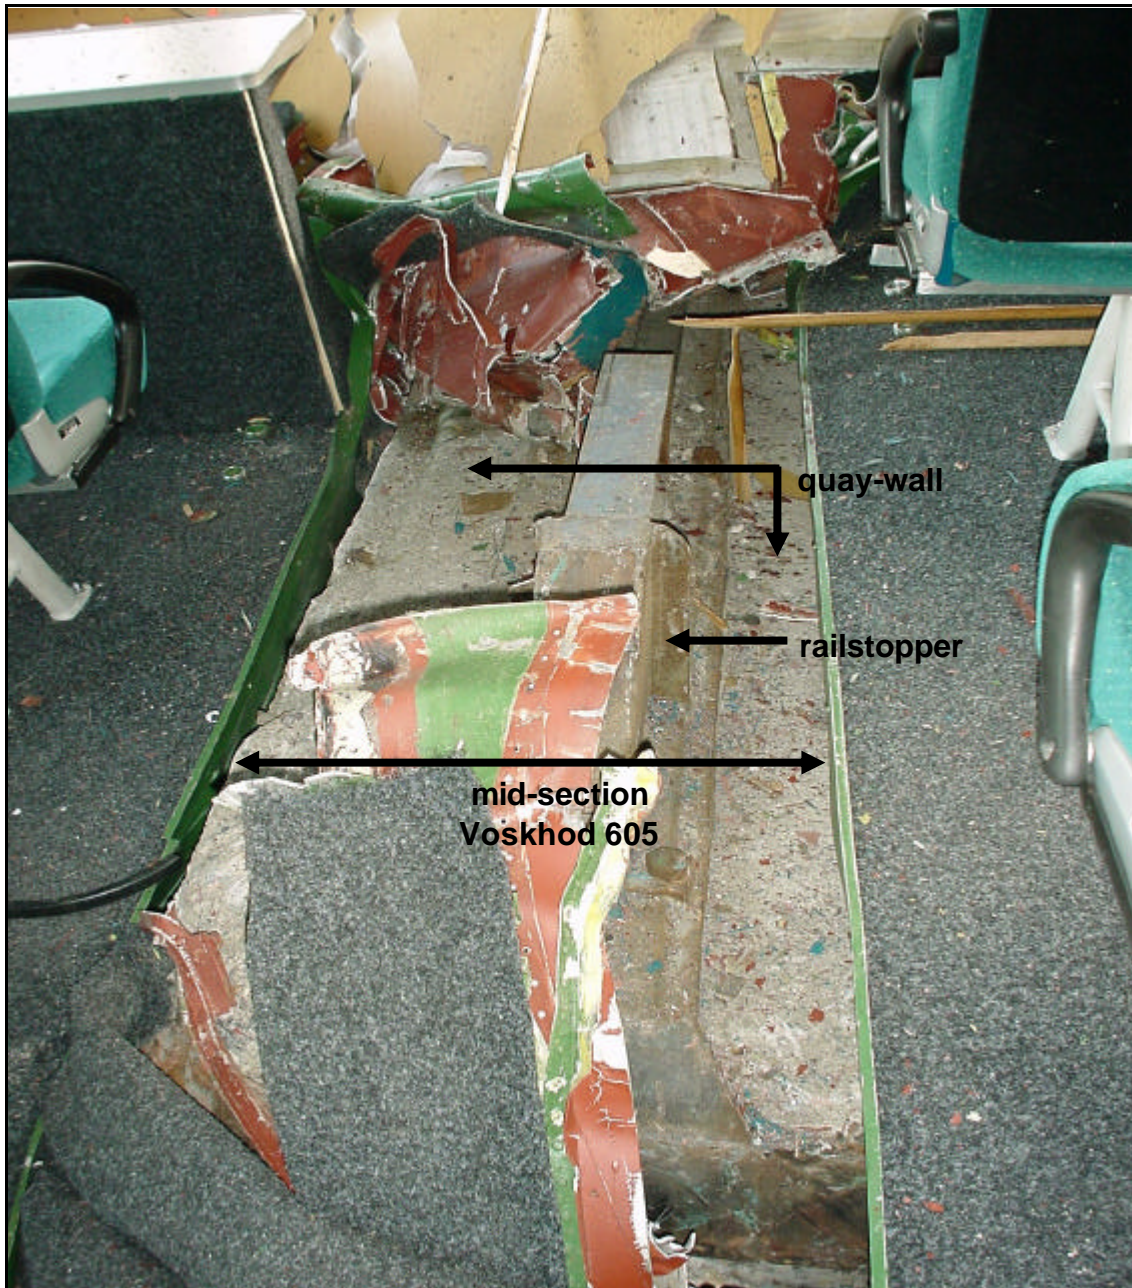
At the collision, the fast ferry Voskhod 605 was pushed onto the quay, at which the stopper tore open the bottom of the vessel along several meters, exactly in the walking space between the chairs (see figures 3, 4 and 5).

Figure 3: Photo of the quay wall and a rail that have torn open the mid-section, taken from the front passenger compartment of the Voskhod 605.

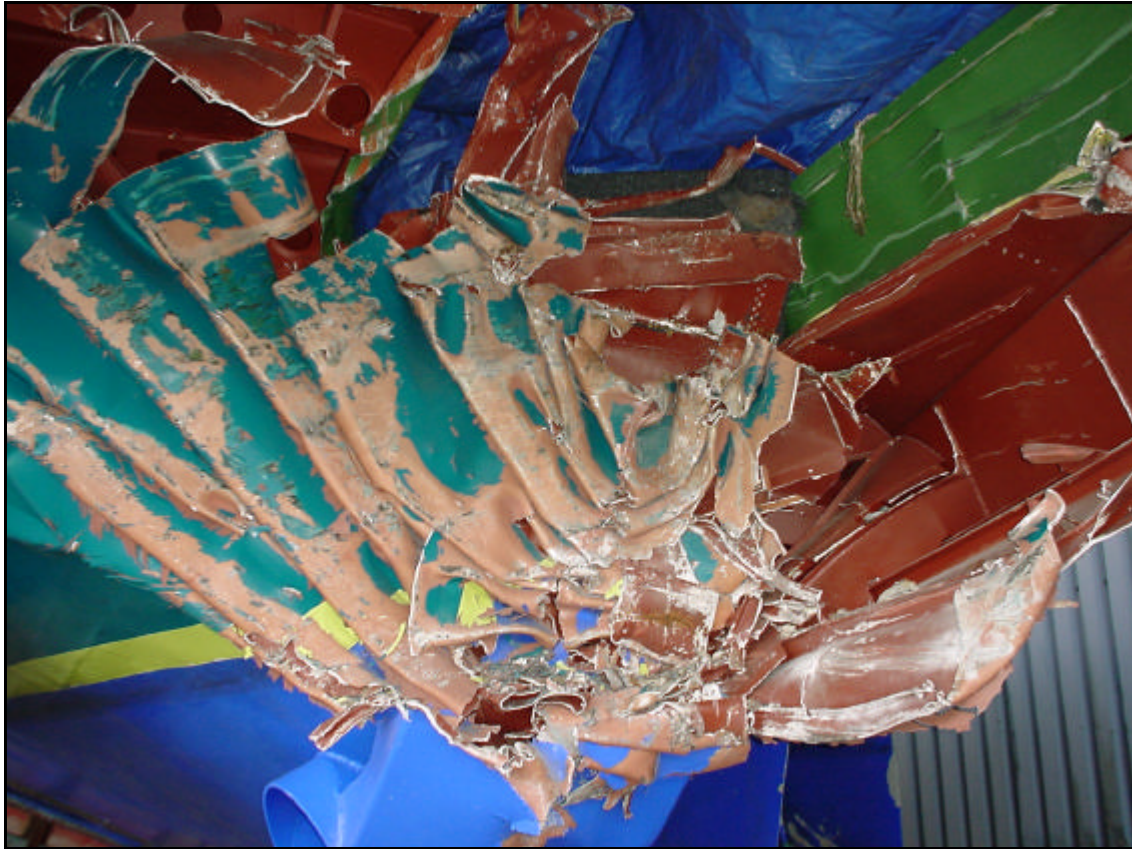
Figure 4: Photo of the deforming of the ship's hull of the Voskhod 605 as a result of the forces exerted at the collision.

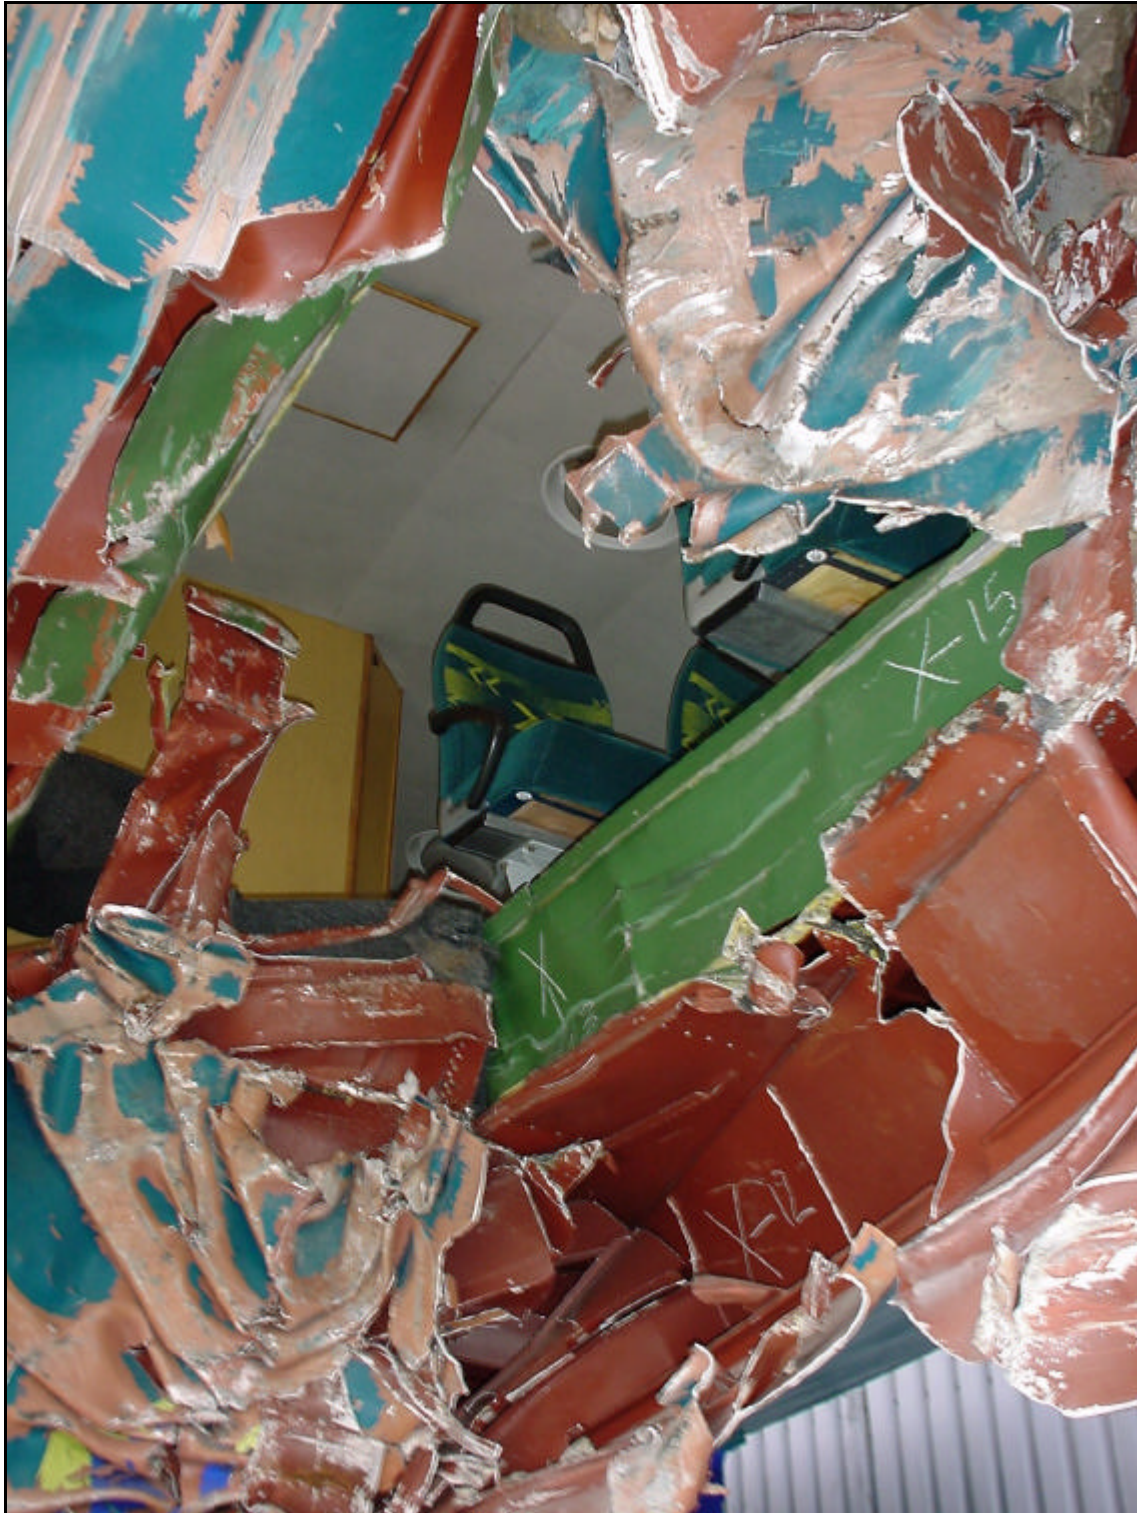
Figure 5: View of the front passenger compartment of the Voskhod 605 through the torn-open ship's hull.

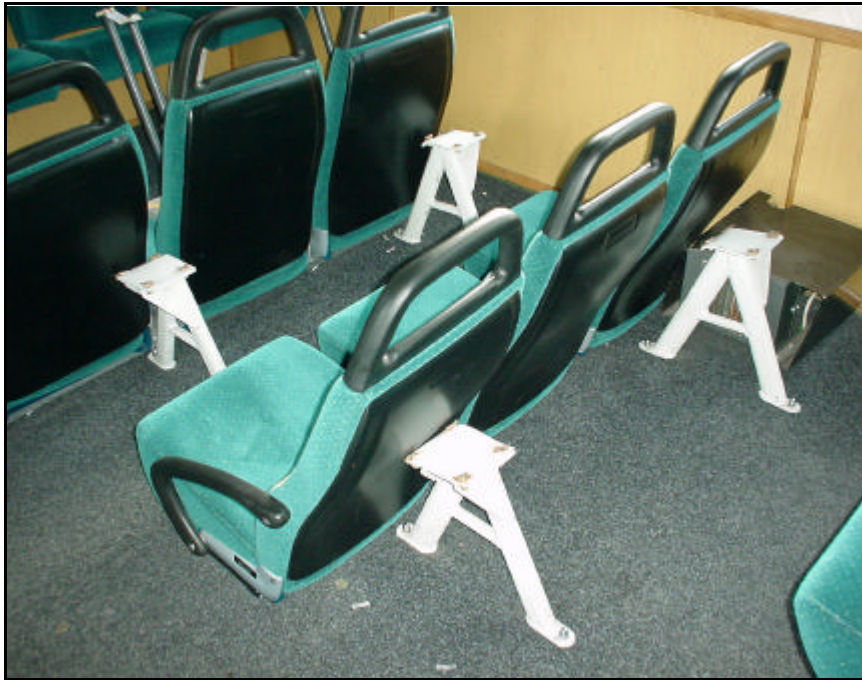
A good example of either the lack, or later, the implementing of regulations is the mounting of the chairs. By the force of the impact the fastening points broke off, as a result of which passengers got injured. The lack of shock-absorbing material has probably caused even more serious injuries. The photos below (figures 6 and 7) clearly show that many chairs, or parts of chairs, have broken off. They also show that the connection between the metal frame and the seats as well as the mounting of the frame to the floor has appeared insufficiently solid.

Figure 6: Photo of broken mountings of passenger seats

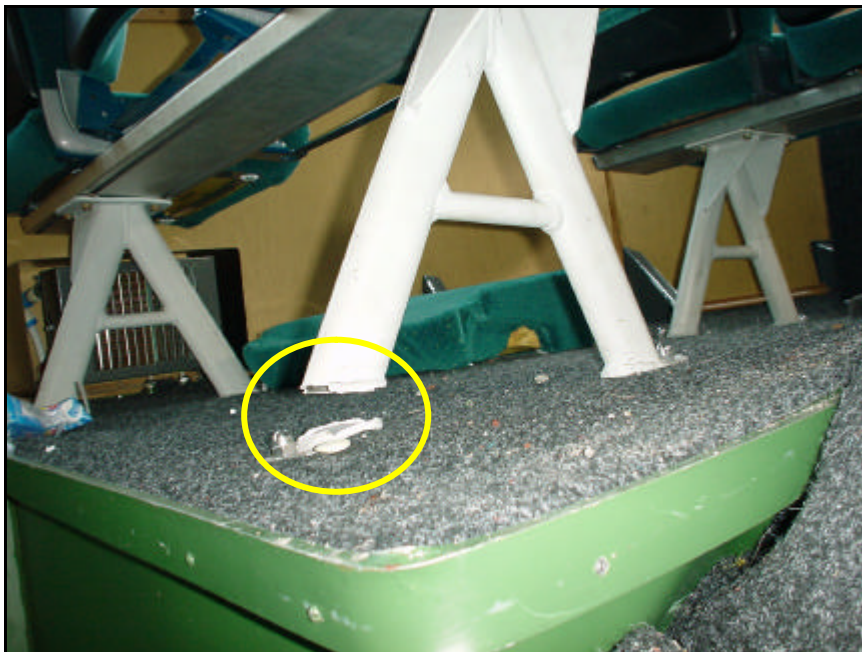
Figure 7: Photo of passenger seat torn off floor mounting.
