# Train collision Amsterdam Westerpark

*The Hague, December 2012*

On 21 April 2012 a train collision occurred in Amsterdam, near Westerpark. A sprinter and an intercity train collided head-on. At least 190 out of at least 425 occupants<sup>1</sup> were injured, of whom 24 were found to have sustained serious injuries. A day after the accident one of the seriously injured passengers died as a result of the injuries suffered.

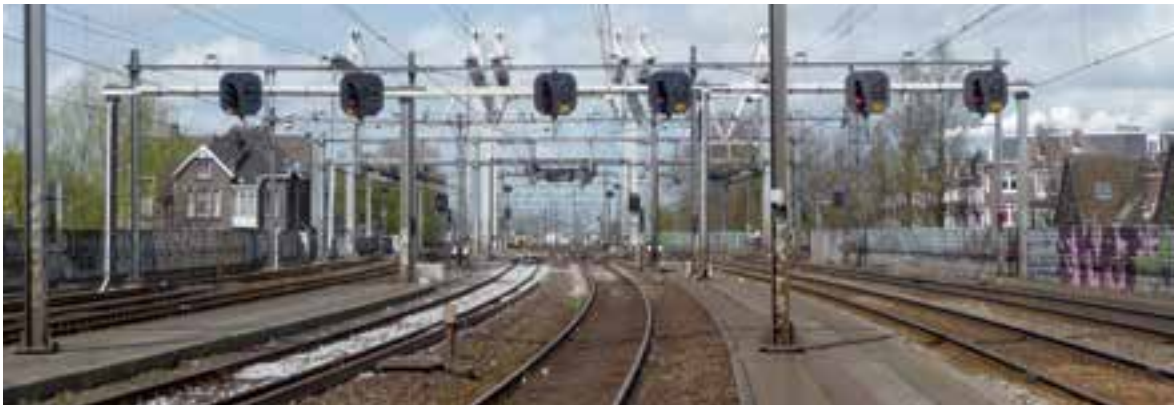
The driver approached signal 494 at Singelgracht Aansluiting in this manner. This signal is positioned just before the Singelgracht bridge (see figure 5). This signal marked the end of the route that the signaller had set for the sprinter. The signal was therefore red on approach. The ATB signal in the train's cab had remained 'yellow' since the previous signal, which in this situation means that the train was approaching a red signal.<sup>23</sup> The ATB also monitored that the train was not approaching the signal faster than 40 km/hour.

Figure 5: Signal 494 is the fourth signal from the left and is positioned just before the Singelgracht bridge. The photograph was taken the day after the collision; the sprinter had been towed away by this time. Source: Dutch Safety Board

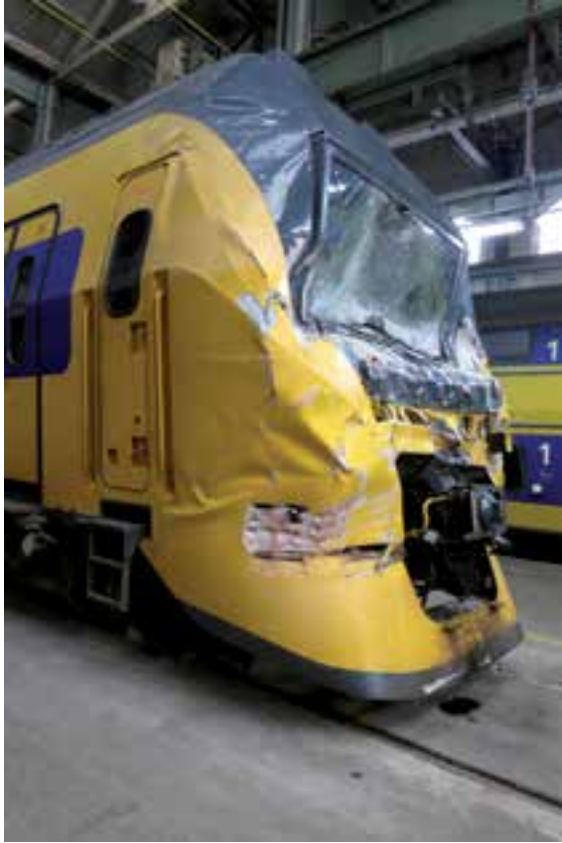
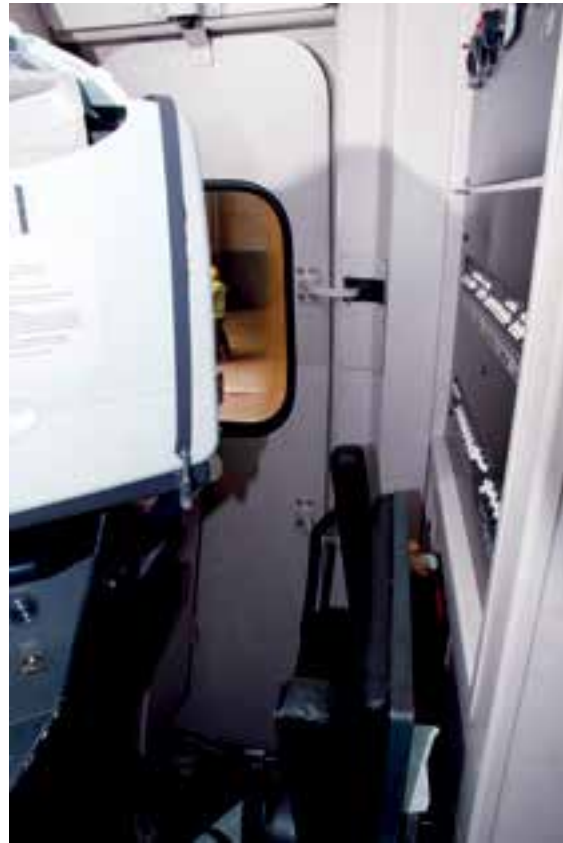
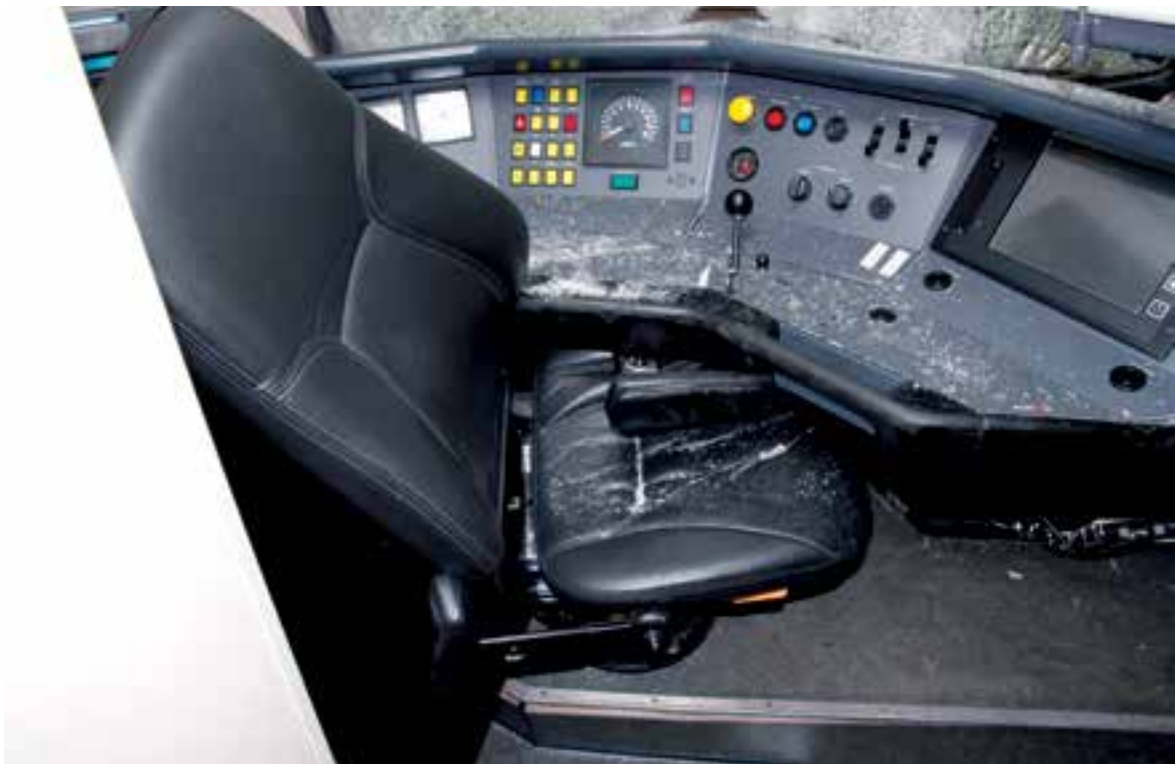
The intercity's driver's compartment was deformed during the collision. This caused the driver's desk to be moved back around 0.5 metres and pushed over the driver's seat. An air-conditioning unit mounted on the driver's desk was moved backwards along with the desk (see figure 9).

Figure 9: Upper left: damaged nose of the intercity. Upper right: the air conditioning unit that had been pushed backwards. Bottom: damage to the driver's desk. Source: Dutch Safety Board

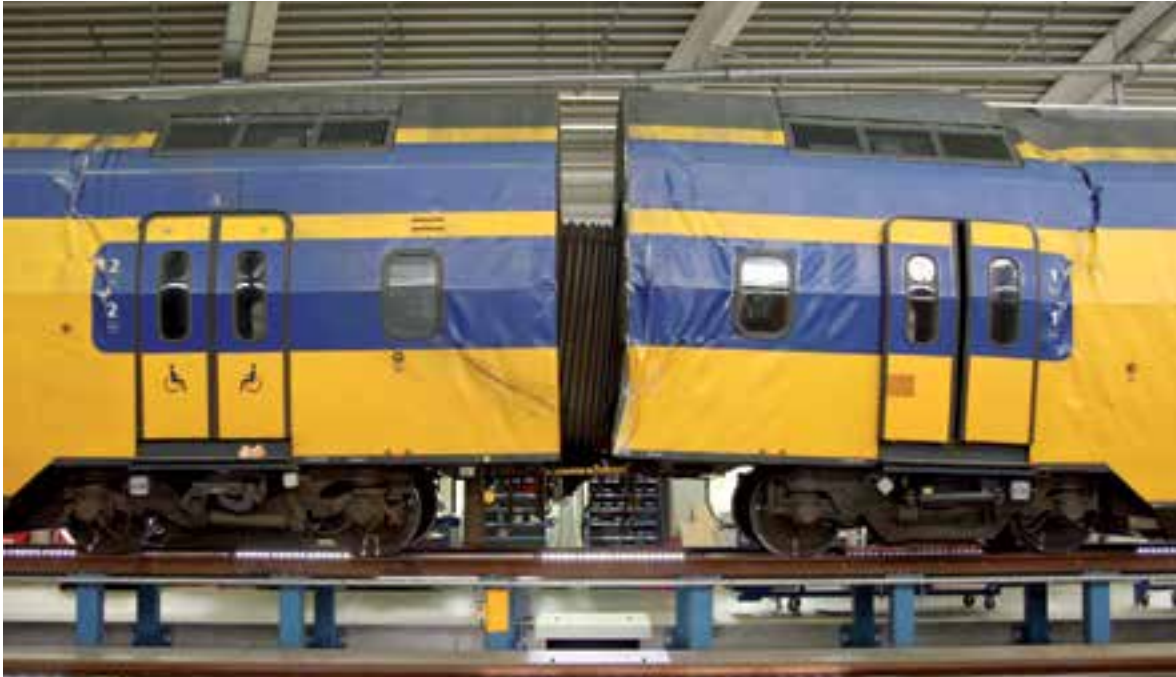
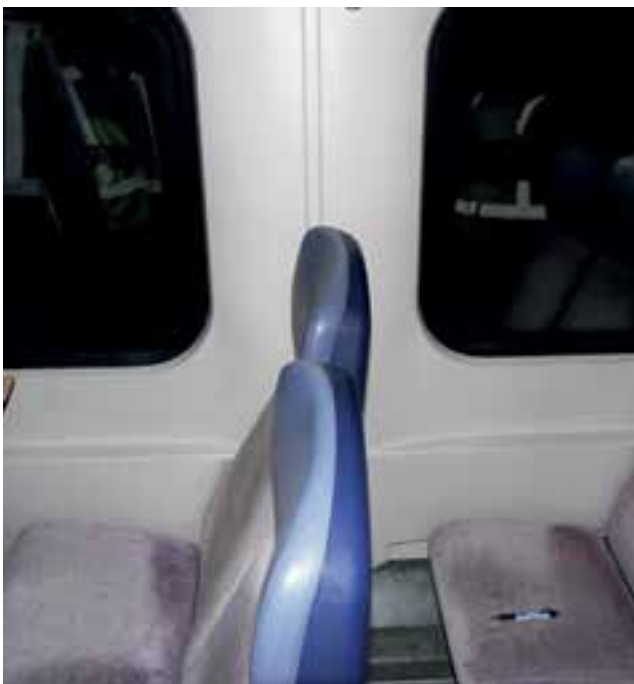
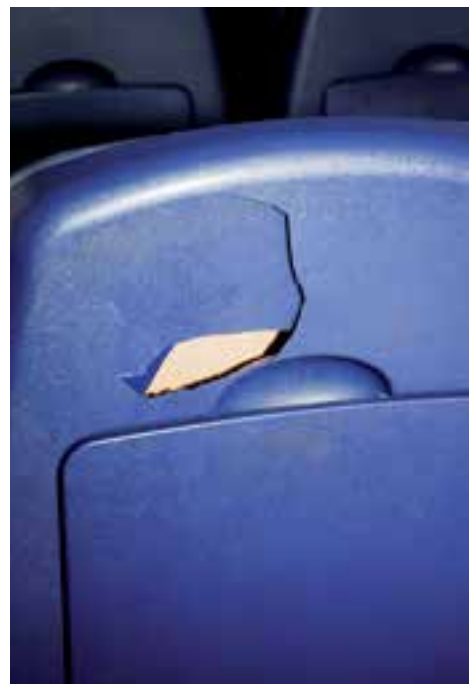
During the collision the coupler at the end of the train was pushed inwards around 0.3 metres. The couplers between the coaches failed, causing the coaches to collide with one another. This led to deformation of the front ends of the coaches. The coaches were also deformed at the junction between the vestibule and the passenger compartment.

Damage to the interior mainly affected the seats and the dislodging of components such as ceiling units and light boxes.

Figure 10: Top: damaged ends of coaches. Bottom left: deformed seat. Bottom right: damaged seat. Source: Dutch Safety Board

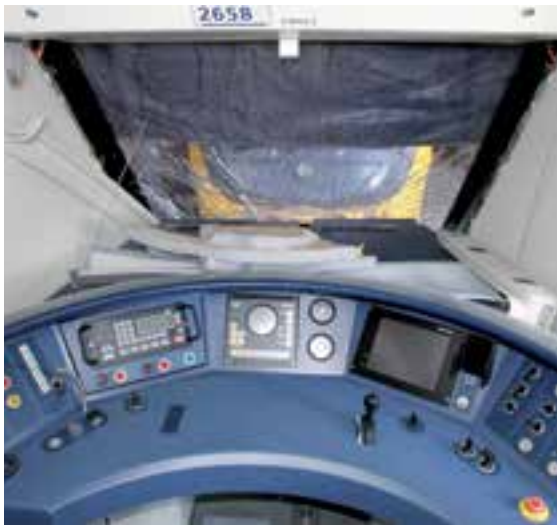
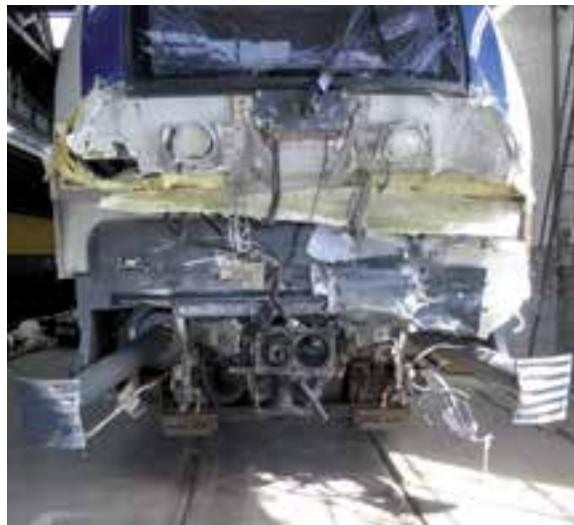
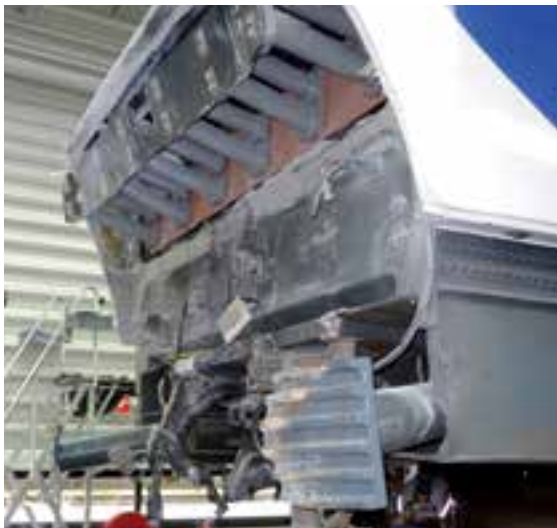
The couplings between the coaches are also fitted with crash absorbers. The crash absorbers between the first four coaches were compressed as far as they would go during the collision. The crash absorbers between the remaining coaches were not or only partially compressed.

*Figure 11a: Top left damaged driver's compartment of the sprinter. Top right: damaged nose of the sprinter. Bottom left: nose of the sprinter following removal of the entire plastic nose. Source: Dutch Safety Board*

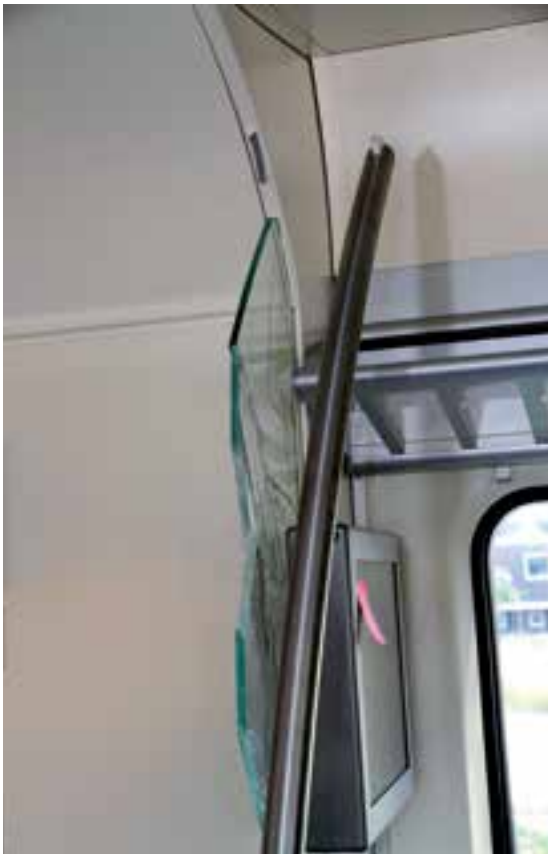
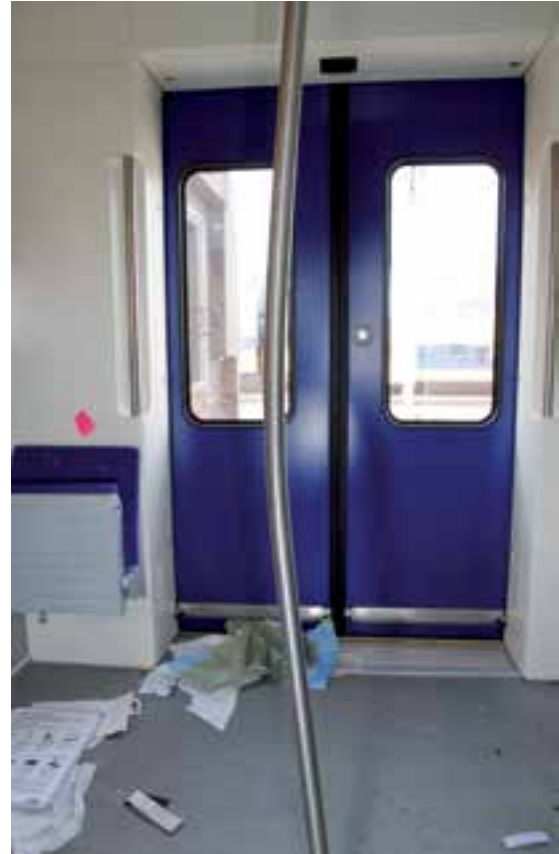
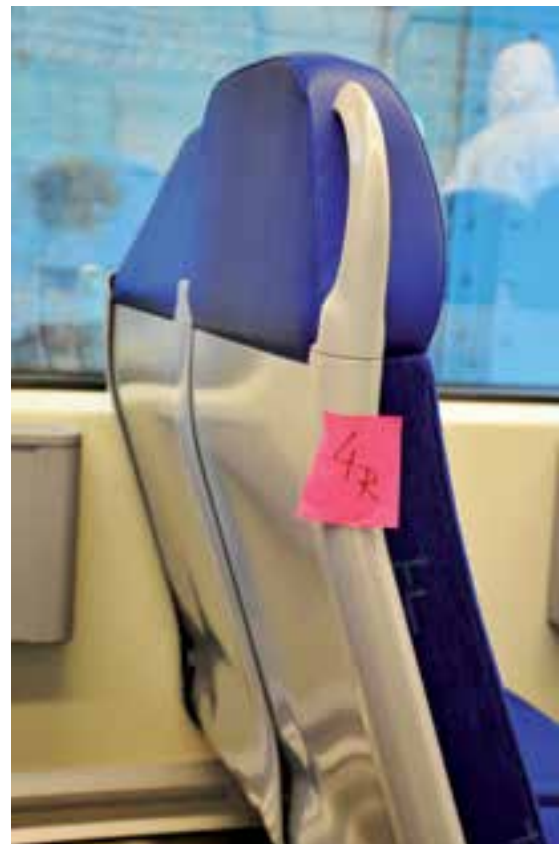
The sprinter's passenger compartments were not visibly deformed, however a number of interior glass partition walls were broken. A number of the bars to which these partition walls were attached had broken away from their ceiling fastenings. Some of the handrails, head rests and rear seat panels were also deformed (see figure 11b). A number of ceiling units were also partially dislodged.

Figure 11b: Top left: broken track fastening. Top Right: deformed handrail. Bottom left: glass wall. Bottom right: deformed seats. Source: Dutch Safety Board

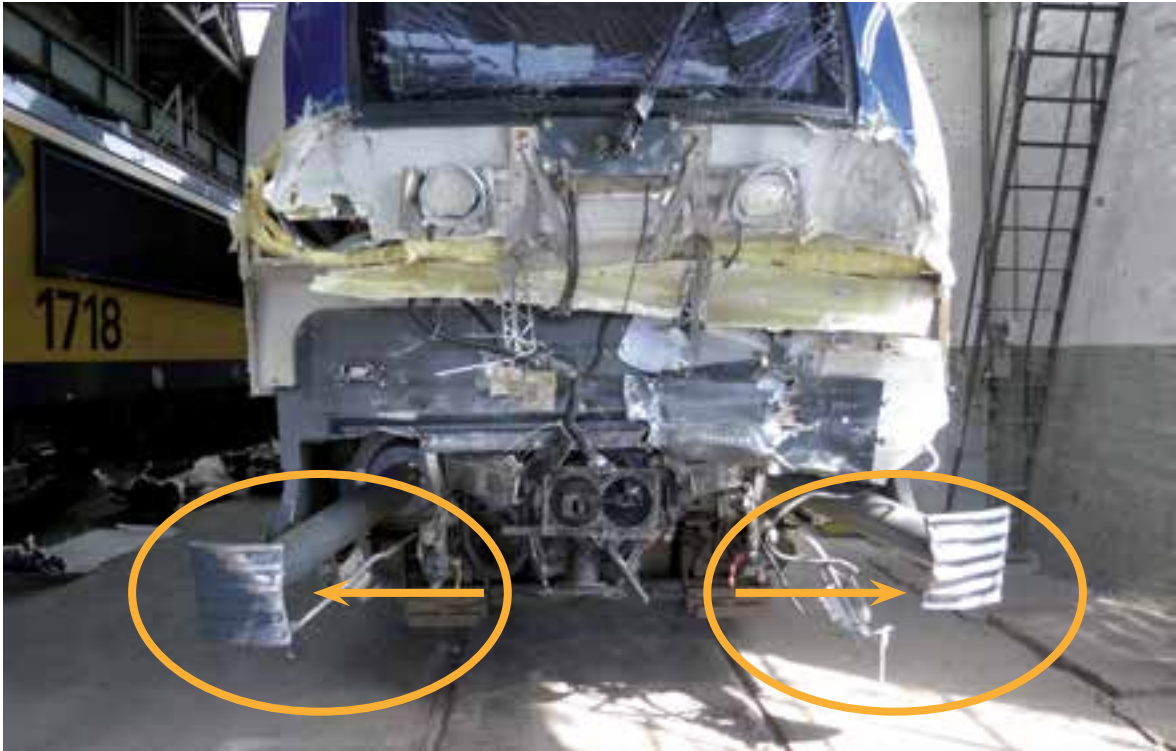
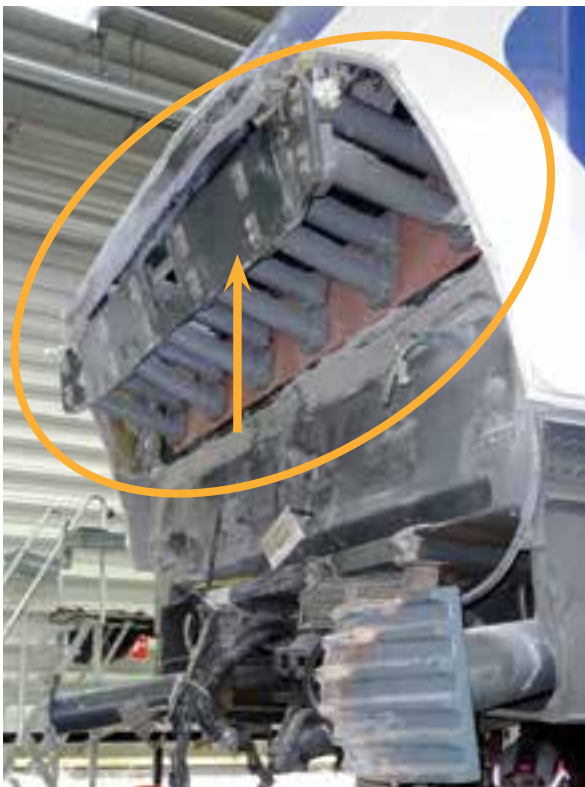
Figure 14: The two photos show the sprinter's twisted crash absorbers (lower photo: after removal of entire plastic nose). Source: Dutch Safety Board

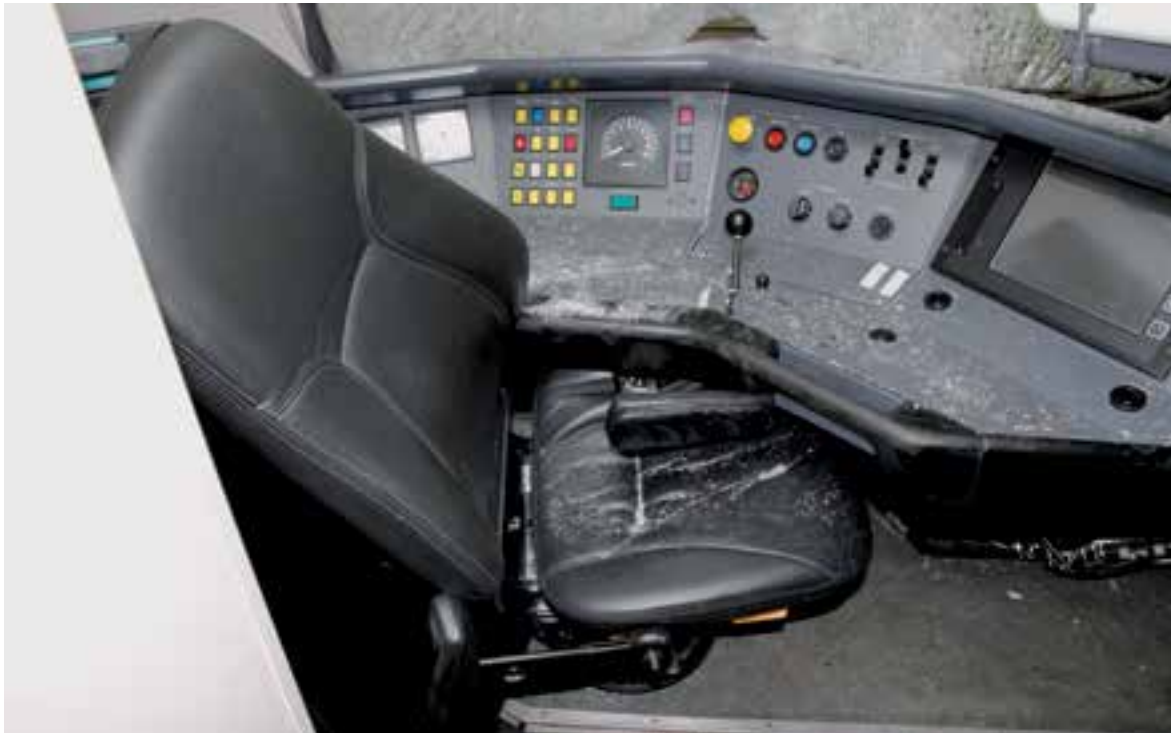
The investigation revealed that the front of the intercity was especially deformed by the impact of collision. This deformation of the train's structure also affected the driver's compartment interior: the driver's desk and the various interior components connected with it were pushed back around 0.5 metres, thus reducing the amount of survival space available to the train driver and second man (see figure 15). The train driver and second man thus ran the risk of becoming trapped and sustaining potentially fatal injuries. In accordance with the unwritten rule, the two both left their seats right before the collision. They therefore avoided becoming trapped, however they did not escape injury (see section 4.4.2).

Figure 15: Compacted intercity driver's desk. Source: Dutch Safety Board

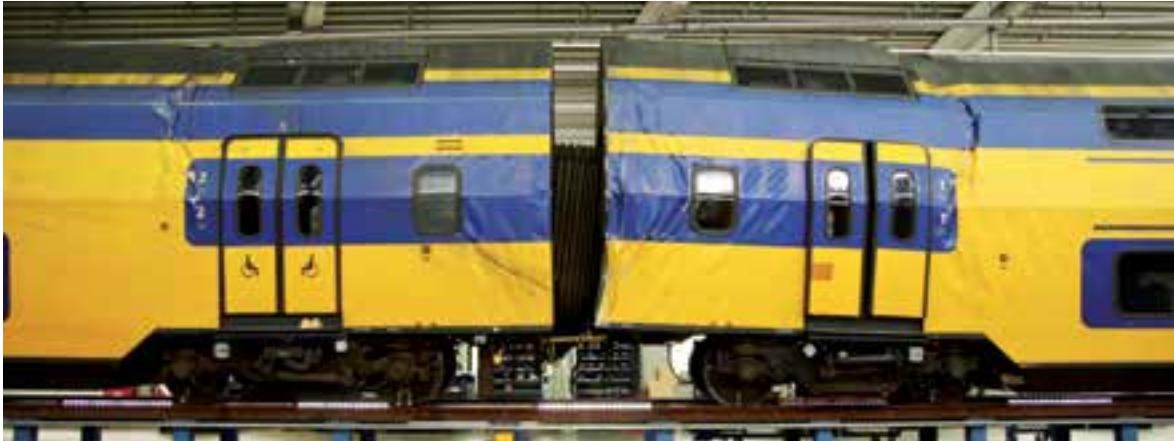
The intercity's coaches collided with one another. This resulted in deformation of the ends of the coaches (see figure 16). These deformations were not serious enough to cause the entrapment of any occupants. However, they did affect the train interior (see section 4.4.2). The sprinter's coaches were barely deformed.

Figure 16: Deformation of the ends of the intercity coaches. Source: Dutch Safety Board

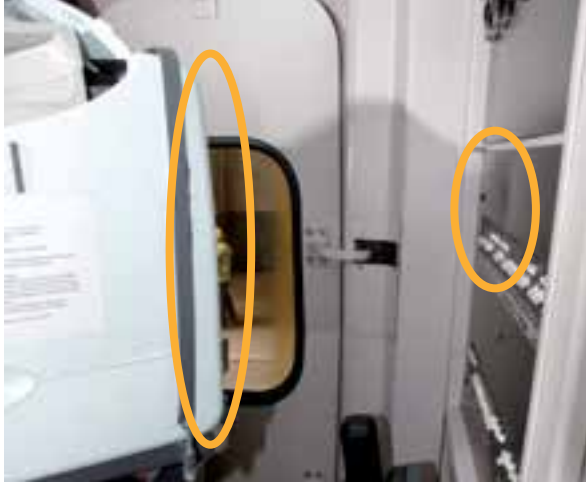
Figure 18: Top: interior of intercity's driver's compartment, at second man's station. The photo clearly shows the retracted air conditioning unit and dented rear wall, with circles around the probable contact points. Bottom: sprinter driver's compartment interior with console. Source: Dutch Safety Board

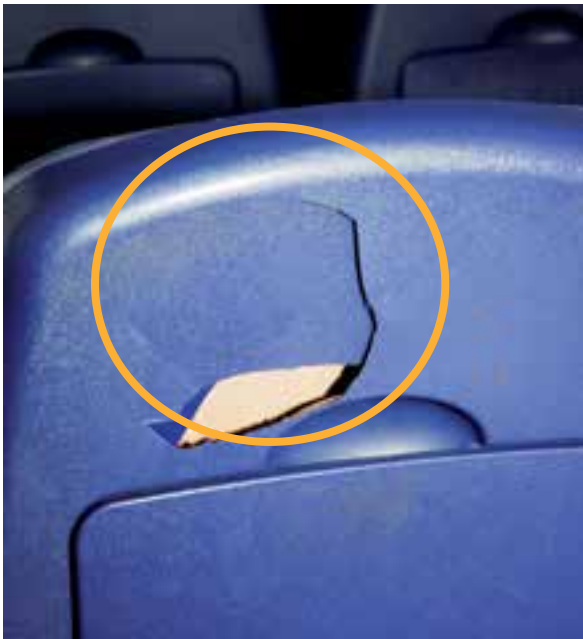
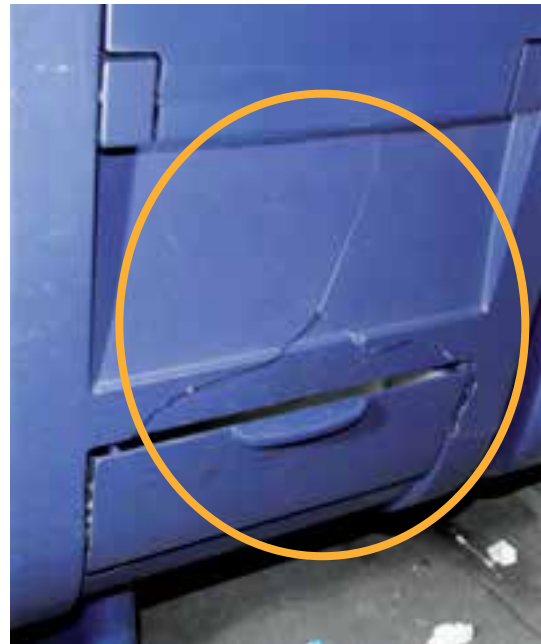
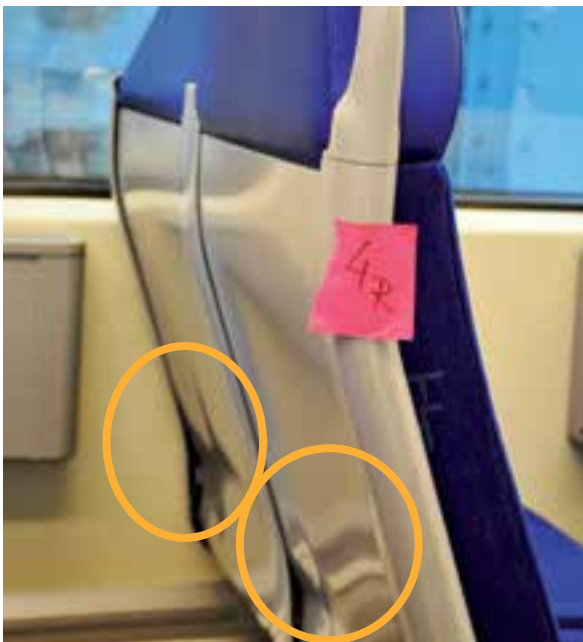
The headrests of various sprinter seats were bent forward. The aluminium plate at the rear of several chairs was dented at knee-height. The deformation of these seats helped to limit the force exerted on the occupants who collided with the seats, thus limiting the risk of injury.

Figure 19: Damage to the intercity and sprinter interiors. Top left: broken plastic in the rear of intercity seats, at head height; Top right: broken plastic in the rear of intercity seats, at knee height; Bottom left: damage to the rear of sprinter seats positioned behind one another in rows. Source: Dutch Safety Board

Based on the insights yielded by previous train crashworthiness studies<sup>70</sup> it is reasonable to assume that the different seat materials played a role in the occurrence of injuries. Plastic can crack and result in sharp edges. This occurred in the rear of the seats in the intercity and may have affected the nature and seriousness of the injuries sustained.

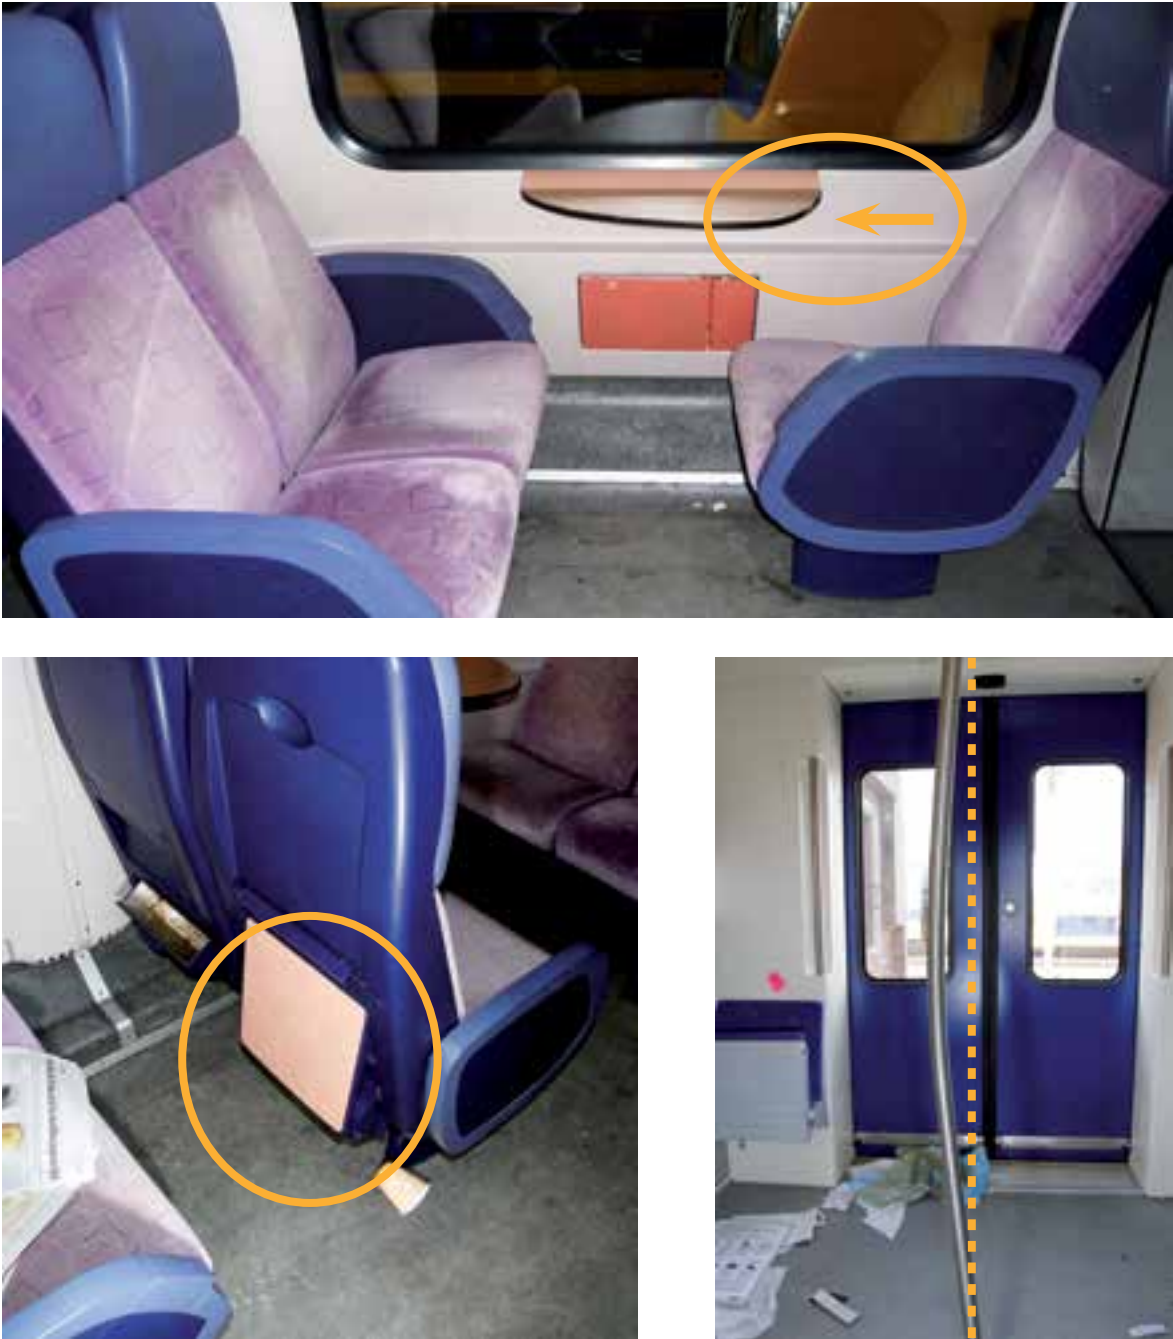
Figure 20: Top: the undamaged table in the section of the intercity where the passenger was fatally wounded; Bottom left: a folded table in the rear of an intercity seat; Bottom right: a deformed bar in the sprinter vestibule, probably bent in a collision with a passenger. Source: Dutch Safety Board

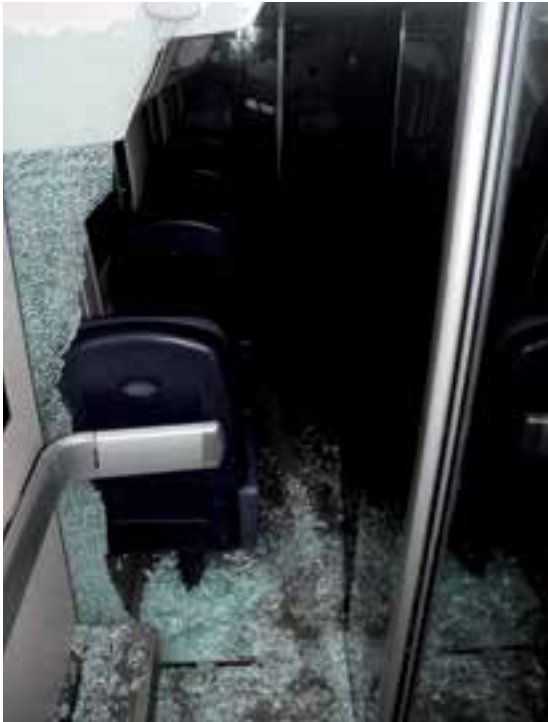
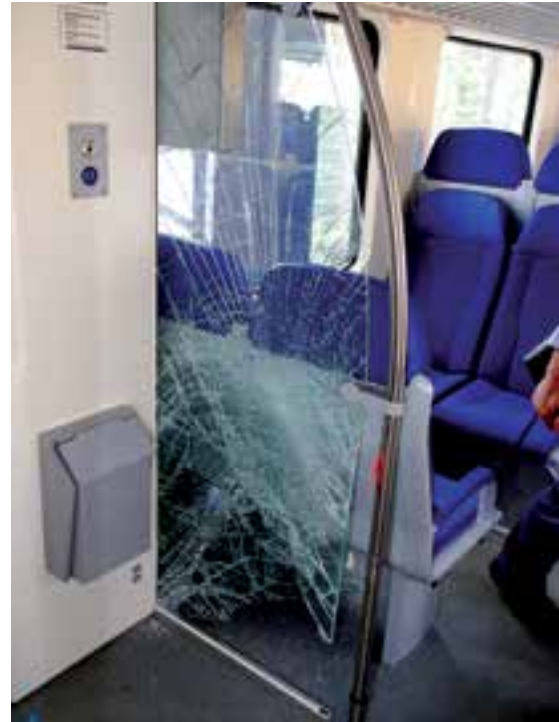
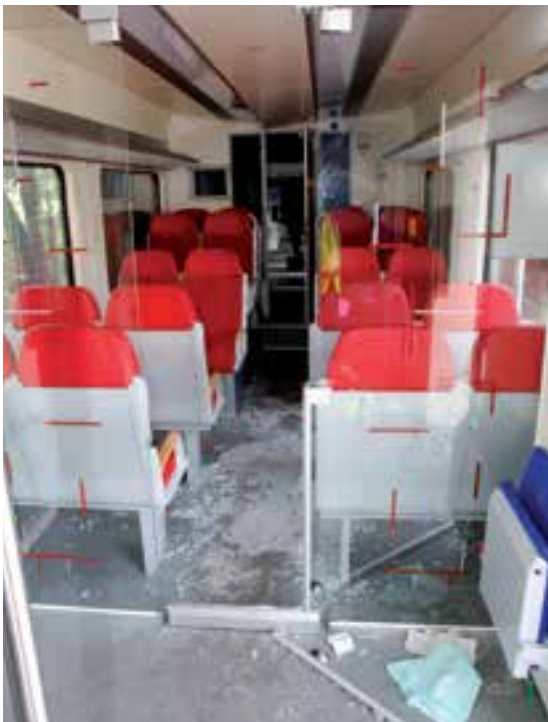
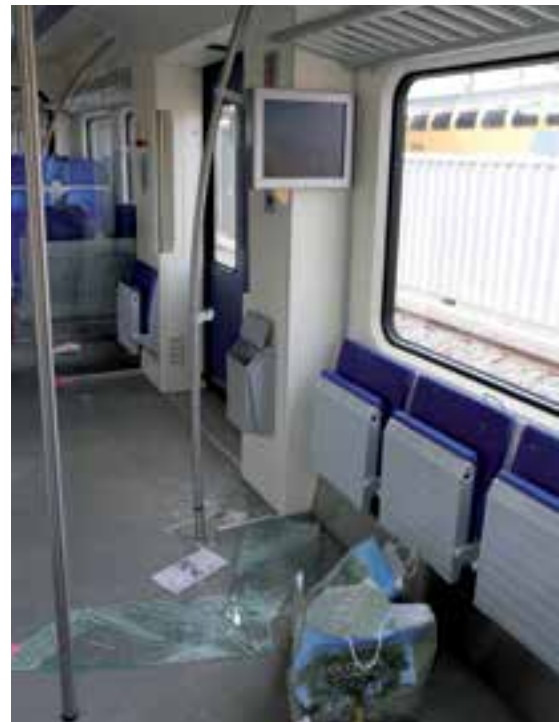
No requirements are imposed on the performance of the glass in the event of a collision, such as the load the glass must be able to bear, the consequences of a collision, and whether the glass must break or remain whole. From the perspective of crashworthiness and injury risk management, it is advisable to avoid the occurrence of sharp components (sharp edges, splinters) when glass breaks. It is also important that glass does not become separated from mounting points or foil layers and fly through the compartment in the event of a collision.

Figure 21: Glass damage. Top left: entrance to intercity passenger compartment; Top right: broken glass partition wall in sprinter; Bottom left: shattered glass door in sprinter; Bottom right: broken and dislodged glass shards in sprinter. Source: Dutch Safety Board

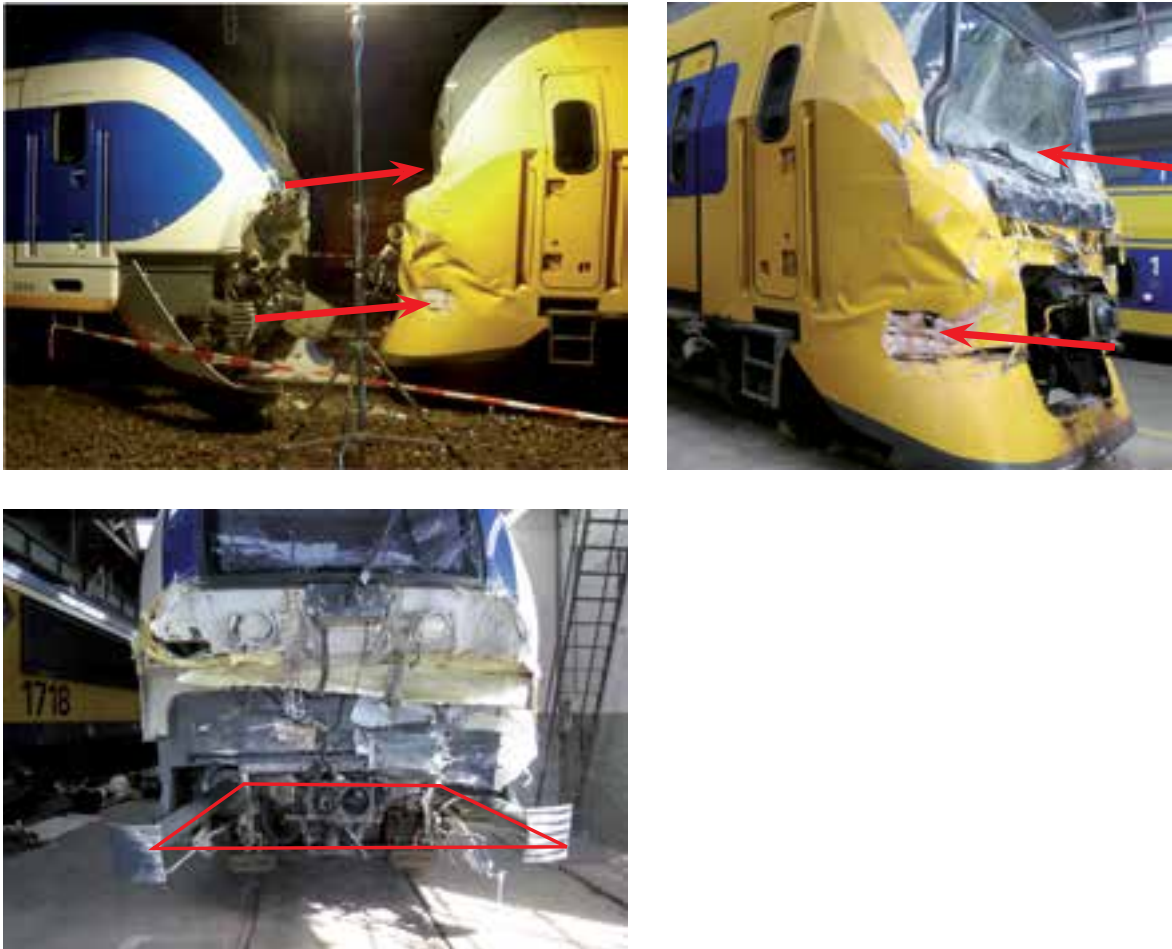
Figure 24: These photos show the incompatibility of the two trains. Top left: the final position with deformations caused by the collision. Top right: damage to the intercity's nose. Bottom left: the sprinter's crash absorbers, which bent outwards as a result of the collision. Source: Dutch Safety Board

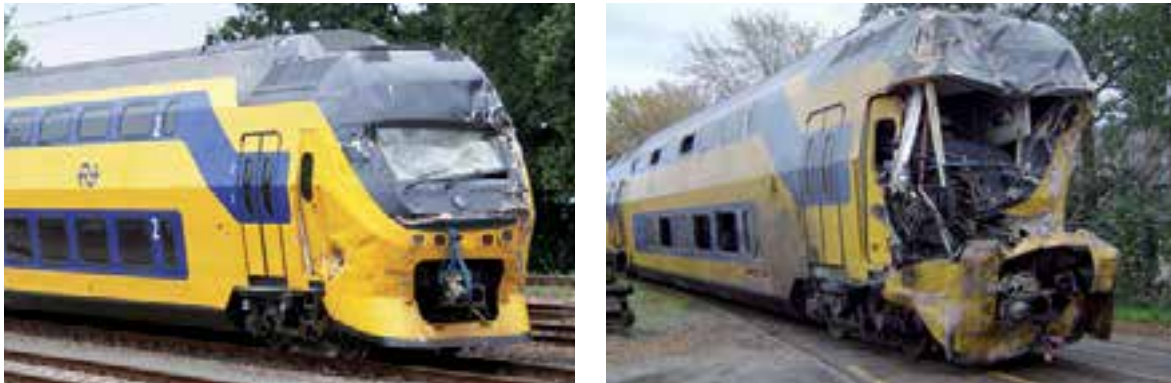
Figure 25: Examples of serious deformations of the driver's compartments of comparable intercity trains (VIRM) as a result of level crossing collisions with a truck; left: Maarheeze, June 2010; right: Wijhe 2005.

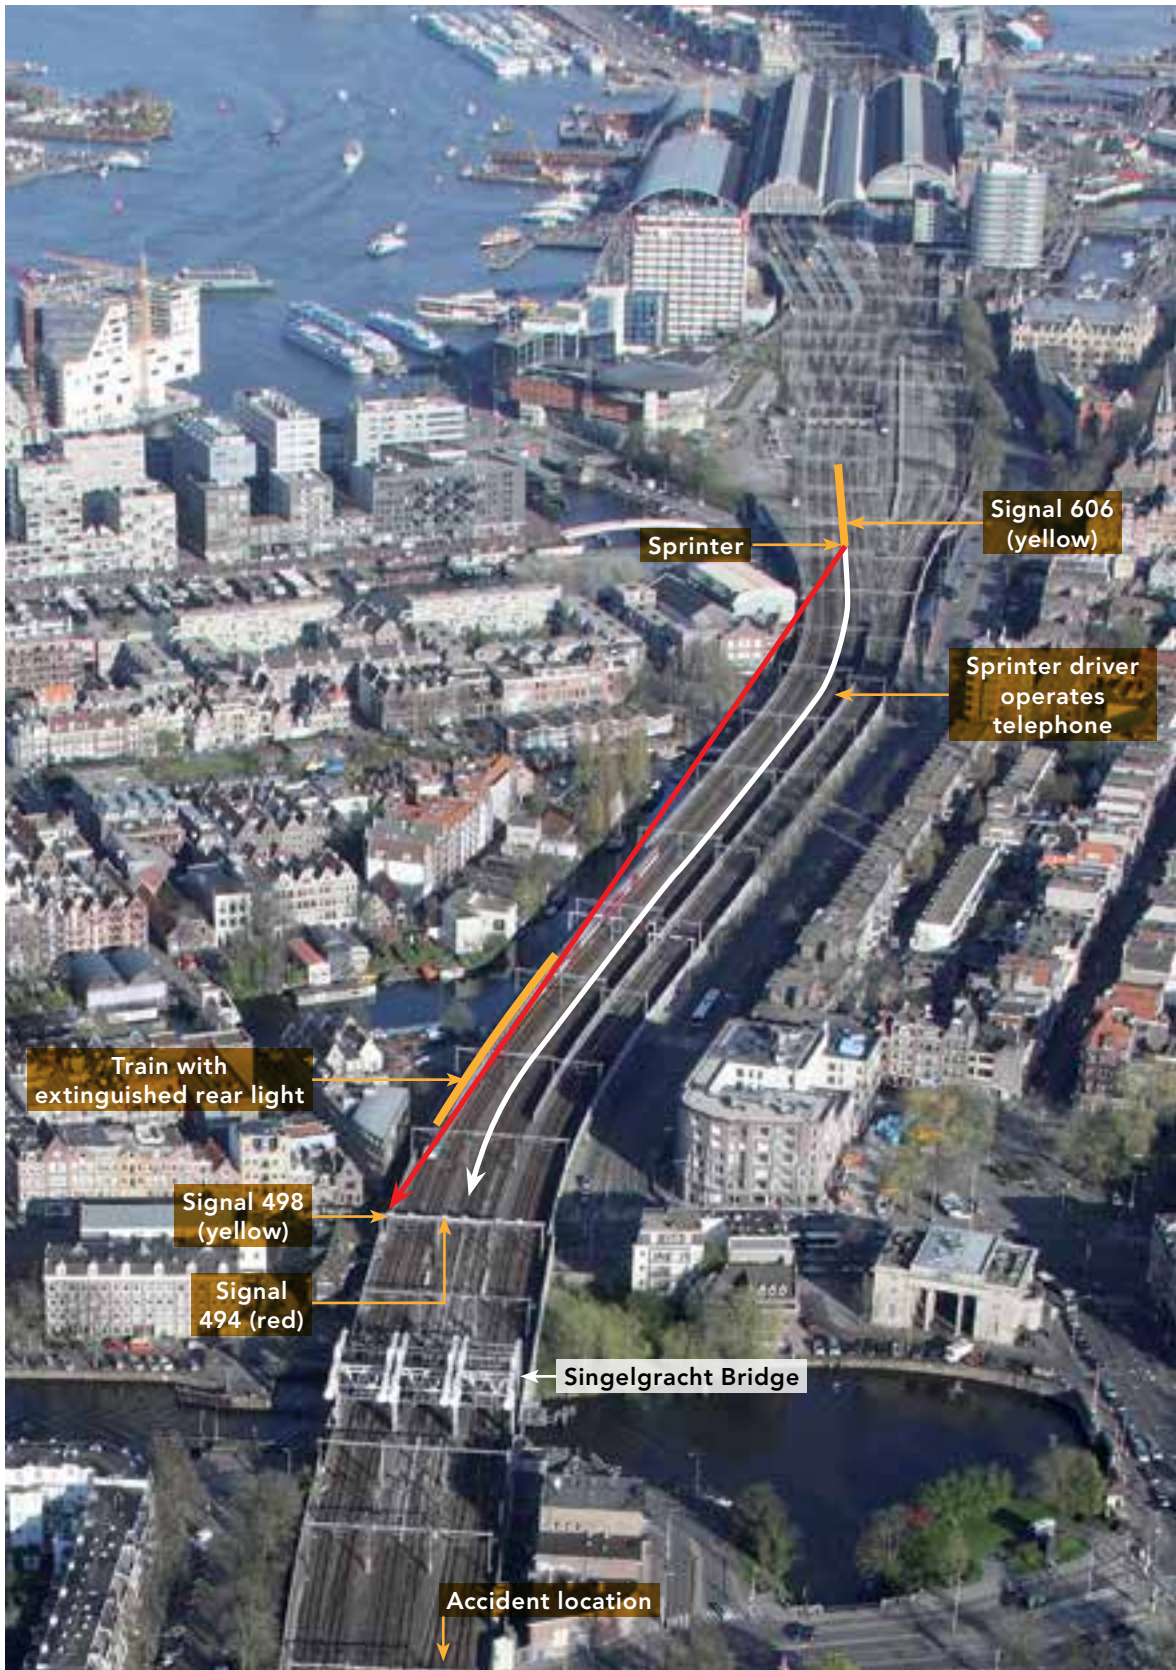
At the moment the sprinter departed from Amsterdam Central Station, the yellow signal 606 indicated that the following signal (494) displayed red at that moment. The driver expected that he would have to stop. When the driver subsequently saw for the first time the row of signals that included signal 494, for several seconds the situation arose as illustrated in Figure 1.

Figure 1: At the moment that the six signals before the Singelgracht Bridge first came into the view of the driver of the sprinter, signal 498 (intended for the train with the extinguished rear light) displayed yellow for a short time. However, as this signal is visible to the left of this train, the impression could have arisen at that point that the signal was intended for the track on which the sprinter was running. Photograph: KLPD.

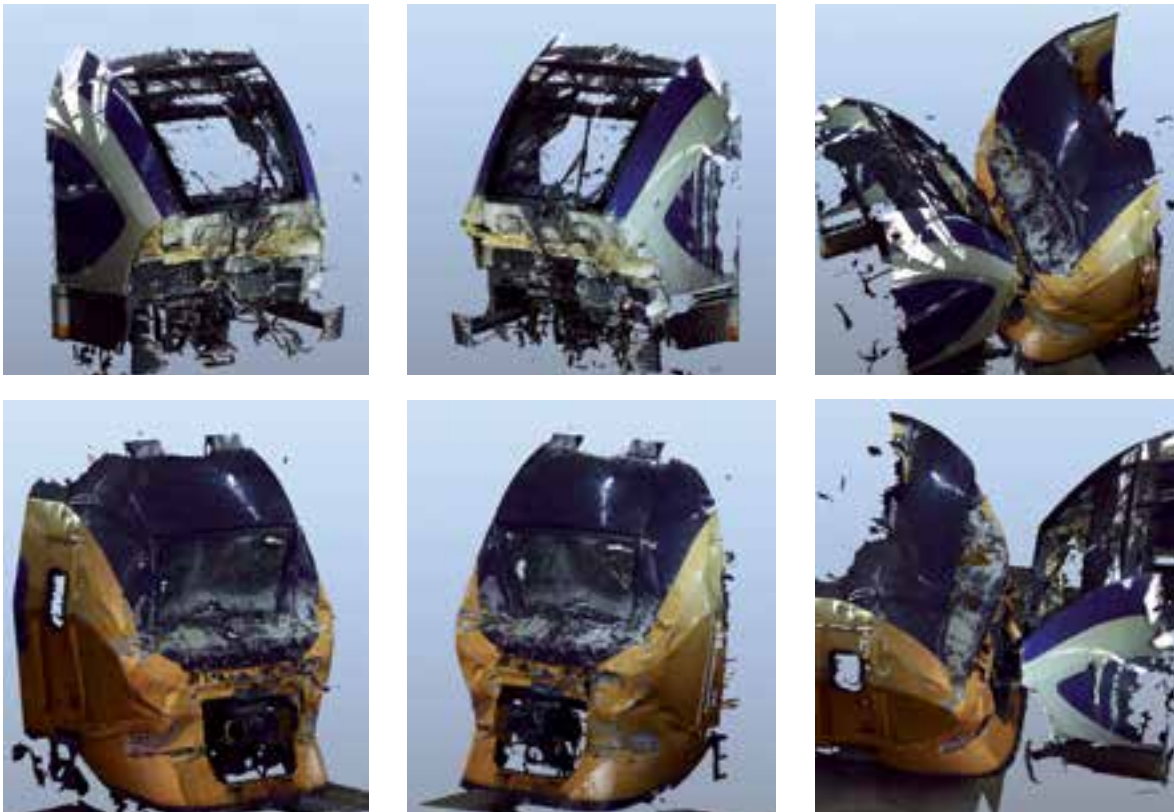
Figure 1: Laser scan images of the damage to both trains

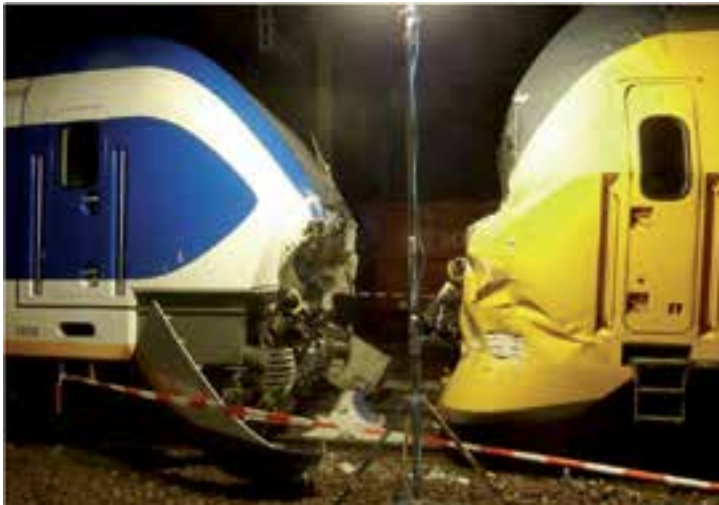
Figure 3: Damage to the sprinter and intercity train at the collision site. Source: Dutch Safety Board.

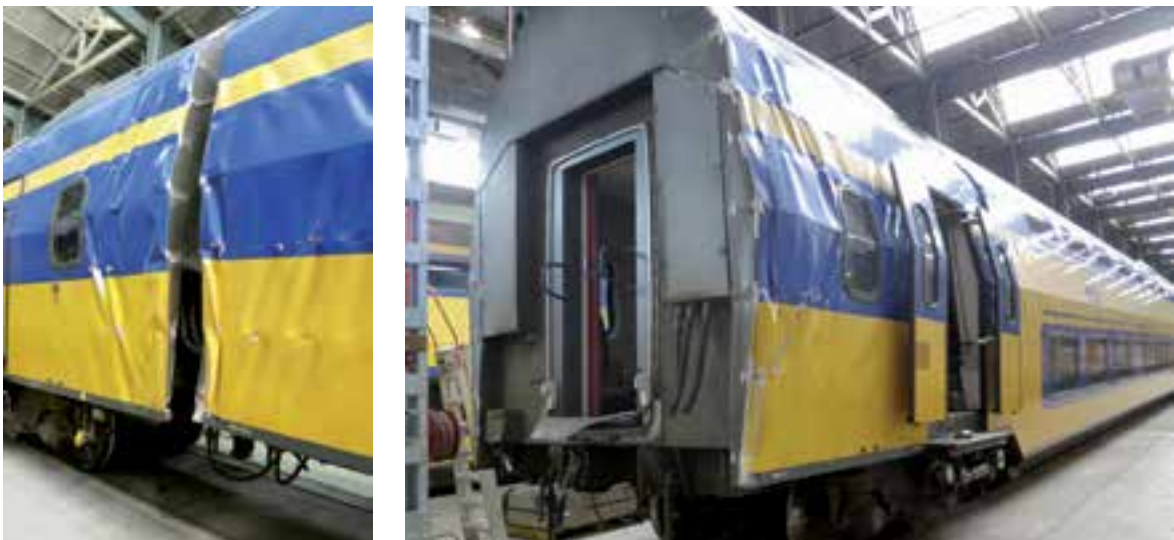
Figure 4: Damage to the intercity coaches. Source: Dutch Safety Board.
