Mortar Accident Mali 2016

Reopened investigation 2022

The Hague, August 2022

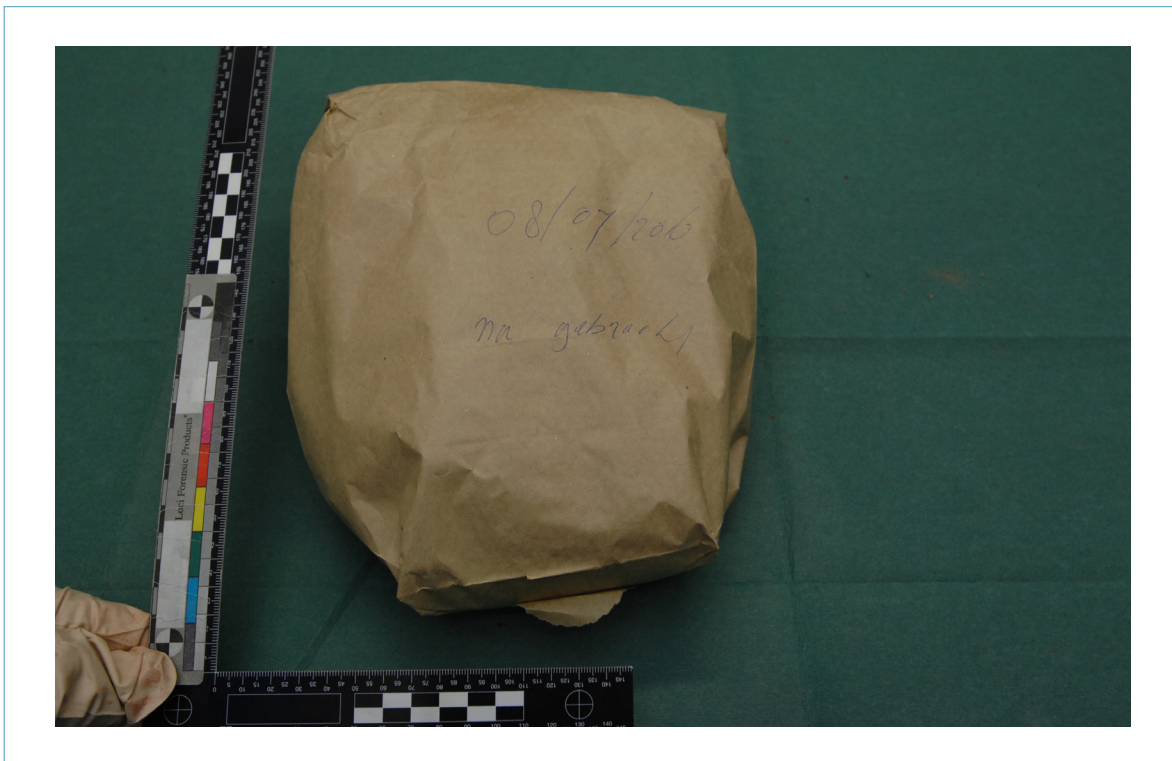
The KMar did not record who handed in the brown paper bag, that was subsequently handed in on 8 July. The initial statement reveals that the bag was delivered by an employee of Role-1, with a comment about its origin, as recorded in the report, *'from the French - or words to that effect'*. However, during this reopened investigation, the collection of the material and the route taken by the brown paper bag were traced; the content of the brown paper bag had previously been recorded by the KMar on 9 July 2016.

Figure 1: The brown paper bag delivered later, on 8 July 2016, in Gao.²¹

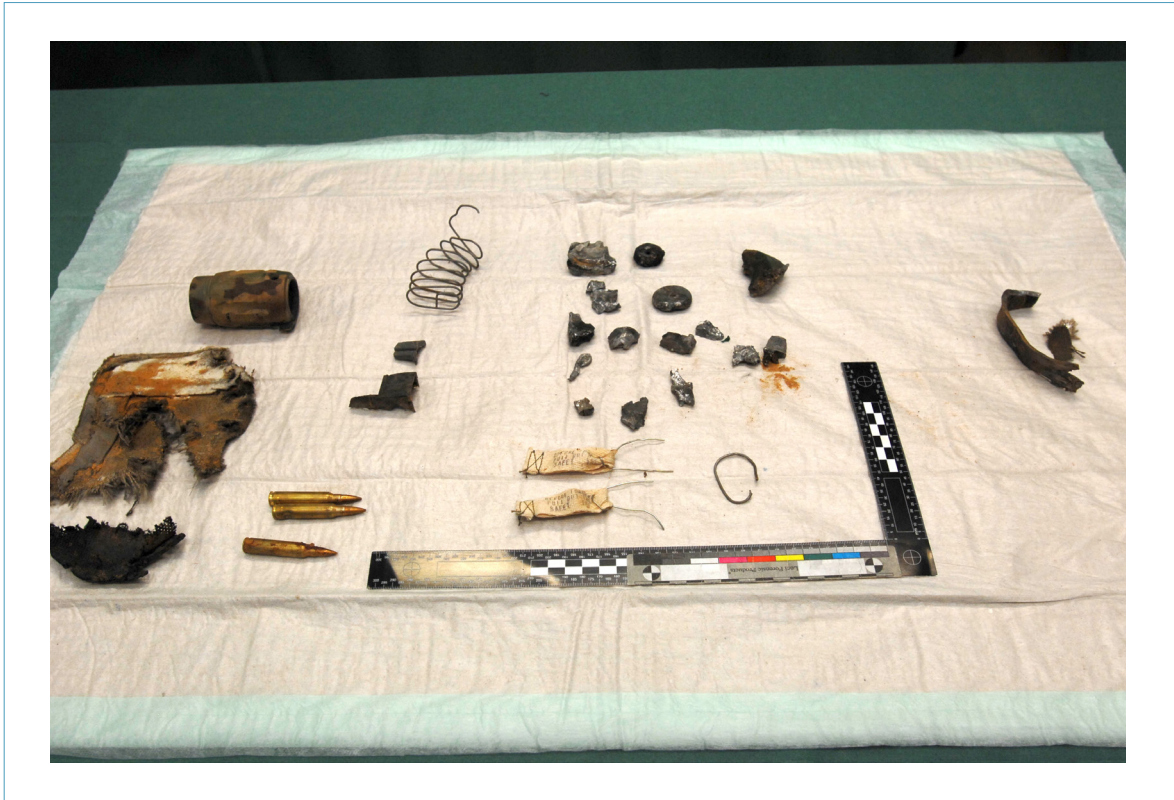
Figure 2: The contents, collected during the search operation before the destruction of the five mortar rounds.²²

This reconstructed course of events leads to the conclusion that the mortar round fragments and remains contained in the brown paper bag handed over to the KMar in Gao on 8 July 2016 cannot otherwise be interpreted than as mortar round fragments and remains collected on 6 July 2016 during the search operation immediately following the accident. The possibility can also be excluded that during the search operation immediately following the accident the fragments of the dud destroyed prior to the accident were picked up. The dud had ended up approximately 500 metres from the accident location without detonating. The search area for the mortar round involved in the accident at the accident location covered an area of 100x100 metres.

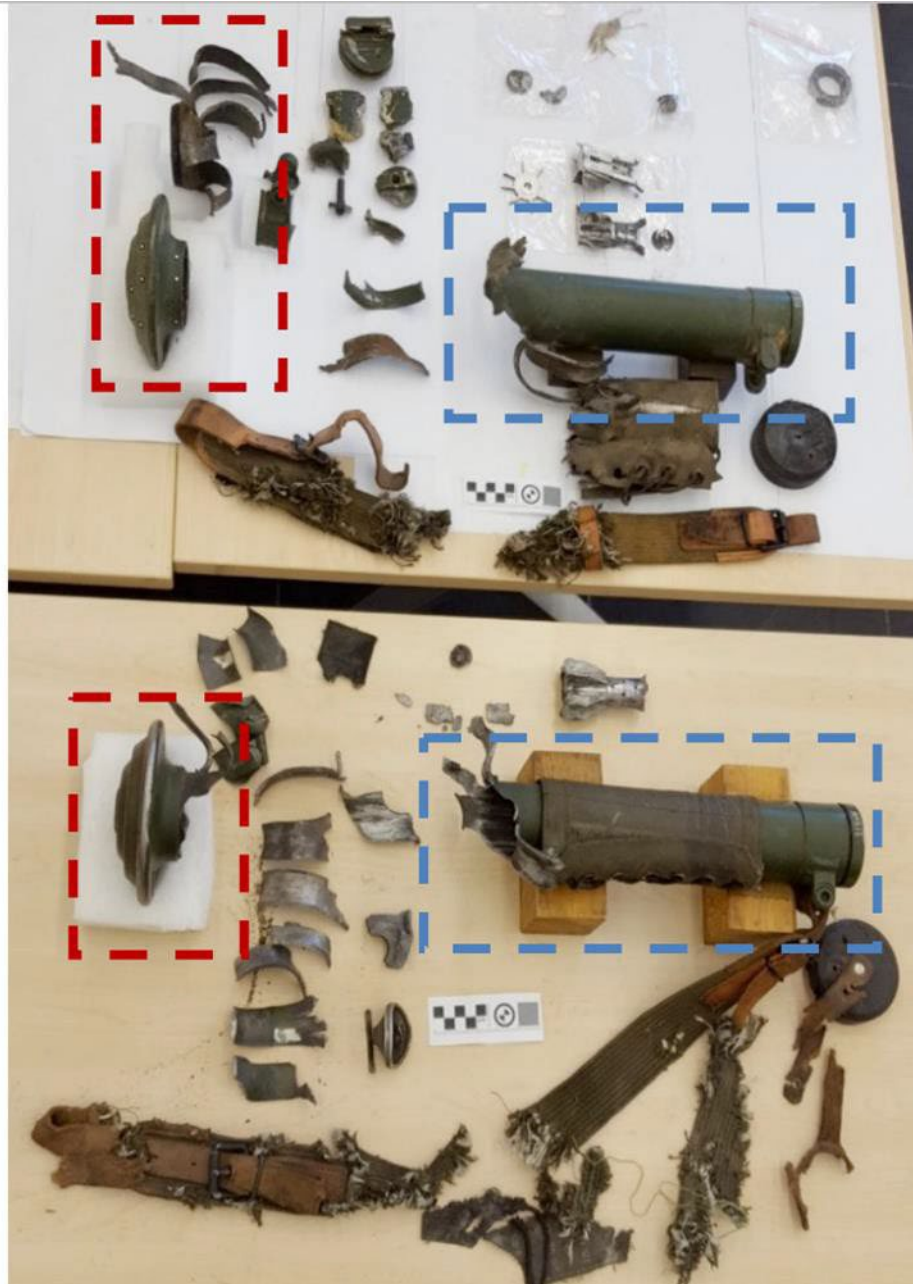
The damage to the mortar tube provides an indication as to when the mortar round detonated prematurely. As interpreted in the TNO report from 2019,³⁷ the experts also expressed doubts as to whether the round was armed, after assessing the damage to the mortar itself. If a round is armed, immediately after being dropped into the mortar, it will detonate on the base plate. The picture of the damage incurred differs between the test carried out by the KCW&M and the round that caused the accident, in that the round that caused the accident did not detonate on the mortar base plate.

Figure 26: Damage to the mortar tube from the accident (top) and after the test with the fuze in armed position by KC W&M (bottom). The picture contrasts the length of 'petaling' of the tube remnants near the base plate (red boxes) and the lengths of the residual tube from the muzzle end (blue boxes). (Picture: TNO)

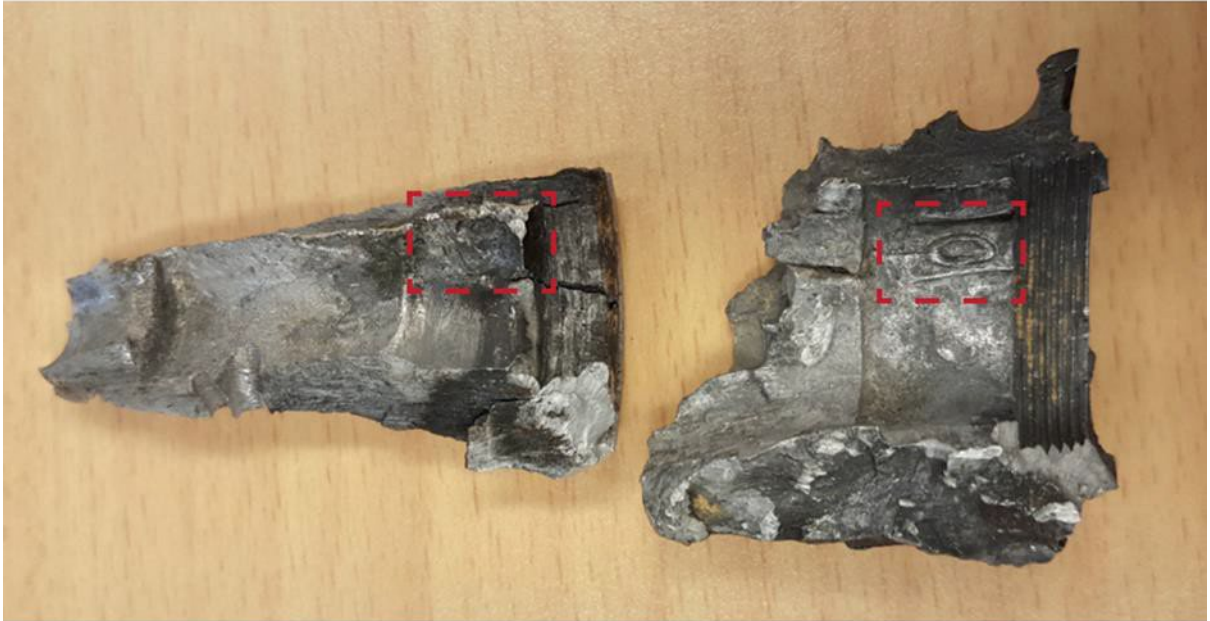
Figure 27: Imprint of the slider and slider spring on the inner wall of the fuze body from the test in armed position (left) and on the inner wall of the fuze body from the accident mortar round (right). (Picture: TNO)

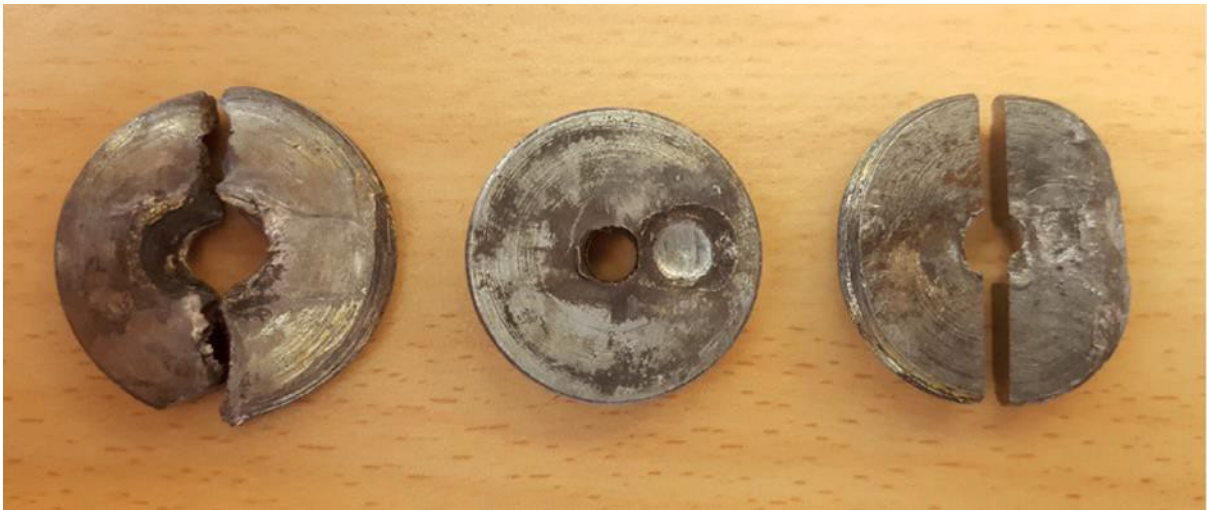
Figure 30: Top surfaces of the explosive train interrupter plate from the test in armed position (left), from the test in safe position (centre) and from the accident (right). The plate from the test in armed position is broken as a result of the detonation, the plate from the accident was recovered in one piece, but cut in half for further examination. The off-centre dent in the accident plate is thought to demonstrate the detonator fired in the 'safe' position. (Picture: TNO)
