Bezwijken torenkraan

Rotterdam 10 juli 2008

Collapse of a tower crane

The Hague, 2009 (project number S2008BD0710-03)

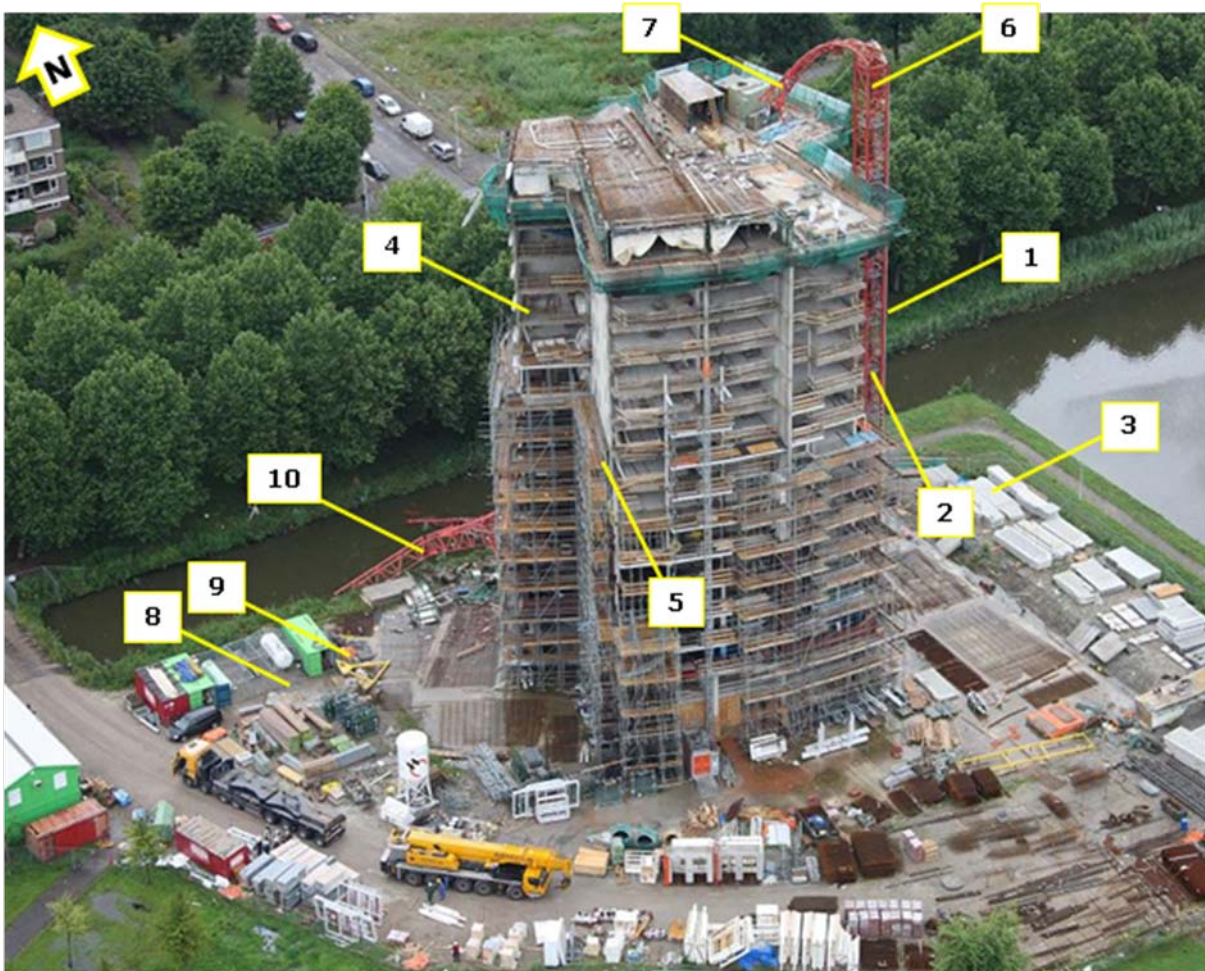
Figure 5 – Overview photo of the construction after the collapse of the crane (source: KLPD Dienst Luchtvaart)

The investigation revealed that the tower of the crane collapsed due to a load that was too heavy on a radius that was too large. The load (the balancing device and the balcony – Figure 4) unintentionally moved to the end of the jib, as a result of which more weight ended up on the tip of the jib than the crane could manage¹. The mast of the crane bent as a result, which led to the front (the side of the jib) being pressed down, and the back (the side of the rear jib) being pushed out. As a result of this stress, the tower leg directly in front buckled, which caused the crane to fold over (number 6 in Figure 5). The tower leg at the left rear ripped off due to the tension strain. Both the other tower legs served as pivots. As a result of the bending, the rear jib with the counterweight came up and then dropped to the side. The immense stress on the steel construction caused the mast above the bend to violently tear off of all four of the tower legs (number 7 in Figure 5). The crane tumbled and fell to the ground. The lifting drum then knocked a hole in the concrete on the north side of the building, and various parts of the scaffolding were hit

and damaged. The balcony slab fell to the ground in line with the position of the jib (number 8 in Figure 5), with the balancing device close by (number 9 in Figure 5). The crane ended up on the north side of the building, and the jib with the crane trolley fell in the water (number 10 in Figure 5).

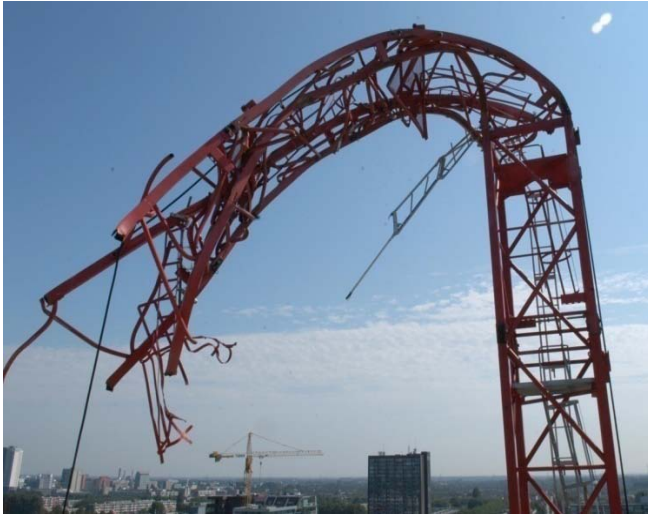
*Figure 7 - Bent, broken and torn mast
(Photo: Rotterdam Rijnmond police department)*

After the crane collapsed, all mast sections up to and including the transitional section were still upright, having suffered no visible damage. The first mast section above the transitional section was bent. The left rear tower leg (see Figure 6 for the designations of the tower legs) had broken loose at the mortise and tenon connection at the bottom (58.5 metres above the foundations). The upper part of the first mast section above the transitional section was bent completely out of shape, as were the next two sections. The tower legs, which normally form a square, were now positioned in the shape of a diamond shape in relation to one another, approximating a flat surface. The uppermost of those deformed parts, the third mast section, had torn loose at all four tower legs. The left front tower leg was visibly buckled.

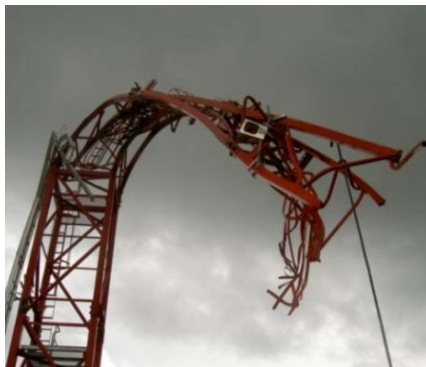
The tower crane's mast was bent, broken and torn loose (see Figure 10). The second obvious scenario based on the damage profile is that the steel construction of the mast did not match the design specifications at the moment of the accident. The analysis of this scenario required a destructive investigation. The Dutch Safety Board coordinated with the Public Prosecution Service¹ to have this investigation carried out by the Schielab laboratory in Rotterdam.

Schielab investigated the material specifications and the fractures (see Annex C). Schielab took samples from the material surrounding the fractures and subjected those samples to chemical analyses and tensile tests. These revealed that the material used matched the specifications defined. The fractures were found to be "ductile fractures". Schielab was able to determine this using microscopic investigation and based on the fact that warping and a reduction in the thickness of the sides were visible at and near the fractures. The fractures were caused by overloading. This led Schielab to conclude that the crane's failure was not the result of material defects. The Dutch Safety Board endorses that conclusion.

Figure 10 – Bent mast sections Figure 11 – Broken connecting part Figure 12 – Buckled tower leg
(Photograph: Aboma Keboma).

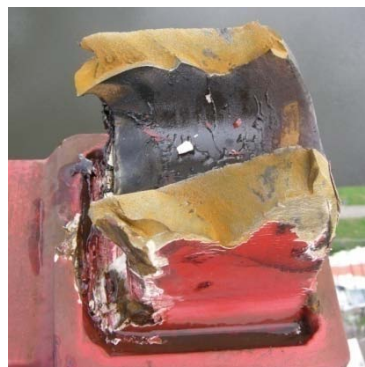
The profile of the damage to the mast shows a series of constituent events. The first is that the four tower legs all tore loose at the same place in a mast section. The second is that the mast sections were warped, causing the tower legs, which are normally positioned in a square, to land almost in a flat plane (see Figure 10). The third is that the connecting plug in the left rear tower leg broke (see Figure 11).
