# Hatch cover wheel breaks free

Fatal accident on board the Marja

*The Hague, December 2021*

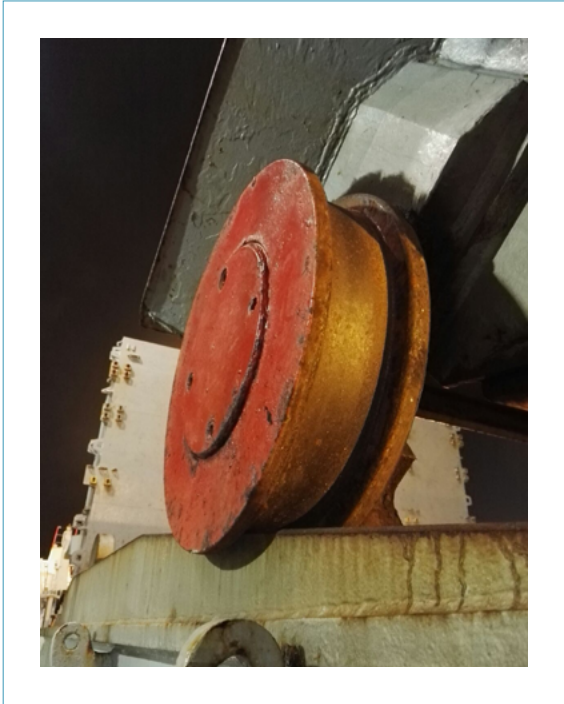
Figure 3: Guide wheel with flanges on the port side. (Source: Dutch Maritime Police)

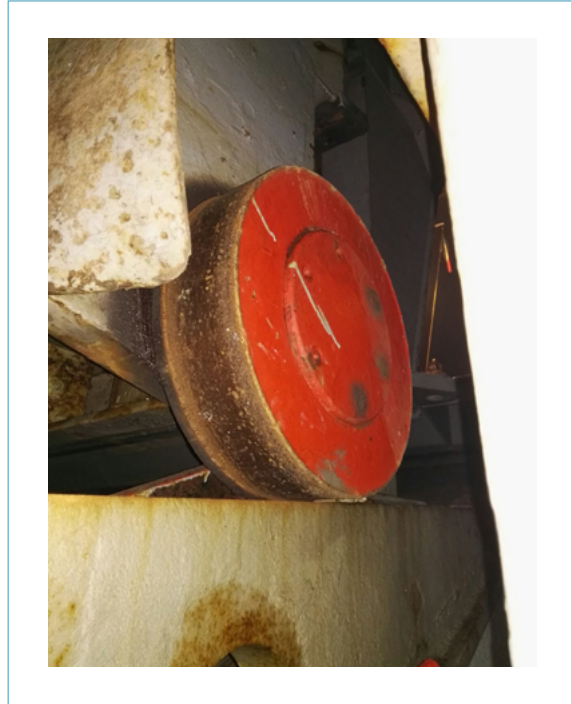
Figure 4: Freewheel on the starboard side. (Source: Dutch Maritime Police)

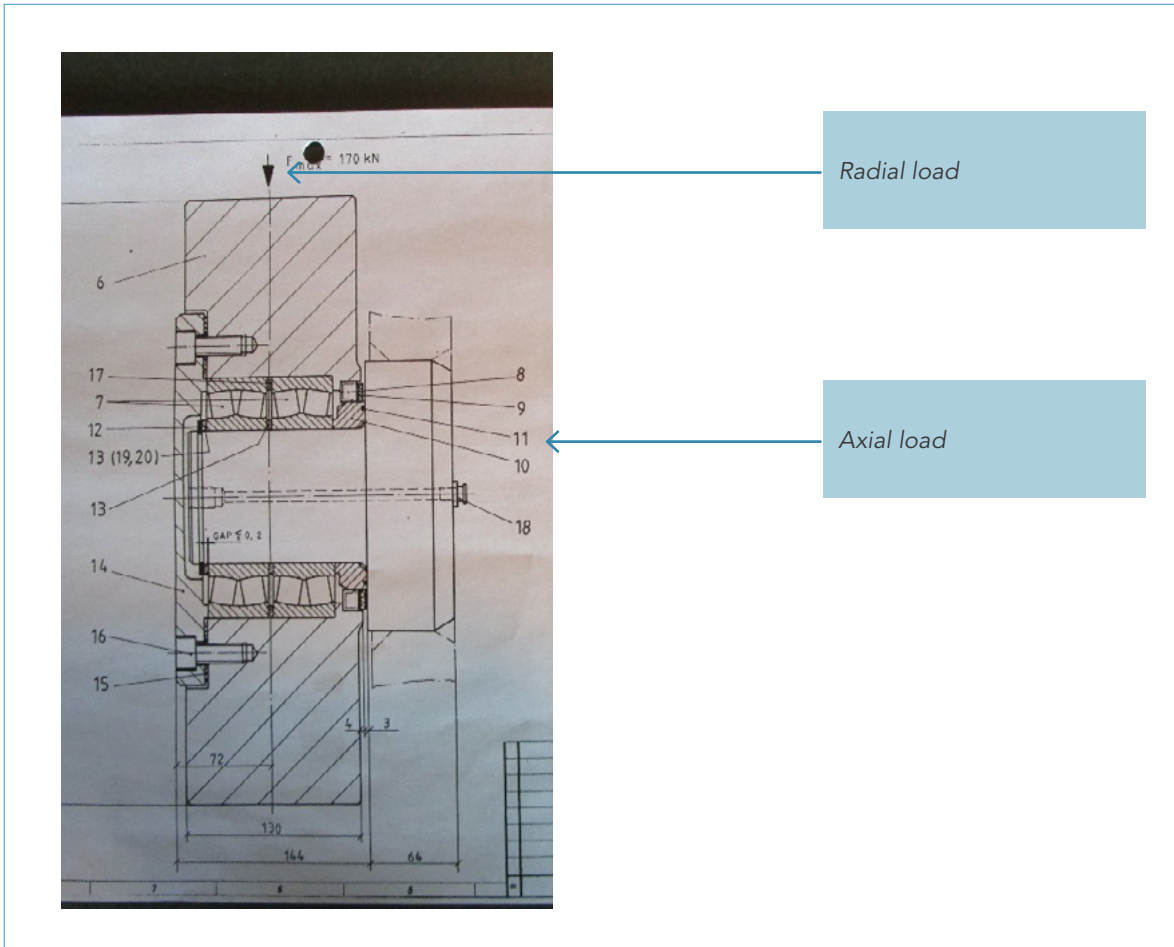
Figure 5 as a sample shows a plain wheel located on starboard side. The bearing roller design and -arrangement within the guide wheels on port side is identical. Given the construction of the hatch cover, the axial forces during normal operation are minimal.

Figure 5: Cross section of the wheel showing radial and axial load

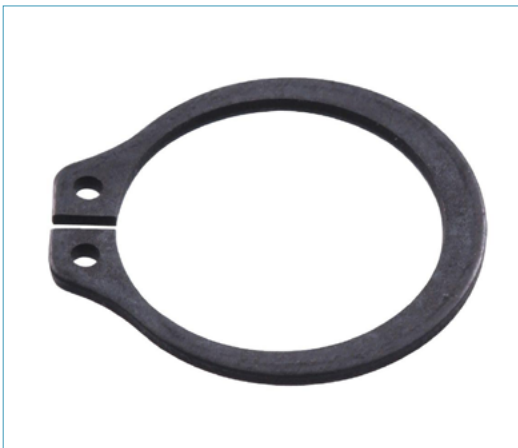
Figure 6: Circlip used to retain the bearing

The malfunctioning of the bearings may eventually have led to the blocking of the bearing race, and the breaking of the circlip (see figure 6). As a result, the wheel was able to run off the axle. Given the passage of the grease through the bearing, it is plausible that the injection of grease made a further negative contribution.

The wheel was able to run free from the axle because the circlip that was used to secure the wheel onto the axle was no longer working. The Safety Board was unable to determine the precise cause, with absolute certainty. With the limited information available, the Safety Board was able to generate a picture of how the wheel was able to come off the axle. The analysis of the grease left behind on the axle, and which was subsequently secured, contained indications that the bearings were no longer functioning correctly, and that the wheel at some point had become stuck. As a result of the build-up of pressure, the circlip securing the wheel must have broken.

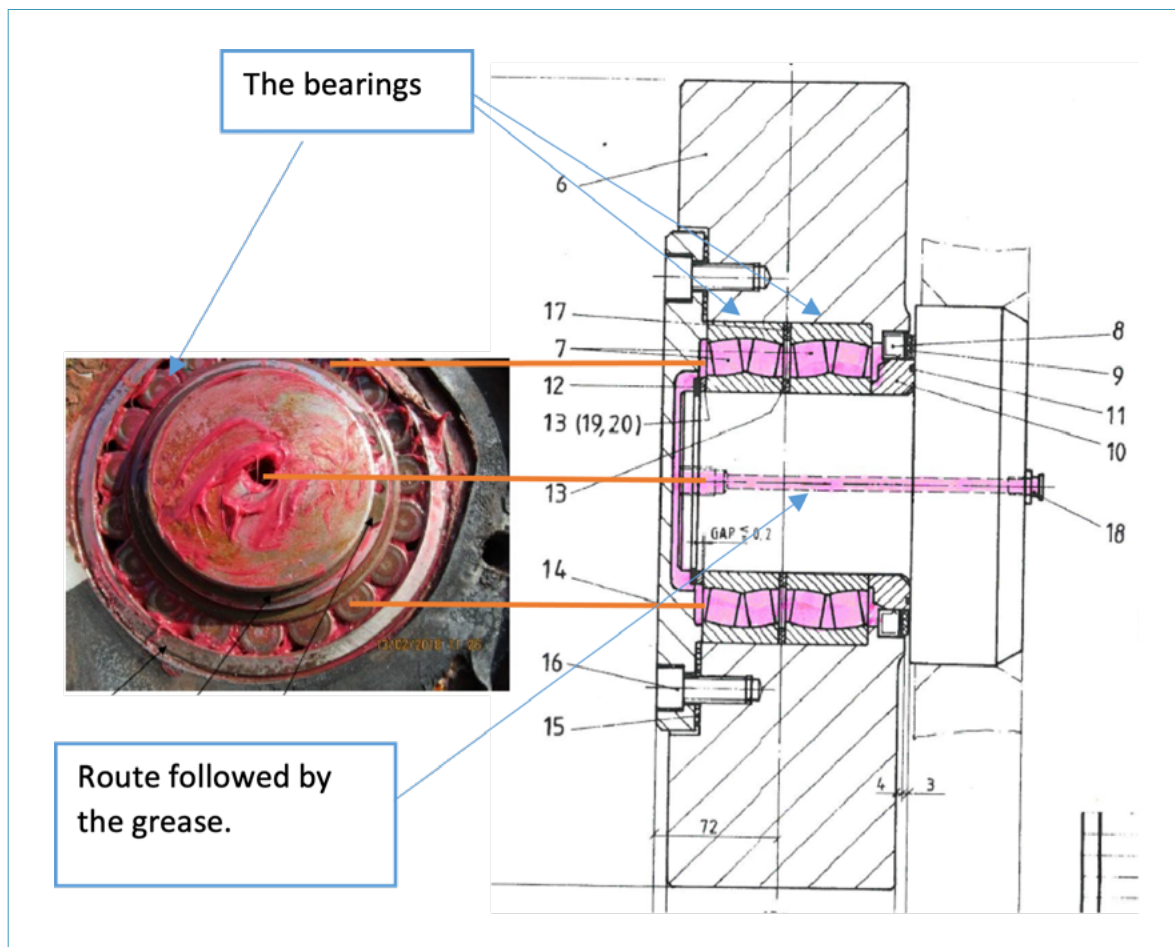
According to a maintenance timetable, the wheels of the hatch cover must be injected with grease every month. The grease is filled in via a grease nipple (pos. 18 of figure 7) into the axle, located at the inner side of the hatch cover side plates, and is led through the boring within the wheel axle to the opposite exit where it is spread all over the space between the axle (pos. 1) and the cover (pos. 14). From there the grease attains to the bearing rollers. Figure 7 includes a red line that represents the route taken by the grease. The chief engineer is responsible for periodic lubrication. The moment at which the grease is injected is recorded in a grease schedule. The wheel in question was last lubricated with grease on 15 January 2018.

Figure 7: Front of a wheel without cover plate and a graphic reproduction of the wheel. Red: the route taken by the grease, Orange: the corresponding points on the graphic reproduction and the photograph. (Source: Holwerda Shipmanagement B.V.)

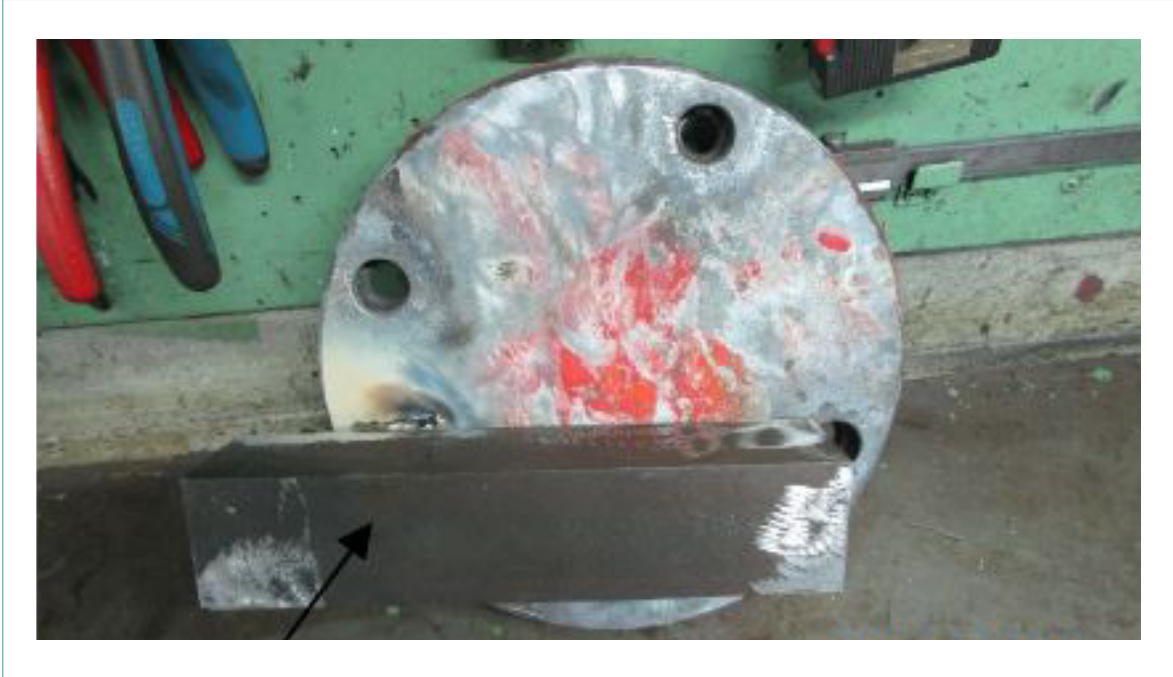
The visual inspection of the wheels and the bearings for wear requires considerable preparation and work. The cover plate is difficult to lift off. A tool first has to be installed to be able to remove the plate, see figure 8.

*Figure 8: The cover plate onto which an angle bar is welded as a tool for removing the cover plate from the wheel. (Source: Holwerda Shipmanagement B.V.)*

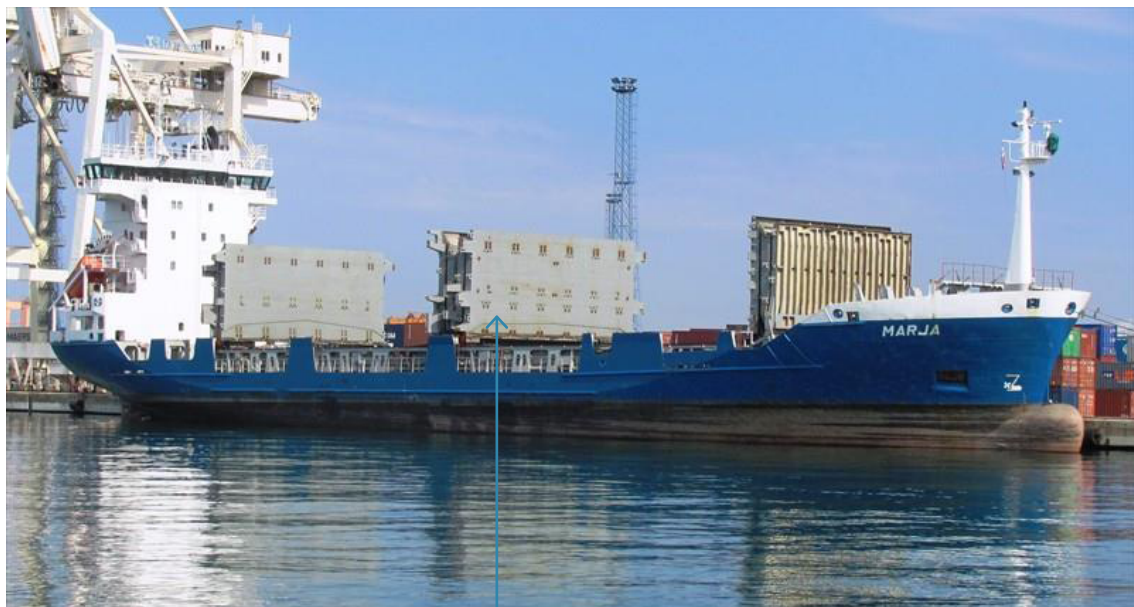
*Hatch cover 2B, with behind it hatch cover 3A. Both in opened position.*

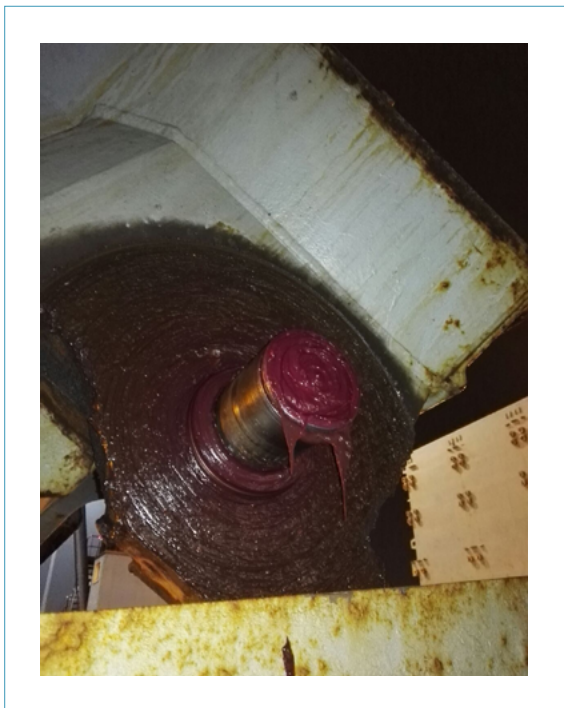
The first mate approached hatch cover 2B and just like the deckhand, saw that the wheel had run between five and seven centimetres off the axle, and was therefore not in line with the rail. The deckhand called the captain and then the chief engineer. In the meantime, the first mate approached the stevedores on shore, to halt the unloading operation. By this time, the captain and chief engineer had arrived at the wheel, and were in the process of examining the situation, when the first mate arrived back. The chief engineer suggested collecting a sledge hammer to hammer the wheel back into its starting position, on the axle. The captain agreed. While the chief engineer walked away to collect a sledge hammer, the first mate asked the captain whether the unloading operation could be restarted. The captain decided that the unloading operation at hatch 3 could be continued. The first mate duly informed the stevedores. As the first mate started to walk back towards hatch cover 2B, he saw how the chief engineer started to hit the wheel. The captain stood on the other side, with no clear view of the chief engineer; he did however have a clear view of the back of the wheel. After the chief engineer had hit the wheel several times, it unexpectedly came off the axle, and fell towards the gangway. Before the wheel reached the gangway, it hit the chest of the chief engineer. Figure 10 shows the axle to which the wheel was attached, and figure 11 shows the position in the gangway where it ended up.

Figure 10: Wheel axle. (Source: Maritime Police)

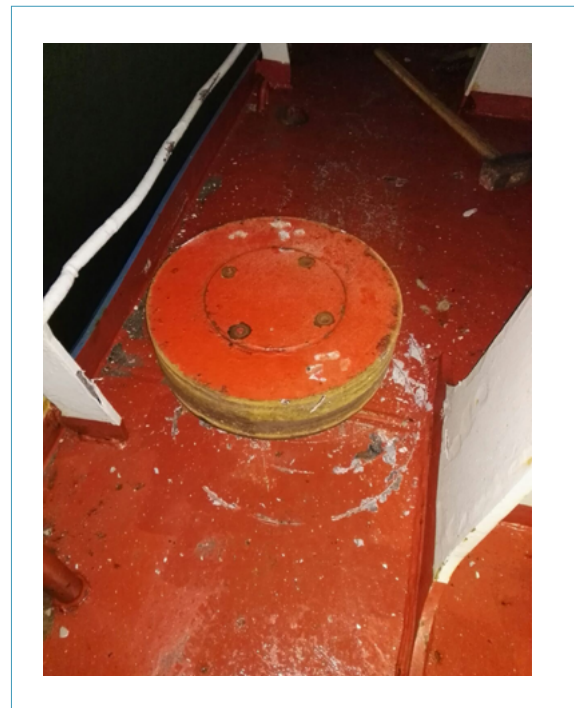
Figure 11: Wheel in the gangway. (Source: Maritime Police)

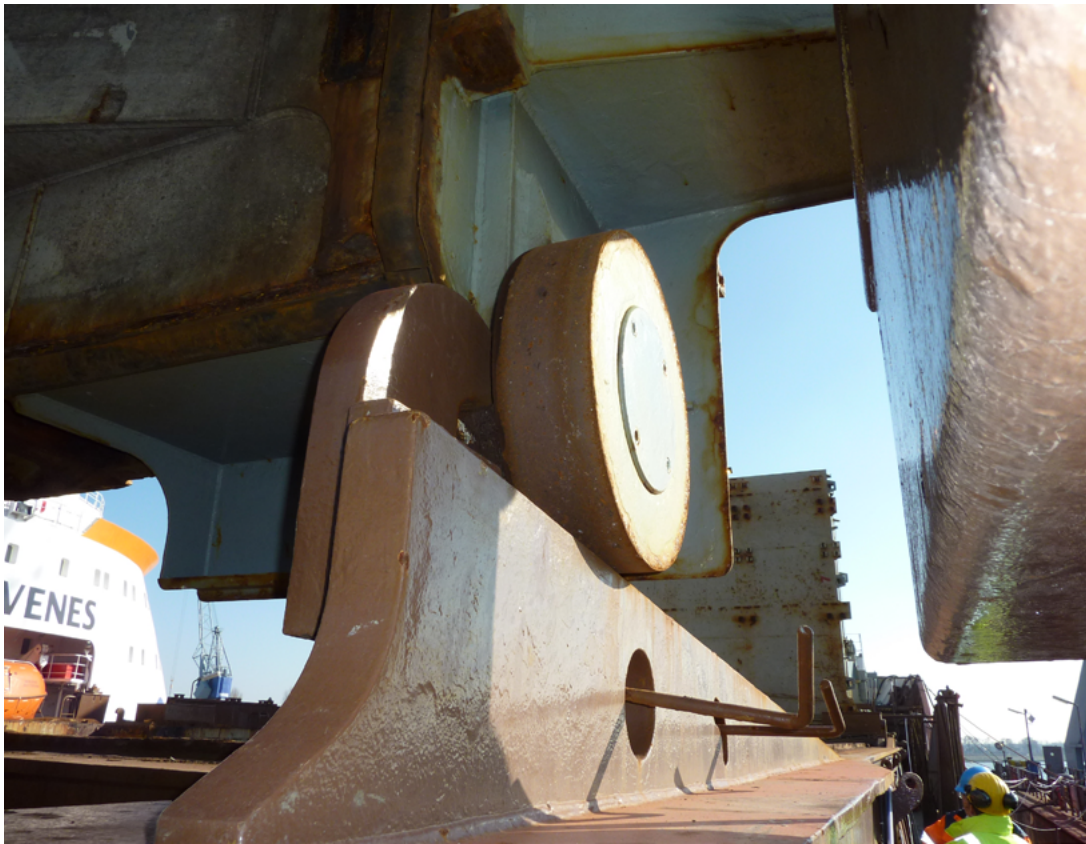
Figure 12: Similar wheel on a sister ship of the Marja.

Figure 12 is a photo taken on a sister ship of the Marja. The photo shows that half the weight of the hatch is transferred to the wheel. The wheel has an intrinsic weight of approx. 300 kg. Given the height at which the wheel is fitted, due to its mass, it contains considerable stored (potential) energy which is released if the wheel breaks free and falls. It is essential to recognize that the mass of the wheel represents considerable potential energy.
