# **GABINETE DE SEGURANÇA AEROPORTUARIA**

## **SEGURANÇA OPERACIONAL**

**DUTCH SAFETY BOARD REPORT**  
**RUNWAY TAKE-OFF POSITIONS**  
**NL.SIA-2018-0002**

Reference; DSB Report - NL.SIA-2018-0002

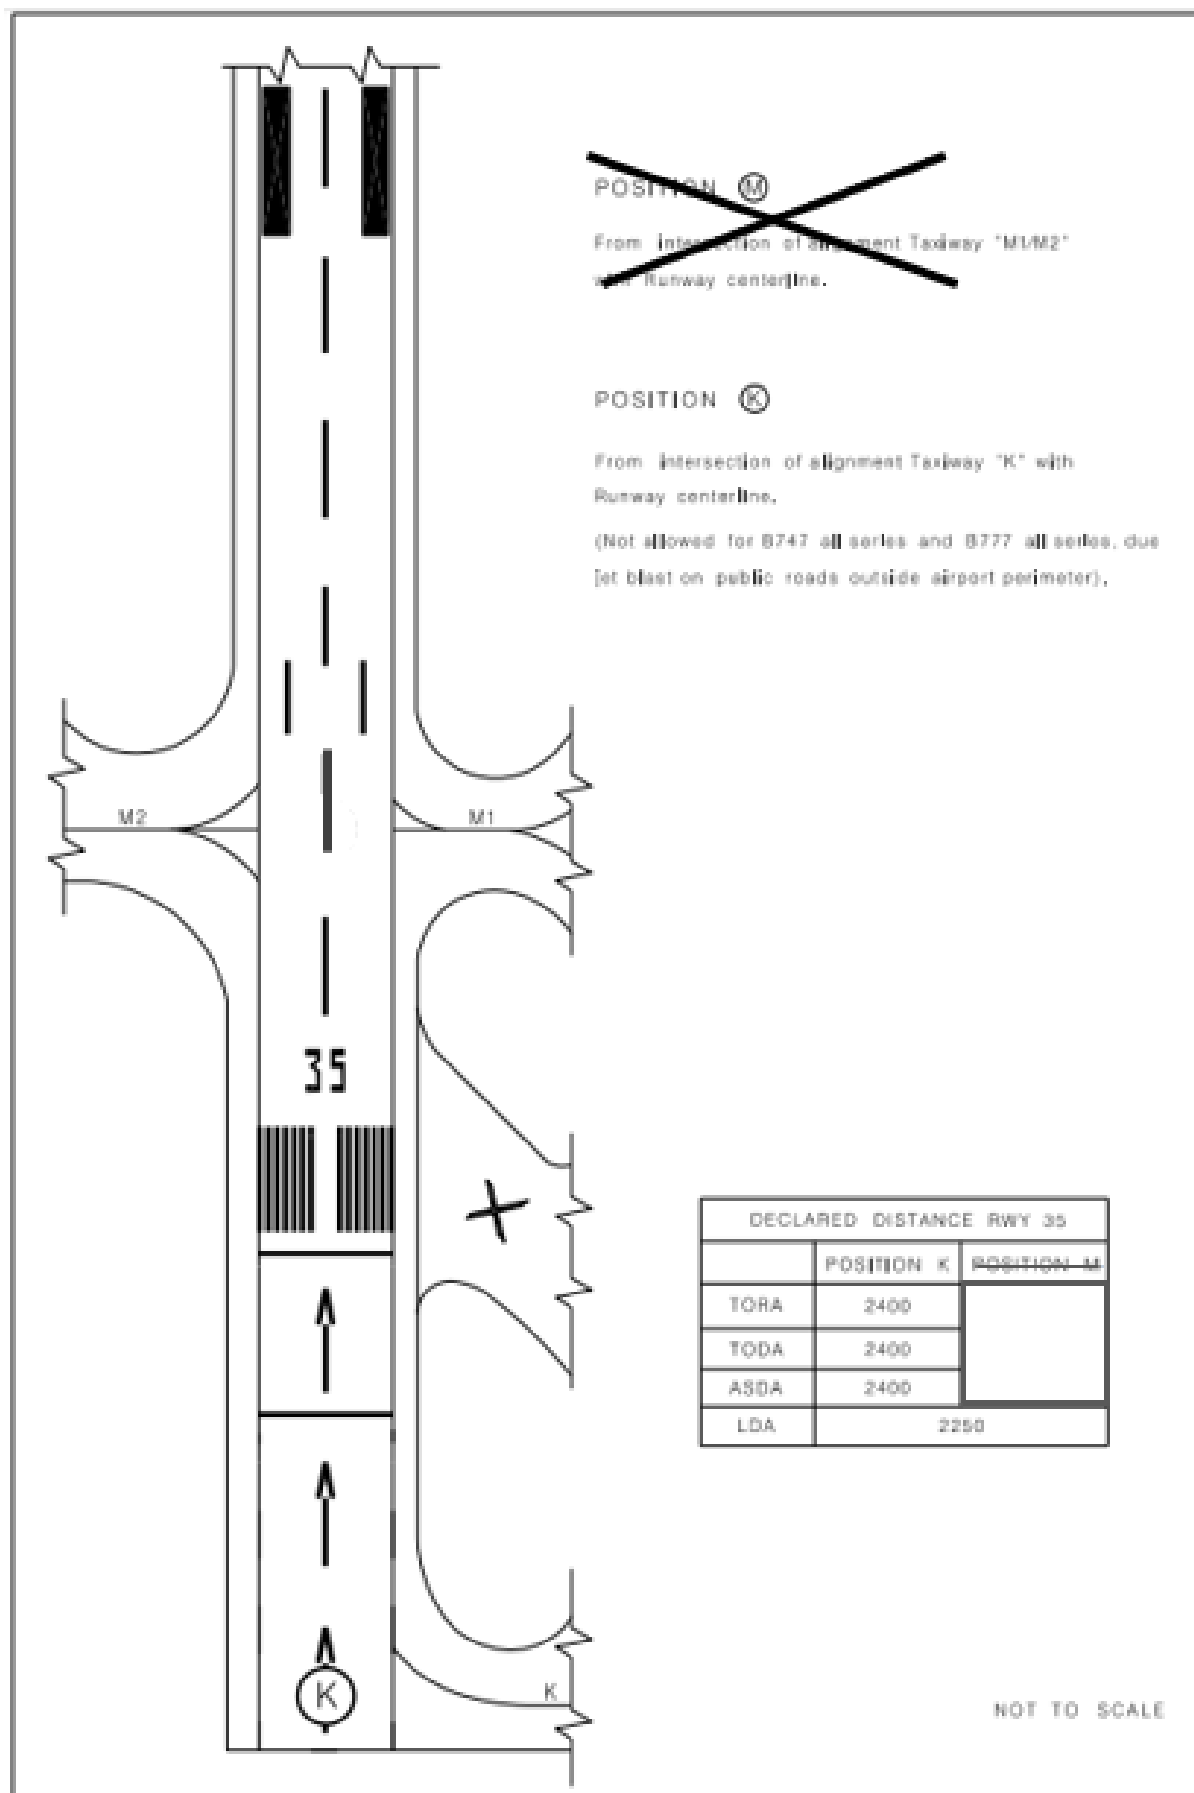
## RUNWAY 35 TAKE-OFF REVISED POSITIONS NAMING

Lisbon Airport has since, changed all runway intersection names. The revised take-off intersection names are now named according the runway intersecting taxiway designation. However, the revision made to the take-off intersection names, did not result in a unique naming of all the take-off intersection positions, because at present, there´s a take-off position designated “PSN M” available for runway 03 as well as runway 35 as the accompanying intersecting Taxiway is designated respectively “M5” at intersection with RWY 03, and “M2/M1” cross runway 35 at the position named “M” (located used for departures of aircraft code “E” due to jet blast hazard avoidance. Therefore, according the DSB report, there still is a potential for pilots selecting the wrong runway in the take-off performance calculation in the EFB, thus the take-off positions are still not according ACI recommendations stated on ACI Runway Safety Handbook (unique naming for each position).

- The RWY 35 Take-Off position located at intersection of Taxiway “M1” with Taxiway “M2” and at present moment designated “PSN M” (for RWY 35) will be deactivated.

- RWY 35 will have only one designated TKOFF position, (PSN “K”).

- LPPT AIP will be changed accordingly. See next page LPPT AD 2 - 29 amendment proposal for the AIP LPPT AD.

- Aircraft ICAO Code “D” and code “E” intending to Take-Off from RWY 35 must coordinate all taxiing maneuvers between TWY M1 and TWY K with the Airport Apron Management Services.

- Follow-Me guidance is mandatory for aircraft ICAO code “D” and code “E”, between TWY M1 and TWY K.

- Airport Apron Management Services must close the airside vehicle roadway between Stand 107 and Stand 104, before any aircraft ICAO code “D” or code “E” movement along the TWY A1.
