DUTCH
SAFETY BOARD

Runway excursion after loss of thrust at low speed

The Hague, March 2020

Identification number:	2017118
Classification:	Serious incident
Date, time of occurrence:	11 November 2017, around 22.36 hours ¹
Location of occurrence:	Maastricht Aachen Airport (EHBK)
Registration:	TC-ACR
Aircraft type:	Boeing 747-400 ERF
Aircraft category:	Aeroplane
Type of flight:	Commercial cargo flight
Phase of operation:	Take-off
Damage to aircraft:	Substantial
Flight crew:	Two (captain and first officer)
Other crew:	Two (technician and load master)
Passengers:	None
Injuries:	None
Other damage:	Deep tracks made by the landing gear in the soft ground of the airfield
Light conditions:	Darkness

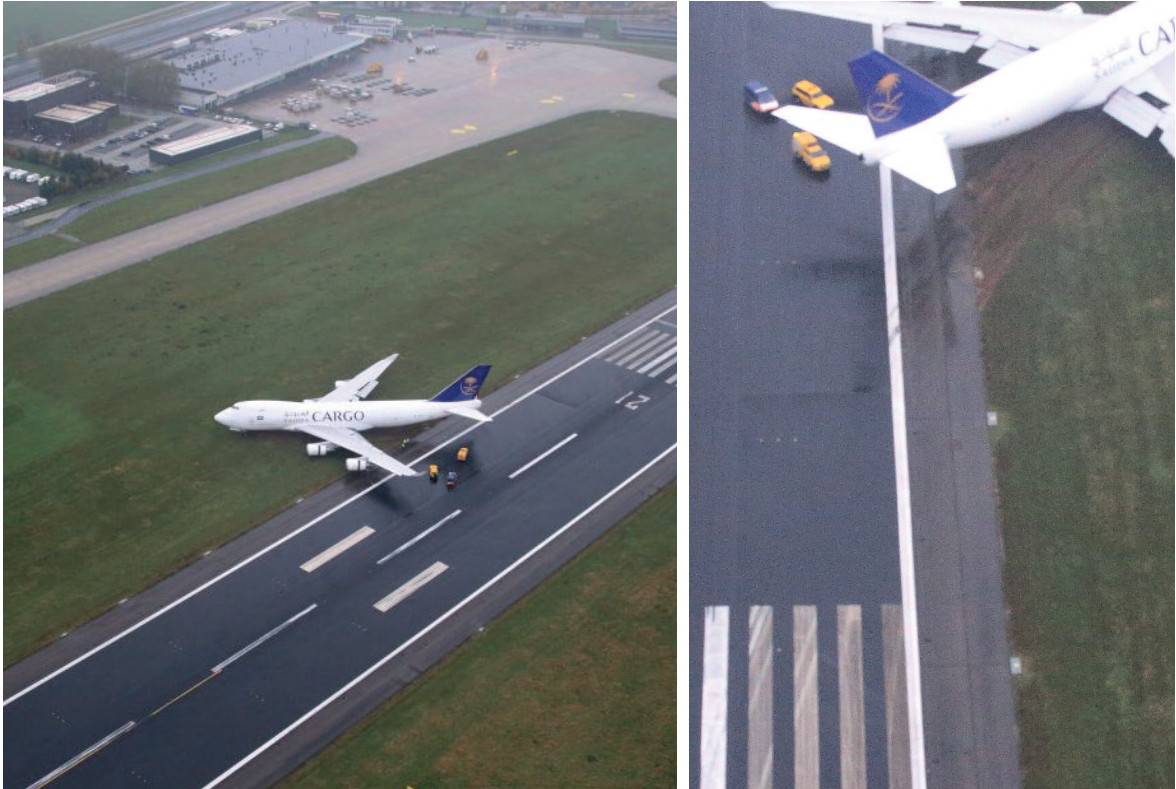
Figure 1: Aerial pictures of the runway excursion. (Source: Aviation police)

The aircraft had veered off the runway and had come to a standstill in the soft soil of the grass field on the right side of Runway 21. After the occurrence, it was found that all of the aircraft's engines were in reverse and its speed brakes were up.

The aircraft sustained substantial structural damage as a result of the occurrence. This damage consisted of several bent and deformed skin panels and stringers. In addition, the nose wheel well web had several deformations on the right- and left-hand sides. As a result of this damage, the manufacturer of the aircraft had to carry out major repairs at Maastricht Aachen Airport.

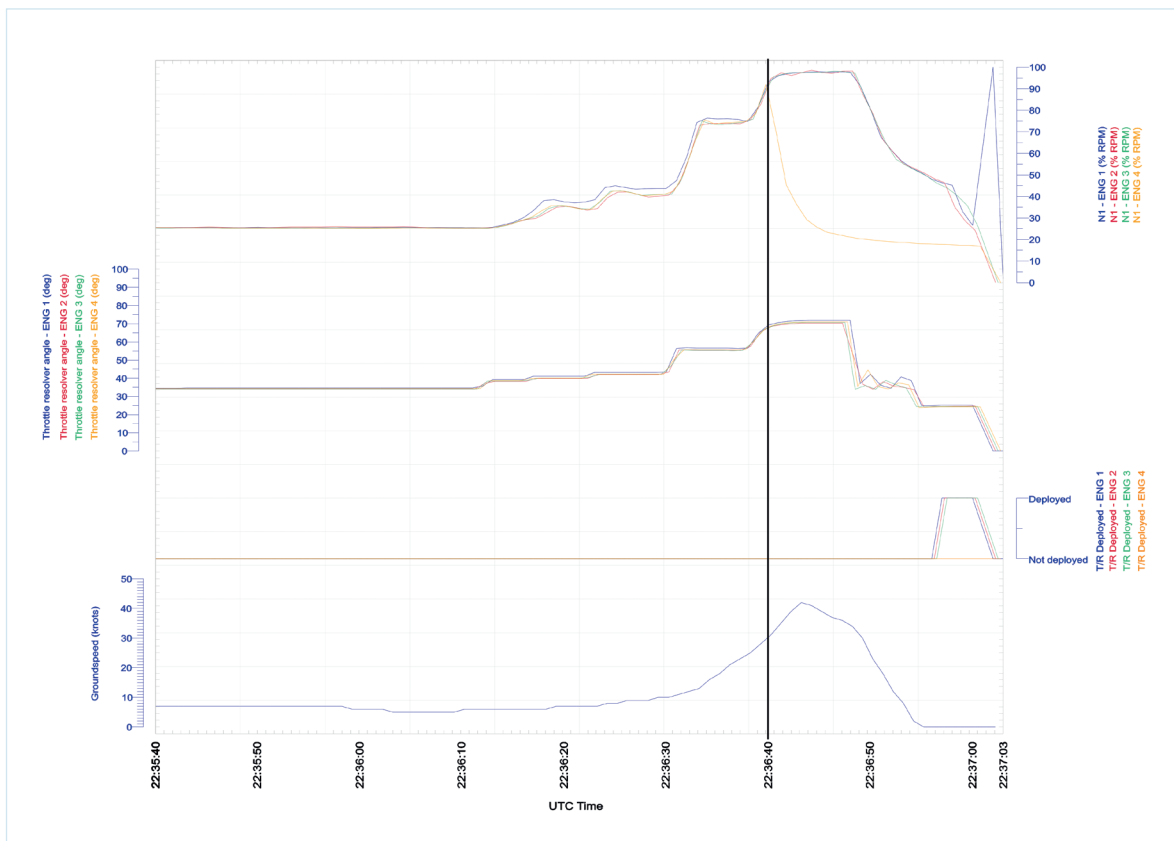
Figure 2: Plot of FDR data (N1, TRA, T/R, GS). The vertical line indicates the moment at which engine #4's N1 dropped.

Almost immediately after the TRAs were increased, at a ground speed of 30 knots and at 92% N1, there was a sudden drop in engine #4's N1 – yet the corresponding TRA had not been changed. Engine #4's N1 dropped to a value of around 20%, while the N1 of the other three engines remained at around 97%.

The aircraft's lateral (sideways) acceleration to the right increased, and the magnetic heading also began to increase as the aircraft's course deviated to the right of the runway heading. Input to the right pedal was quickly discontinued, and full left pedal input was applied at 22.36:42 hours. The left pedal was briefly released, for an interval of one second, at 22.36:43 hours, before quickly being reapplied. At the same time, the control wheel was deflected slightly to the left.

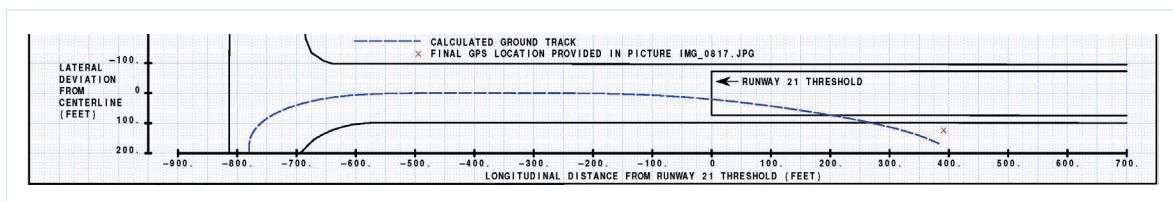
Figure 3: Ground track analysis. (Source: Boeing)

Using FDR data, the manufacturer prepared a ground track analysis. The results indicate that engine #4's N1 began to decrease 300 feet before the runway displaced threshold. Full left pedal was applied around 80 feet later. The aircraft began to deviate to the right of the runway centreline around 150 feet before reaching the threshold, and the wheel brakes were applied around 100 feet before the threshold was reached. Around 200 feet after crossing the threshold and at a ground speed of 35 knots, the aircraft's centre of gravity (CG) crossed the right edge of the runway. After the aircraft had travelled about another 20 feet (220 feet beyond the threshold), the TRAs were reduced to approximately forward idle. The aircraft's CG departed the paved surface 270 feet beyond the threshold, and the aircraft came to a stop with its CG approximately 380 feet beyond the threshold.

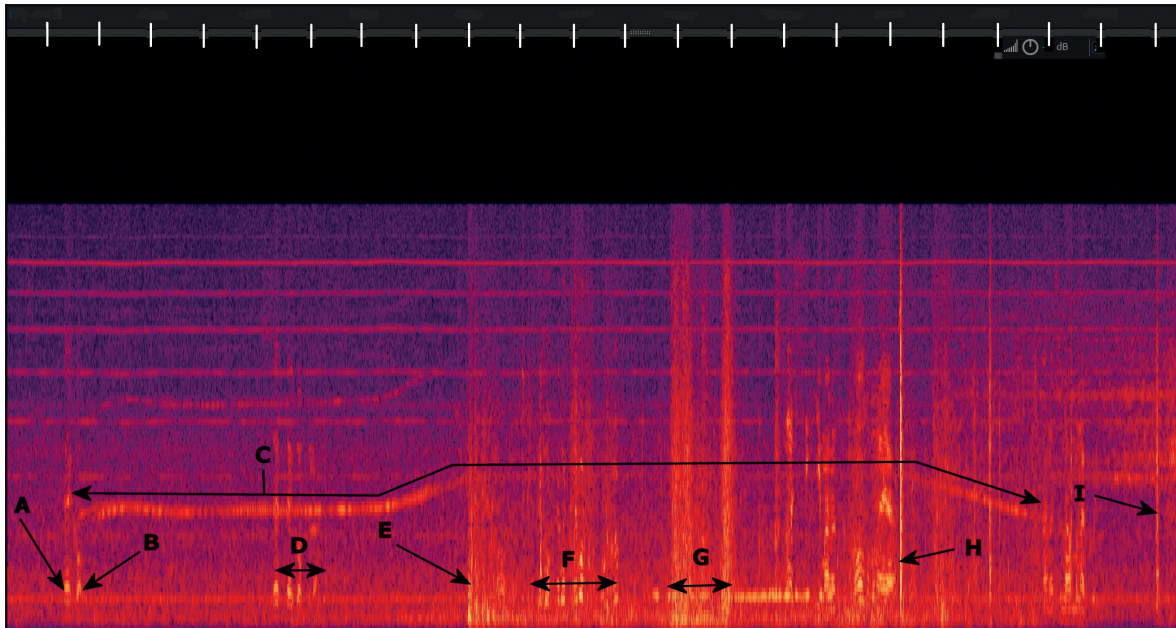
Figure 4: Spectrum analysis of the occurrence. Each vertical white line corresponds to 1 second.

Spectrum analysis of the cockpit area microphone was used to analyse significant sounds, and to determine the exact moment at which the loud bang (that was heard by witnesses) occurred. Following the captain's 'take off' call at 22.36:32 hours (A, Figure 4), the sound of the engines spinning up is visible on the sound spectrum (B). The sound of the engines during the occurrence is visible under line C. At 22.36:36 hours, the captain called 'Set take-off thrust' (D) and the sound of the engines spinning up increases. Around four seconds later a peak can be seen in the sound spectrum, corresponding to the loud bang that was heard (E). The voice of the first officer calling 'abort, abort, abort' is visible at (F), almost immediately followed by the noise of the gear leaving the runway and entering the area of grass (G). (H) is the sound of the TRAs being reduced to idle thrust. The noise made by the deflection of the speed brake handle at around 22.36:55 hours is also visible, at (I).

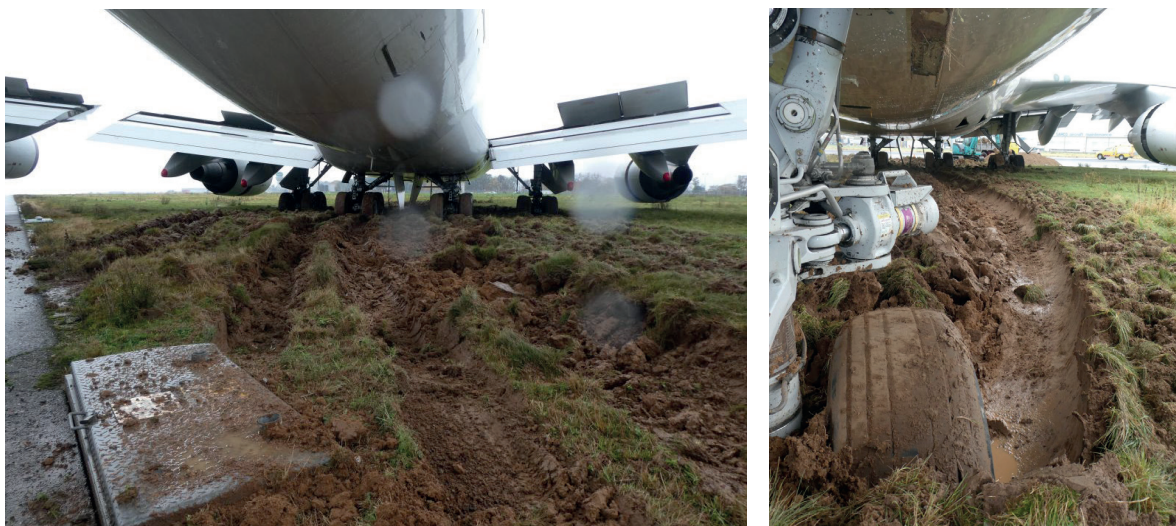
Figure 5: Photographs of wheel tracks in the soft ground.

After veering off the runway, the aircraft came to a standstill in the field to the right of Runway 21. All of the main gear's wheels had left deep tracks in the soil. A single track made by the nose gear was clearly visible, as were the double tracks left by each main gear. The left nose wheel had left a curved track, which was wider than the tyre itself. Mud had also been thrown up to the right side of the track. The nose wheels were turned slightly to the left.

The distance from the (displaced) threshold of Runway 21 to the main body gear of TC-ACR was approximately 143 metres. The distance from the entry point of Runway 21 to the aircraft was approximately 363 metres. Skid marks left by the landing gear, deviating to the right, were found on the threshold stripes.

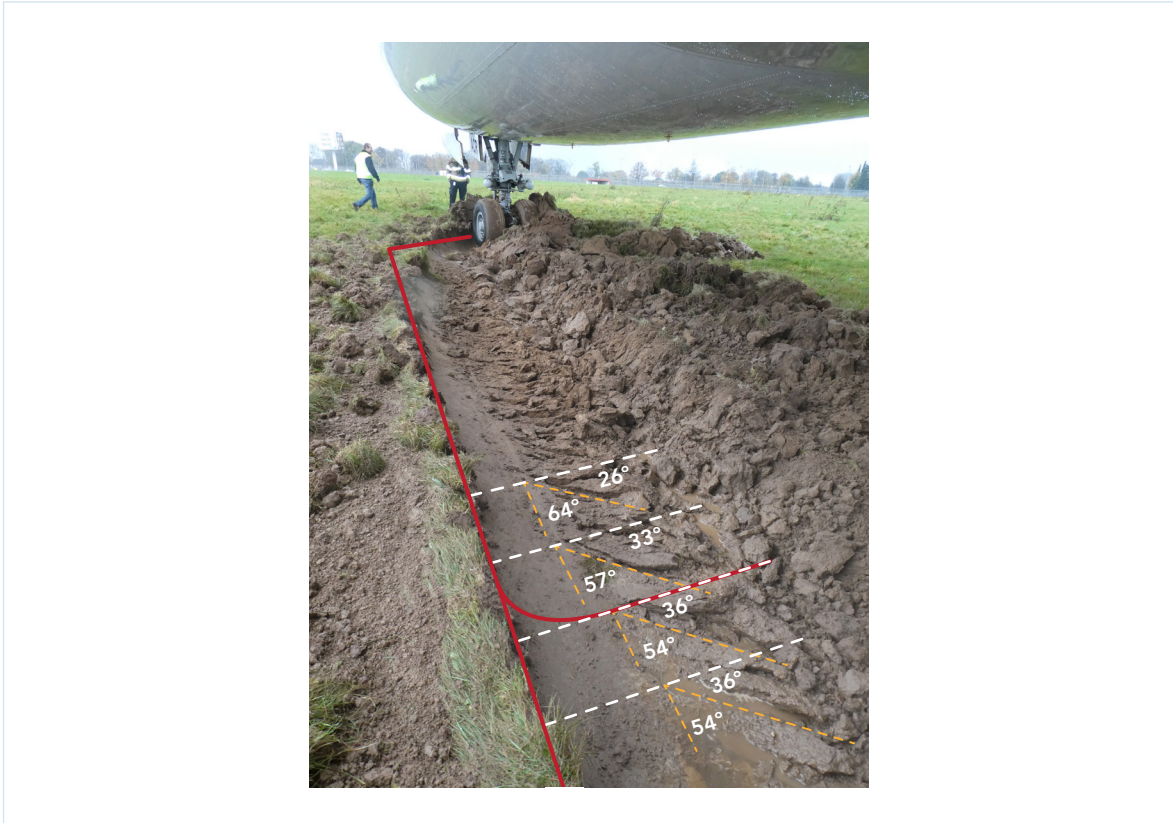
Figure 6: Analysis of the nose wheel track. The red line indicates the orientation of the aircraft; the yellow line indicates the angle of the nose wheel.

The tyre marks associated with each individual landing gear strut were carefully examined. The nose wheel tracks in the grass were of particular interest. It was concluded that the shape and size of the nose wheel track in the grass indicated a nose wheel steering angle ranging from around 26 degrees to around 36 degrees to the left. This track ran from the point where the nose wheel had left the runway surface to the aircraft's final resting place. Although the calculated steering angles (based on the nose wheel track) are merely an indication, they clearly exceed the maximum steering angle of 7 degrees that can be achieved by pedal steering. It is, therefore, very likely that this was caused by inputs to the tiller nose wheel steering system.

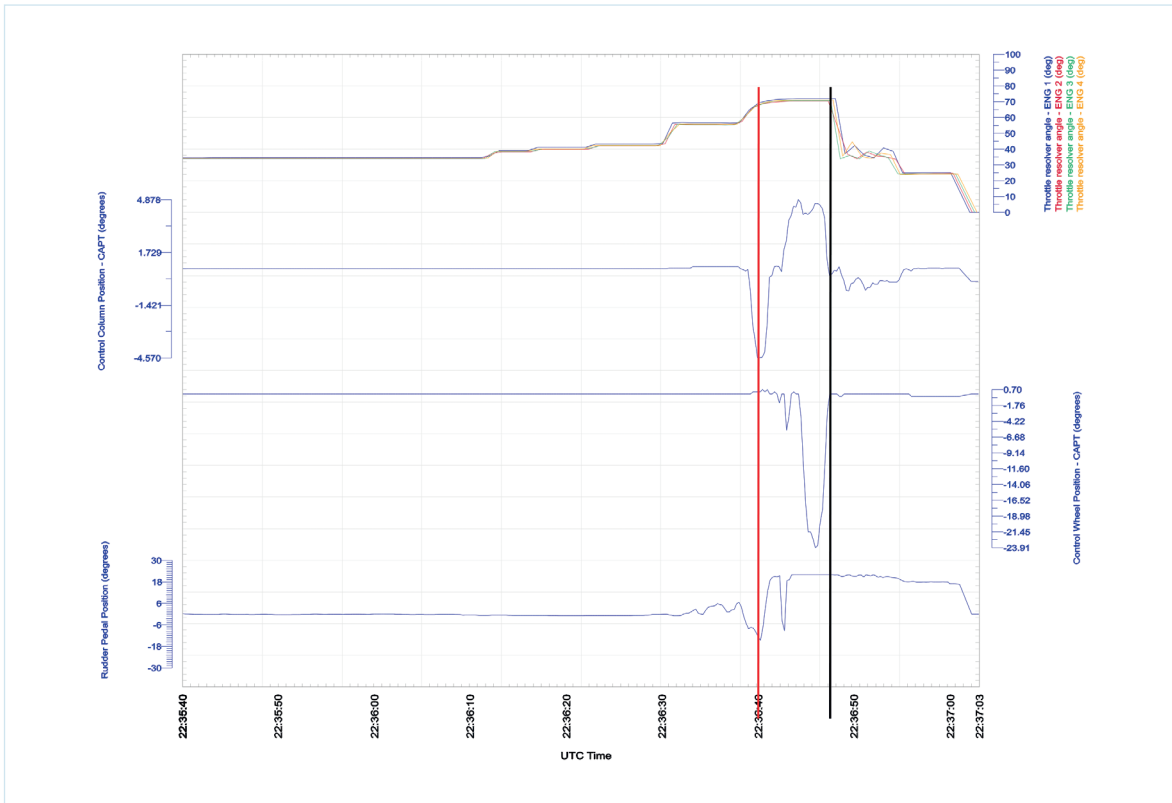
Figure 7: Plot of FDR data (TRA, control column, control wheel, rudder pedal). The red vertical line indicates the point at which the N1 of engine #4 dropped; the black vertical line indicates the moment at which the throttles were retarded.

FDR analysis revealed that left control wheel input was recorded from the moment the engine failure occurred until the moment the throttles were finally retarded to idle. There was an interval of 1 second between control column release and retardation of the throttles. This is consistent with the time required for the captain to move his right hand from the control column to the throttles. Accordingly, it is likely that the captain was not holding the control column with his left hand, but that he was instead using this hand to operate the tiller. It can be concluded that the captain was holding and using the tiller throughout the event, making control steering inputs that exceeded 7 degrees of nose wheel steering.
