# Shifting cargo causes emergency

Lessons learned from the occurrence  
involving the Eemslift Hendrika,  
5 April 2021

*Den Haag, July 2022*

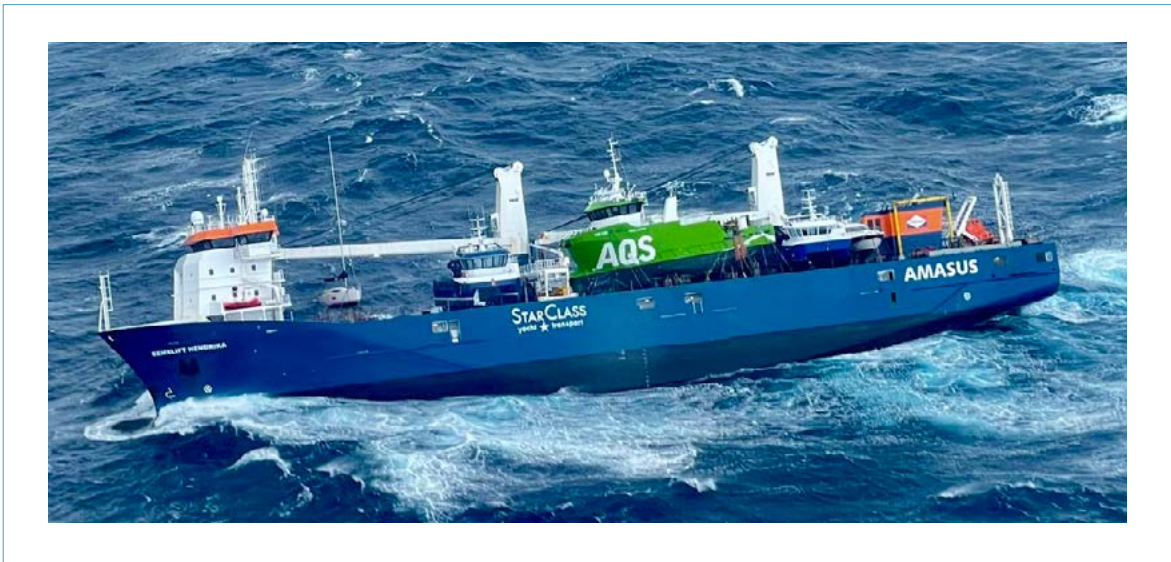
Figure 1: The listing Eemslift Hendrika off the Norwegian coast. (Source: Norwegian Coastguard).

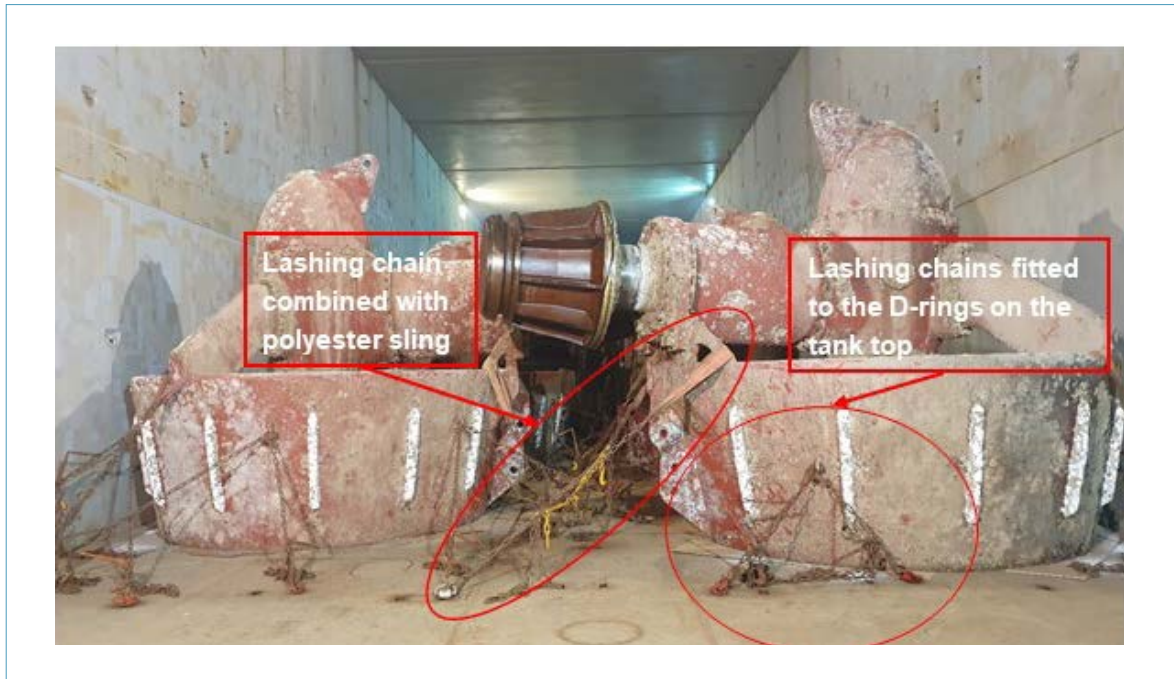
The lashings consisted of lashing chains, some of which combined with polyester slings and secured to D-rings on the tanktop<sup>4</sup> of the cargo hold. Because the number of integrated D-rings in the cargo hold was insufficient, additional D-rings were welded on the tank top. The harbour authorities of Palermo did not give authorisation for hot work (welding) while in port, making the captain and relief first officer decide to weld the D-rings to the tank top during the voyage to Palermo.

Figure 4: The thrusters as they were stowed in the hold, showing the lashings. Photo taken from the front of the hold looking aft. (Source: Amasus)

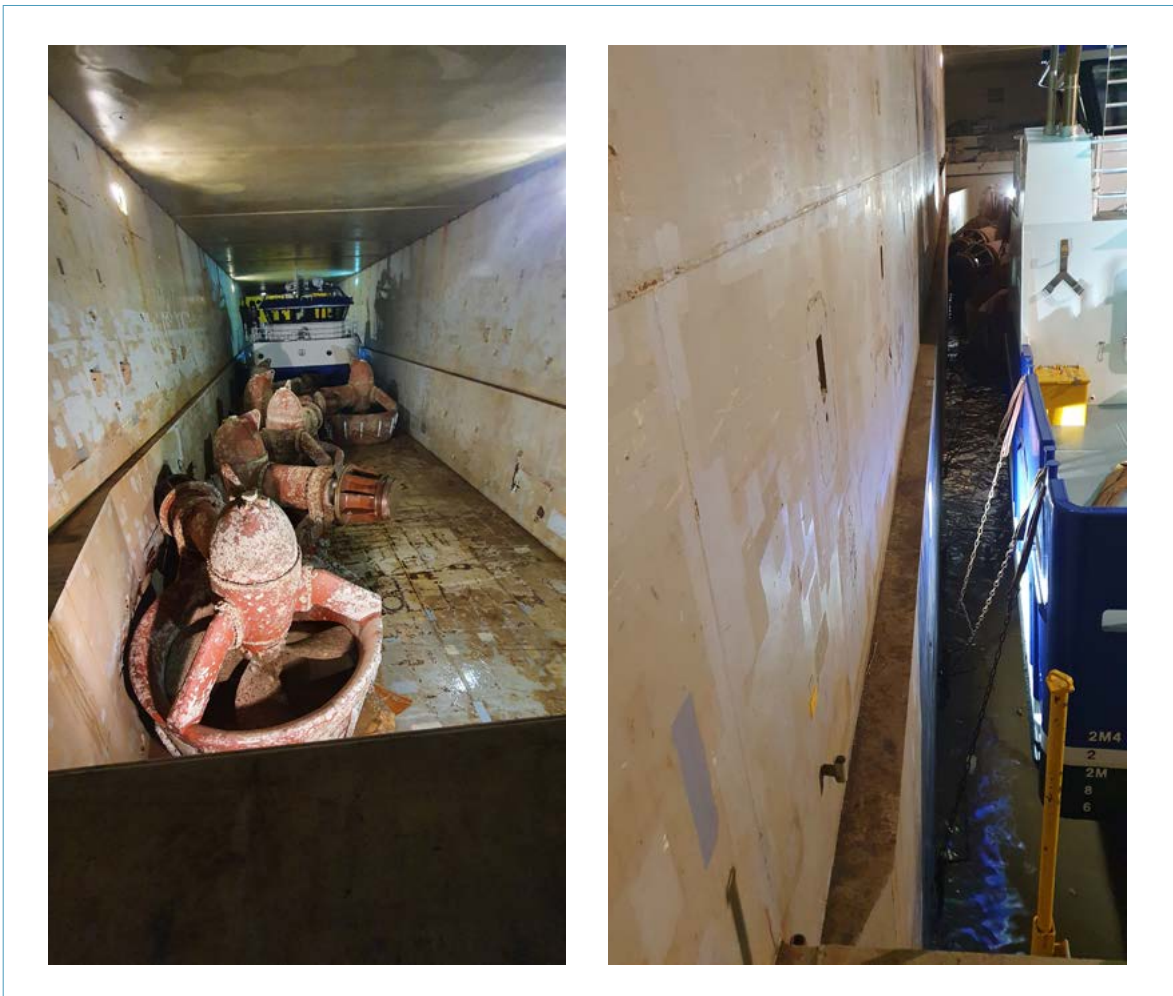
Upon arriving in the hold, the relief first officer and the cargosuperintendent found a large quantity of water and noticed that the three most forward stowed azimuth thrusters had dislodged. One of these three had come loose first and had caused a domino effect, causing the other two to also become dislodged. It was observed that the thrusters had punched a hole in the portside anti-heeling tank and that water was running into the hold. The anti-heeling tank was completely filled and contained 355.2 m<sup>3</sup> of water, rapidly filling the hold. Upon their discovery the relief first officer and the cargosuperintendent went to the engine room where they ordered the engineers to start the open top pump<sup>8</sup>.

Figure 6: The situation in the hold at the time of the occurrence. The photo on the left shows that the front three thrusters have detached. The photo on the right shows part of the water in the hold. (Source: Amasus)

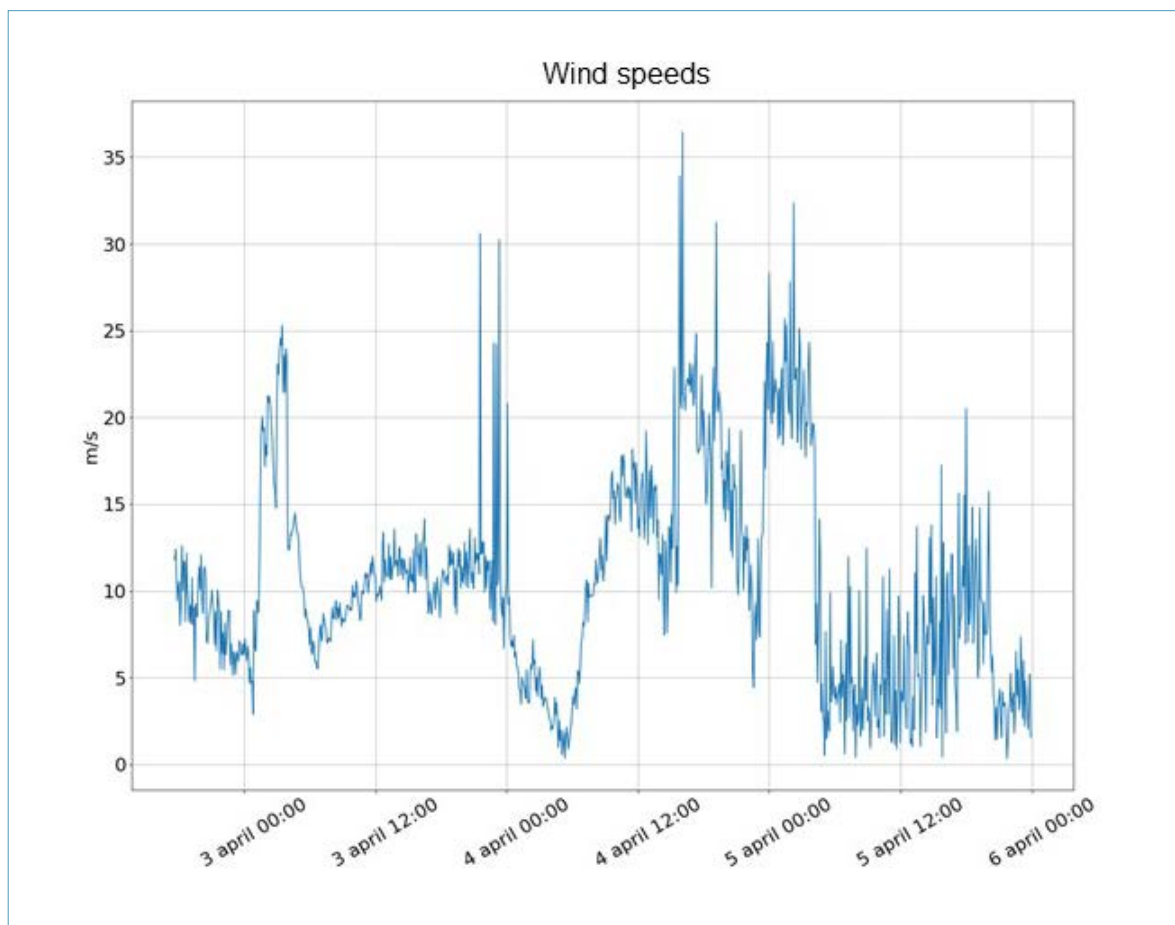
The actual weather conditions at the time of the incident were in line with the predictions. On the day of the occurrence the speed of the northwesterly wind varied between 34 and 40 knots (8 beaufort). Early in the day the measured wave heights were around 7.5 metres and by late afternoon they reached up to 10.8 metres. There was a swell from the west-northwest rising to 4.5 metres in height.

Figure 12: An overview of the wind speeds in metres per second (m/s) as saved in the VDR on board of the vessel.

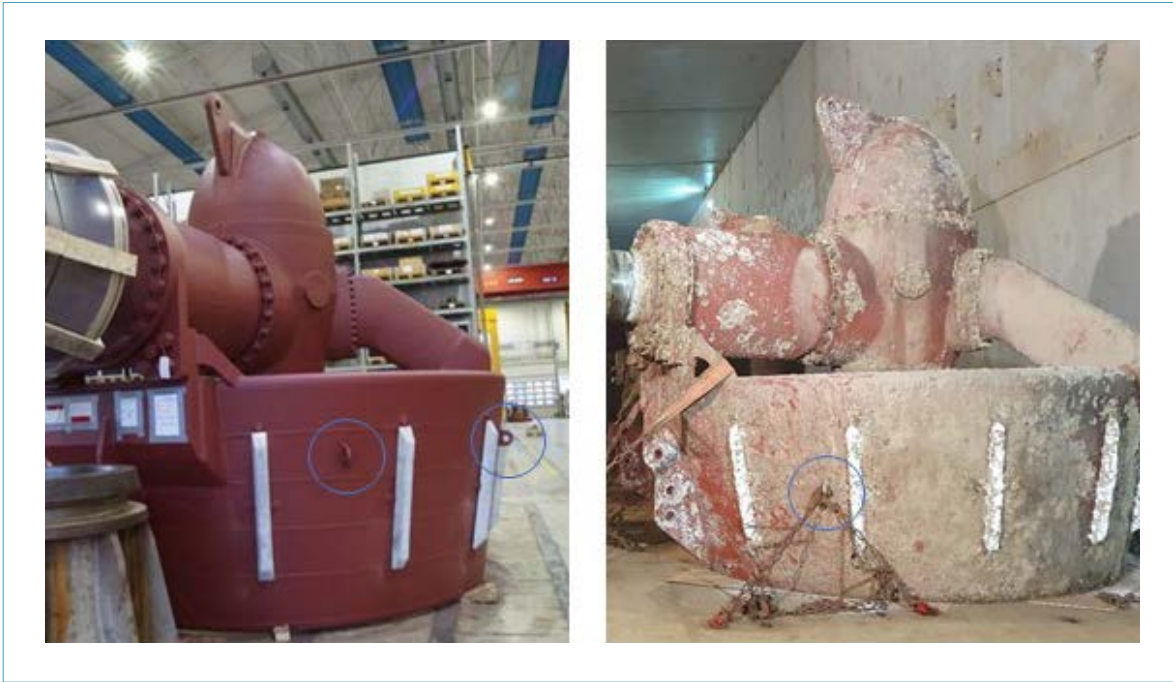
The photograph of the thruster supplied by the freight broker shows two padeyes on the nozzle (figure 13). No further details of the padeyes were communicated to the operator and therefore their purpose and load capacity were unknown. The operator did not request further information on the capacity of the lashing points of the thrusters.

The photograph taken of the thrusters after these had been lashed shows that the number and the position of the padeyes varied from one thruster to another. The photograph provided by the freight broker shows two padeyes at 4/5 of the height of the nozzle. The photograph of the thruster in the hold shows one padeye at about half of the height of the nozzle. The photograph that was provided of one of the thrusters was not representative for all azimuth thrusters.

Figure 13: The photo on the left is the one provided by the freight broker and shows an azimuth thruster with two padeyes. The photo on the right shows one padeye on one of the azimuth thrusters in the hold. Note that the position of the padeye differs from the position of the padeye in the photo on the left. (Source: Amasus)

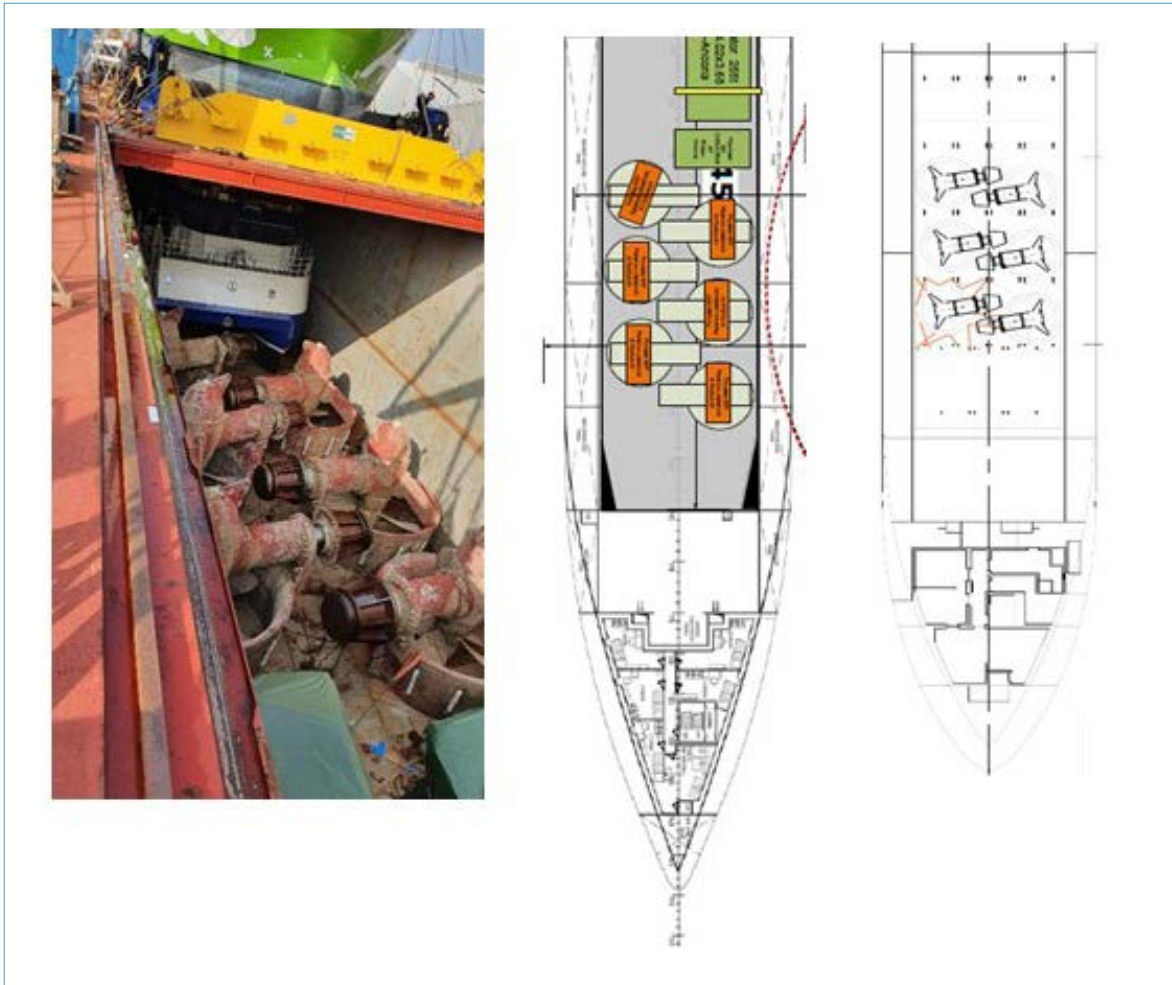
Figure 16: The azimuth thrusters stowed and lashed in the hold after departure from Palermo and next to it the stowage plan as prepared on board and the stowage plan as prepared by a third party. (Source: Amasus and EVH Surveys)

Experts stated that because the longitudinal accelerations of a vessel are smaller than the lateral accelerations it would be best practice to stow the thrusters with the gearbox pointing in longitudinal direction. The forces exerted on the lashings will then be smaller. By placing the thrusters longitudinally in the hold, it will also be easier to fix the lashings symmetrically. Because of the limited space in the hold and the presence of other cargo, the captain and relief first officer in this case opted for placing and lashing the thrusters transversely.

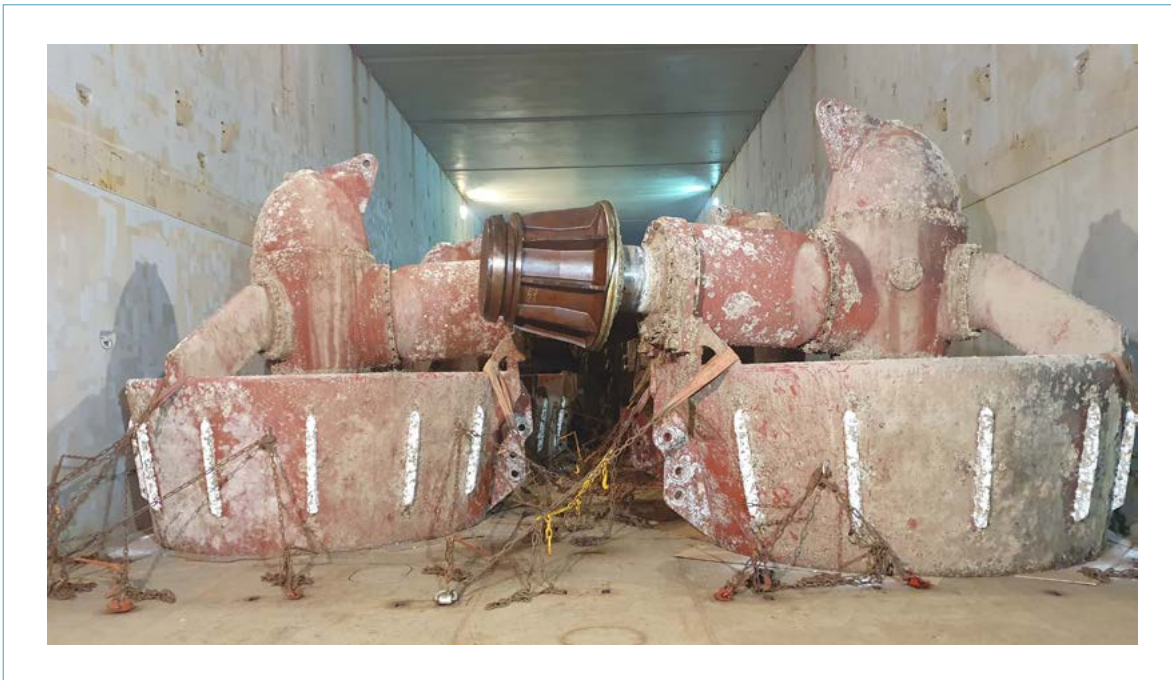
The results of both the initial lashing calculation and the verification calculation made by the relief first officer based on the entry data for angles and lengths of the lashings, indicated that theoretically the number of lashings calculated would be sufficient to counter the movements of the vessel in longitudinal, transverse and vertical directions. However, looking at the photographs (figure 17) it could be concluded that the lashings were not installed in accordance with the lashing calculations made by the relief first officer. The positions of the lashings, the angles and the lengths of the installed lashings did not correspond to the data entered in the calculation. The calculation was also based on a single type of lashing instead of a combination of materials. This caused other loads to be exerted on the lashings than had been anticipated.

Figure 17: The thrusters on the port side and starboard side in the front part of the hold (Source: Amasus)

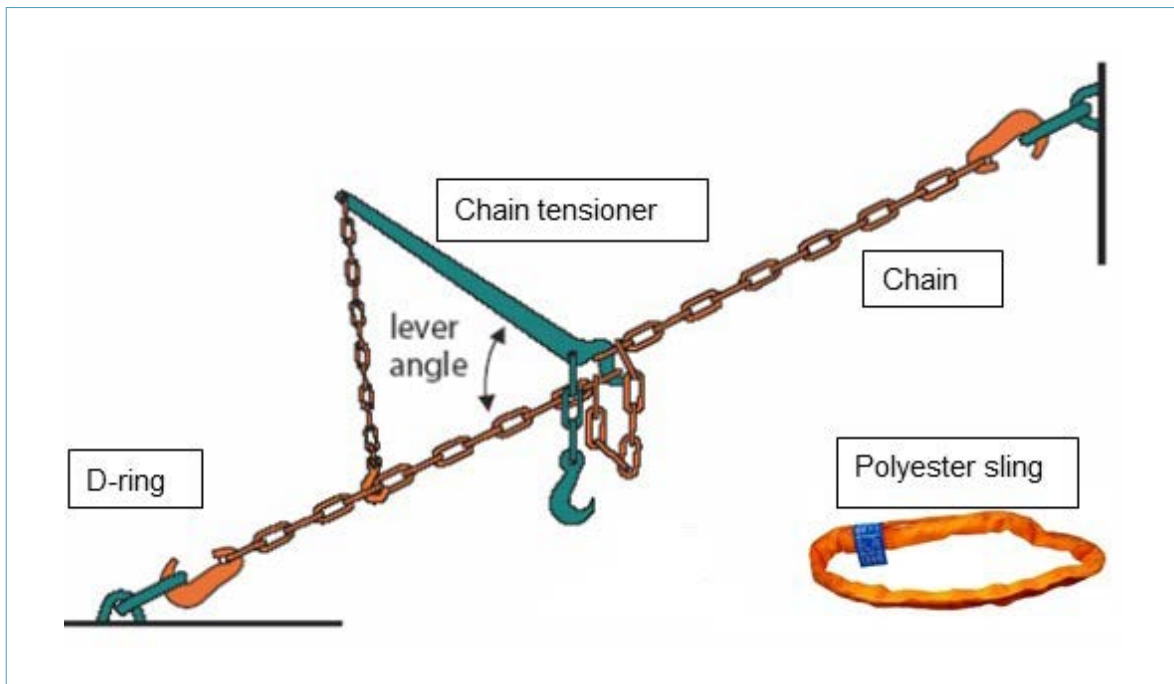
For each thruster on average fourteen lashings were used. One thruster had a lashing less, another one more, just what was convenient. The lashings consisted of lashing chains, in some cases combined with polyester slings and secured to D-rings on the tank top and the wall of the cargo hold (figure 18). These were fixed D-rings as well as twistlock D-rings and welded D-rings. The lashing chains and tensioners were between six months and three years old. The age of the polyester slings and welded D-rings could not be determined from the information available. The crew considered the condition of the lashing material to be adequate.

Figure 18: Visual overview of the lashing material used for lashing the thrusters.

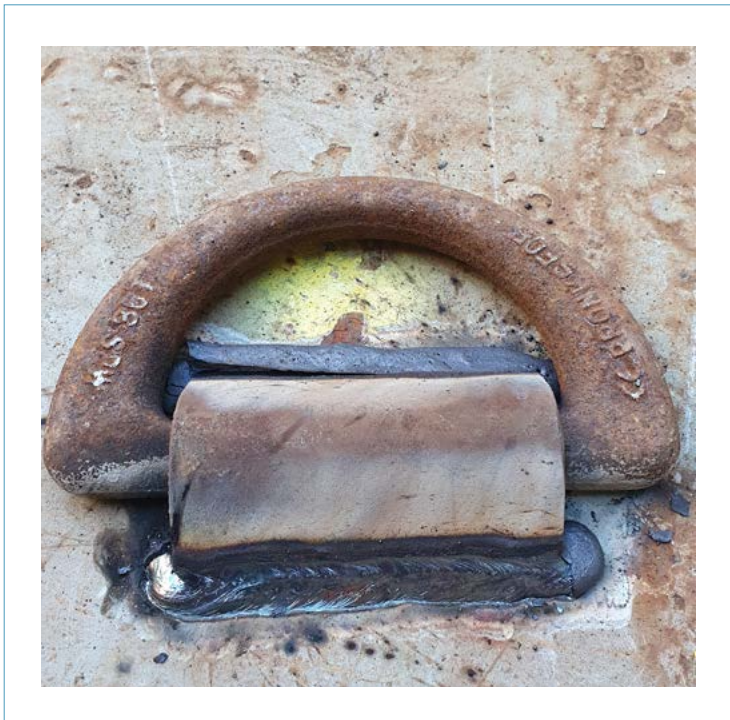
During the visual inspection no abnormalities were found in the welds, and after reviewing the photographs of the welded D-rings, experts confirmed that the welds looked fine. It was noted that the weld ran round the corner of the base of the D-ring, which indicated the weld had been made in a professional manner. Such a visual inspection can never completely confirm the quality and load capacity of a weld because of the superficial nature of the assessment, but it is unlikely that a badly welded D-ring caused the cargo to dislodge.

*Figure 20: One of the welded D-rings for securing the lashings of the thrusters.*

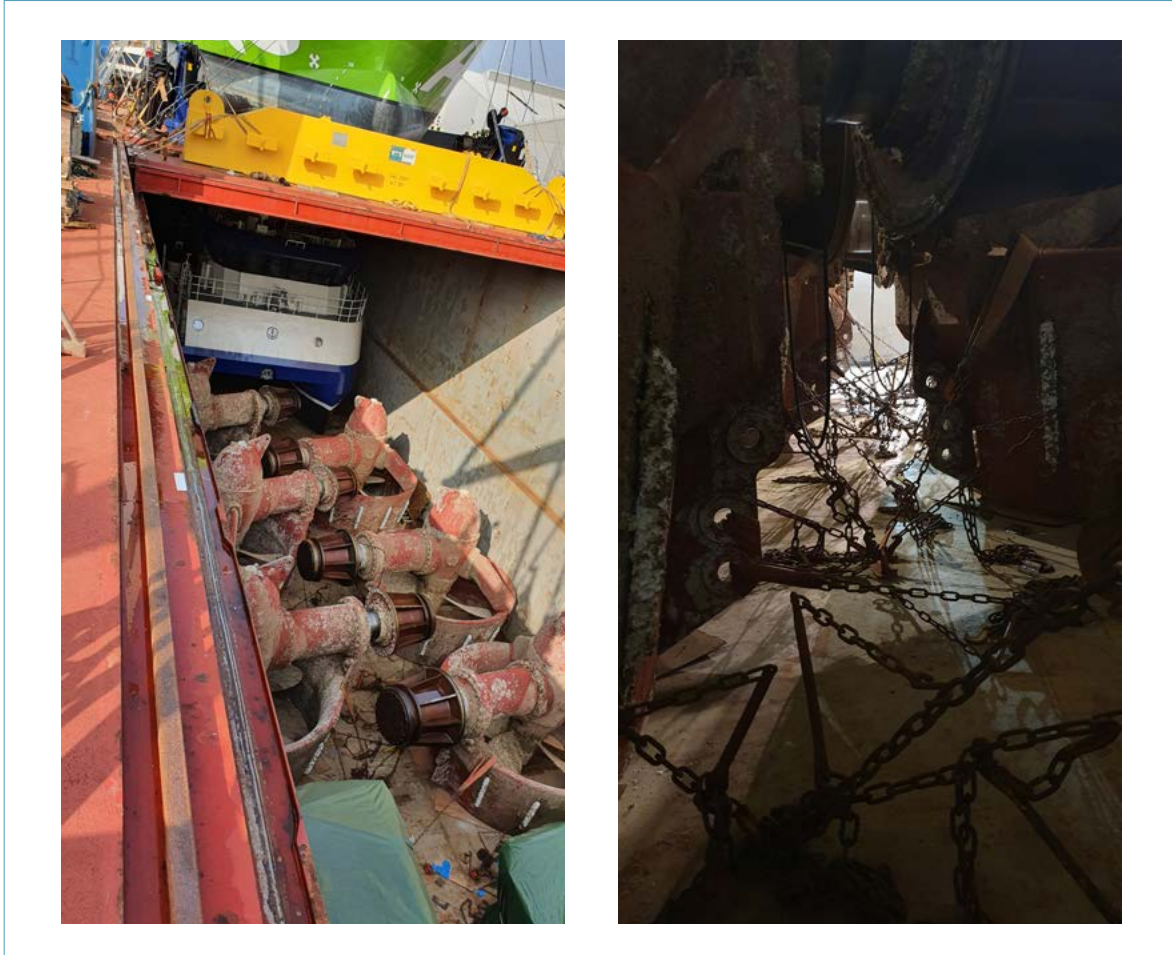
The thrusters were placed in the hold on several smaller pieces of plywood with a thickness of 1.5 cm. These plywood pieces provided friction between the thrusters and the deck. The photographs of the lashed thrusters show that the lashings were made in different configurations (figure 21).

The thrusters were almost stowed against the walls of the hold. This limited the options for attaching lashings and their orientation on that side of thrusters. As the thrusters in the hold were in slightly rotated position, it can be assumed that the lashings could not be attached symmetrically. A number of lashings was attached under a vertical angle of more than 60 degrees or almost 60 degrees and the lengths of the lashings differed. The lashing chains were also combined with polyester slings that in some instances were placed under large vertical angles across the edges of the nozzle.

Figure 21: The azimuth thrusters stowed and lashed in the hold. (Source: Amasus)

The difference in elasticity of the materials has a negative effect on the effectiveness of the lashing system. For the same reason, large differences in length between the various lashings can also have an adverse effect. The difference in elasticity causes play which in turn causes lashings to become loose, generating jolts in the loads exerted on the lashings. Lashing chains in particular are prone to shock loads which may cause breakage. If there is a possible risk of cargo tipping over, the elasticity of the lashings in the vertical plane should also be taken into account. Because of the difference in elasticity, the pressure on the plywood on the deck could be significantly reduced, causing the plywood to slide away. In addition, the use of polyester slings at large vertical angles and across edges increases the risk of the slings being cut.
