DUTCH
SAFETY BOARD

Shipping Occurrences Report

January 2023 - July 2023

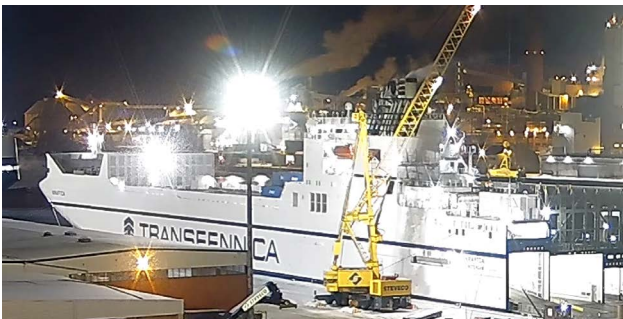
On 28 December 2022, the Dutch RoRo freighter *Kraftca* was in the port of Kotka (Finland) for loading and unloading operations. With the help of local stevedores, the crew members were moving steel support beams that were part of the ship's gear. During this work, the stevedores' foreman was hit by sliding support beams and was knocked over. The foreman fell onto a lower deck and the beams fell on top of him. He died on the spot.

▲ The quay crane being used to move the support beams just before the accident. (Source: CCTV Steveco)

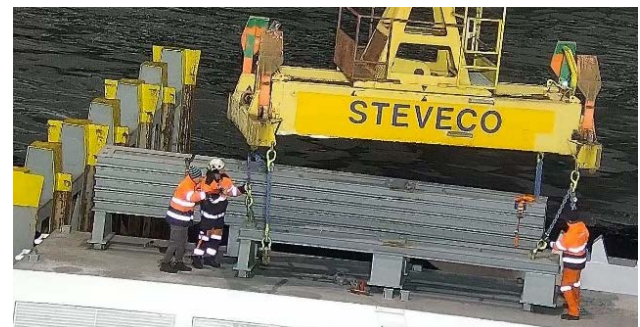
▲ The support beam is hooked to the spreader with two hooks. The two loose hooks can also be seen. (Source: CCTV Steveco)

While hooking the support beams to the four corners of the spreader by means of chains and hooks, it became apparent that the hoisting height of the crane was insufficient, which is why the foreman and the crane operator decided during the operation that the chains had to be shortened. This was personally communicated to and coordinated with the first mate and the cadet. The shortened chains meant that only two chains from two corners of the spreader fit on the support beams. The other two chains were not tied up or secured; they remained loose.

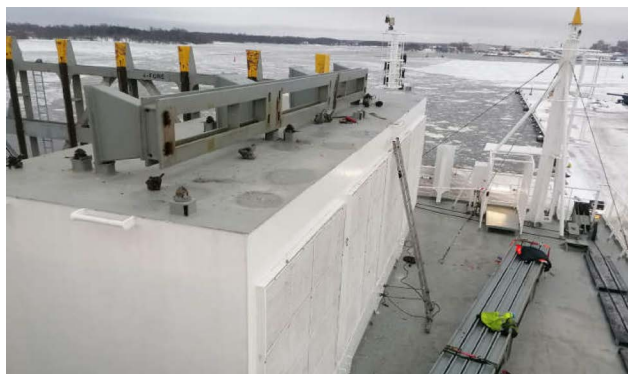
During the hoisting operations, the rear loose chain got caught on the stack of support beams. The beams were no longer secured by twistlocks and therefore started sliding. In the process, the beams pushed the foreman off the housing of the ventilator, causing him to fall more than 2.5 metres onto a lower deck. The stack of beams then landed on top of him. The foreman suffered such serious injuries that they led to his death shortly afterwards.

▲ *Toppled support beam on housing of ventilator and support beams that fell down on lower deck next to housing of ventilator. Next to this is the loosely placed ladder used by people to climb up the housing of ventilator. (Source: Spliethoff)*

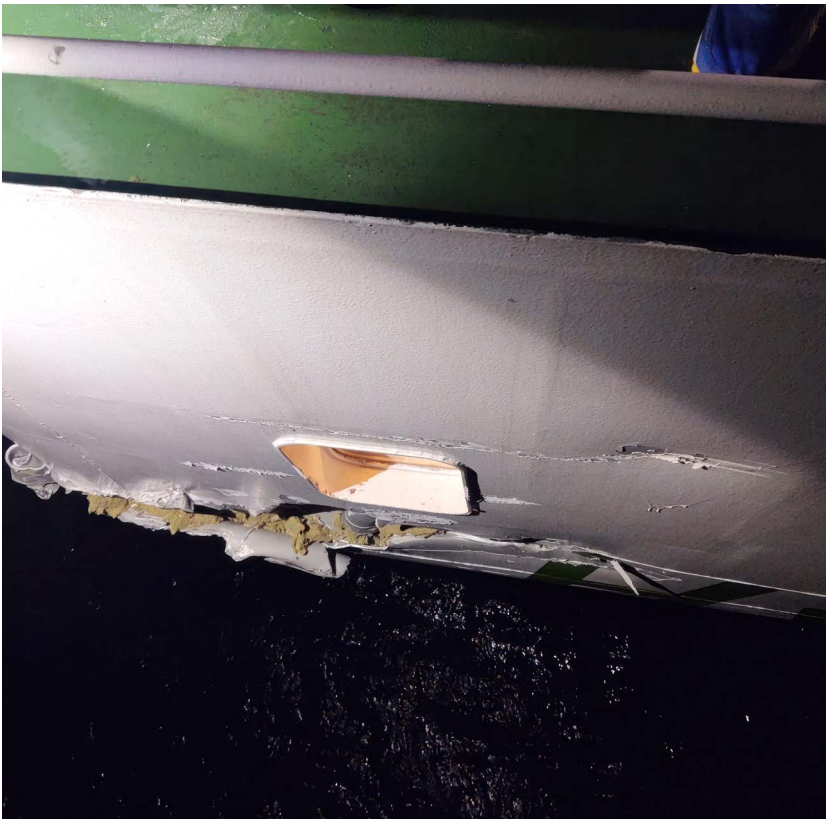
suffered damage to the starboard railing and part of the gear. The seaworthiness of the Fuldaborg was not threatened. The Gann suffered damage to the cabins on the starboard side, and a tear in the vessel's hull, above the waterline.

▼ *Damage Gann. (Source: Wagenborg)*

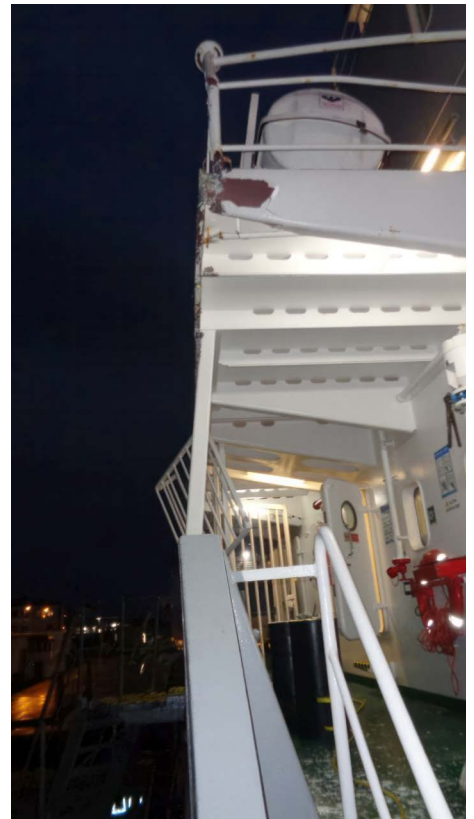
▼ *Damage Fuldaborg. (Source: Wagenborg)*

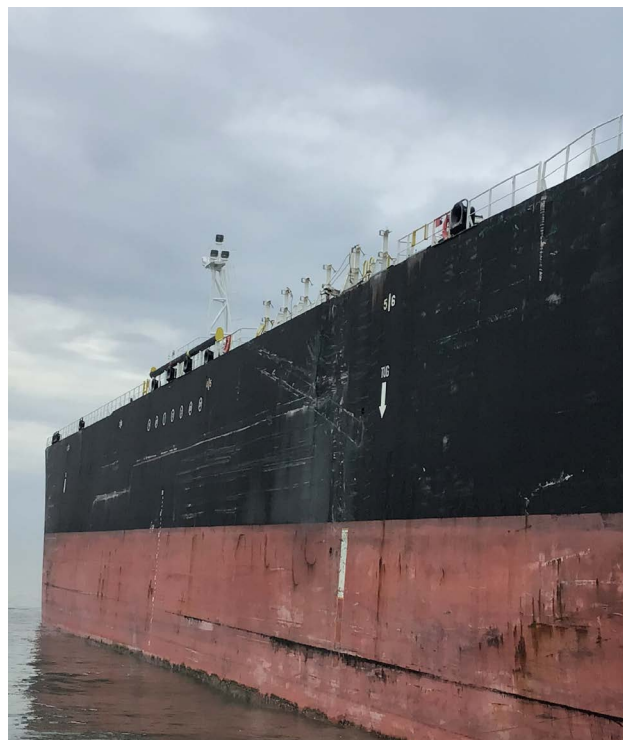
▼ *Kriti Emerald - markings of the broken gangway in the shipside. (Source: RWS)*

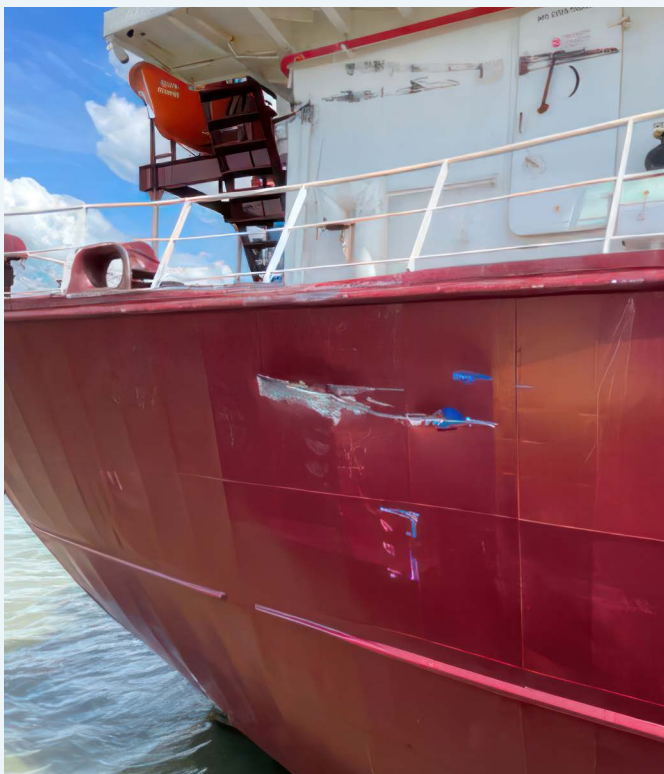
The Karen thus hit the Oralora and both vessels sustained damage. The Karen had damage to the fore part (crack of 30cm). The Oralora had a crack of 30cm on the starboard side and damage to a railing and drainage pipe. There was no leakage or underwater damage.

▲ Damage Oralora. (Source: DMAIB)

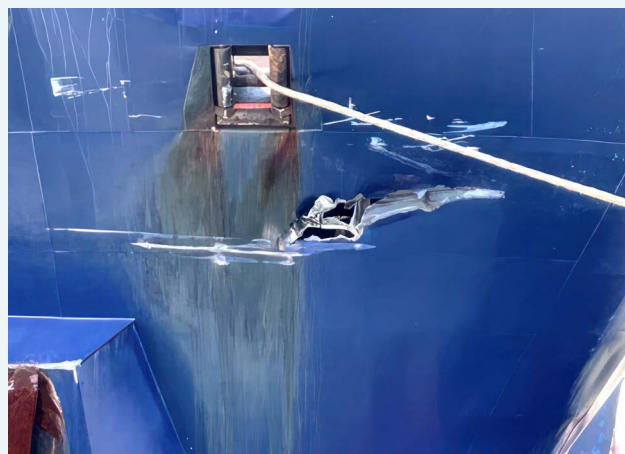
▲ Damage Karen. (Source: MSIU)

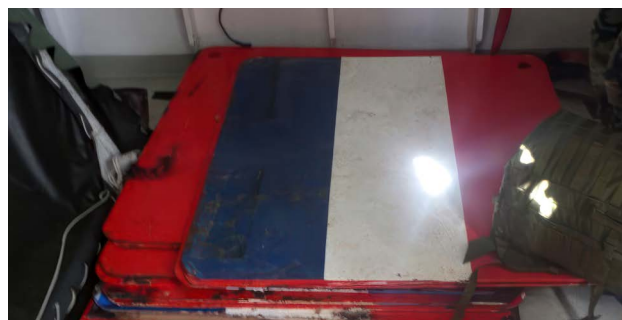
On board the Dutch seagoing vessel Bigroll Bering, two crew members and two members of the counter-piracy team were involved in storing a number of steel sheets used as part of several anti-piracy measures, at around 11.15 hours UTC. The sheets are stored upright. For every new sheet added to the stack, a securing bar has to be removed which holds the stack in place. While returning one of the steel sheets, the stack toppled on the two crew members. The medic of the security team provided immediate first aid. One crew member suffered only a minor cut to the lower leg and a slightly swollen right foot. The other crew member was trapped underneath the sheets. After being released, he was unable to raise his right leg, and suffered a hematoma on the right-hand side of his lower back. At 12.15 hours, radio medical advice was obtained, and following a short discussion, the decision was taken to send this crew member to shore, at the nearest port. Following admission to hospital, it became clear that the crew member had fractured his pelvis.

▲ The toppled plates on board the Bigroll Bering. (Source: Bigroll)

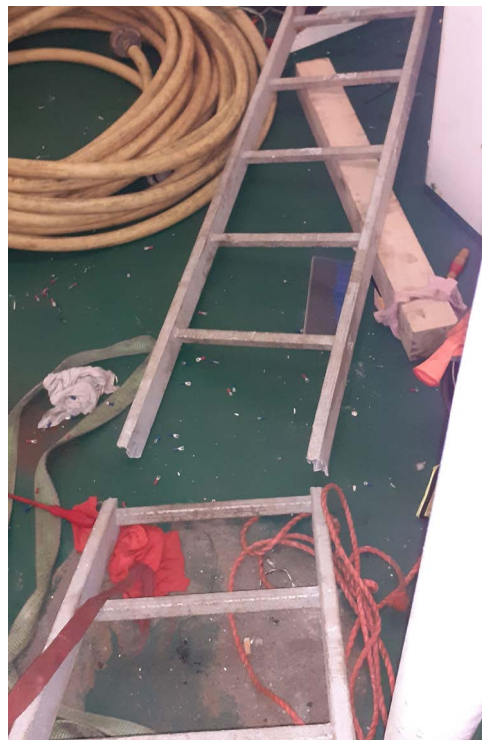
In the afternoon of 22 March 2023, the chief engineer of the Dutch seagoing vessel Arklow Brave was working on electricity cables at the front entrance to hold 1. He was using a portable aluminium ladder. While he was standing on the ladder it broke, and he fell a distance of one metre, twisting his left foot. He received first aid for the pain in his foot on board, and following consultation, medical assistance was requested. An ambulance took him to hospital where it turned out that he had broken a bone in his left foot. The victim was unable to continue his work, and was relieved.

▲ The broken ladder on board the Arklow Brave.
(Source: Arklow)

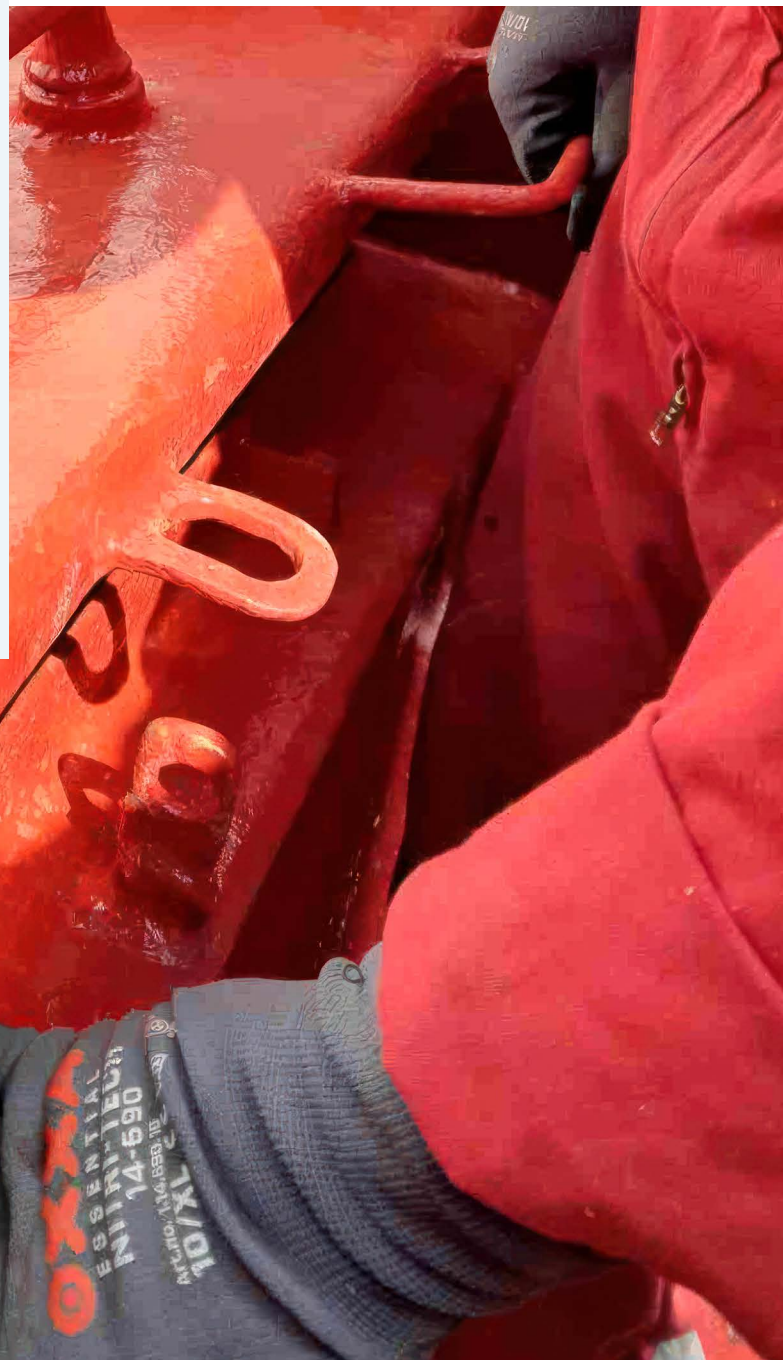
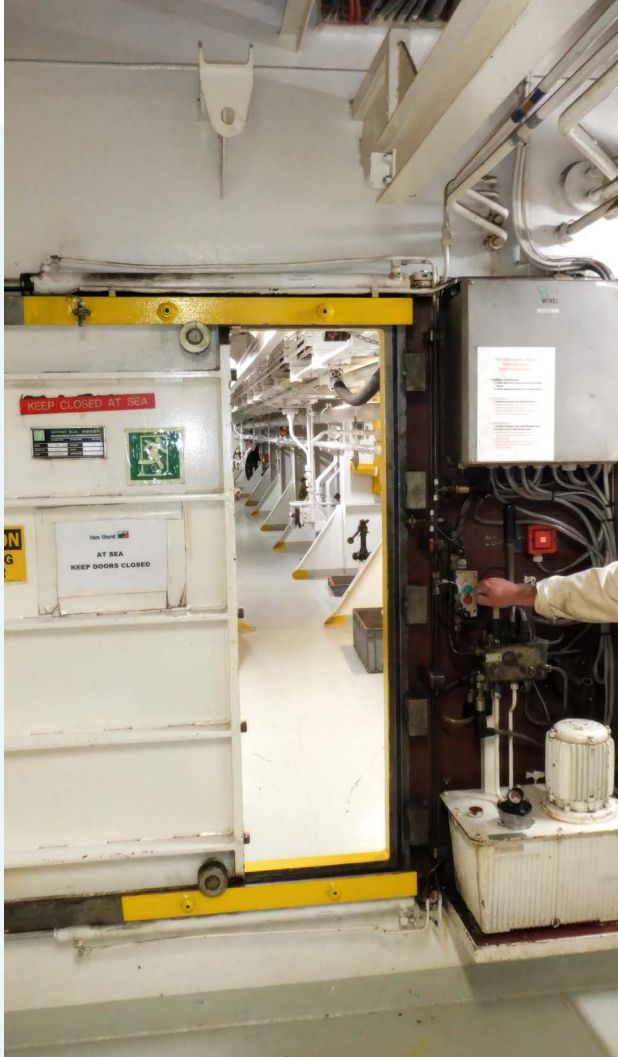
On Monday 27 March 2023, at around 11.00 hours, a hatch slipped out of the right hand of the mate on board the Dutch cargo vessel Jalonborg. He was looking into the entrance to the hold and had raised the hatch around 5 to 10 cm, when the hatch slipped out of his right hand. Part of his left hand was resting on the edge of the entrance, which meant that the hatch closed on the index finger of his left hand. Following inspection by the doctor, he was found to have fractured his index finger. The first mate was unable to work for probably one to two weeks.

▼ *Simulation of the occurrence – Jalonborg.*
(Source: Wagenborg)

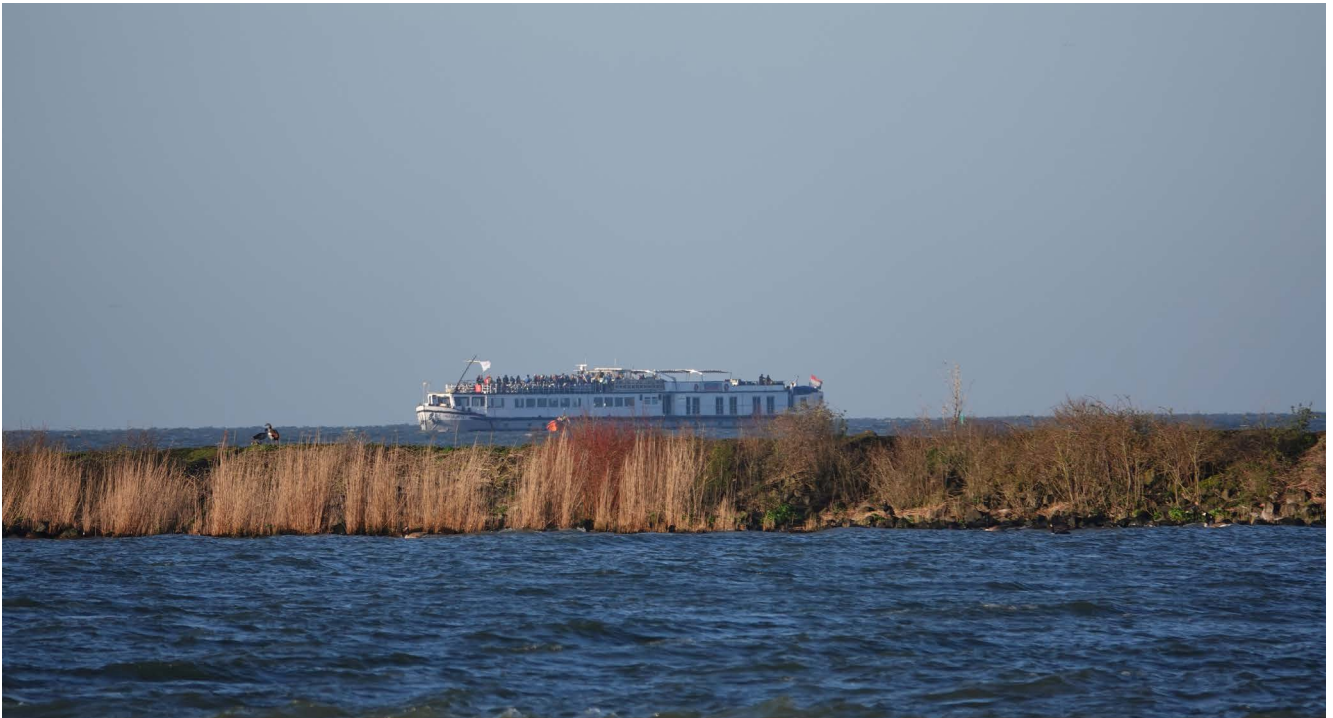
On board the Dutch inland passenger ship De Holland, fire broke out on the morning of Friday 14 April 2023. At that moment, the vessel was sailing on the Markermeer close to Enkhuizen, with around 56 passengers and 14 crew members on board. The crew were able to put out the fire that was burning in the engine room. No one was injured. After the fire had been extinguished, the fire brigade carried out a final inspection.

The cause of the fire was a broken fuel pipe.

▼ *De Holland.* (Source: InterVisualStudio/Danielle Rood)

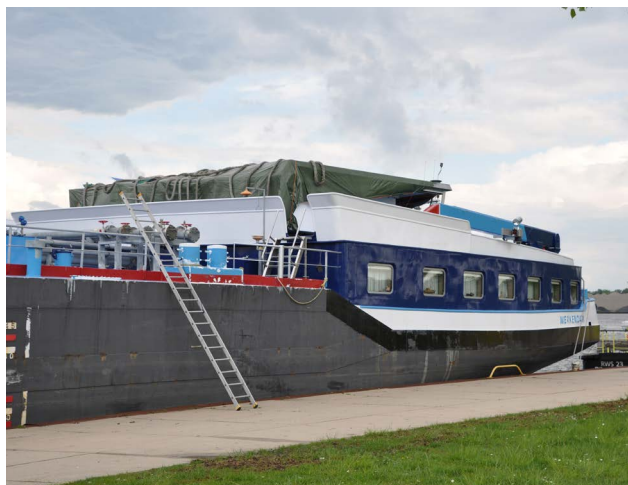
The Dutch inland vessel *Antonie C* collided with the bridge near Sas van Gent over the Ghent-Terneuzen Canal on 12 May. The wheelhouse of the inland vessel hit the bridge. This caused the wheelhouse's roof to come loose. No one was injured during the collision. The vessel remained fully manoeuvrable. A lamp on the bridge was damaged.

▲ Wheelhouse *Antonie C*. (Source: Adri van de Wege)
