DUTCH
SAFETY BOARD

Shipping Occurrences Report

May - October 2020

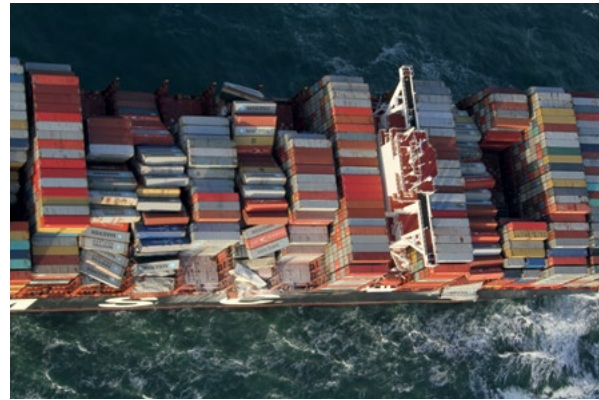
On the night of 1 to 2 January 2019, the Panamanian flagged containership MSC ZOE (19224 TUE) lost 342 containers to the north of the Wadden Islands. This was not the first occasion that a ship had lost containers on that route, but the numbers made a deep impression. Never before had a ship lost so many containers at one time, on this route. The beaches of the Dutch and German Wadden Islands and the coast of Friesland and Groningen were awash with the contents of the containers. For months after the occurrence, the cargo of the MSC ZOE continued to wash ashore. The possible long-term damage to organisms can still not be fully assessed, but the pollution itself represents considerable harm to the natural value. Where in the past the losses of containers had been dealt with basically as a matter for insurers, the loss of the containers by the MSC ZOE was classified as a 'very serious' marine casualty based on its environmental impact.

Top view MSC ZOE after losing 342 containers.

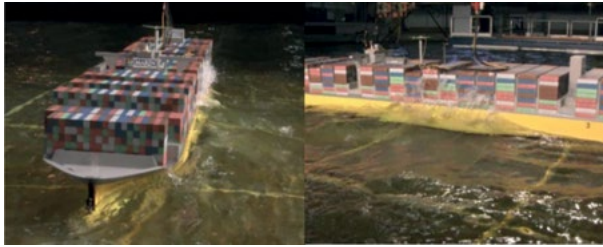
The investigations that lead to the reports mentioned above have for example revealed that for large, wide and stable container ships, there are route-specific risks on the shipping routes north of the Wadden Islands. Four hydrodynamic phenomena were measured and observed, which can individually and in combination introduce a risk of loss of containers. The four hydrodynamic phenomena are: extreme ship motions resulting in large accelerations and forces on lashing equipment and containers, contact with the seabed, green water and impulsive wave impacts (slamming) against the ship.

Observation of green water during de basin tests by MARIN.

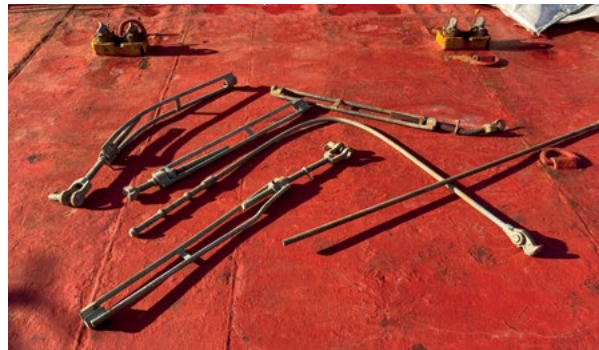
Because the acting forces and accelerations on lashing equipment closely approach the design limits, the risk of losing containers will become even larger if the containers are not properly lashed. The subject lashing was recently the focus of a report by the Human Environment and

Damaged lashing equipment after the loss of containers.

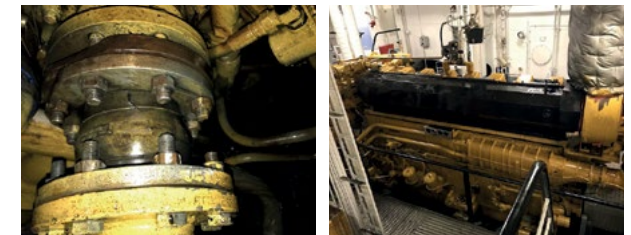
On 19 March 2020, the DC Vlaanderen 3000 lost power as a result of a fire in the engine room. The fire was caused by a leak in the lubricating oil pipe. After fuel supply to the engine room was shut off, causing the main engine to shut down, the crew activated the solid CO2 extinguisher installation and put out the fire. The ship was able to return to Breskens using the bow thruster for auxiliary power. The next day, when the engine room was opened, it became clear that besides the leak from the lubricating oil pipe, there was no further damage in the engine room. There were no injuries as a result of the incident.

The incident was classified as 'serious'. The cause of the incident was a crack in a pressurized lubricating oil pipe close to the turbocharger. As the pipe cracked, lubricating oil was sprayed onto a hot surface on the main engine, causing it to ignite.

The damaged lubricant oil pipe. (Source: DC Vlaanderen 3000)

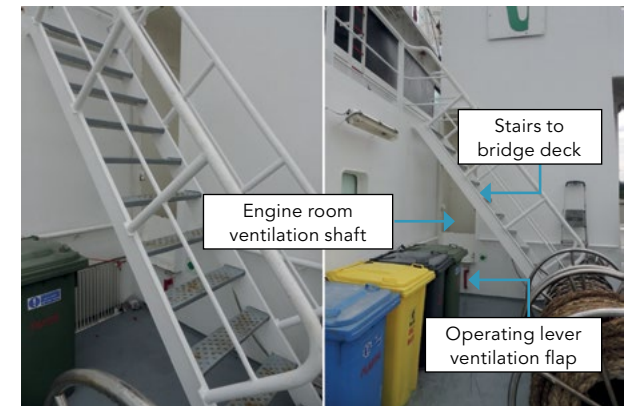
- Both crew members saw the fire start and were barely able to escape from the engine room, but they did suffer burns;
- Before the fire could be extinguished with CO₂, all ventilation openings with fire valves first had to be closed. The fire valve below the outside stairs to the bridge was difficult to close, because the operating handle was difficult to reach as a result of smoke and heat.

Position of operating handle fire valve engine room ventilation.
(Source: Dutch Safety Board)

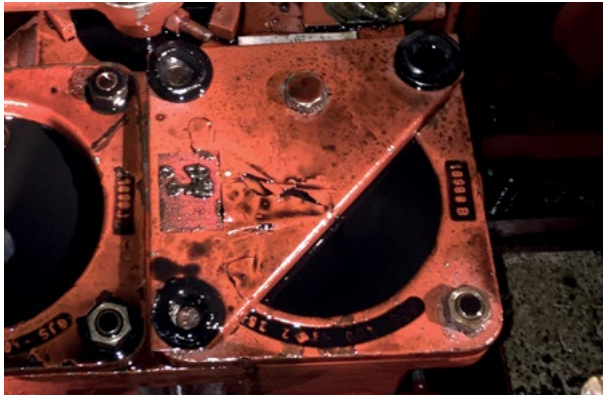
Top of filter cover, including safety cover. (Source: Dutch Safety Board)

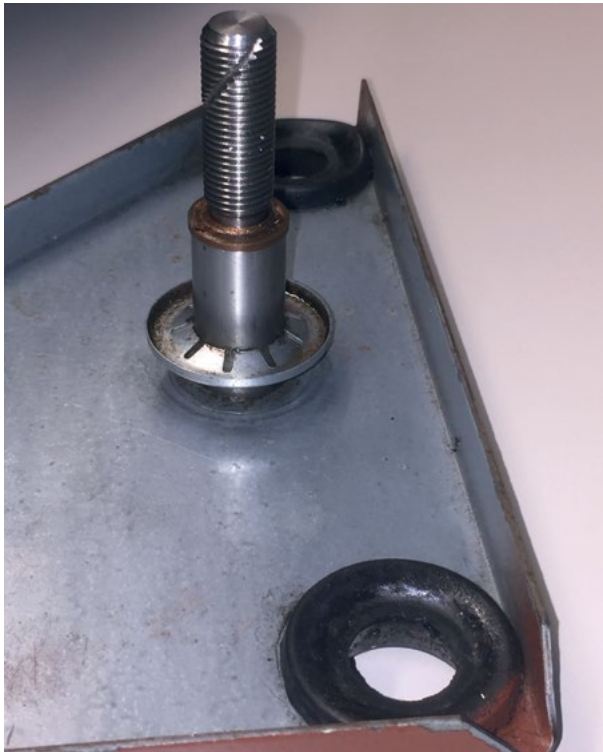
Inverted safety cover with venting bolt. (Source: Dutch Safety Board)

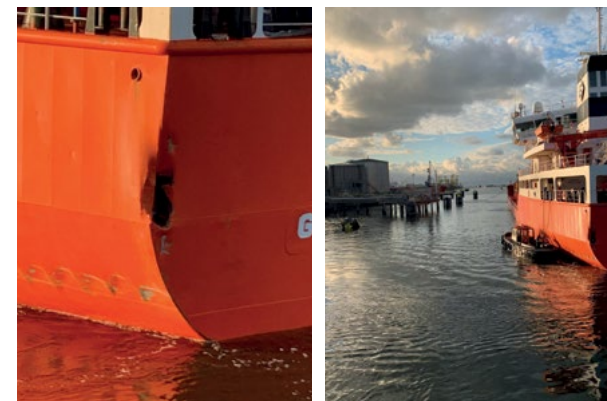
The pilot had come aboard at sea at around 17.00 hours, and piloted the vessel into the Caland Canal. The captain took over control on reaching the 7^e Petroleumhaven. The ship made a turn to starboard before making a parallel reverse landfall. After building up speed, the captain decided to transfer control of the ship from the central console on the bridge to the console on the port bridge wing. At this point, the pilot pointed out the post behind the ship, to the captain, and recommended that the captain move the ship forward. The captain attempted to comply with this recommendation, but the adjustable propeller failed to respond to the controls, as a result of which instead of slowing down, the ship collided with the post. After switching back to the central console, and from there once again back to the port bridge wing, the operation of the propeller was once again possible.

Damage to the stern part of the Gisela Essberger. (Source: Rotterdam Harbour Police)

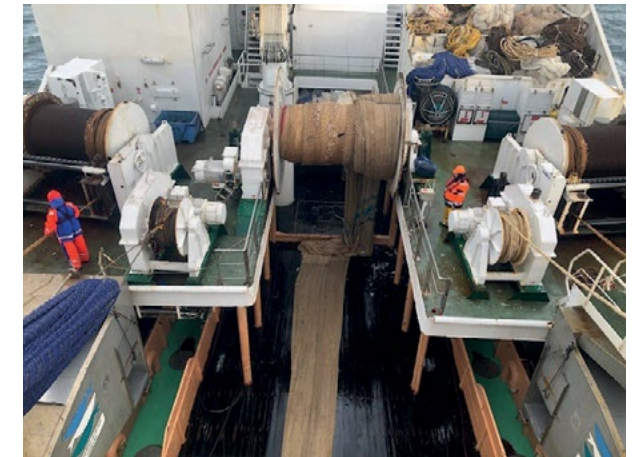
In the afternoon of 7 July 2020, a deckhand on the fishing vessel SCH302 Willem van der Zwan trapped his leg between the fishing cables he was guiding. While hauling in the cables around the drums, the cables became entangled behind the victim, causing his leg to be trapped. As a result, he was pulled up against the guide frame, leading to a broken ankle and fibula. The victim required hospital treatment, and was evacuated by helicopter.

Reconstruction photograph of the accident. On the left, the position of the victim. (Source: Van der Zwan)

In response to the occurrence, the operating position for the drums was examined. Before the accident, the only available drum operating position was on the starboard side. To ensure a clearer overview of the activity, a control panel will also be mounted on the port side. Depending on the situation, the drums can then be operated either from the port or starboard side.
