DUTCH
SAFETY BOARD

Shipping Occurrences Report

November 2018 – May 2019

Safety during cargo handling operations

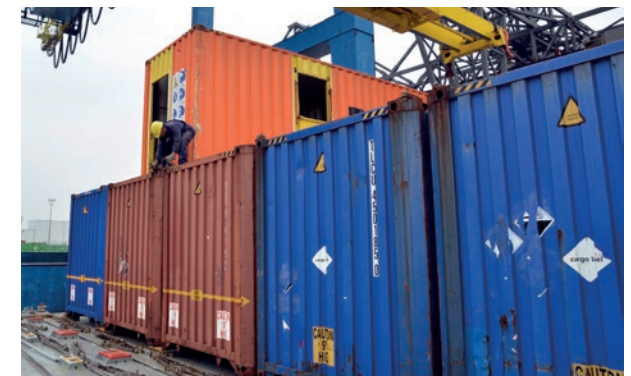
Unsafe working situation due to fall risk. (Source: Dutch Safety Board)

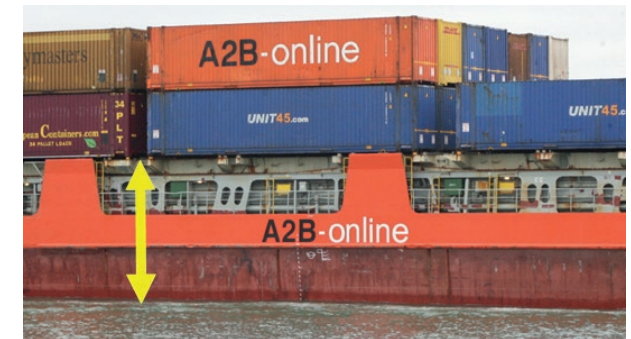
The crew member was working on one of the hatches. Due to the absence of permanent fixtures to limit the risk of falling (for example a railing) and the absence of personal protective equipment (for example a harness) to limit the consequences of falling from height, the victim entered the water. Eventually the low water temperature on the day of the accident and the fact that the crew member was not wearing a life jacket reduced the possibility of rescuing the victim in the water.

A2B Future with indication of the fall height. (Source: Dutch Safety Board)

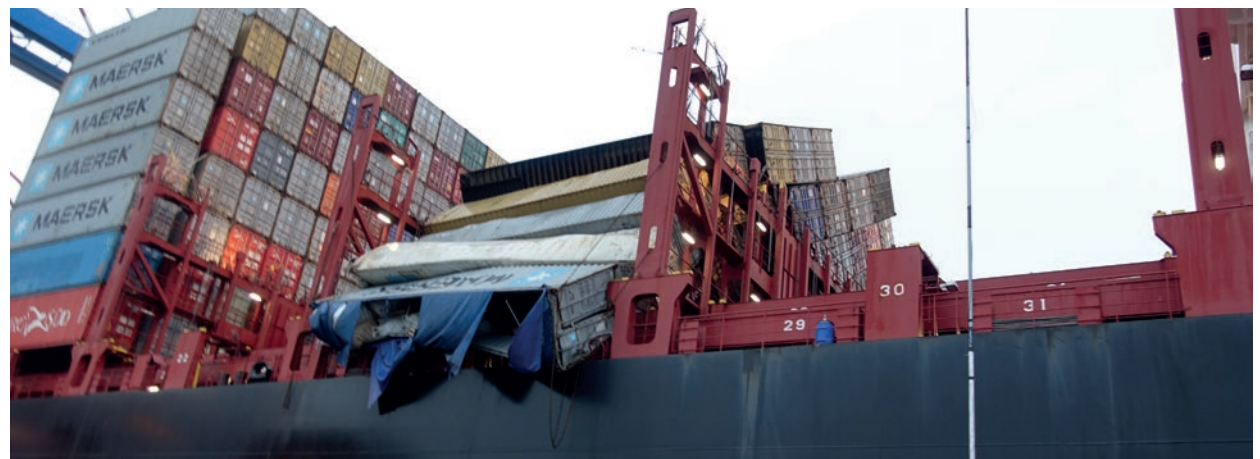
Containers hanging overboard. (Source: Dutch Safety Board)

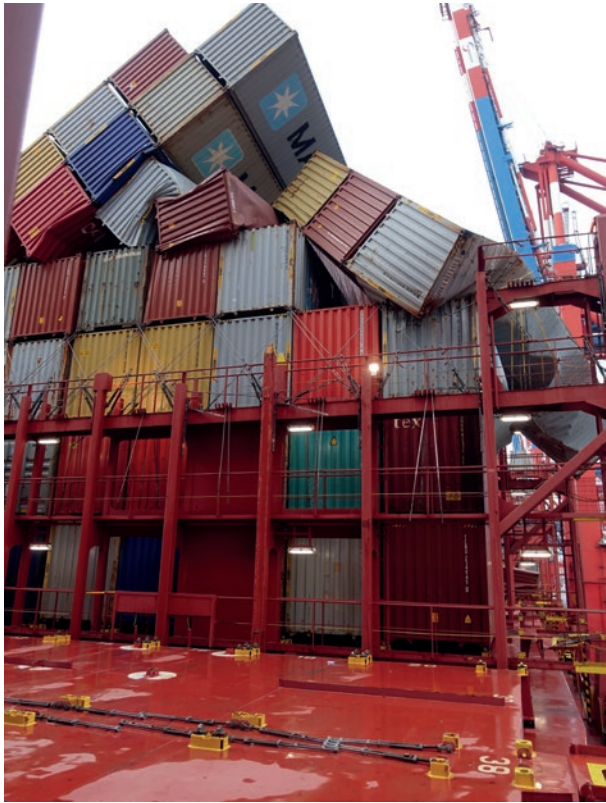
Fallen containers on board. (Source: Dutch Safety Board)

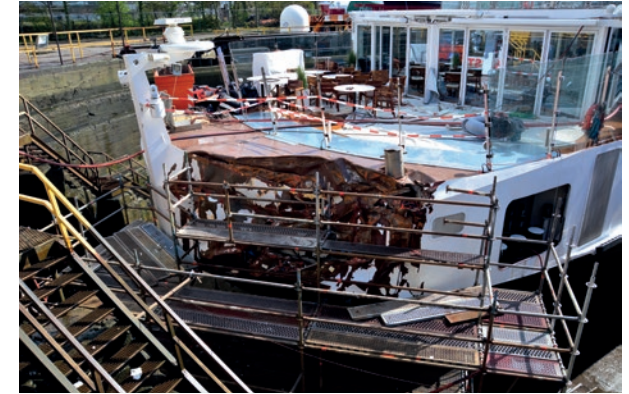
Damage to the river cruise ship. (Source: Dutch Safety Board)

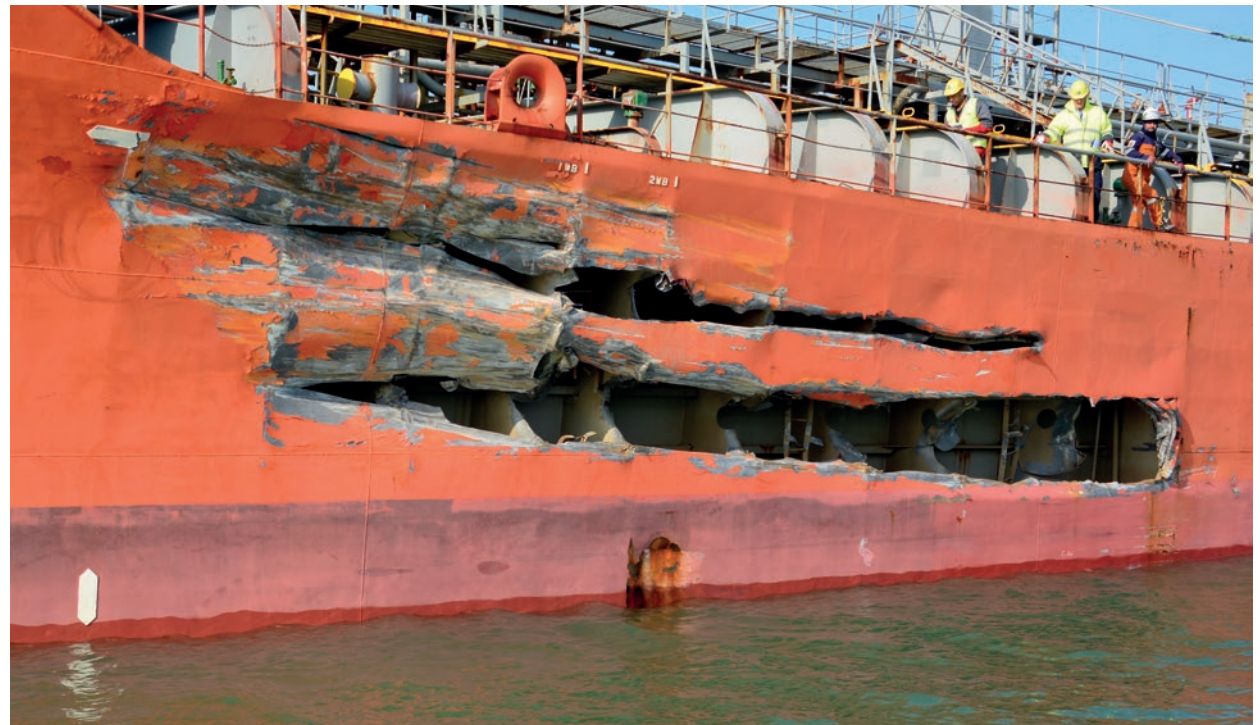
Damage to the chemical tanker. (Source: Dutch Safety Board)

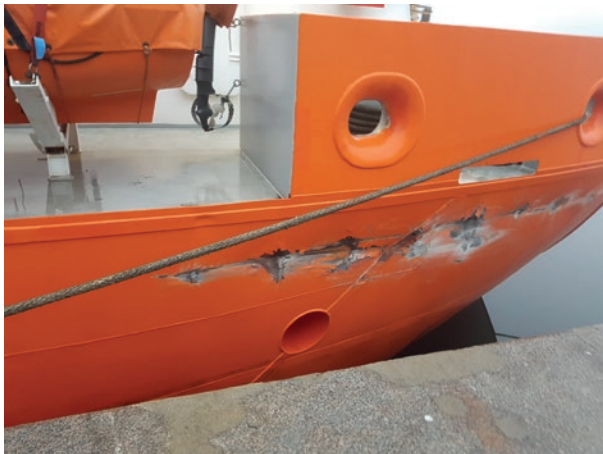
In the morning of 9 November 2018, during mooring in the port of Szczecin (Poland), the Dutch general cargo vessel Lady Alexandra suffered damage due to a collision. The Lady Alexandra was under pilot supervision and the vessel was travelling towards a mooring. The weather conditions were calm, with variable wind force 2 Beaufort. In the run-up to the mooring, the speed was reduced to 4 knots and control was switched from autopilot to manual. Following the switch to manual control, it was noted that the vessel was not responding to rudder commands. The captain took over the wheel from the pilot and attempted to keep the vessel clear of the quayside on the port side,

Following the incident, the vessel travelled to the yard for damage repair and to identify the source of the steering problems. Technical investigation revealed that all systems were operating correctly and it was not possible to determine the cause of the incident.

Damage following collision with the quayside. (Source: Ship operator)

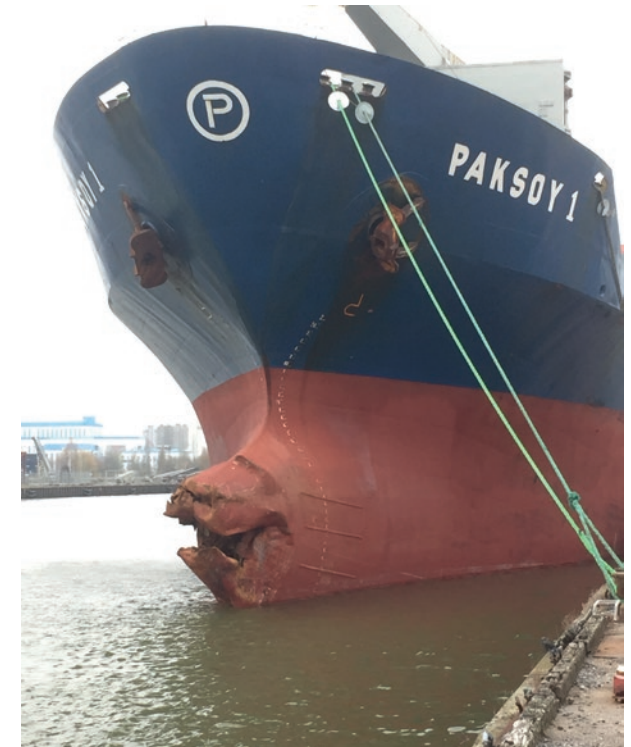
Both vessels suffered serious damage, but were eventually able to reach port safely.

Damage to the bulbous bow of the Paksoy 1. (Source: Dutch Safety Board)

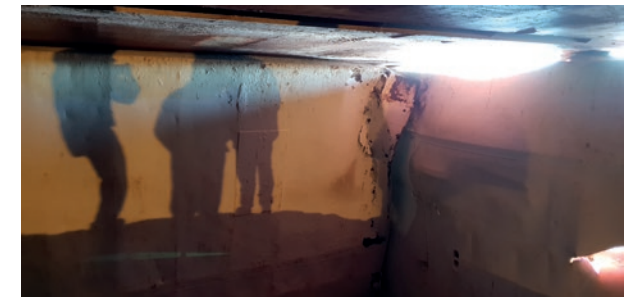
Damage in the hold of the Eems Cobalt. (Source: Dutch Safety Board)

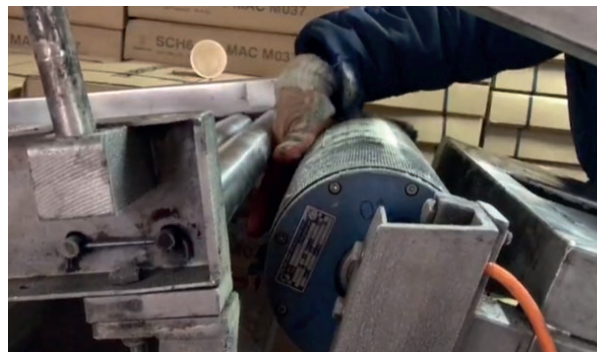
A crew member on board the Dutch fishing vessel *SCH6-Alida* intended to return to his workplace. He decided to climb across a running conveyor belt, rather than walking around it. At the end of the conveyor belt was a roller belt. The forearm of the crew member became trapped between the conveyor belt and the roller belt, while the conveyor belt continued to run. The crew member suffered serious burns.

Reconstruction of accident on board the SCH6. (Source: Ship operator)

The accident took place on 25 January 2019. Following the accident, the operator has taken measures so it is no longer possible to become trapped between the conveyor belt and the roller belt.

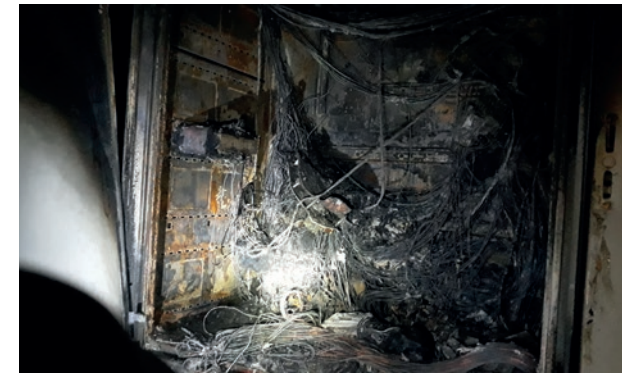
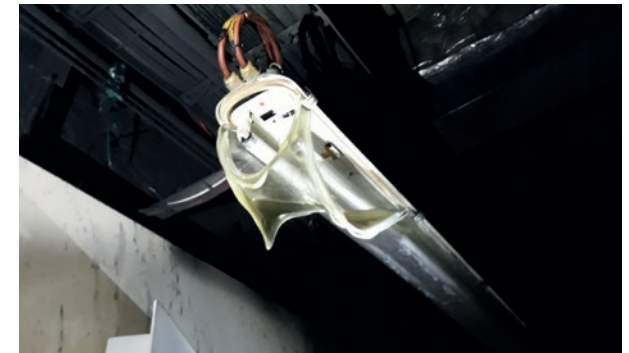
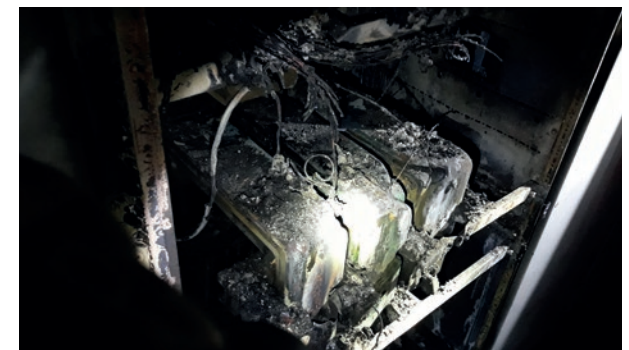
On Friday 11 January 2019, the Dutch trailing suction hopper dredger DC Orisant was travelling from Gdansk out to sea. At 02.56, the vessel had passed the buoy at Hel, and at 03.08, the vessel suddenly suffered a blackout. At that moment, no alarm had been activated on the bridge. The chief engineer went to the control room where various alarms had been activated, and observed a fire in the main switchboard. The general alarm was then sounded and the crew prepared to fight the fire. The duty officer remained on the bridge and maintained close contact with the traffic control centre. At 05.00, the fire was brought under control. By this time, contact had been sought with the relevant parties and a tugboat was sent out to the ship. A tow was attached at 10.15. The vessel was then towed back to the port of Gdansk. The fire was restricted to the main switchboard but caused considerable damage.

Damage following fire in engine room. (Source: Ship operator)

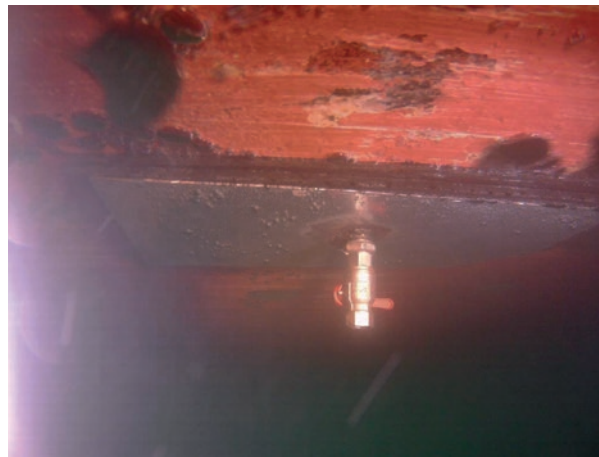
In the morning of 4 December 2018, the Dutch dredging vessel Hegemann III ran aground in the Wismarbucht close to Wismar in Germany. The vessel suffered two leaks in the pump room, which on board the Hegemann III was located closely behind the engine room. The propeller also suffered damage. Following a dive inspection, a number of emergency repairs and a series of additional measures, subject to strict conditions, the vessel was given permission to complete a single trip to Emden for further repairs.

Temporary repair to ship's skin. (Source: Ship operator)

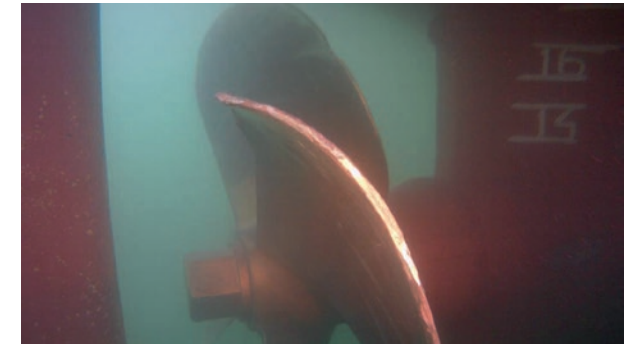
Damage to propeller blade. (Source: Ship operator)
