DUTCH
SAFETY BOARD

Stalled during take-off

Hilversum aerodrome, 15 December 2018

The Hague, January 2022

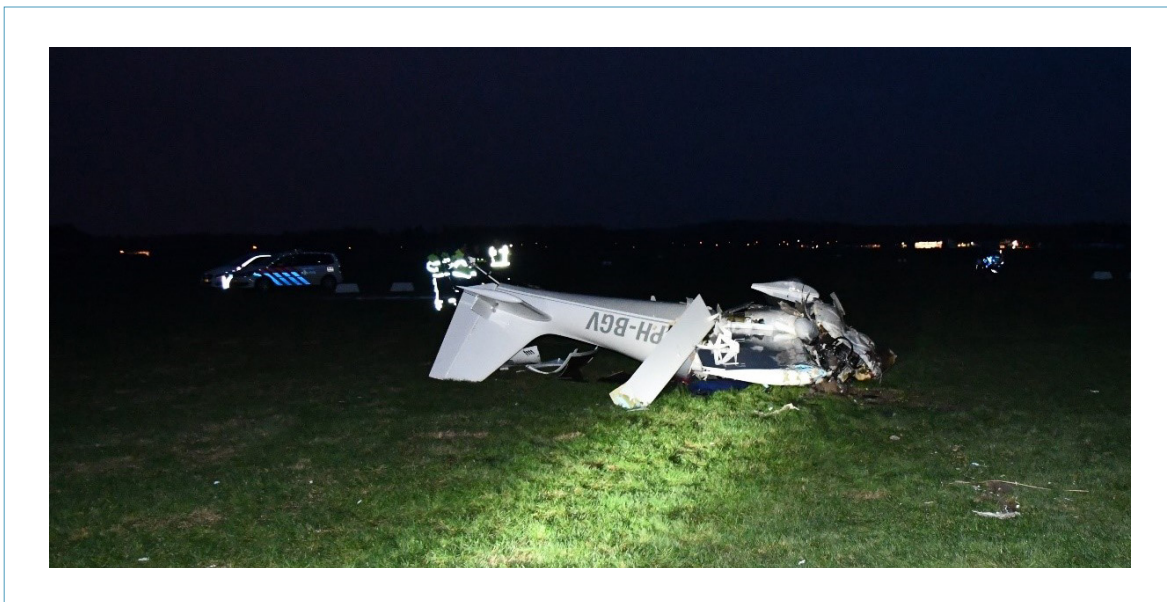
The operational manager stated that he did not hear any radio communication on his handheld radio during the time he temporarily left the operating room. One of the mentioned witnesses phoned to tell him that an aircraft had just crashed. An airport rescue car was deployed by the operational manager and the driver found the destroyed aircraft in an inverted attitude with the pilot still inside the aircraft. The pilot was taken out of the aircraft and appeared to be fatally injured.

Figure 1: The crashed aircraft. (Source: Dutch Aviation Police)

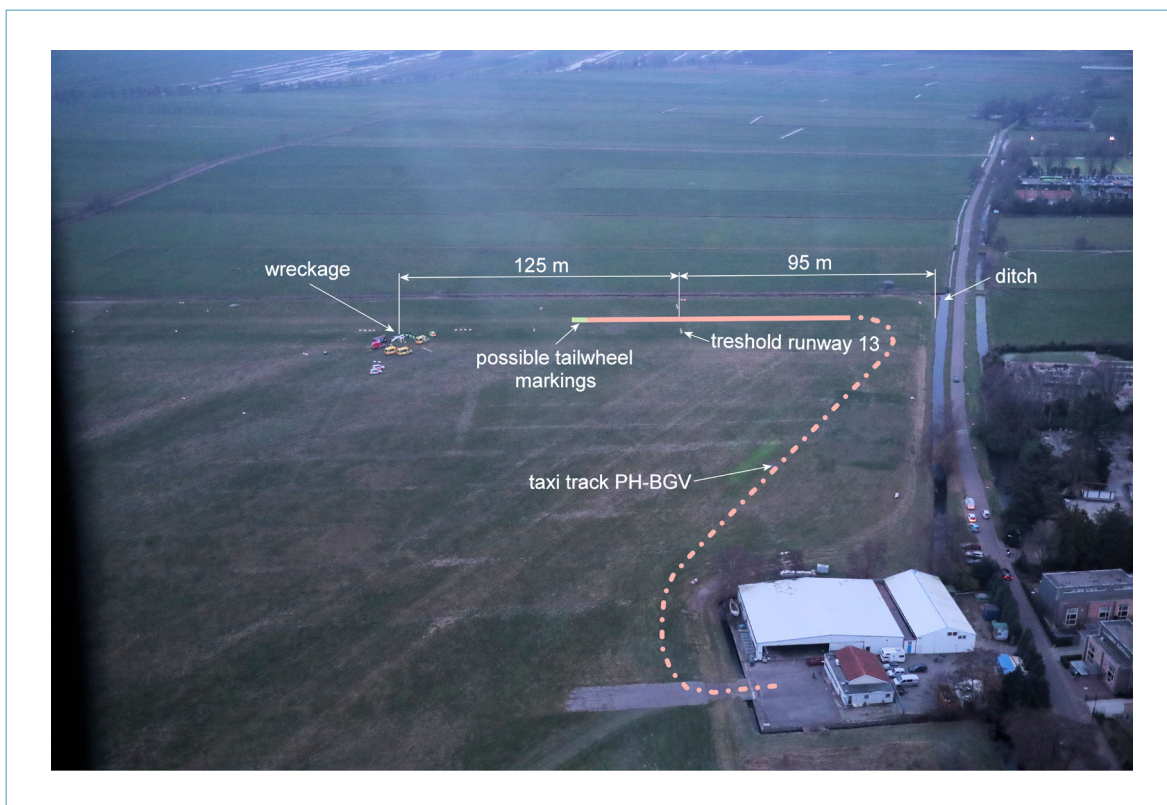
Figure 2: Overview of taxi route and take-off dimensions. (Source picture: Dutch Aviation Police)

The threshold of Runway 13 is located approximately 95 meters from a ditch and is marked with triple red-white markers on each side of the runway. PH-BGV crashed at approximately 125 meters from the threshold, just north of the runway, see Figure 2.

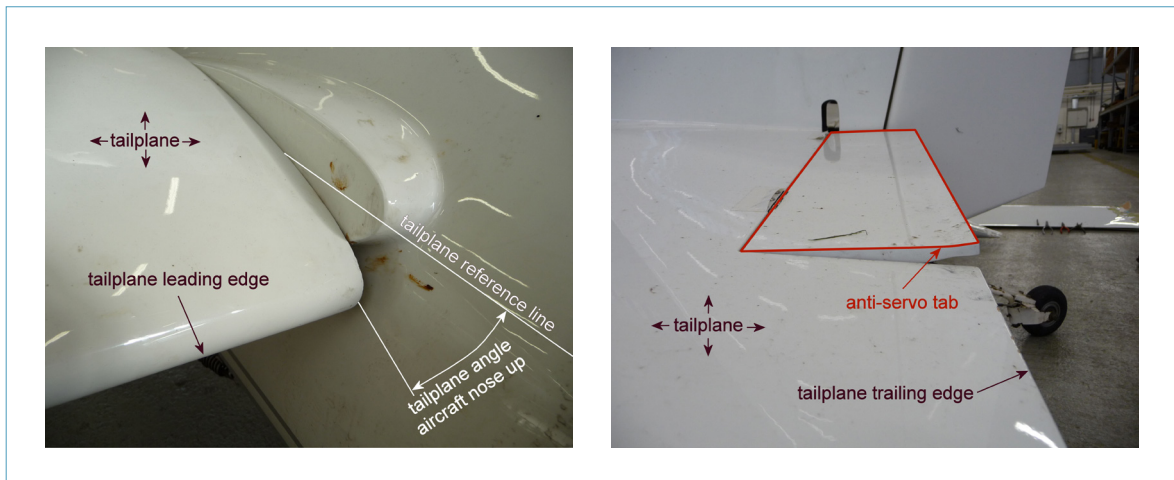
All connections between the stick, rudder pedals and primary flight control surfaces were found broken or out of position. Damage demonstrated the tailplane (elevator) was in an aircraft nose-up (ANU) position at the moment of impact as seen in Figure 3.

After reconnecting the anti-servo/trim tabs, as seen in Figure 3 for the left one, they showed an aircraft nose-down (AND) trim position. Further examination of the trim servo motor demonstrated it was in the full AND position.

Figure 3: Left: tailplane in ANU position on impact. Right: the left anti-servo/trim tab in full AND position (Source: Dutch Safety Board).

The full AND trim position would have facilitated in lowering the nose, but as seen in Figure 3 in Paragraph 2.6.2, the tailplane was in an ANU position at the moment of impact. The found ANU position of the tailplane can only be the result of pilot input. This might be the intuitive response of a pilot when being close to the ground.²⁷ This intuitive response would have opposed increasing the margin to stall or, when already in a stall, perpetuated the stall.

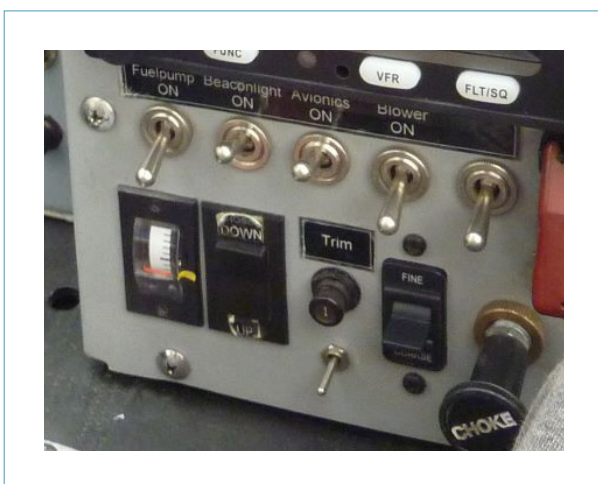
Past pictures of the PH-BGV instrument panel show that the trim indicator in the cockpit used to have a small yellow pointer-shaped bug (placard), pointing at approximately the second unit below the middle position on the trim indicator scale. The co-owner of PH-BGV, who flew on PH-BGV regularly, confirmed the yellow bug indicated the trim position for take-off. The small yellow placard, as seen in Figure 4, was not found during the investigation and it is unknown whether the yellow bug was still attached to the trim indicator prior to the accident flight.

Figure 4: The trim indicator with yellow bug during flight a few years before the accident.
