DUTCH
SAFETY BOARD

Takeoff with erroneous takeoff data, Boeing 737-800

The Hague, May 2022

Identification number:	2018095
Classification:	Serious incident
Date, time of occurrence:	10 June 2018, 16.06 hours ¹
Location of occurrence:	Amsterdam Airport Schiphol
Registration:	PH-BXG
Aircraft type:	Boeing 737-800
Aircraft category:	Commercial - fixed wing
Type of flight:	Commercial Air Transport (Passenger)
Operator:	KLM Royal Dutch Airlines
Phase of flight:	Takeoff
Damage to aircraft:	None
Number of flight crew:	Three
Number of cabin crew:	Four
Passengers:	182
Injuries:	None
Other damage:	None
Light conditions:	Daylight

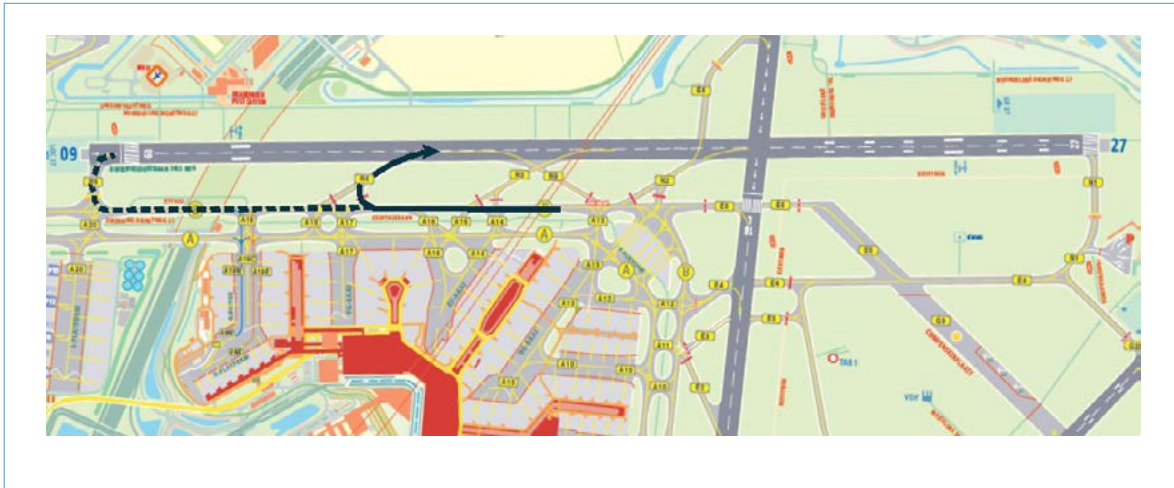
Figure 1: Picture of the intended (dotted line) and actual (solid line) taxi route to Runway 09. (Source: Amsterdam Airport Schiphol)

At 16.02:17 hrs the captain informed ATC that, with the actual wind conditions, they could accept a takeoff from Intersection N4. Subsequently ATC immediately instructed the aircraft to taxi to Intersection N4. At 16.02:52 hrs ATC instructed to hold short of the runway and to contact Schiphol Tower. Meanwhile, the first officer taxied the aircraft to the assigned Intersection N4 and during taxiing the safety pilot handed over the ACARS print with the changed data to the captain, who entered the data into the FMC, without further checking the used input variables. The entire process of changing the Intersection and entering the new data into the FMC was not monitored by the first officer. At 16.03:18 hrs the V_1 , V_R and V_2 speeds were re-inserted into the FMC. The aircraft was cleared to line-up on Runway 09 at 16.04:20 hrs and subsequently cleared for takeoff at 16.05:51 hrs. Together with the takeoff clearance, ATC informed the crew that the actual wind was 010° with 8 kts.

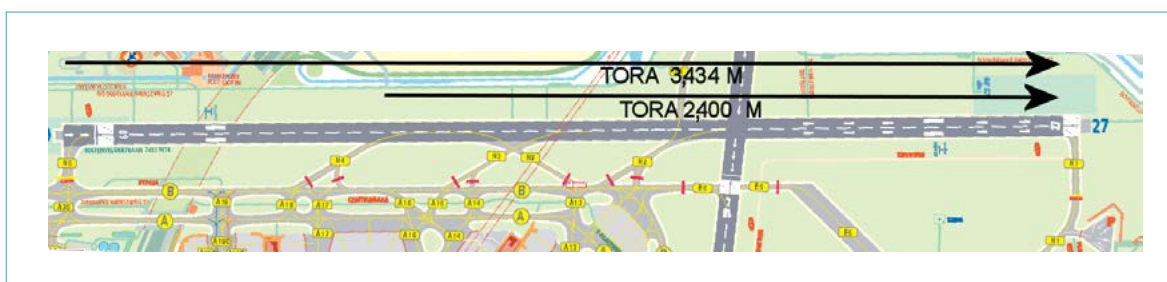
Runway	TORA (m)	TODA (m)	ASDA (m)	LDA (m)	Remarks
09	3,434	3,494	3,434	3,363	Takeoff from Intersection N5. DTHR 90 m.
	2,400	2,460	2,400	NA	Takeoff from Intersection N4.
	1,881	1,941	1,881	NA	Takeoff from Intersection N3.

Figure 2: Picture of Runway 09. (Source: Amsterdam Airport Schiphol).

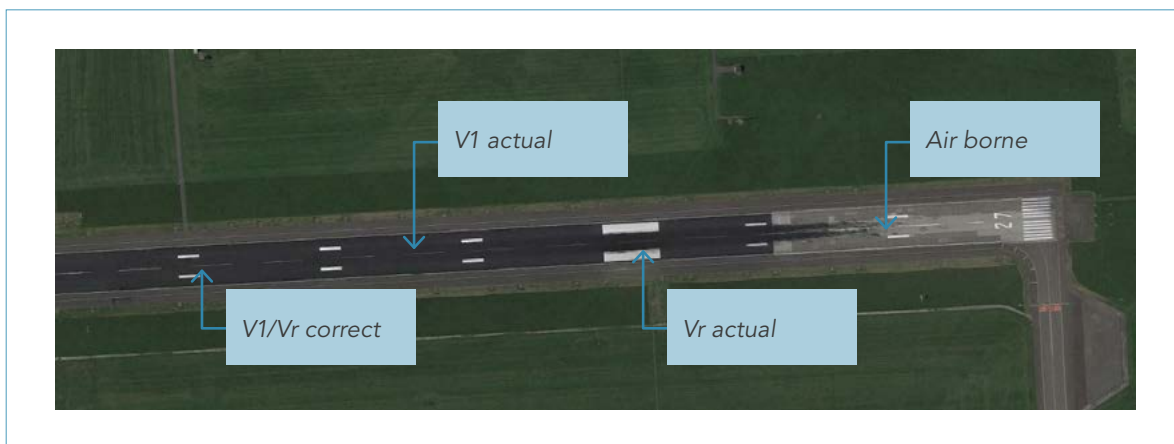
The takeoff information that was used for the Lintop calculation, mentioned intersection N5 for takeoff instead of N4. The takeoff data calculated by Lintop was loaded into the FMC without being checked by either the captain or the first officer. Therefore the thrust setting was based on the assumption that the available runway length was 1,064 metres (the difference between the two intersections) longer than it actually was.

As a result of the reduced takeoff thrust application, the engines produced the thrust required for a runway with a TODA of 3,494 metres, resulting in a slower acceleration than needed. This explains why the aircraft became airborne at the very end of the runway. The speed at which the takeoff could still be safely rejected (V_1 , 154 kts) was based on these erroneous data. Calculations afterwards showed that the correct V_1 should have been 143 kts in the current conditions. The actual rotation speed V_R , as calculated was 157 kts, while the correct V_R should have been 144 kts.

Figure 3: Significant places of the takeoff. (Source: Google Earth)

During the investigation, the aircraft manufacturer calculated that the aircraft would have been unable to stop on the runway in case the takeoff had to be aborted at V_1 . Due to the slower than required acceleration of the aircraft during the takeoff roll, the aircraft reached the calculated V_1 further down the runway with insufficient runway length remaining to stop the aircraft within the confines of the runway.
