Tweendeck falls into hold with fatal outcome

Lessons learned from the occurrence on
board the FWN Rapide

The Hague, December 2021

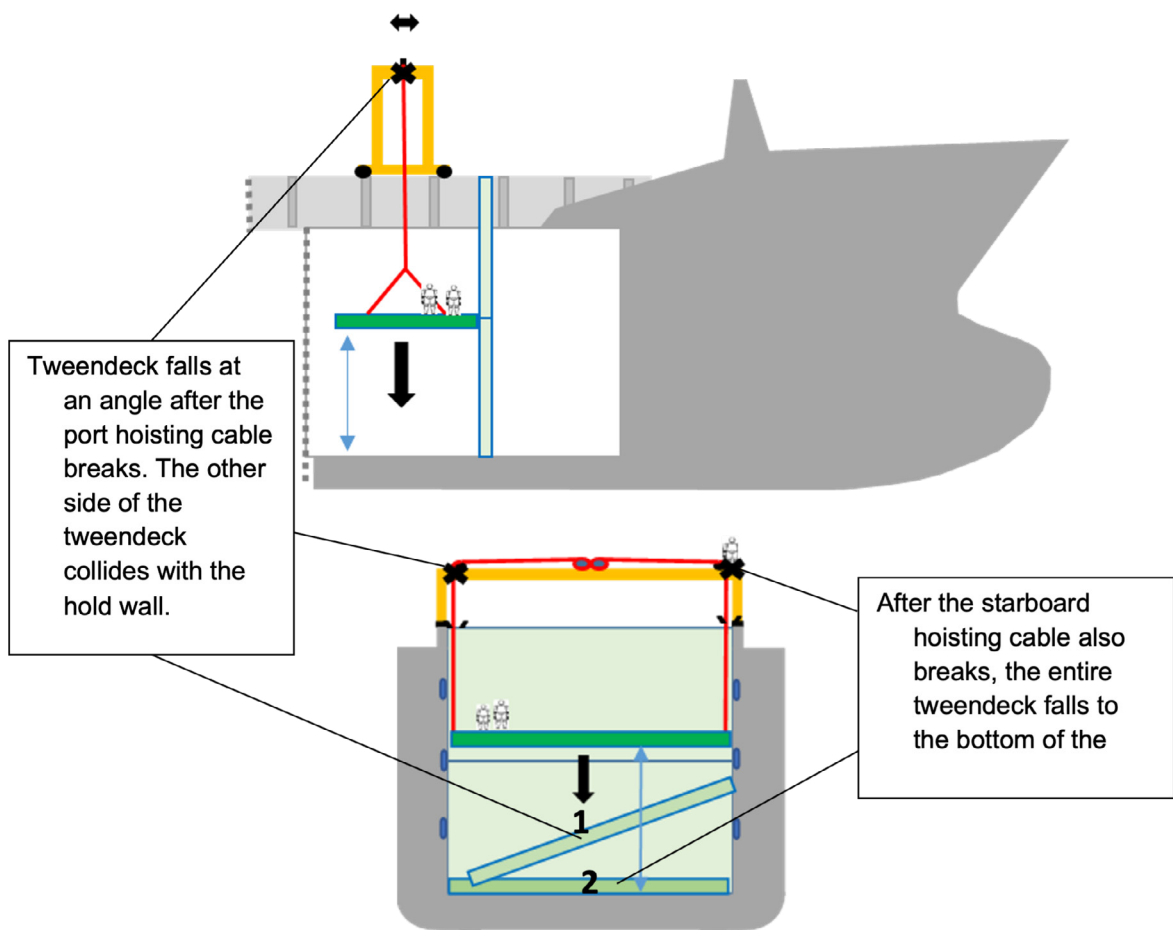
Figure 4: The occurrence. (Source: Dutch Safety Board).

As shown in figure 4, the port side of the tweendeck fell. Because the tweendeck was initially still suspended from the starboard hoisting cable, the tweendeck tilted to port thereby causing damage to the starboard side of the hold wall. The starboard hoisting cable then also broke, and the entire tweendeck fell to the bottom of the hold.

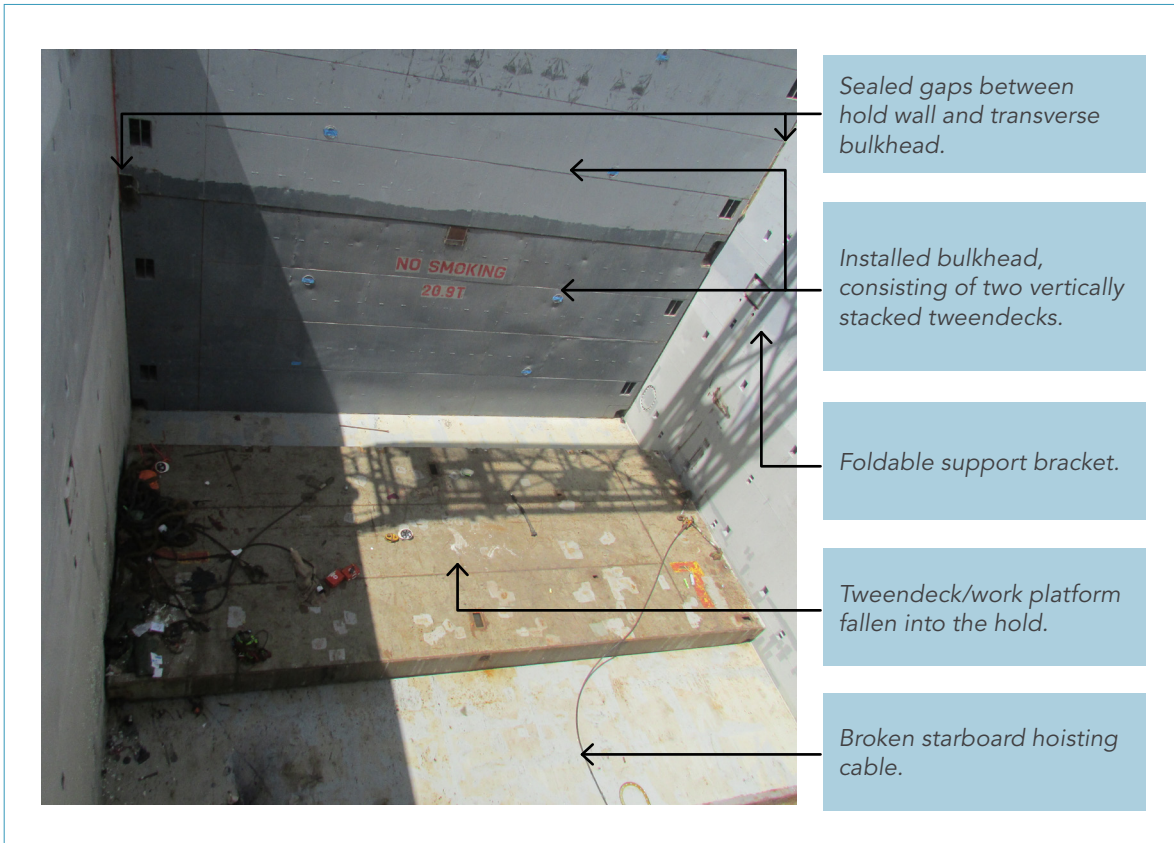
Figure 5: The tweendeck fallen into the hold. (Source: ForestWave Navigation)

Both deckhands fell together with the tweendeck. One of them trapped his arm between the port hold wall and the tweendeck. He died at the scene. The other deckhand suffered serious injuries and was transported to hospital in Georgetown. He was subsequently repatriated to the Philippines. It was confirmed that at the moment of the accident, neither of the deckhands was wearing fall protection. Following the occurrence, three safety harnesses were discovered stacked on the tweendeck. The hold wall on the starboard side was pierced, puncturing a ballast water tank.

Figure 5 is an overview photograph of the hold following the occurrence. Figure 6 shows the portside of the tweendeck that fell into the hold.

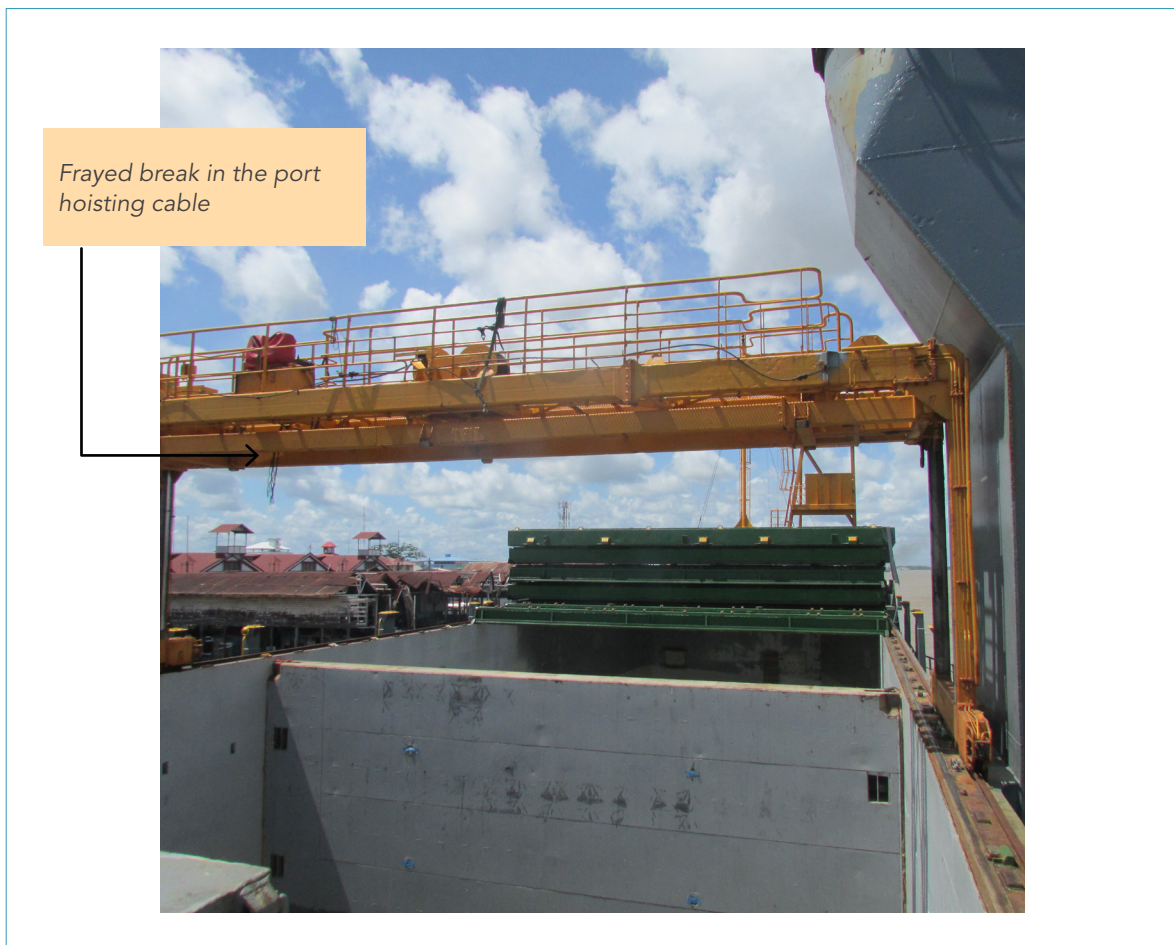
Figure 7: Hatch crane following the occurrence. (Source: ForestWave Navigation B.V.)

During the investigation on board the FWN Rapide, the hatchcover crane underwent a further visual examination. During the examination, the following observations were made:

- Both hoisting cables were frayed at the breaking point;
- Pieces of strands of the hoisting cables were found both on the hatchcover crane and in the hold;
- The outside of both hoisting cables showed evidence of rust;
- The guidewheels for both hoisting cables demonstrated sharp points of damage next to the running surfaces for the cables. These guidewheels were mounted on the hatchcover crane.

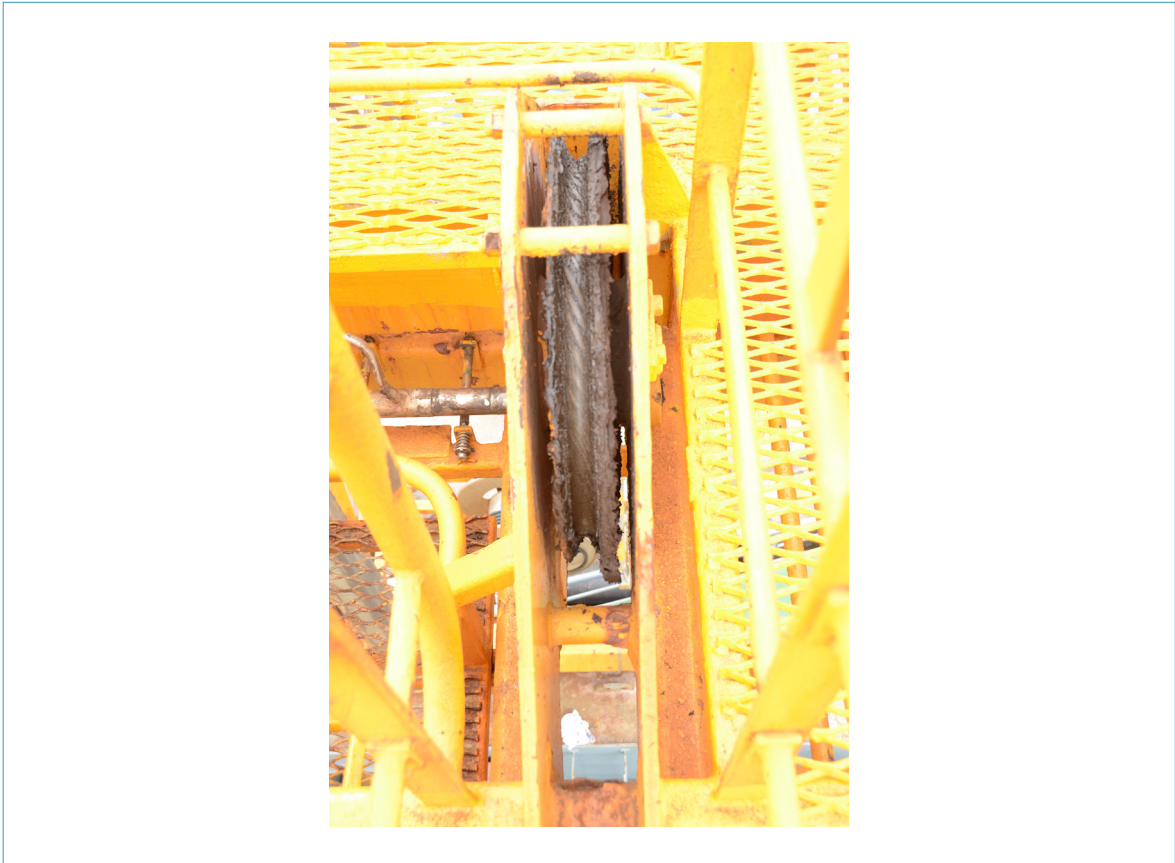
Figure 8: Hoisting cable guidewheel on hatch crane. (Source: National Police)

- Both cables broke at the height of the guidewheels on the hatchcover crane;
- The corroded condition of the wheels contributed to the accelerated wear of the cables;

- As a result of corrosion, the wheels were in such poor condition that this could have been noticed during the previous annual inspection;
- Each hoisting cable consisted of a steel core of 49 wires around which 6 strands were wrapped, each consisting of 36 wires. Each hoisting cable therefore consisted of 265 steel wires. On the port hoisting cable, at the fracture surface of the cable, 229 (86%) of the wires had already broken, before the cable broke during the accident. On the starboard hoisting cable, 214 (81%) of the wires had already broken.

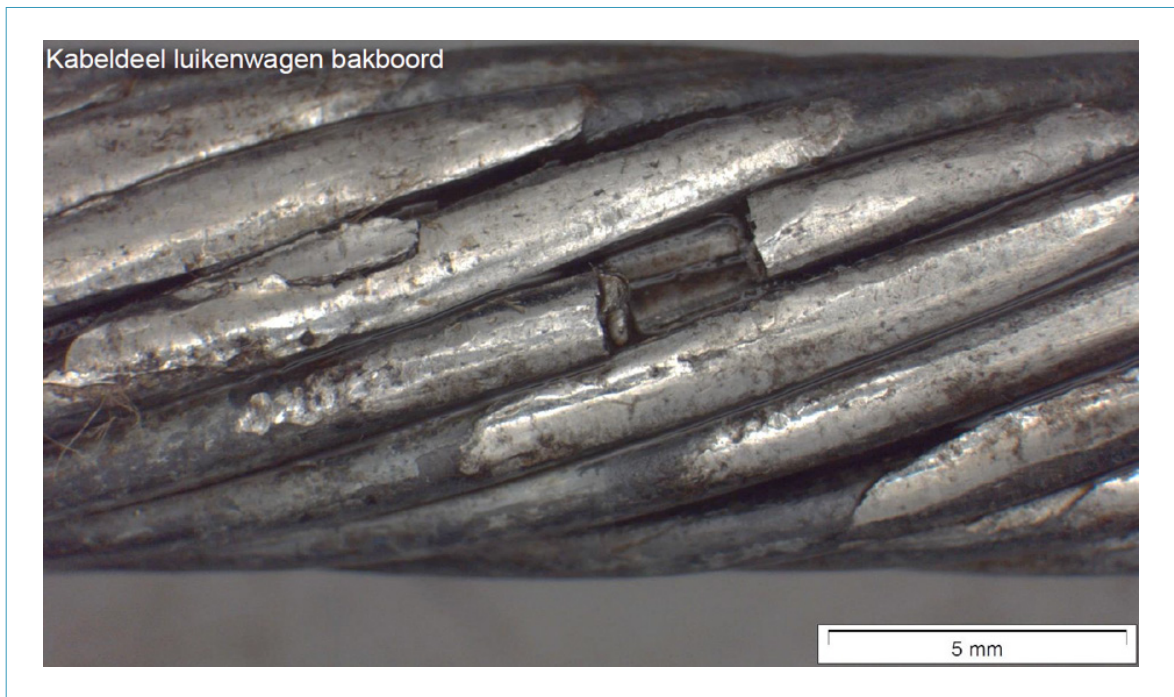
- The cables were not well coated with lubricating grease to protect them against the corrosive maritime environment;
- Repeated use of the weakened cables resulted in the flattening and further breaking of wires due to the fluctuating bending at the guidewheels;

Figure 9: A photograph from the EMT report. The widespread damage on the strands of the port cable, on the hatch crane side of the fracture, appears besmeared at the point where some of the wires are broken. (Source: Elements Materials Technology)

Before the accident, both broken hoisting cables were in poor condition. Of the individual steel wires that made up the port cable, 86% were already broken before the entire hoisting cable broke in the occurrence. 81% of the wires in the starboard cable were already broken. The primary cause for the poor condition of the cables was insufficient protection against the corrosive maritime environment.

- Improved record keeping of certificates of hoisting gear and steel wires, together with an increased supervision on the 5 yearly replacement of steel wires, especially on second hand purchased ships.
- Newly purchased hoisting wires having a higher Working Load Limit (WLL)(considering the same diameter of the wire). Previously used wires had a sufficient WWL, but were regularly loaded almost up to the maximum WLL. The new cables will have more margin between WLL and actual load.
