GENERAL INFORMATION

Occurrence:	2008107
Classification :	Accident
Date, time of occurrence:	14 September 2008 at 12.47 ¹
Place of occurrence:	Markermeer, near Hoorn, the Netherlands
Aircraft registration:	PH-4B6
Aircraft model:	Zenair CH601 Zodiac
Type of aircraft:	Micro light aircraft (MLA)
Type of flight:	Recreational flight
Phase of operation:	En route
Damage to aircraft:	Destroyed
Number of crew:	One
Number of passengers:	One
Injuries:	Both occupants fatal
Other damage:	None
Lighting conditions:	Daylight

SYNOPSIS

During flight, at an altitude of 1100 feet, the right hand wing of the aircraft suddenly collapsed upwards. Subsequently the aircraft crashed into the Markermeer. Both occupants were fatally injured.

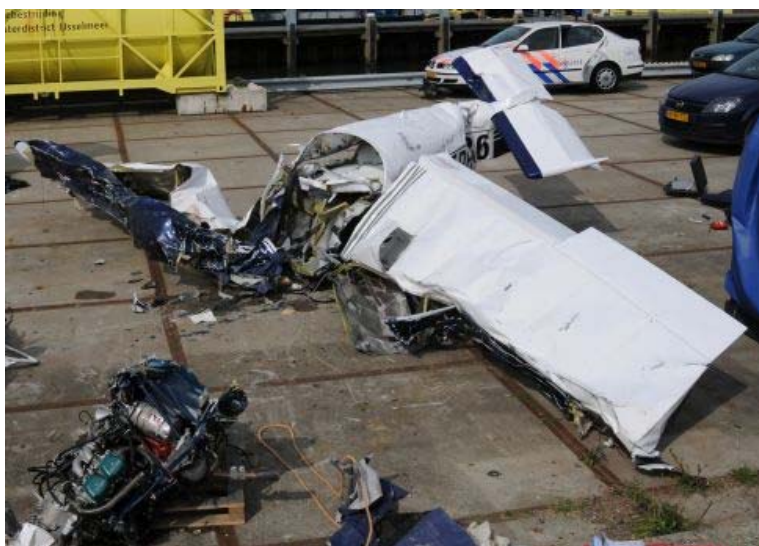
Figure 2: PH-4B6 after recovery

- The engine and propeller were detached from the aircraft's fuselage.
- The cockpit was destroyed completely.
- The tail section of the fuselage was bended to the left.

- The right-hand wing main spar was twisted and broken.
- The right hand wing was bended near the root and the curve of the bending was similar to the curve of the fuselage top.

- The right-hand wing flap was missing.
- The right-hand wing box assembly was torn apart. Along a considerable distance as from the fuselage, the rivet joints between main spar and wing skin had failed.

- The right-hand wing leading edge had been crushed.
- The right-hand wing to fuselage rear attachment assembly had failed.
- Apart from its leading edge and the area at the right side of the aileron, the left hand wing was damaged comparatively lightly.

- The leading edge of the left-hand wing had been crushed.
- The wing construction near the left- and right aileron drives was heavily damaged.
- The left- and right aileron inboard edges were heavily damaged.

- Both fuel tanks were burst open.
- The vertical stabilizer was torn off.
- The leading edge of the right horizontal stabilizer showed impact damage.

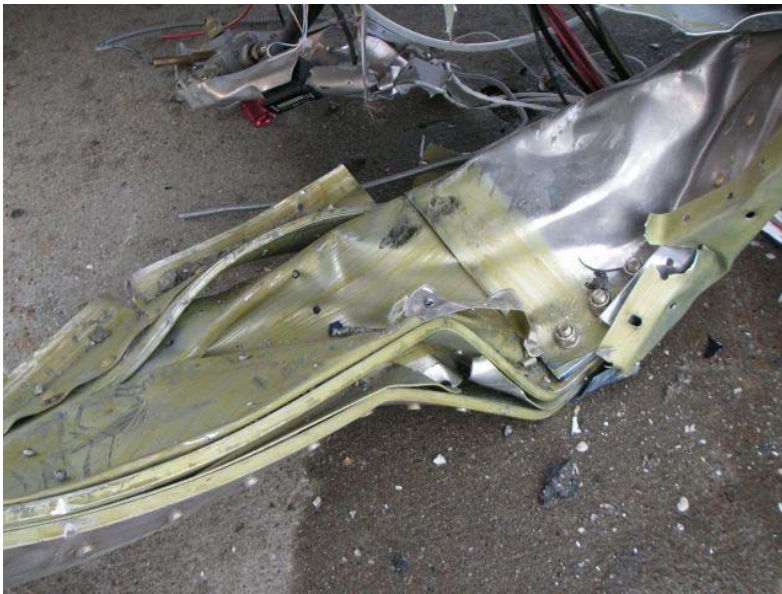
Figure 7: buckled right wing main spar

The upper- and lower girders (spar doublers and spar caps) of the right-hand wing main spar were buckled. A similar form of failure indicated exceeding of the permissible bending-moment in this part of the wing spar.

The solid-rivets joining the main spar web plate to the upper- and lower girders, had failed by shearing. This failure mode indicates exceeding of the permissible vertical transverse-force in this part of the spar.

The main spar upper girder of the right-hand wing, had been buckled near the fuselage sidewall. This had caused the right hand wing to be bent upwards. This part of the right hand main spar has been cut off the wreckage for further examination. The main spar lower girder was buckled. Several solid-rivets, joining the main spar web plate with the upper- and lower girders, had failed by shearing.

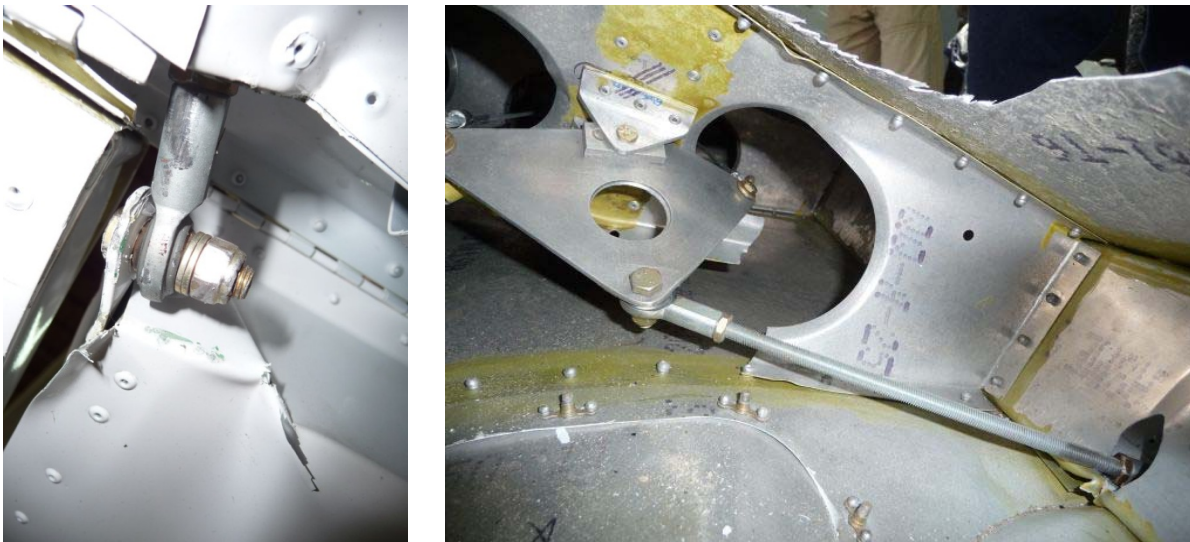
Figure 9: damage to left aileron drive (inboard- and outboard side)

- At the position where the control cables leave the fuselage, vertical cuts had been pulled in the fuselage sidewall.
- The push-pull rod attachment to the aileron, as well as both aileron to wing connections, showed large distortions and damage. Also the ribs (#7) at these locations showed heavy damage.

- The aileron stops on both wings showed damage as a result of ailerons which were moved outside their limits.

At the inboard side of the ailerons at both wings, the wreckage showed heavy distortions and damage near the aileron drives and rib #7. The left aileron drive showed traces of a back-and-forth movement near the feed-through passage in the rear spar. The triangular plate at the inside was bent, and the connected push-pull rod also showed traces of back-and-forth movements near the feed-through passage in the rear spar.

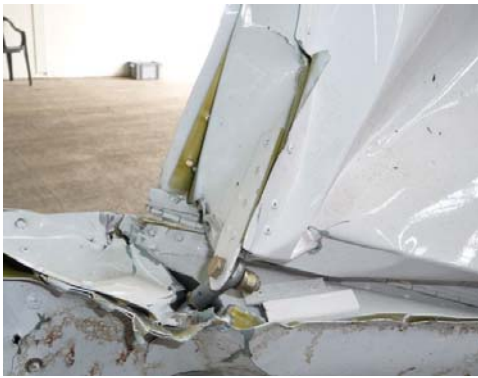
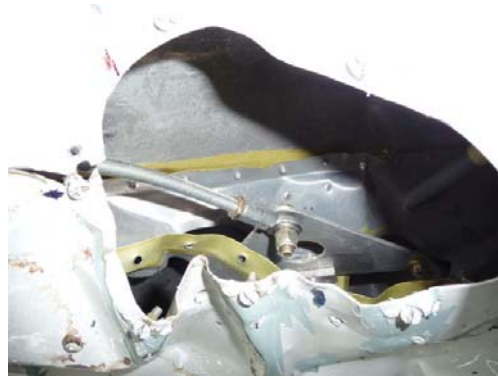
Figure 10: damage to the right aileron drive (inboard- and outboard side)

The distortions and damage as mentioned above only can have been caused by very high- and varying loads in the aileron control drive. Occurrence of varying loads as mentioned above, only can be explained by flutter in the aileron-wing combination.

The heaviest damage could be observed at the right-hand wing. The wing rib had been pulled off the wing skin and was torn. The triangular plate of the aileron control had been bent out of its moving plane. The push-pull rod was buckled. The rear spar was, near the feed-through passage for the rod, buckled and cracked. Also the passage itself was heavily damaged. The damage showed traces/indications of strongly varying load and movement. The connection of the aileron to the wing showed indications of heavy overloading near the aileron drive. Both aileron stops on the wings were damaged and showed marks of aileron deflection beyond the limits.

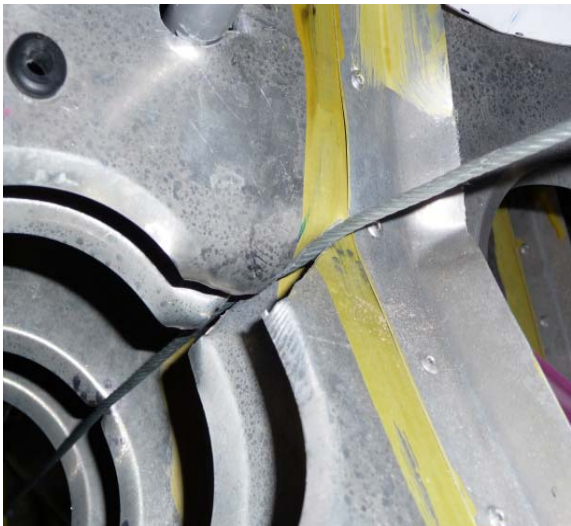
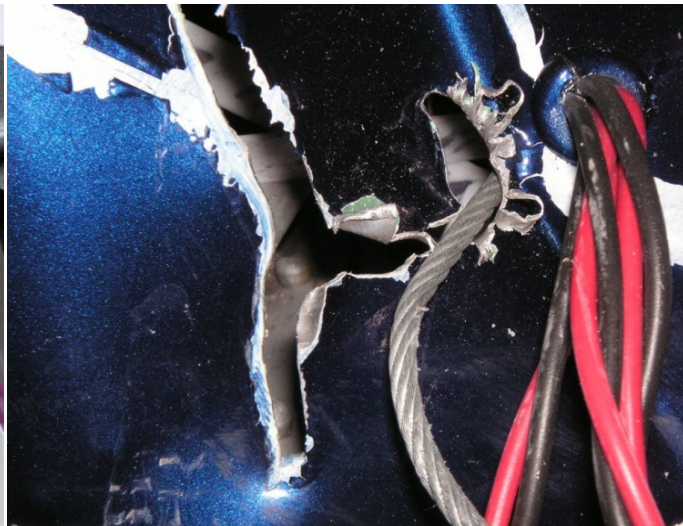
Figure 11: tears in wing ribs and fuselage sidewall caused by aileron control cables

- The control cables had caused cuts of up to approximately 3 cm in the edge of the lighting holes in the wing ribs #1, #2 and #3. The damage, as well as traces on the cables, indicates that back-and-forth movements relative to the ribs had occurred.

The aileron control cables, which are guided through the lighting holes in the ribs, caused tears in the ribs and in the fuselage sidewall. Examination of the tears showed, that they were caused by abrasive action of the cables back-and-forth against the ribs and sidewall. See pictures below.

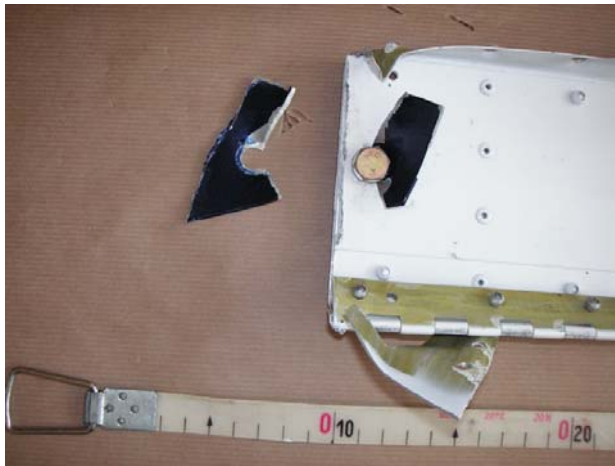
Figure 13: failed right wing rear spar attachment assembly.

The NLR investigation indicated that the attachment had failed by static overload and that failure caused by fatigue did not occur. The strong transformation (ovalization) of the bolt hole indicated that the attachment had failed by a wing tip directed force. This force made an angle of 30 degrees upwards, relative to the wing. This heavy force being wing tip directed indicates, that this force and the subsequent attachment failure it induced, could not have been the primary cause. The attachment must have failed during or after the wing bending upwards. Failure of the rear attachment assembly therefore cannot have been the primary cause of the accident.

This assembly consists of a bolt, loaded by shearing, connecting a bracket, protruding out of the fuselage sidewall, to the reinforced rear spar. The rear attachment assembly of the right hand wing had failed. The connecting bolt was unimpaired and still in its position in the rear spar. The fuselage part of the assembly had been torn across the bolt hole. Part of the fuselage part of the assembly still was in position under the bolt head. The bolt hole in the fuselage part was strongly ovalised. The left attachment assembly was undamaged.
