DUTCH
SAFETY BOARD

Quarterly Aviation Report

July - September 2023

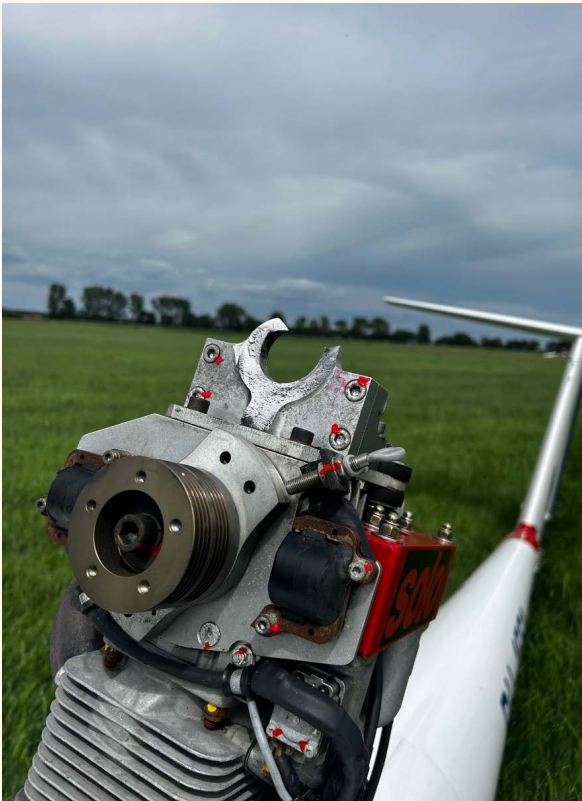
After the pilot had started the glider's turbo engine and subsequently climbed to approximately 300 metres, the propeller became separated from the engine. The glider made a safe landing at Lemelerveld glider airfield.

▼ *The turbo engine without propeller. (Source: gliding club)*

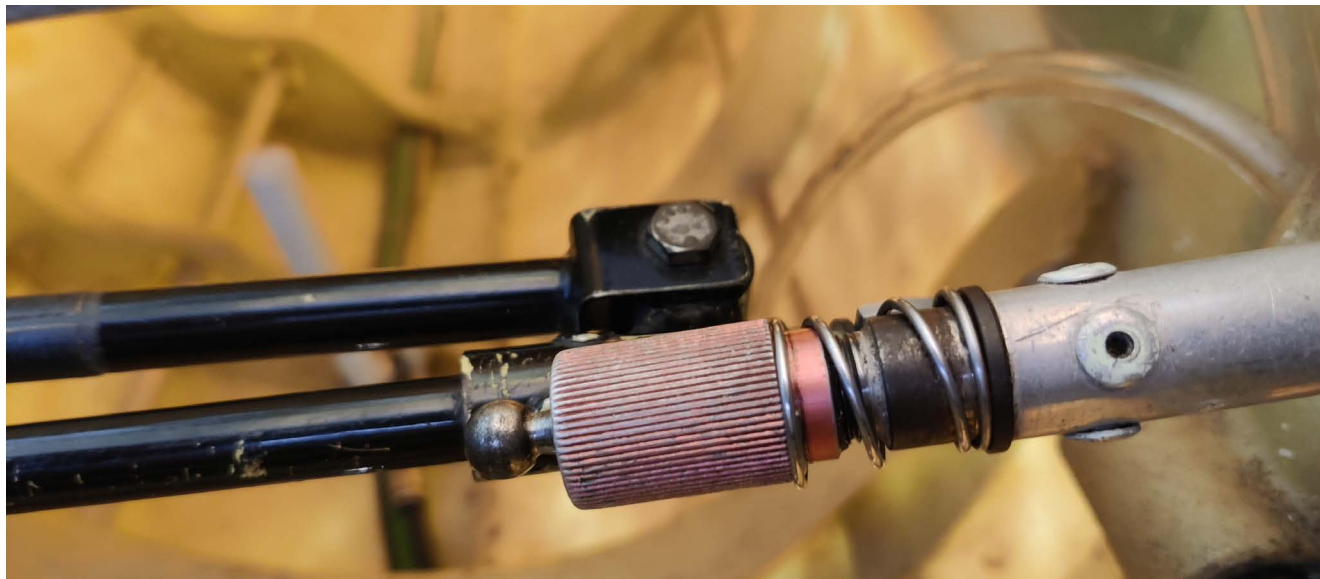
▲ The loose L'Hotellier control connection. (Source: pilot)

The glider's left aileron started to flutter while making a turn. The pilot stated that the left wing also moved up and down and that he temporarily lost control of the glider. Several seconds later, he regained control and decided to land the glider. Increasing the speed a little made the glider controllable. The glider made a safe landing. Inspection showed that the left aileron L'Hotellier control connection was loose.

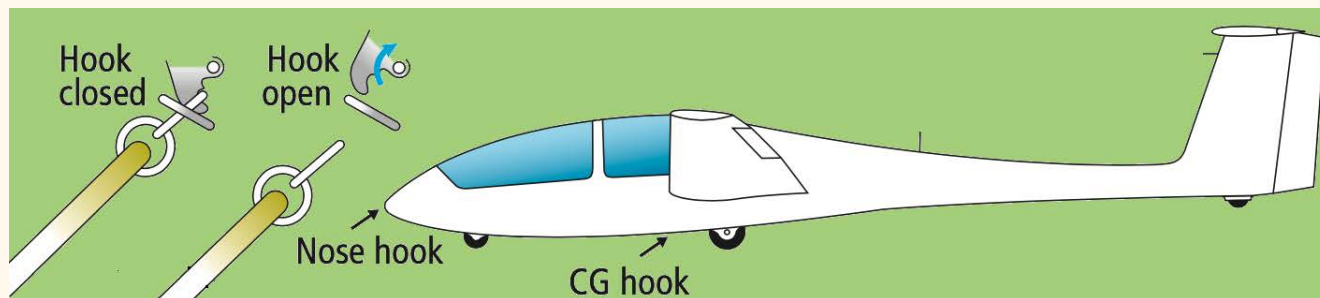
The pilot-in-command noticed that the glider did not climb as usual during the winch launch. As a precaution, he disconnected the winch cable at an altitude of approximately 300 metres. The remainder of the flight was uneventful. After the flight, it emerged that the short stop, which is attached to the parachute at the end of the winch cable, was fixed to the nose hook on the glider, rather than to the centre of gravity hook.

- ▼ Location of the nose hook and centre of gravity (CG) hook.
(Source: *Gliding, The British Gliding Association Student Pilot Manual*, D. and R. Corporaal)

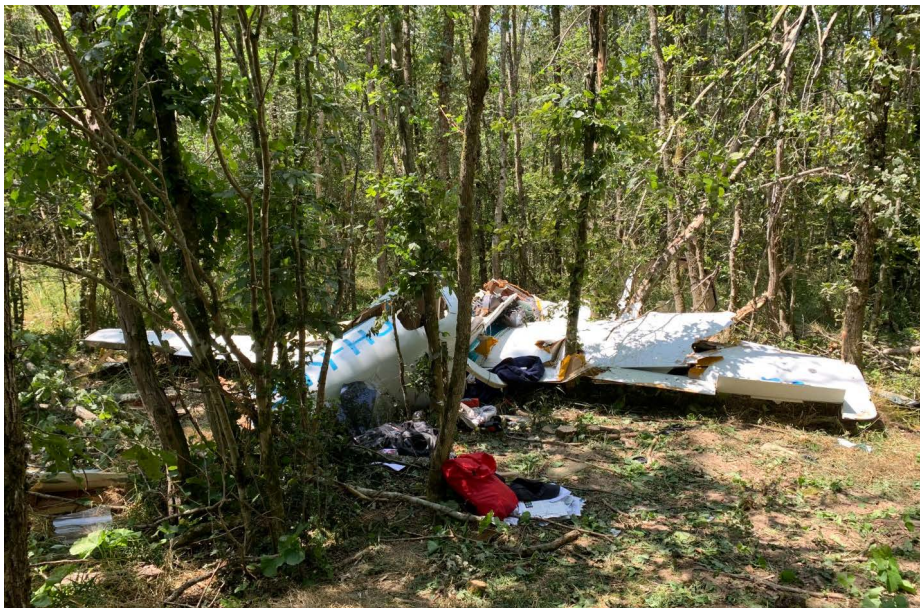
The aircraft, carrying a pilot and a passenger, was making a flight from Karlsruhe/Baden-Baden Airport in Germany (EDSB) to Mulhouse-Habsheim Airport in France (LFGB). The aircraft crashed in the woods near Habsheim. Both occupants were killed.

◀ The aircraft wreckage.
(Source: BEA)

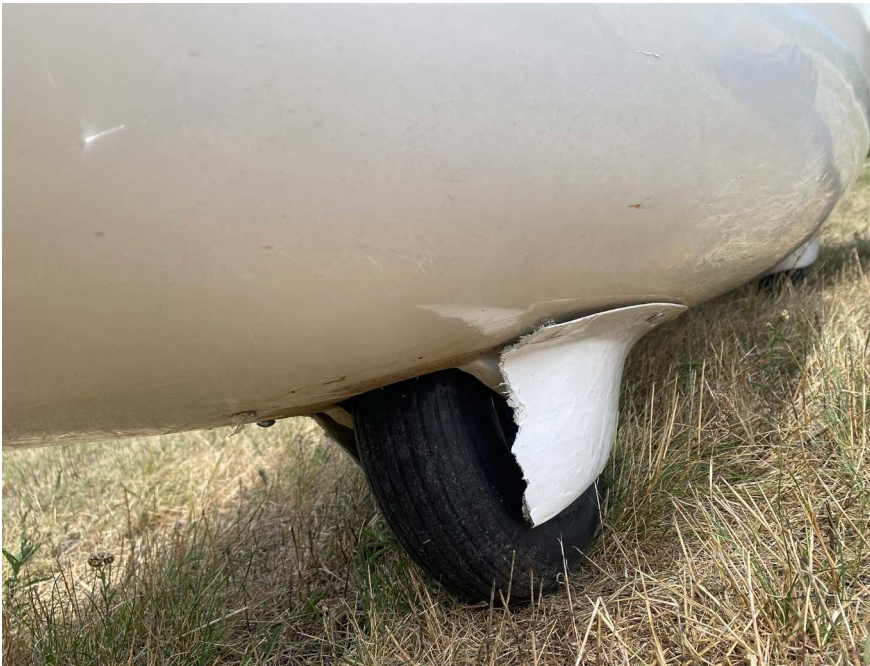
The glider, with an instructor and trainee on board, landed further away on the grass runway because it was full of other aircraft. During the landing roll, the instructor took over the controls and steered the glider to the edge of the runway, clearing it for an approaching motorised aircraft. After leaving the runway and crossing a dirt road parallel to the runway, the nose wheel hit a marker stone lying in the grass. As a result, the fairing and suspension of the nose wheel sustained damage.

▼ *Damaged nose wheel fairing. (Source: pilot)*

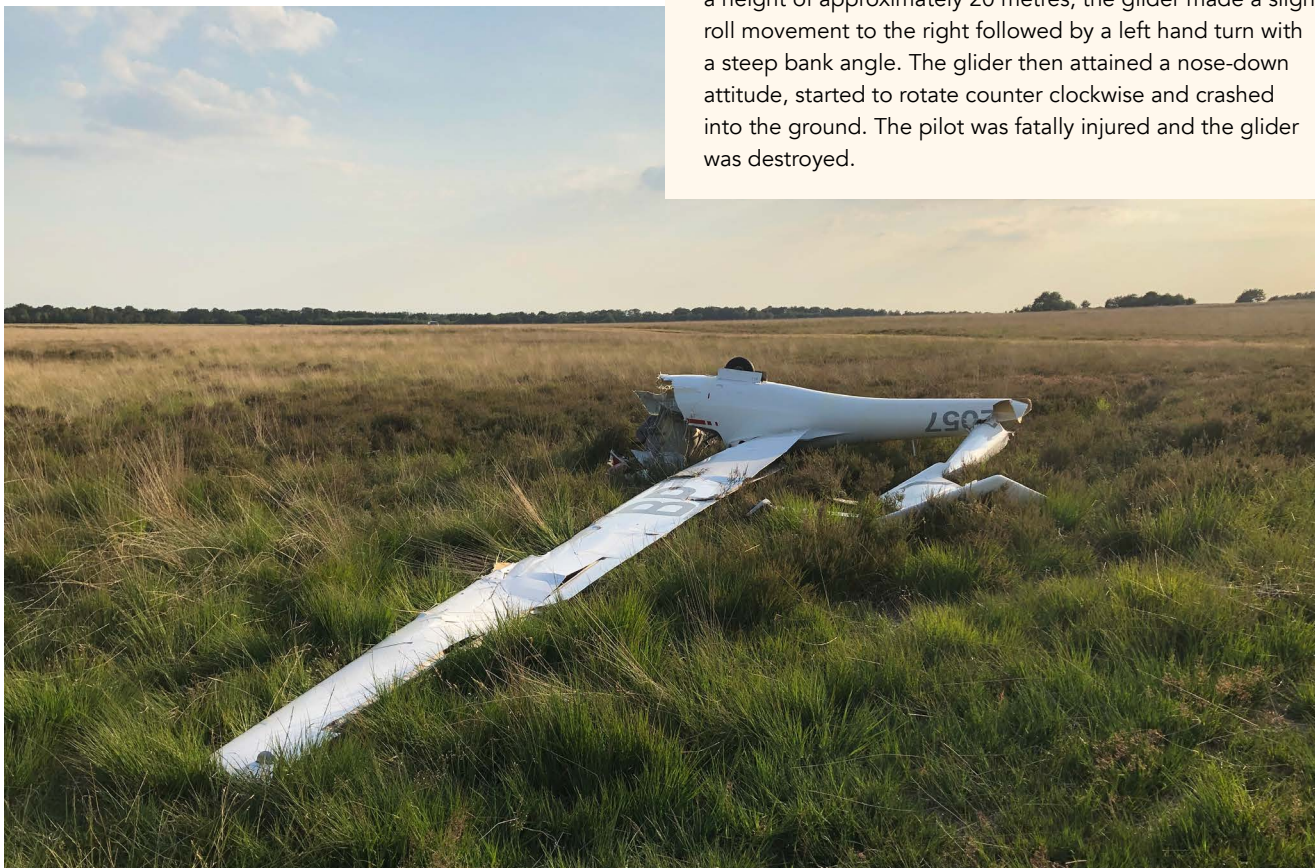
▼ *Accident location.*

The technical investigation of the wreckage has not revealed, insofar as this was still possible due to the damage of the glider, any technical defects in the flight controls that could have played a role in the accident. The slight roll movement of the glider to the right was the first indication of a stall.¹ The pilot's response to this resulted in the left hand nose down turn with a steep bank angle. That moment, the glider had entered a stall condition. The stall arose because the critical angle of attack had been exceeded, which was initiated by a high rotation rate in the beginning of the winch launch. The pilot was not able to recover from the stall at low height.

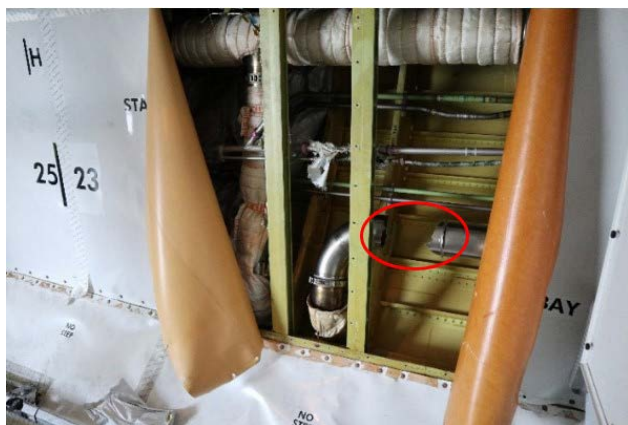
▲ Ruptured pneumatic duct.

Investigation revealed that a titanium pneumatic duct (see photo), located in the left sidewall near the aft cargo compartment, had ruptured. The material insulating the duct was also damaged, which resulted in dust and debris from ducting insulation entering the passenger compartment through the ventilation outlets near the passenger floor.

According to Boeing, the duct is wrapped with a high temperature air duct insulation blanket. In addition to the insulation around the duct, there were insulation blankets along the interior of the fuselage adjacent to the duct rupture. All insulation material used in the area of the rupture is fiberglass-based insulation material.

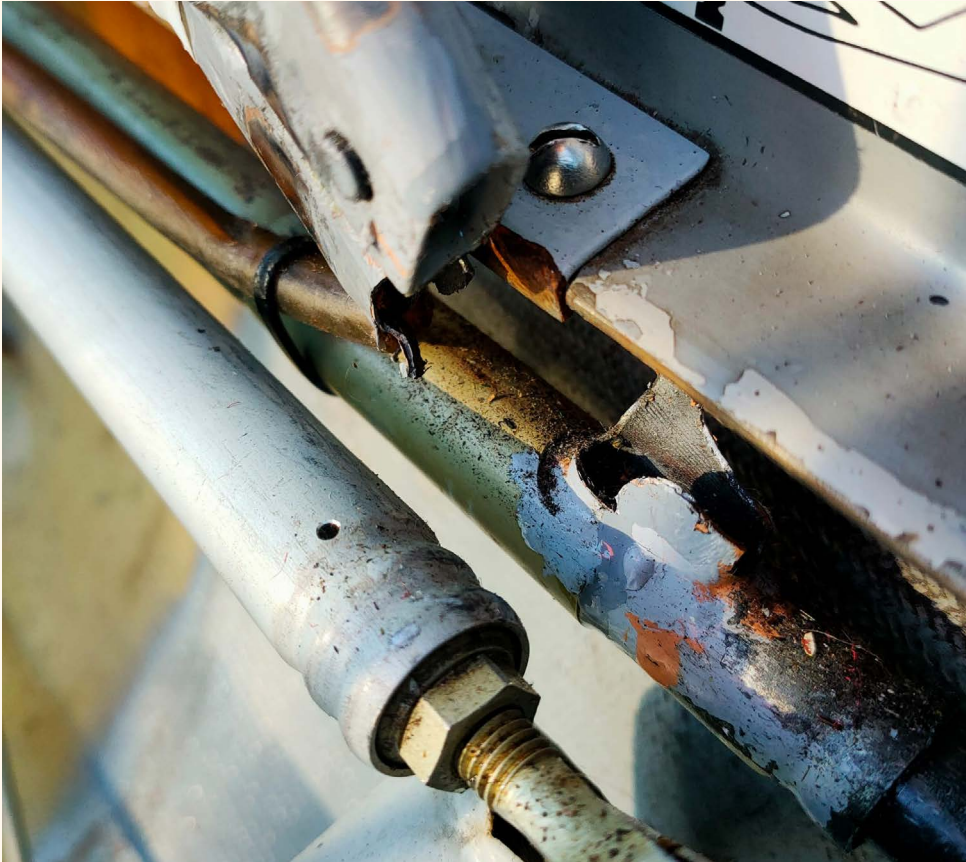
◀ The broken airbrake lever.
(Source photograph on the left: gliding club)

The airbrake lever, which had been in the glider since its construction in 1993, had a fracture in the handgrip. The fracture was a short distance from the weld with the rod of the lever. Material examination showed that the airbrake lever broke off as a result of fatigue. The fatigue appeared to have started at the interior surface. The exact initiation point could not be determined, however. No material defects were identified. The fatigue was probably the result of standard use of the airbrake lever. During the pilot's pre-flight inspection, prior to the flight in question, and during the

routine maintenance of the glider, nothing unusual was found with regard to the operation and condition of the airbrake lever. The gliding club stated that the original lever was never removed for a repair, but there may have been a minor paint repair. The manufacturer stated that they were not aware of any similar incidents.

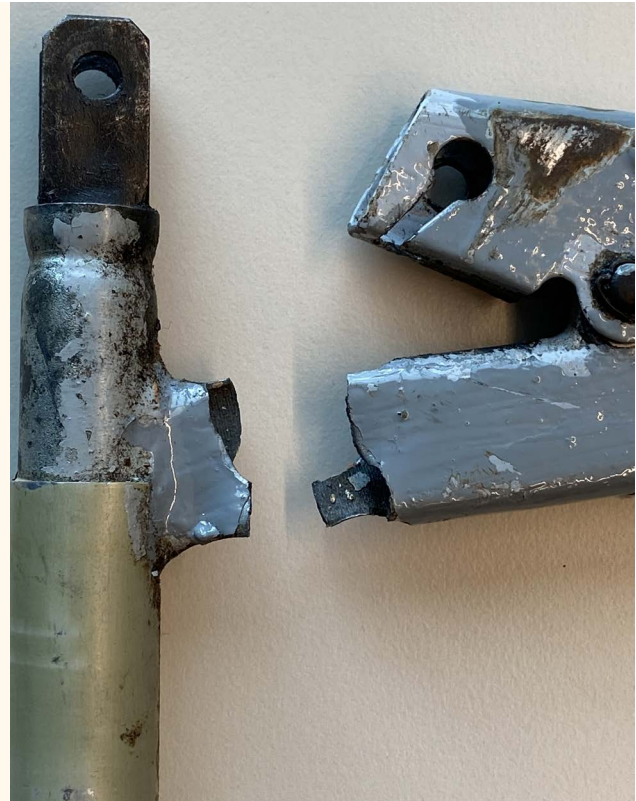
► *The broken airbrake lever.*

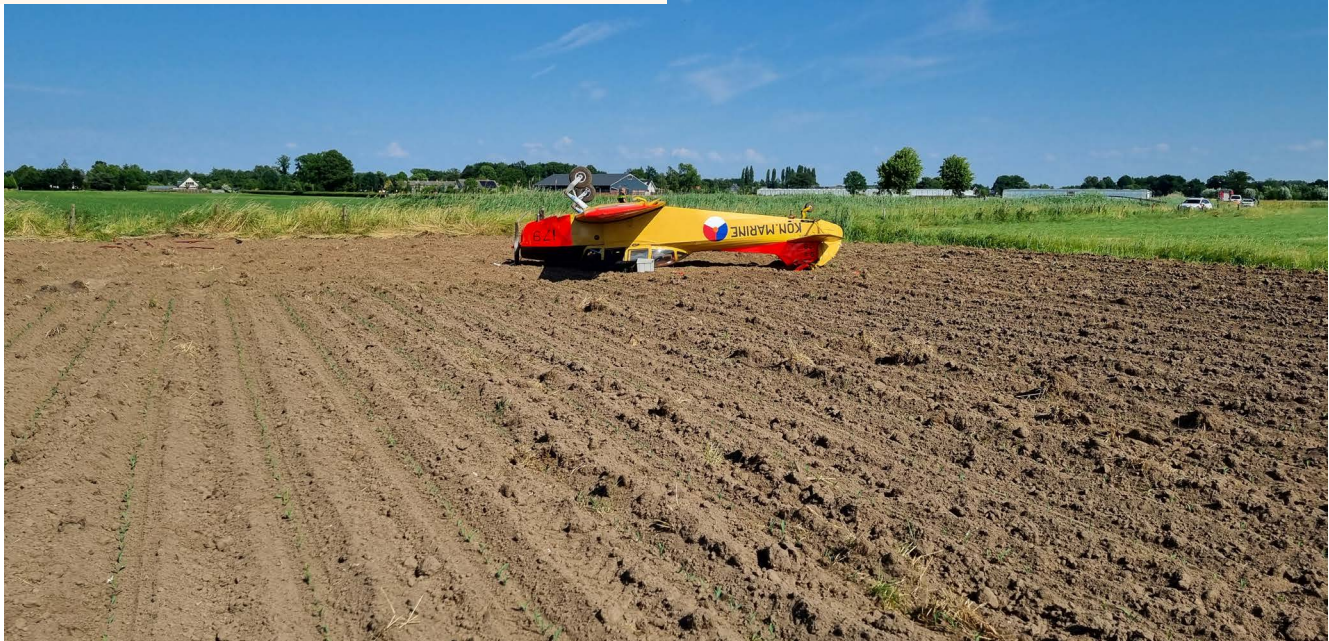
▼ *The Fokker S.11.1 in the field.*
(Source: Dutch Aviation Police)

The technical examination carried out by the owner showed that the engine mounting was bent and the engine controls no longer functioned fully. Further investigation has not yielded any information that could explain the cause of the engine problem. The lock mechanism of the mixture handle no longer functioned due to wear. This may have caused the mixture control to partially move from "rich" to "lean", causing the engine to receive too little fuel and a loss of power.

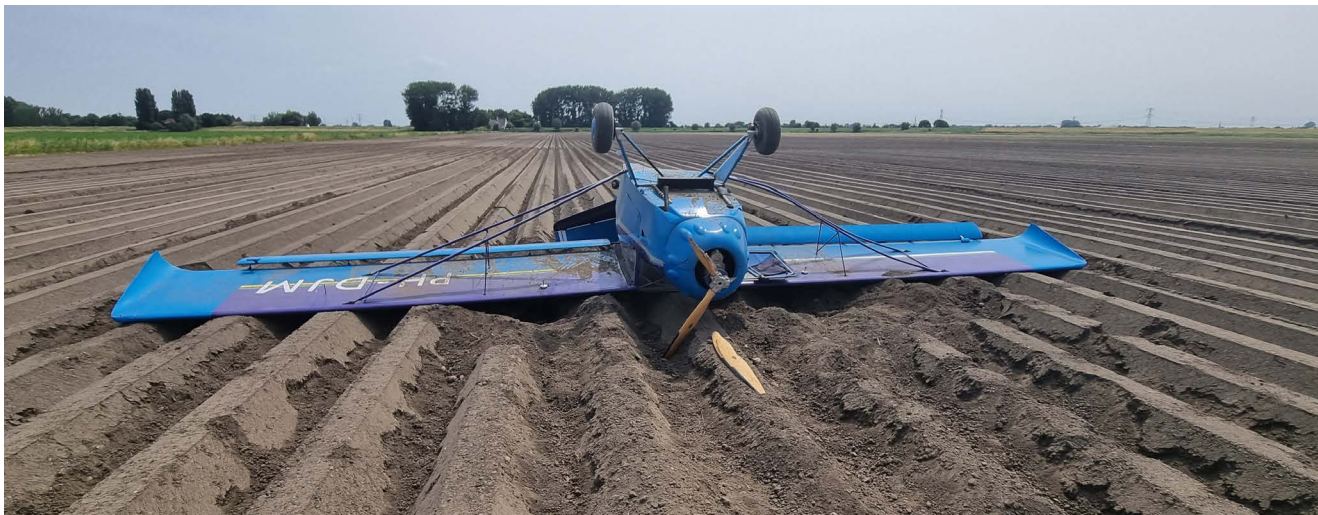
▲ The aircraft after the emergency landing. (Source: Dutch Aviation Police)

The pilot took off from Breda International Airport (EHSE) for a local flight. Near Drimmelen, the pilot gave less throttle, after which he heard a loud bang. Subsequently, the engine power decreased. The engine vibrated heavily and more loud bangs followed. The engine power was insufficient to maintain altitude and speed, upon which the pilot initiated a descent to maintain speed. The pilot decided to make an emergency landing in a field and made a mayday call on the frequency of Dutch Mil. After the emergency landing was initiated, the aircraft landed in a potato field. Because of the loose soil, the aircraft nosed over during the emergency landing and came to rest inverted. The pilot was uninjured and was able to leave the aircraft on his own.
