DUTCH
SAFETY BOARD

Collision off the coast of Denmark

Lessons from the collision between
the Helge and the Wild Cosmos,
9 September 2022

The Hague, February 2024

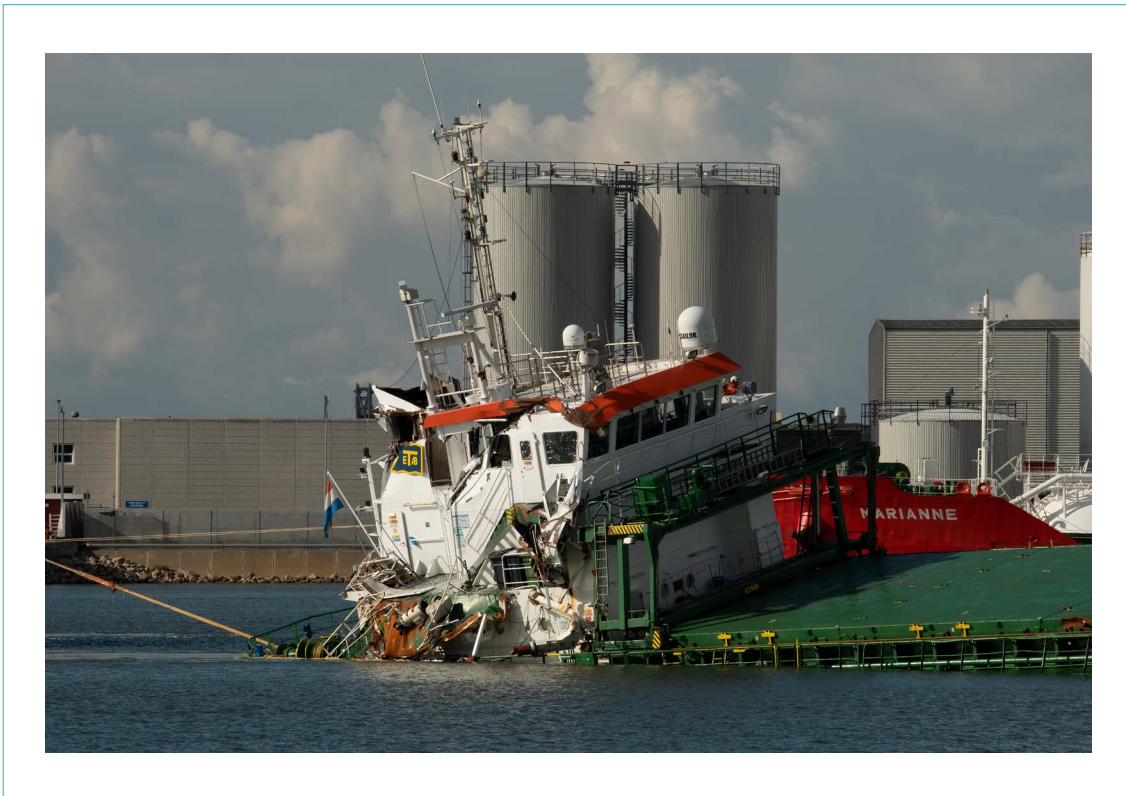
Figure 1: The Helge being towed into Esbjerg, its accommodation heavily damaged and the aft deck almost submerged. (Source: Dutch Safety Board)

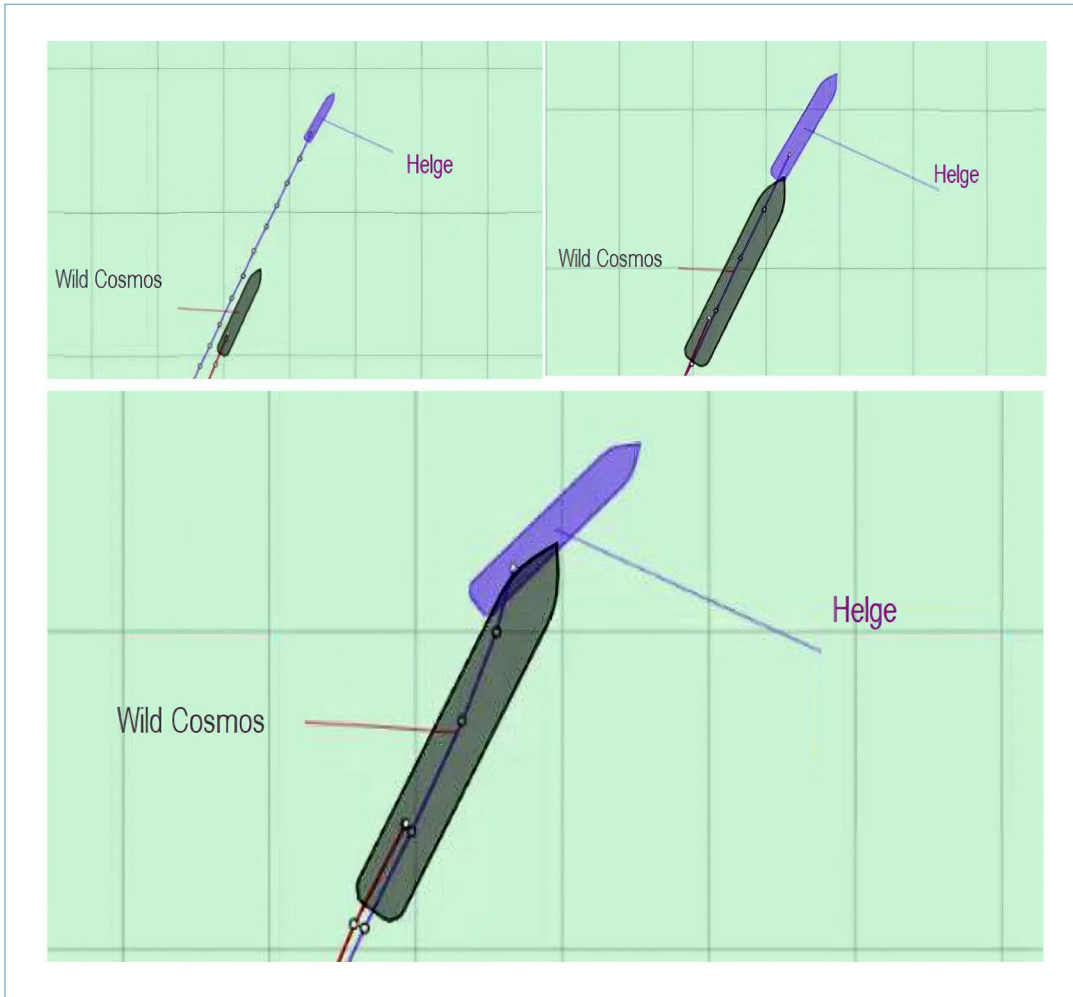
Figure 4: AIS reconstruction of the collision. (Source: OWH)

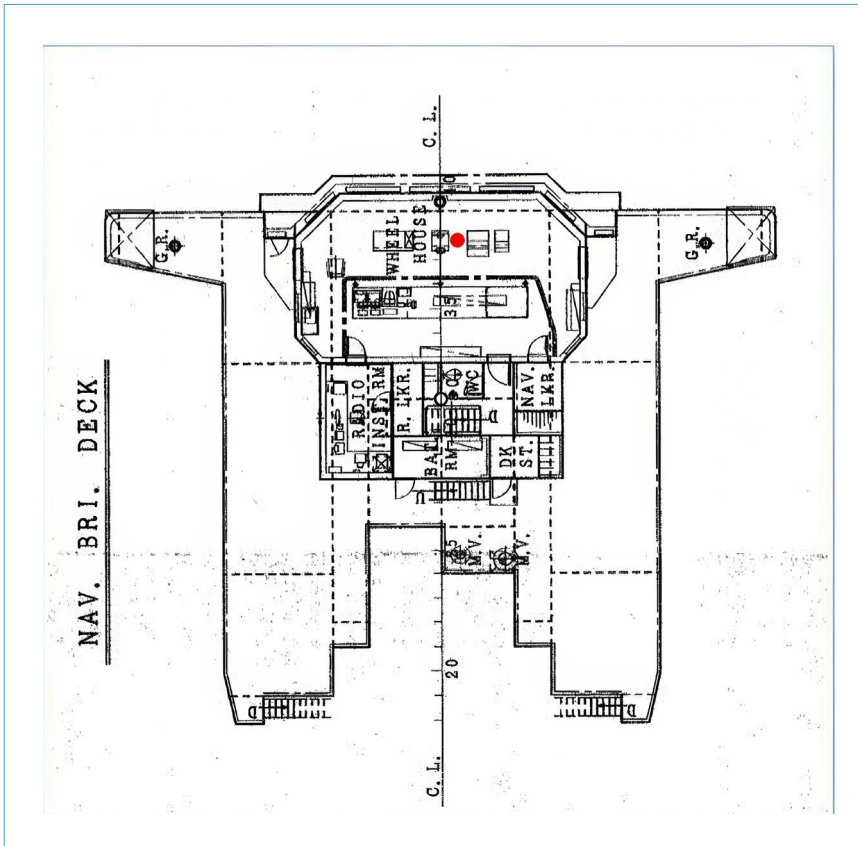
Figure 6: Lay-out of the Wild Cosmos's bridge. The position of the chair is indicated by a red dot. (Source: OWH)

The position of the chair in which the chief officer of the Wild Cosmos was sitting made it difficult to see both radar screens properly.

- Replaced paper charts on all ships still carrying them with ECDIS;
- The crew of these ships received ECDIS training for this purpose;
- Moved the chairs on the bridge to improve visibility of the equipment and to the outside;
- Used the VDR data from this occurrence to make it a training exercise;
- Through various methods, brought this incident to the attention of its fleet.

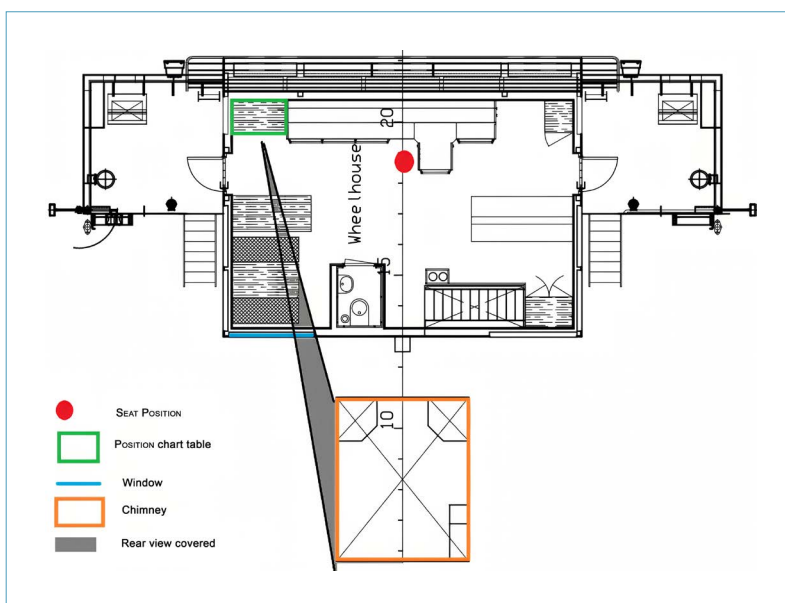
From the position of the chart table, he could see outwards, but the sternwards view towards the Wild Cosmos was blocked by the funnel. Figure 8 shows the position of the chair (red dot) and the chart table (green rectangle) and gives an impression of the line of sight to the rear from the chart table (funnel marked with an orange rectangle, the blind sector marked in dark grey).

Figure 8: Bridge lay-out of the Helge. (Source: MF Shipping Group)

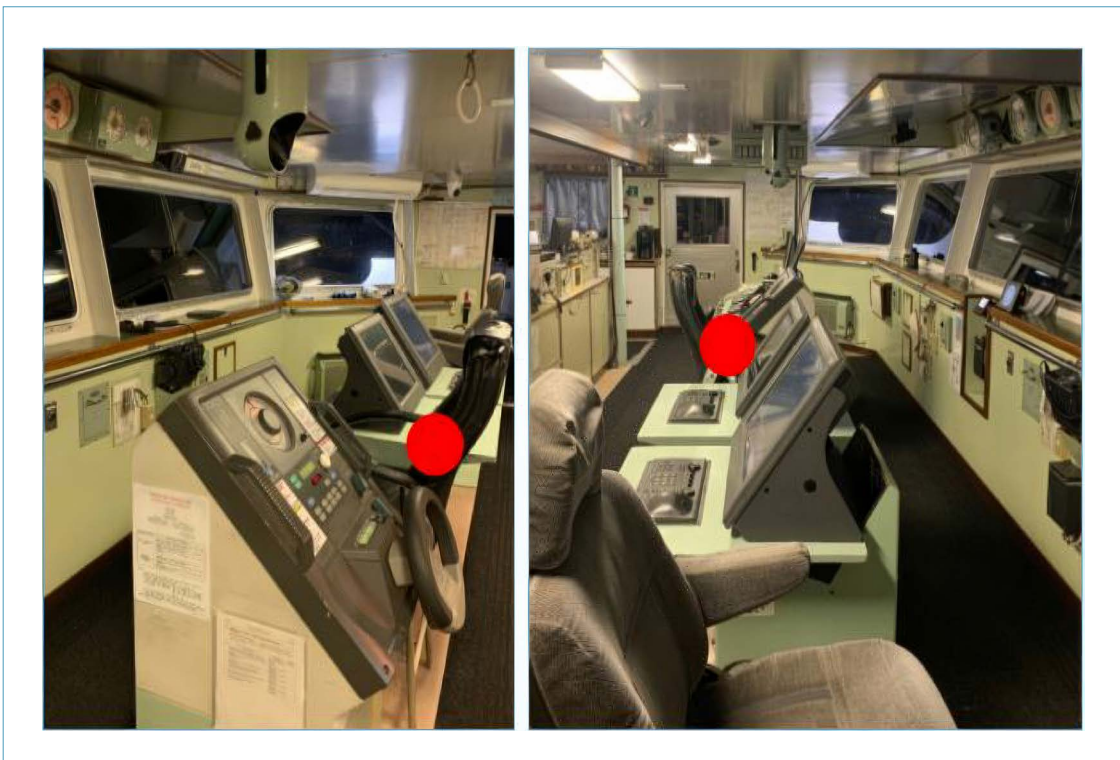
The chief officer occasionally walked around the bridge to look outside, but mainly sat on a chair positioned between the steering position and the radar screens. The chair was not behind the radar screens but next to them, which made looking at the radar screens difficult. Certainly the screen of the starboard X-band radar was difficult to see from the chair. Figure 6 in section 2.2.2 shows the position of the chair on the bridge with a red dot. Figure 9 are photos of the bridge. The radar screens are to the right of the chair in which the chief officer on watch duty sat, here marked with a red dot. Directly to the right of this chair is the S-band radar screen and on the outside right is the X-band radar screen.

Figure 9: Photos of the bridge of the Wild Cosmos. (Source: OWH)

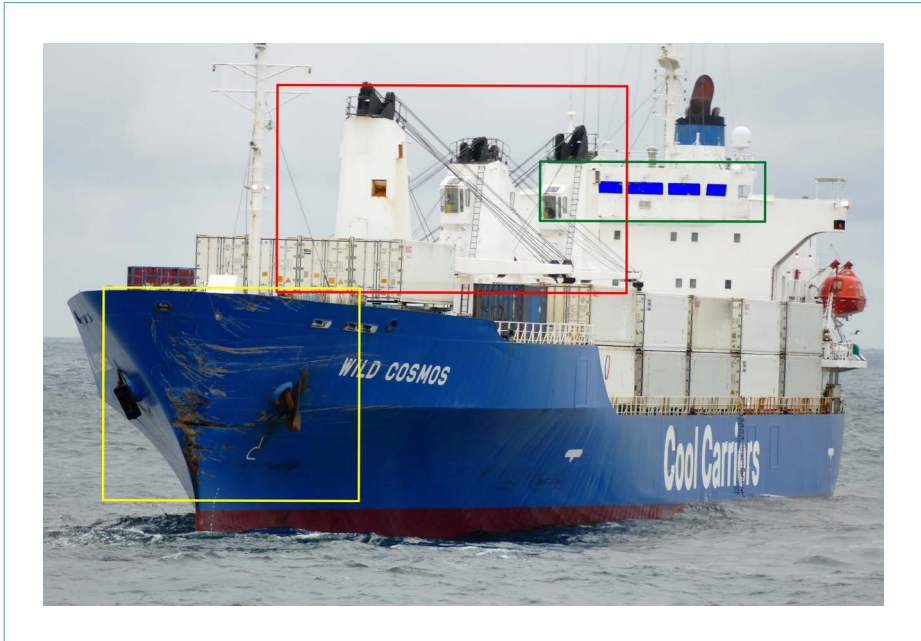
The view through the windows of the bridge was partially blocked by the row of cranes in the middle of the ship. Only by looking out from different positions on the bridge is it possible to see past both sides of the cranes. From the chair used, there is a blind spot port forward, in the direction where the Helge was. Figure 10 and Figure 11 are photos

taken of the side and front of the Wild Cosmos after the collision. The photos show that the ship cranes partially obscure the view forward.

Figure 10: The Wild Cosmos after the collision. The green rectangle shows four of the five bridge windows. The ship's cranes are in the red rectangle. The yellow rectangle shows the damage from the collision. (Source: Danish Fisheries Inspection)

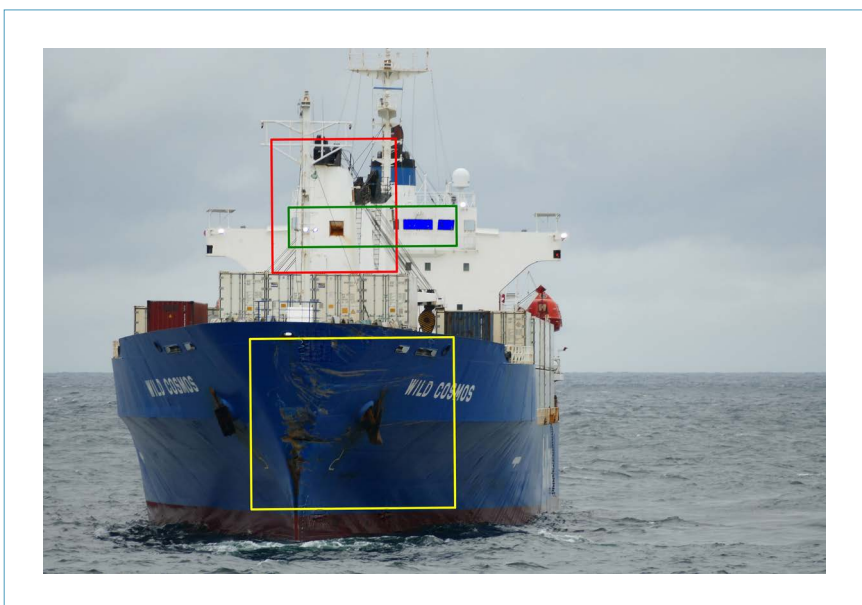
The chief officer of the Wild Cosmos was alone on the bridge during the dark hours, which deviates from legislation and regulations and the ship manager's procedures. Due to the position of the chair he was sitting in, the view forward towards the Helge was partially blocked by the ship's cranes.

Figure 11: This picture shows that the starboard windows in the green rectangle are blocked by the cranes in the red rectangle. (Source: Danish Fisheries Inspection)

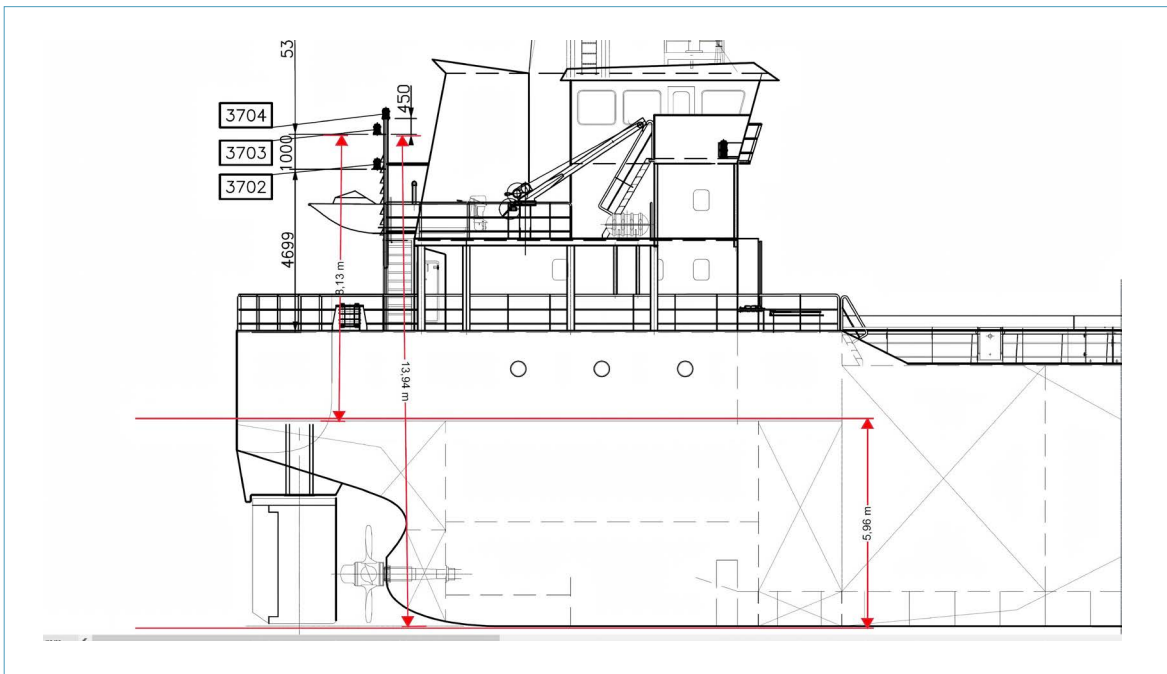
According to the COLREG, a stern light should be visible at least 3 miles away in normal visibility, a top light at 5 miles. The stern light of the Helge was more than 8 metres above the waterline at a draught of nearly 6 metres. With wave conditions of up to 3 metres, when a ship is pitching, the stern light will sometimes be hidden from view by the waves for shorter periods. Nevertheless, it can be assumed that under the given weather conditions, the stern light of the Helge must have been visible to the lookout on the Wild Cosmos well before the collision. Figure 12 shows the height of the stern light from the vessel's keel and height of the stern light from the waterline at a draft of 5.96 metres.

Figure 12: The height of the Helge's stern light (shown here as no 3703). (Source: MF Shipping Group)

From the bridge of the Wild Cosmos, the Helge's stern light should have been visible. Due to weather conditions, it is possible that the stern light will not have been clearly visible all the time.

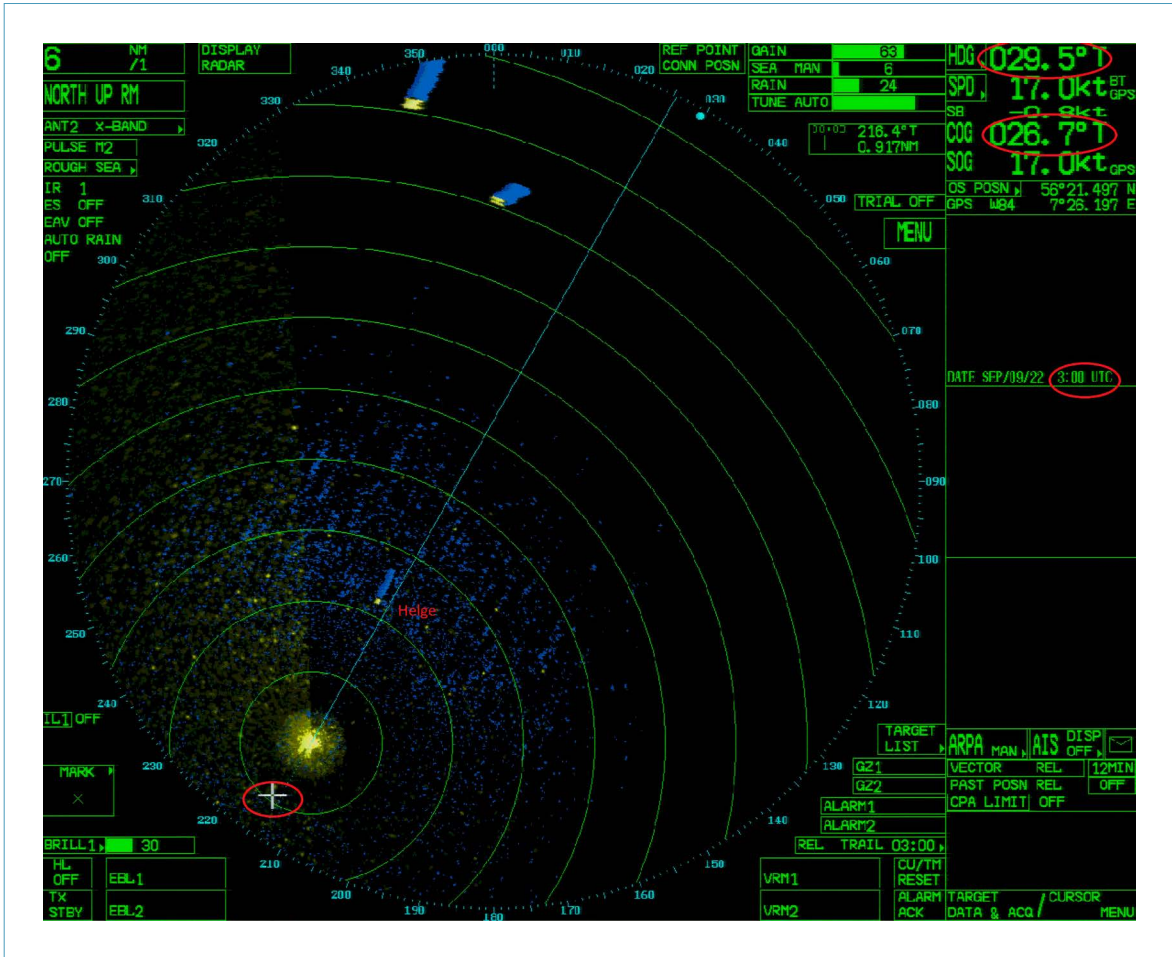
The chief officer of the Wild Cosmos stated that at 05.00 hours he saw some echoes on the radar, emerging from rain. He then looked outside but saw no lights. The radar image recorded by the VDR does not show the rain. See Figure 13. It does show that the Helge's echo is weaker than the echoes from ships further away and easier to overlook. If he did not see Helge at that time, it is likely that the two echoes he mentioned are the two at

the top of the image. If the rain could be seen on radar, it must have been on the other screen, the S-band next to the chair in which the chief officer was sitting. This screen was not captured by the VDR and therefore cannot be verified. Since nothing is known about the settings of this other radar screen, such as its range, it is also impossible to determine with certainty what echoes the chief officer saw.

Figure 13: The X-band radar image of the Wild Cosmos at 05:00 hours. The names in red and the red circle were inserted by the Dutch Safety Board. (Source: VDR of the Wild Cosmos)

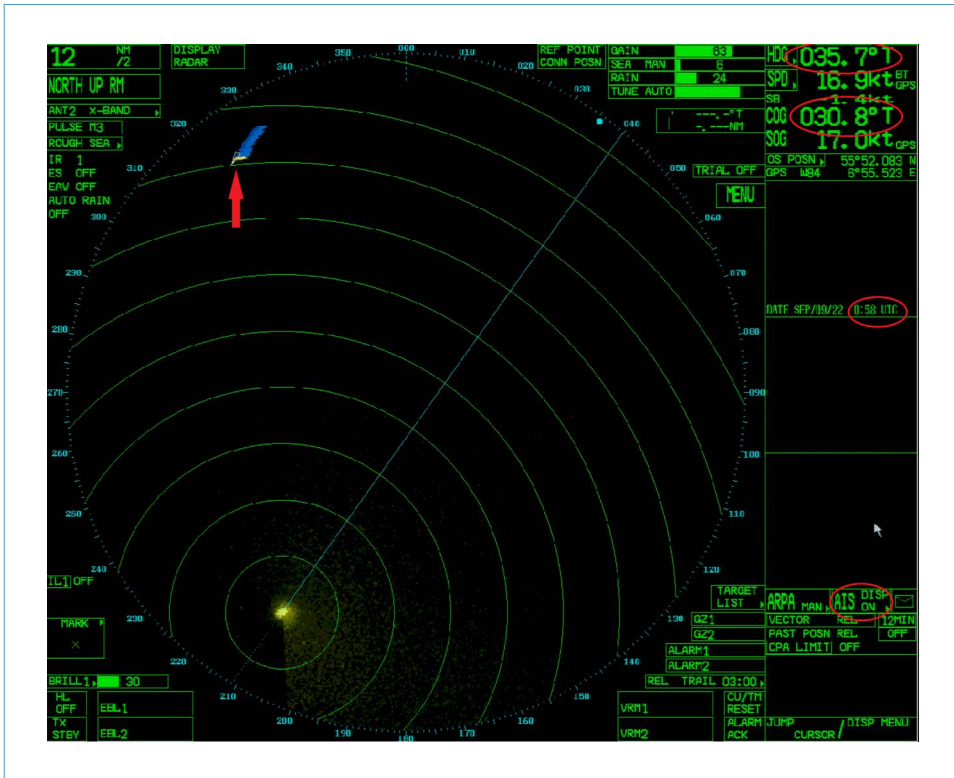
Even if a vessel is in a blind sector of the radar, for example, and no echo can be seen, this triangle will remain visible. The first radar image below (Figure 14) shows in the bottom right corner that the AIS overlay is 'on'. The red arrow shows the AIS symbol (a white triangle) around the radar echo. Top right: the Gyrocompass heading (HDG) and the heading calculated by the GPS (COG). Middle right: the time. The second image (Figure 15) shows in the bottom right corner that the AIS is 'off'. Also, the triangle around the radar echo has disappeared. The range (top left) is still at 12 miles. It can also be seen that the screen is off-centre: the Wild Cosmos is not in the centre of the image but towards the bottom and is displayed much further forward than back.

Figure 14: Radar image of the Wild Cosmos just before the chief officer took over the watch. The red arrow and circle were inserted by the Dutch Safety Board. (Source: VDR of the Wild Cosmos)

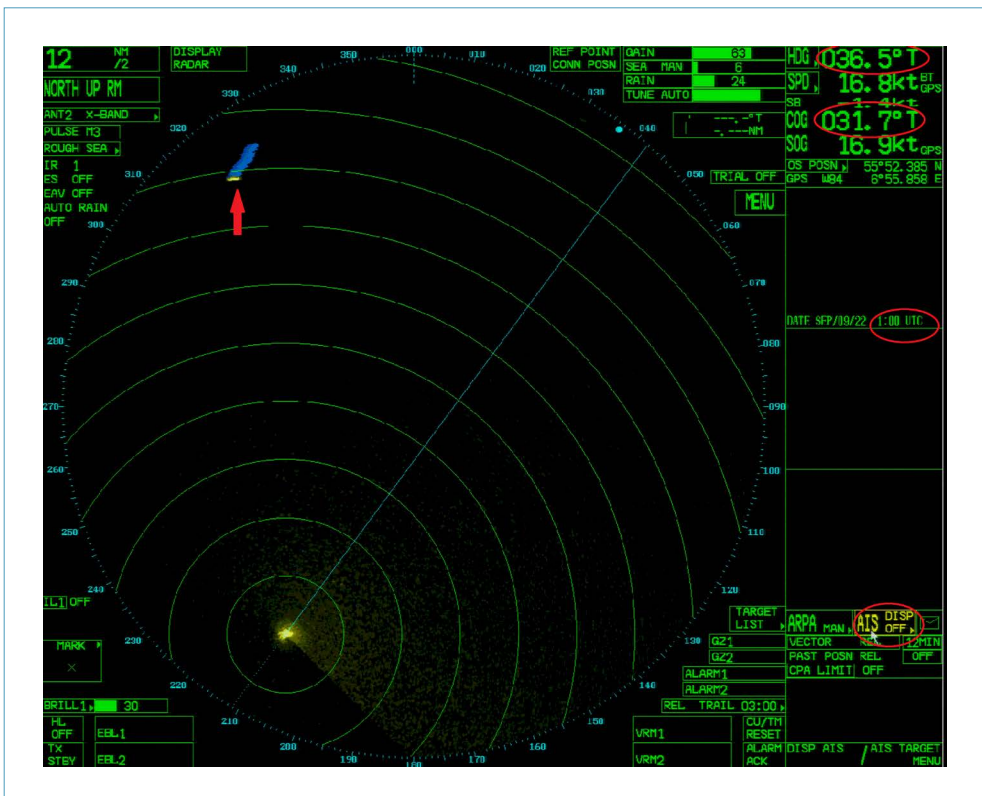
Figure 15: The moment of watch handover. The red arrow and circle were inserted by the Dutch Safety Board. (Source: VDR of the Wild Cosmos)

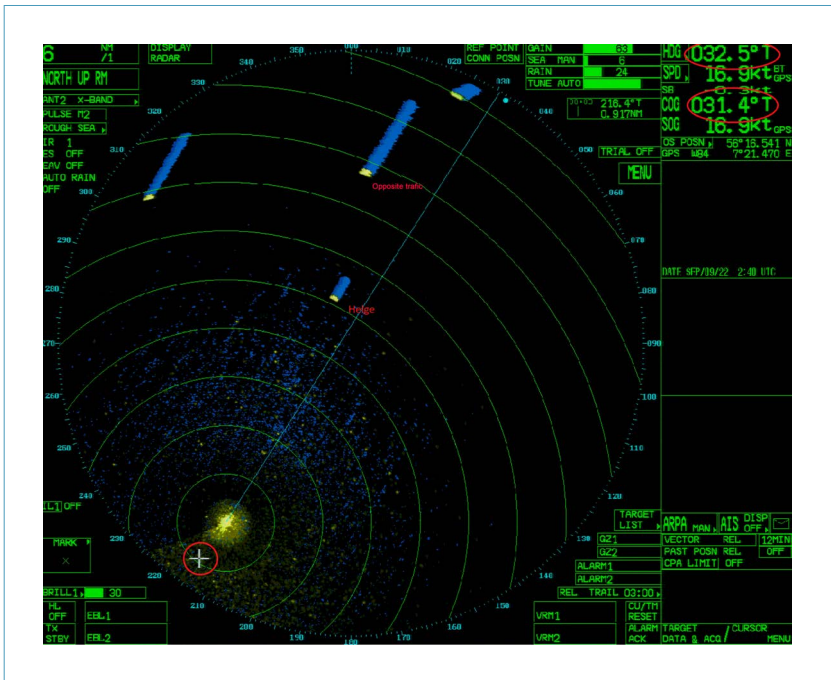
The chief officer declared that he had not seen the Helge. The recorded radar images show that the cursor located in the bottom left corner of the red circle in Figures 16 and 17 did not change its position in the time before the collision. This makes it plausible for the Dutch Safety Board that this radar was not used by the chief officer. The Dutch Safety Board therefore assumes that he has seen the echo of the oncoming vessel on the other radar screen, that of the S-band. This image was not recorded on the VDR, so it cannot be determined whether the echo of the Helge was even less clearly visible there.

Figure 16: The X-band radar image at 04.40 hours. The names in red and the red circle were inserted by the Dutch Safety Board. (Source: VDR of the Wild Cosmos)

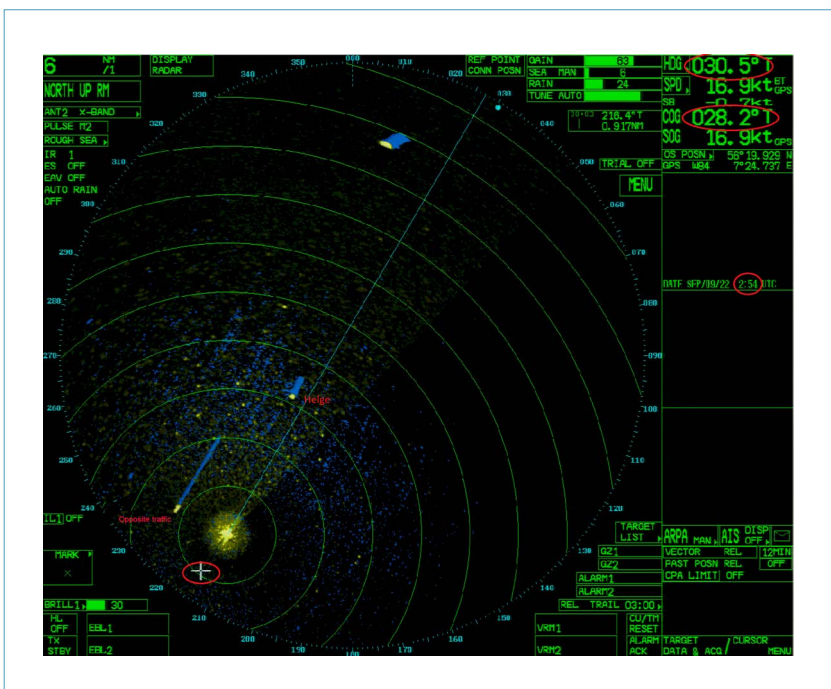
Figure 17: The radar image at 04.54 hours, the oncoming vessel passing on the port side. The names in red and the red circle were inserted by the Dutch Safety Board. (Source: VDR of the Wild Cosmos)
