DUTCH
SAFETY BOARD

Loss of control, Hélicoptères Guimbal Cabri G2 helicopter, Lelystad Airport

The Hague, February 2024

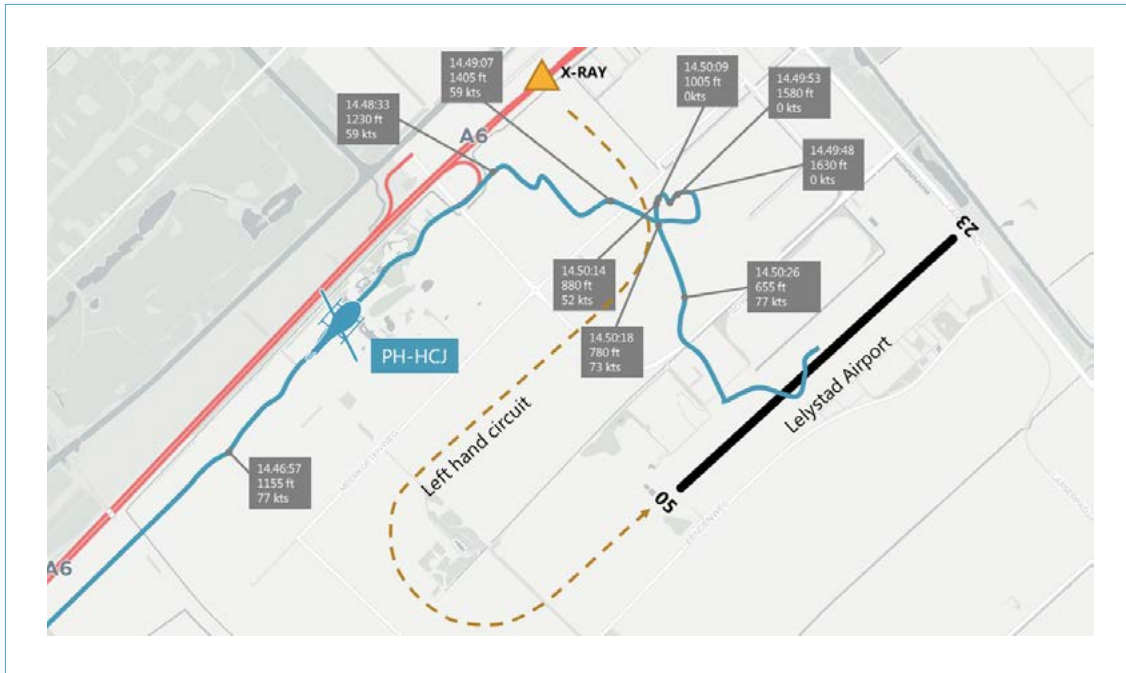
According to radar data, PH-HCJ was at an altitude of 1,155 feet, maintaining approximately 80 knots, while approaching reporting point X-RAY (see Figure 1). The air traffic controller instructed the pilot to fly a right hand downwind for Runway 05 at an altitude of 1,000 feet and informed him that other traffic would be flying below him. The pilot expected the instruction to fly a *left hand* downwind for Runway 05 and asked the air traffic controller to “repeat” the instructions. The controller repeated the same instructions and the pilot turned left in a north-easterly direction. Afterwards, the pilot stated that, in his opinion, the air traffic controller’s instruction was incorrect, because it did not contain the standard, published left hand downwind instruction for Runway 05.

Figure 1: Relevant part of the flight track, indicated airspeed and altitude of PH-HCJ.
(Source: Dutch Safety Board)

The pilot of PH-HCJ had completed a 90-degree left turn in the meantime. During this turn, he noticed on the flight instruments that his airspeed was now almost zero knots. The minimum permitted airspeed for solo flying students, set by the flight school, was 30 knots. This is not explicitly communicated, since a lot of the training and learning to fly a helicopter is focussed on transitioning to and from a hover close to the ground (practicing take-off and landing). According to radar data, the helicopter had climbed to an altitude of 1,630 feet, when suddenly the helicopter rotated rapidly over left around its yaw axis and an uncontrolled spiralling descent started. The helicopter rapidly lost altitude. The pilot estimates that he had made three to four left rotations.
