DUTCH
SAFETY BOARD

Risk management for the transport of dangerous goods by rail

Train collision Tilburg

6 March 2015

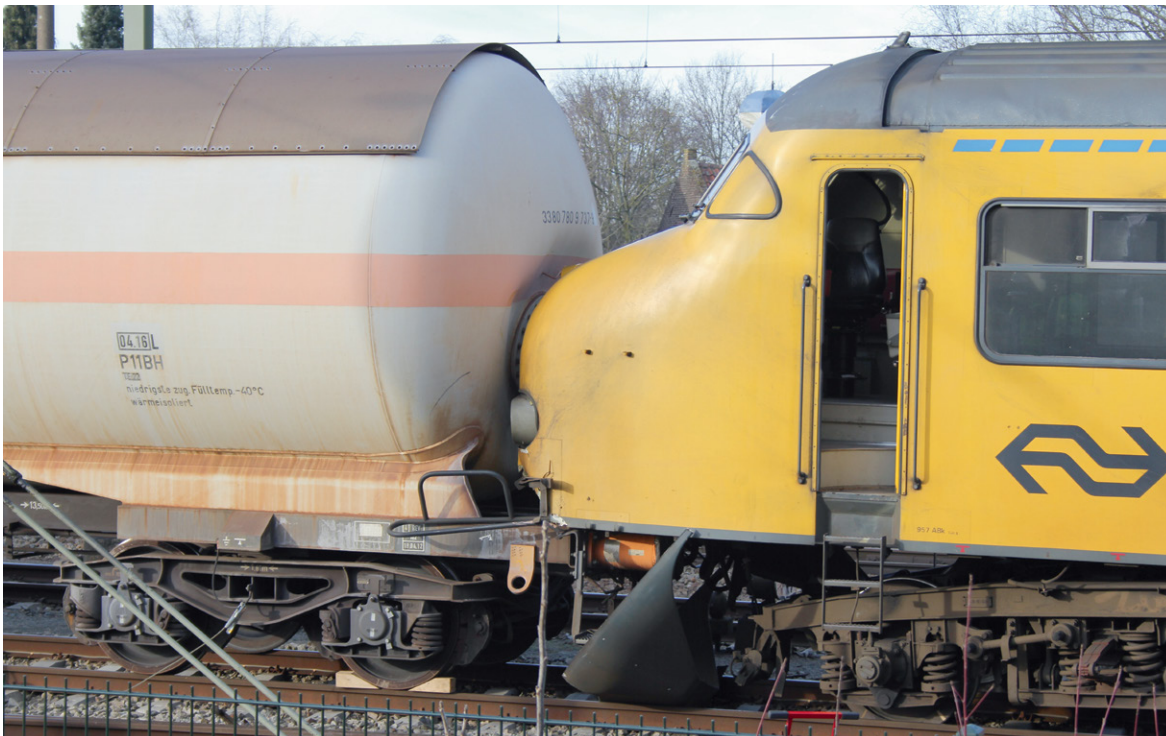
Figure 1: Situation following the collision between the tank wagon and the passenger train. (Photo: Dutch Safety Board)

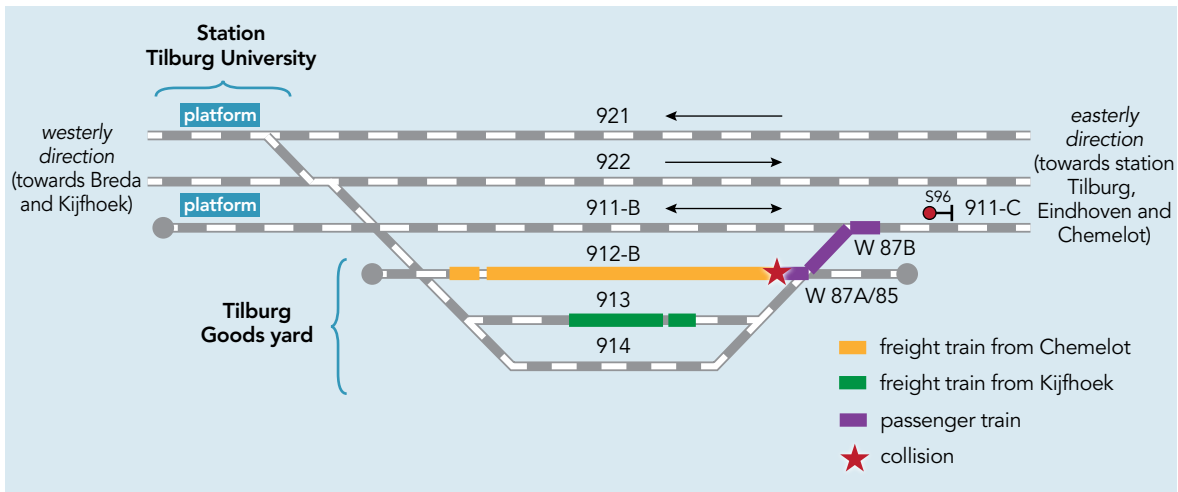
However, the driver of the passenger train did not perceive the signal at red, and as a consequence he failed to brake as he approached the signal. Because the signal is not equipped with an automatic train protection system ATB - Improved Version,¹⁶ no automatic braking was initiated.¹⁷ The eventual consequence was that the passenger train was guided onto the side track on which the freight train was still stationary (see figure 4) via the switch which was still in the diverging position. The driver of the passenger train did start to brake at the last moment, but this had little effect. Because of the limited remaining distance, the speed of the passenger train at the start of the collision was still almost identical to the original approach speed, namely approximately 45 km/hour.¹⁸

Figure 4: The passenger train passed the signal at red and then ran into the back of the freight train which stood on track 912-B.

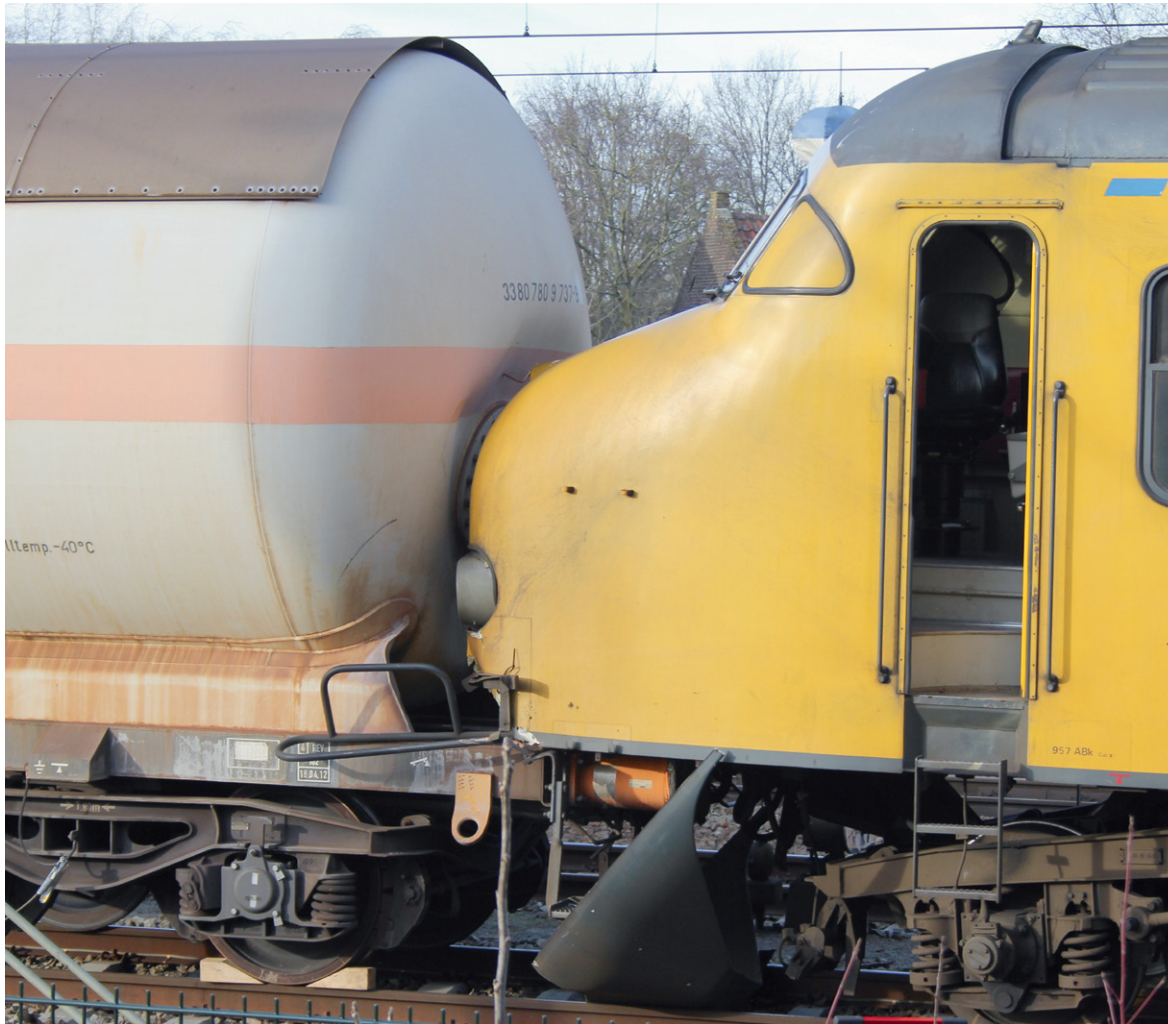
- The first contact occurred between the automatic coupler on the front of the passenger train and the coupling hook on the back of the under frame of the rearmost wagon (a tank wagon) of the freight train.
- After the automatic coupler on the passenger train had been pushed backwards, the front of the passenger train collided with the buffers of the tank wagon. As a result of height differences, only the top section of the buffers was hit. As a consequence, the front of the passenger train rose up and over the buffers.
- The passenger train then continued to slip forwards, and the front of the passenger train collided with the rear wall of the tank (see figure 6).

Figure 6: The front of the passenger train rose up and over the crash buffers on the tank wagon, and ended up against the tank. (Photo: Dutch Safety Board)

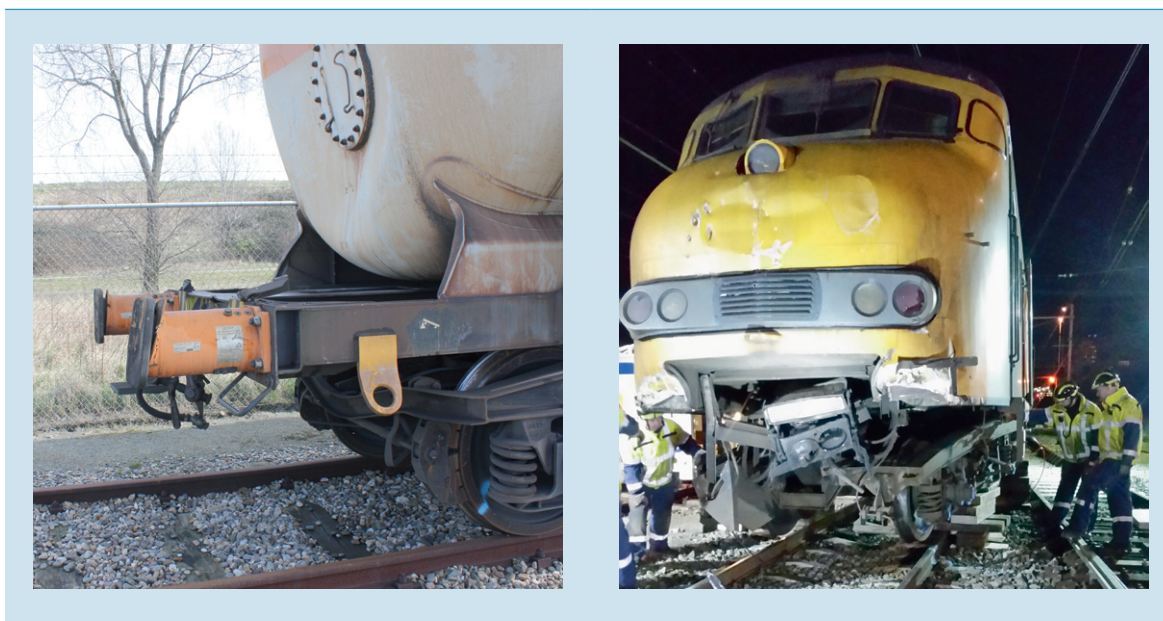
The collision caused damage to both trains (see figure 7). The front of the passenger train and the coupling components between the multiple units suffered damage. On the freight train, only the back end of the rearmost tank wagon suffered damage. This mainly involved the impression and minor deformation of the crash buffers,²² bending of the tow coupling and a dent in the rear wall of the tank.

Figure 7: The damage to the rear of the tank wagon (left) and the front of the passenger train (right). (Photos: left = Dutch Safety Board, right = fire brigade)

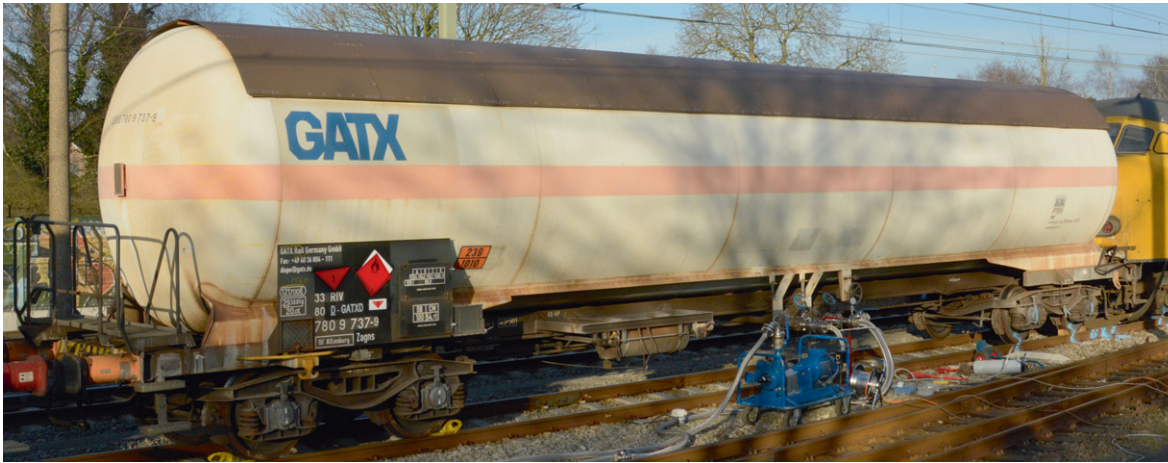
The leak was relatively small (drip level). Before towing away the tank wagon, the content was pumped into another tank wagon, using a mobile pump. It took approximately two days to remove the stock in question and to re-release the accident location for train traffic.

Figure 10: The damaged tank wagon was pumped empty with mobile pumps. (Photo: Dutch Safety Board)

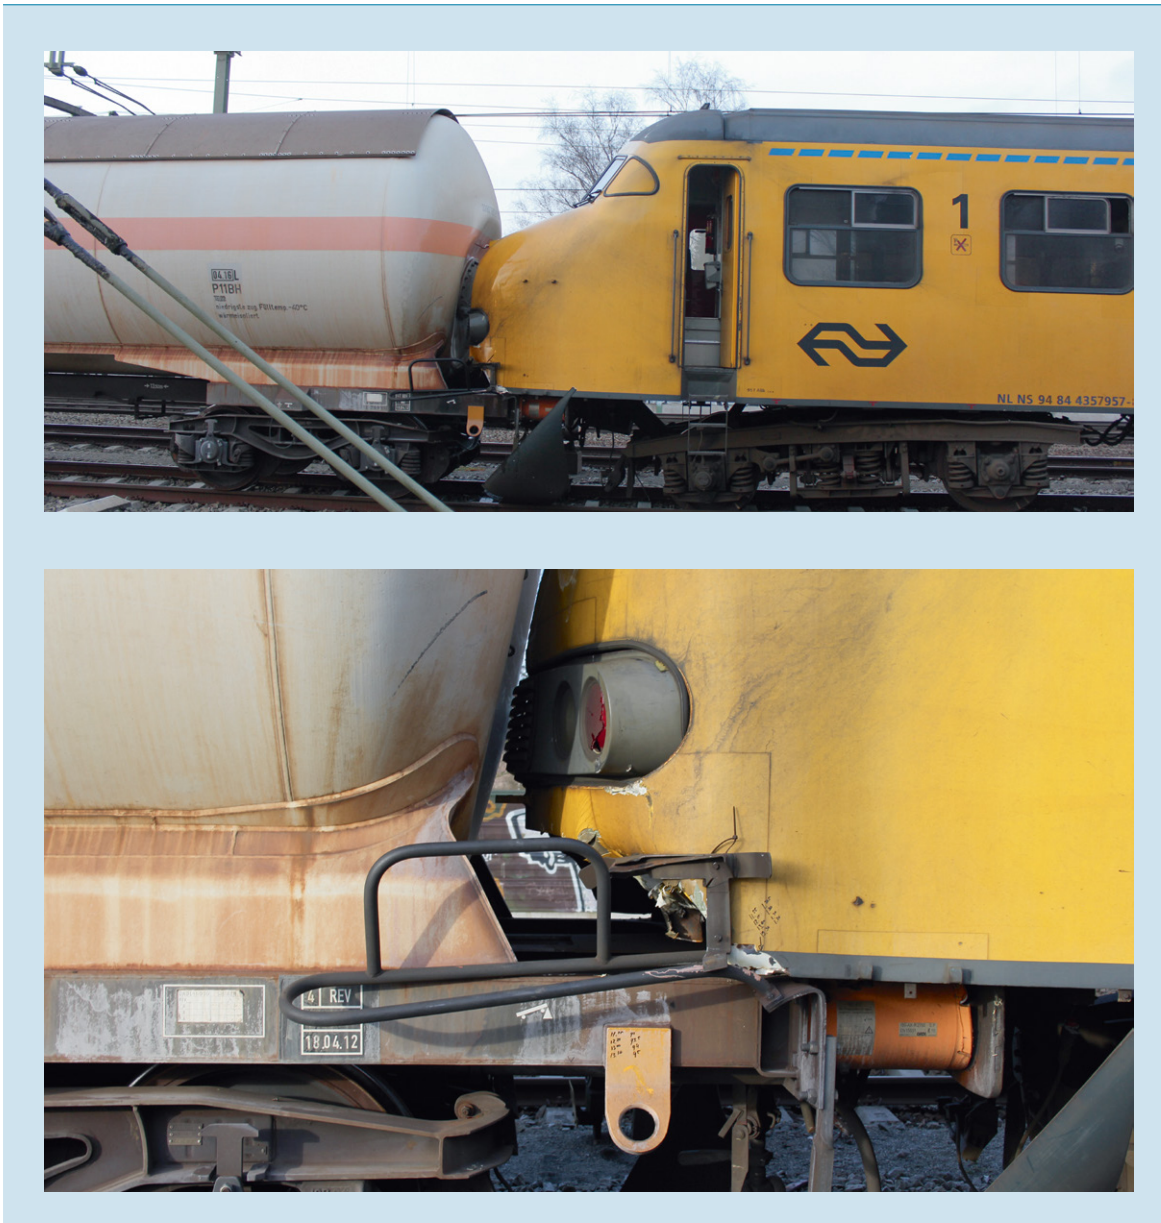
Figure 23: These photographs show that the nose of the passenger train had climbed up and over the buffers of the tank wagon, before colliding with the rear wall of the tank. (Photos: police)

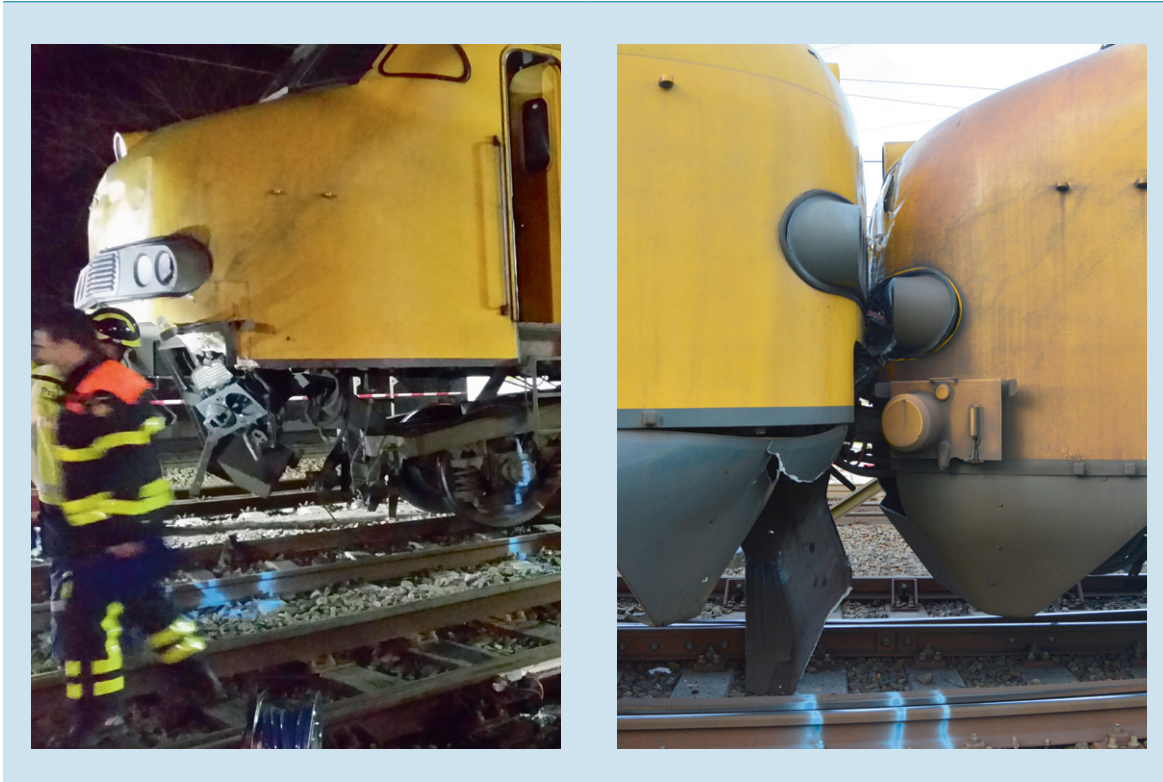
On the passenger train, most damage occurred at the front end of the front multiple unit, and the coupling between the two multiple units. The damage at the front end (see the left-hand photograph in figure 24) mainly affected the automatic coupler, the draw bar and its attachment. The damage to the midsection of the train (see right-hand photograph in figure 24) above all affected the coupling parts that joined the two multiple units together

Figure 24: These photographs show the damage to the passenger train. The left-hand photograph shows the front end of the front multiple unit, the right-hand photograph shows the connection between the two multiple units. (Photos: left = fire brigade, right = police)

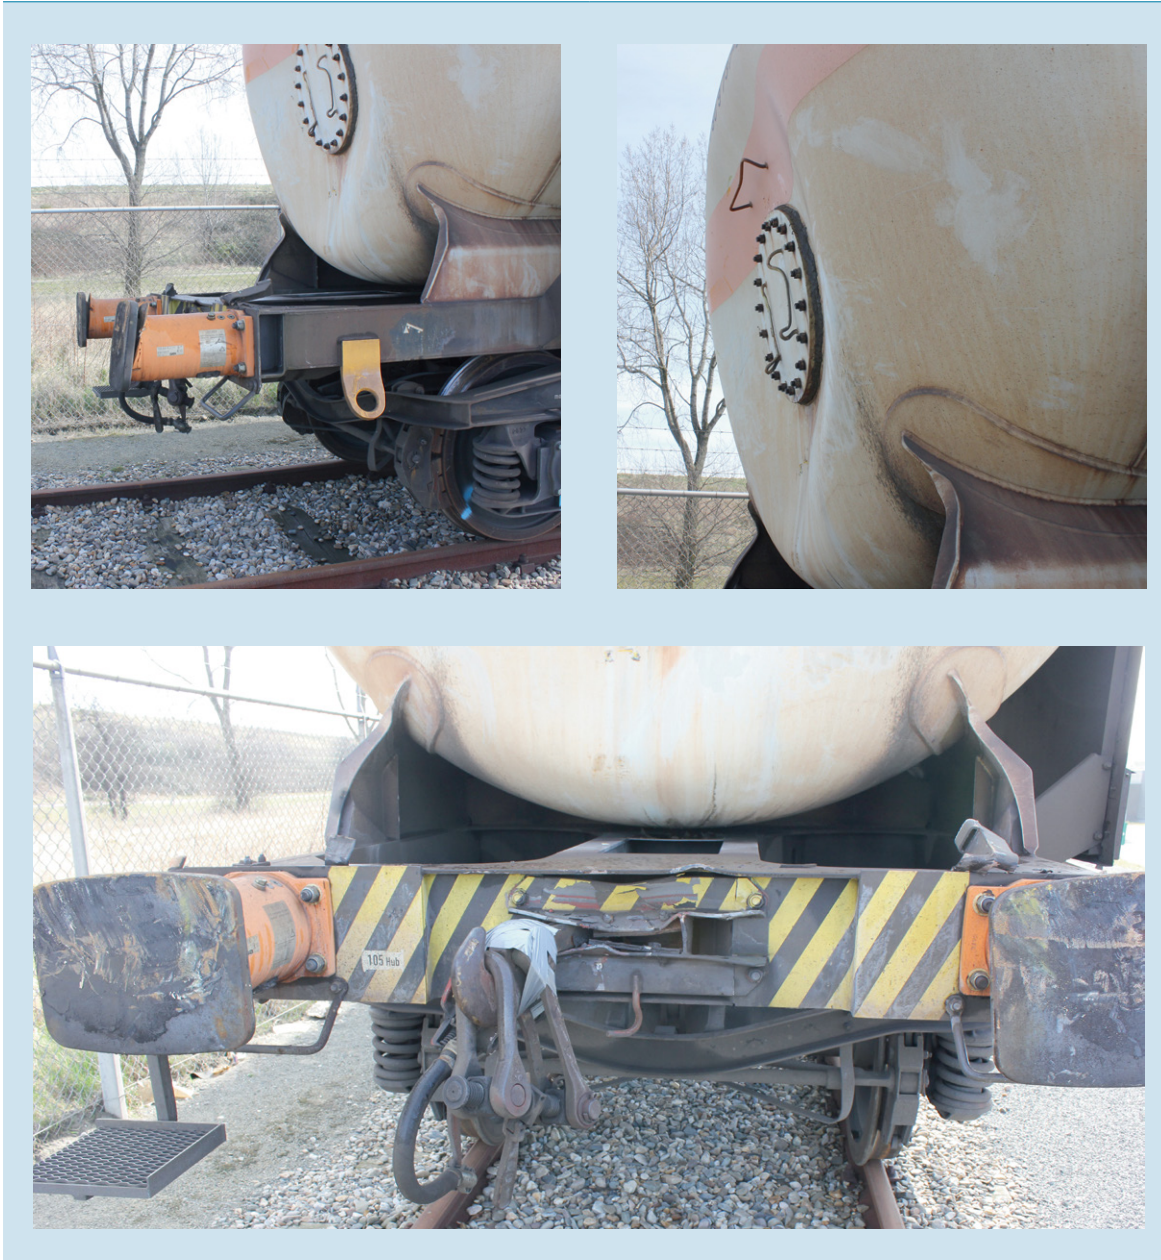
Figure 25: These photographs show the damage caused by the collision to (the back of) the rearmost tank wagon. (Photos: police)

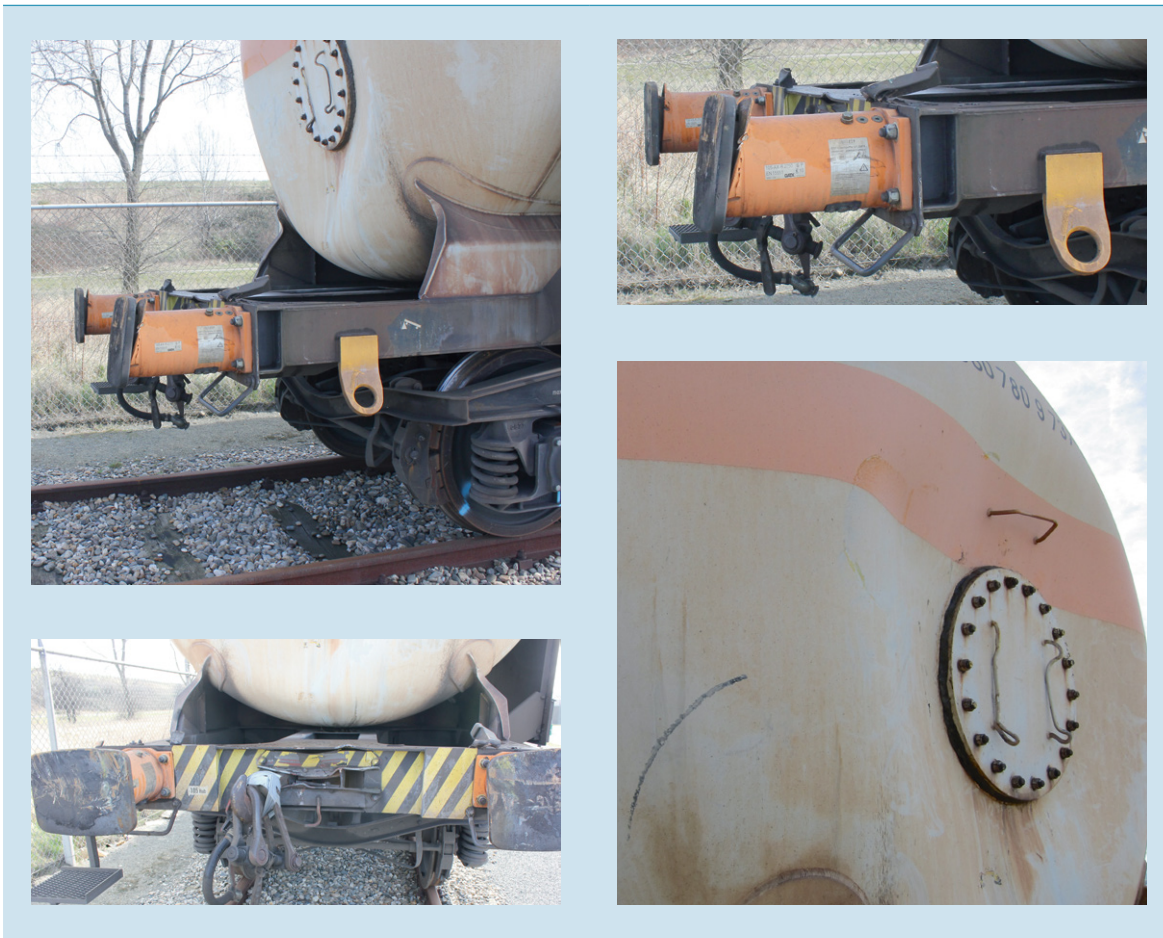
Figure 28: These photographs show the damage to the tank wagon. (Photos: Dutch Safety Board.)

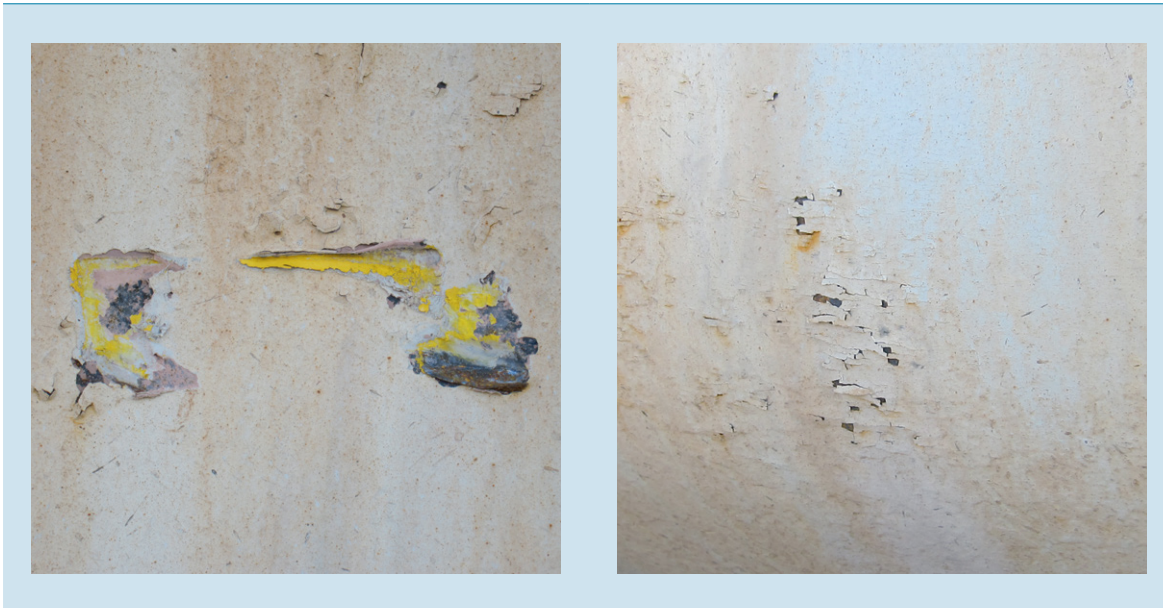
Figure 29: The left-hand photograph shows the mechanical damage observed below the manhole cover on the rear wall of the tank. The damage is the imprint of the draw eye on the front of the passenger train. The right-hand photograph shows local crackling of the paint layer on the tank. (Photos: Dutch Safety Board)

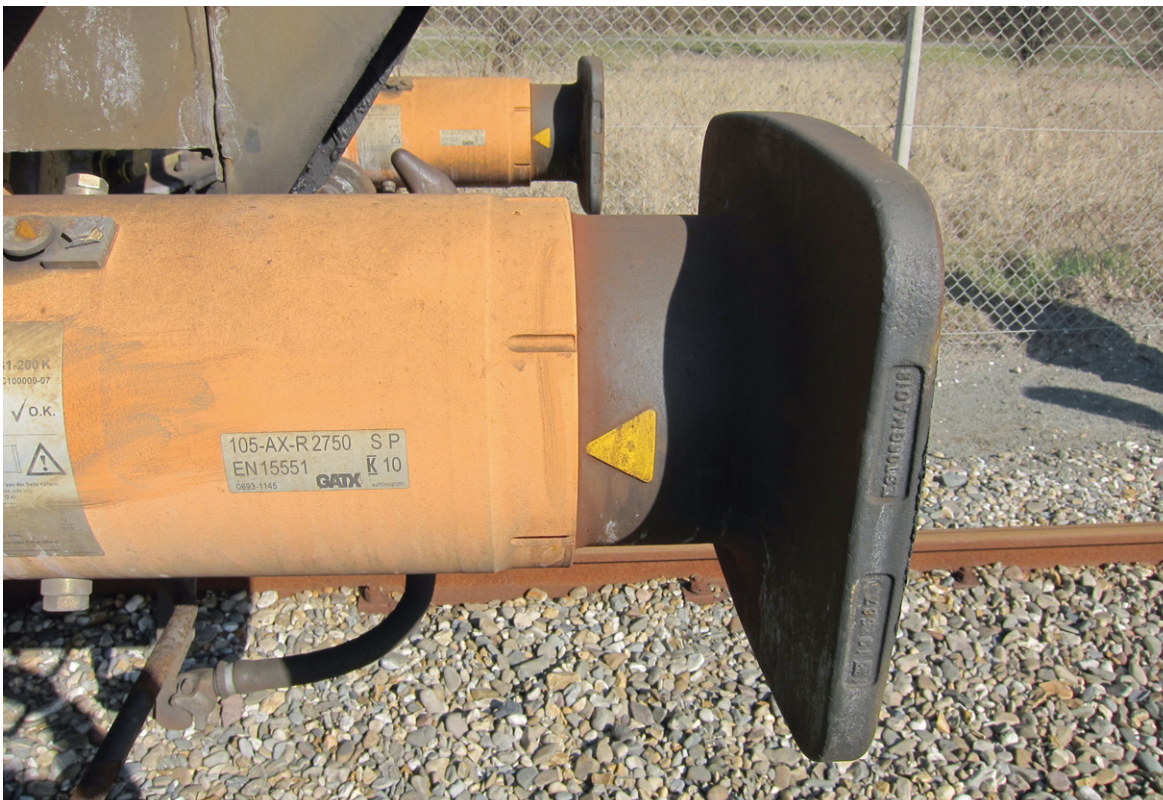
Figure 30: The crash buffers on the side of the tank wagon not run into showed no permanent deformation. (Photo: Dutch Safety Board)

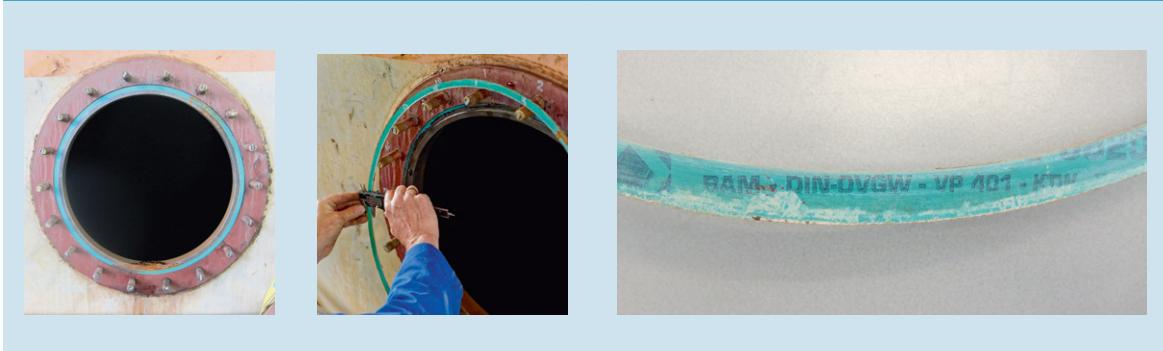
Figure 32: These photographs show the gasket. On the left-hand photograph the (green) gasket is still in the intended flange groove. On the right-hand photograph we see the markings. (Photos: Dutch Safety Board)

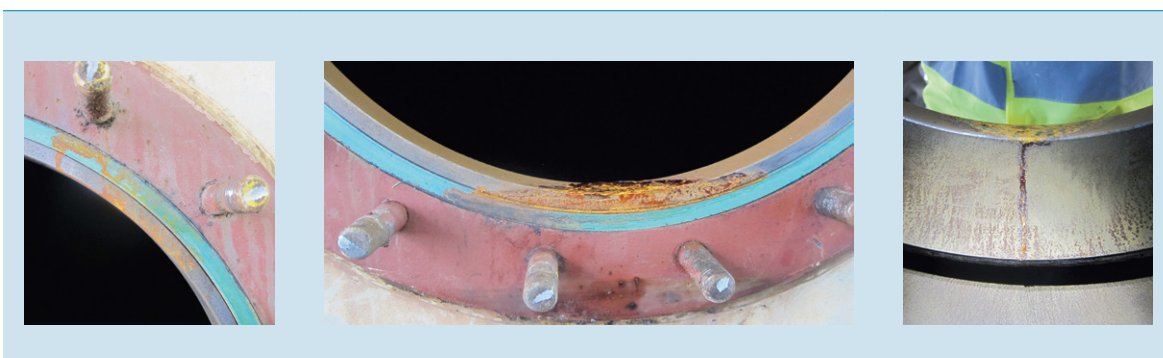
Figure 33: These photographs show the rust-coloured leak tracks, which became visible following removal of the manhole cover. The left-hand photograph and middle photograph show the outside of the flange (including gasket) while the right-hand photograph shows the inside (Photos: Dutch Safety Board)

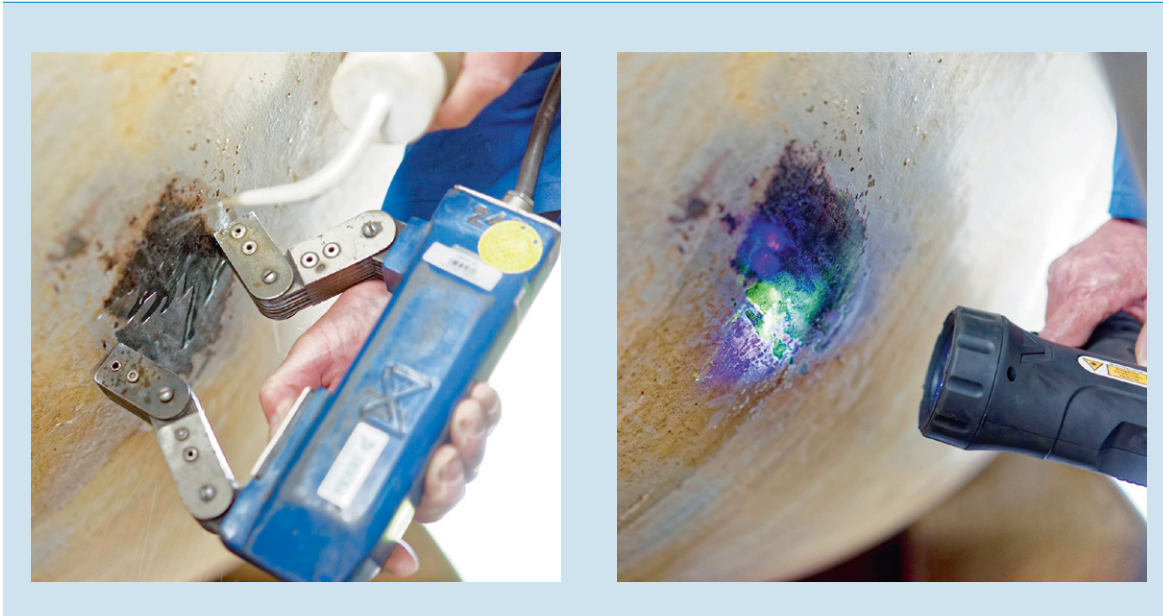
Figure 34: These photographs show the magnetic crack investigation, which was carried out at two locations on the rear wall of the tank. (Photos: Dutch Safety Board)

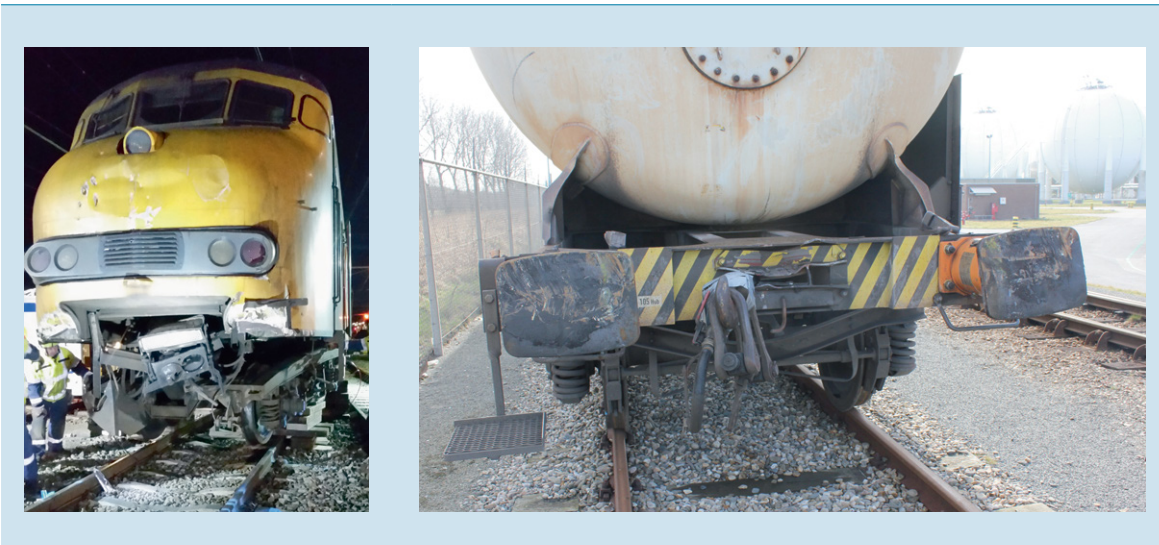
Figure 36: These photographs show the damage caused by the collision on the front of the passenger train (left) and the back of the tank wagon (right). On the front of the passenger train we see the impressions of the buffers and the manhole cover of the tank wagon; on the top section of the buffers of the tank wagon, we see an impression of the passenger train. (Photos: left = fire brigade, right = Dutch Safety Board)

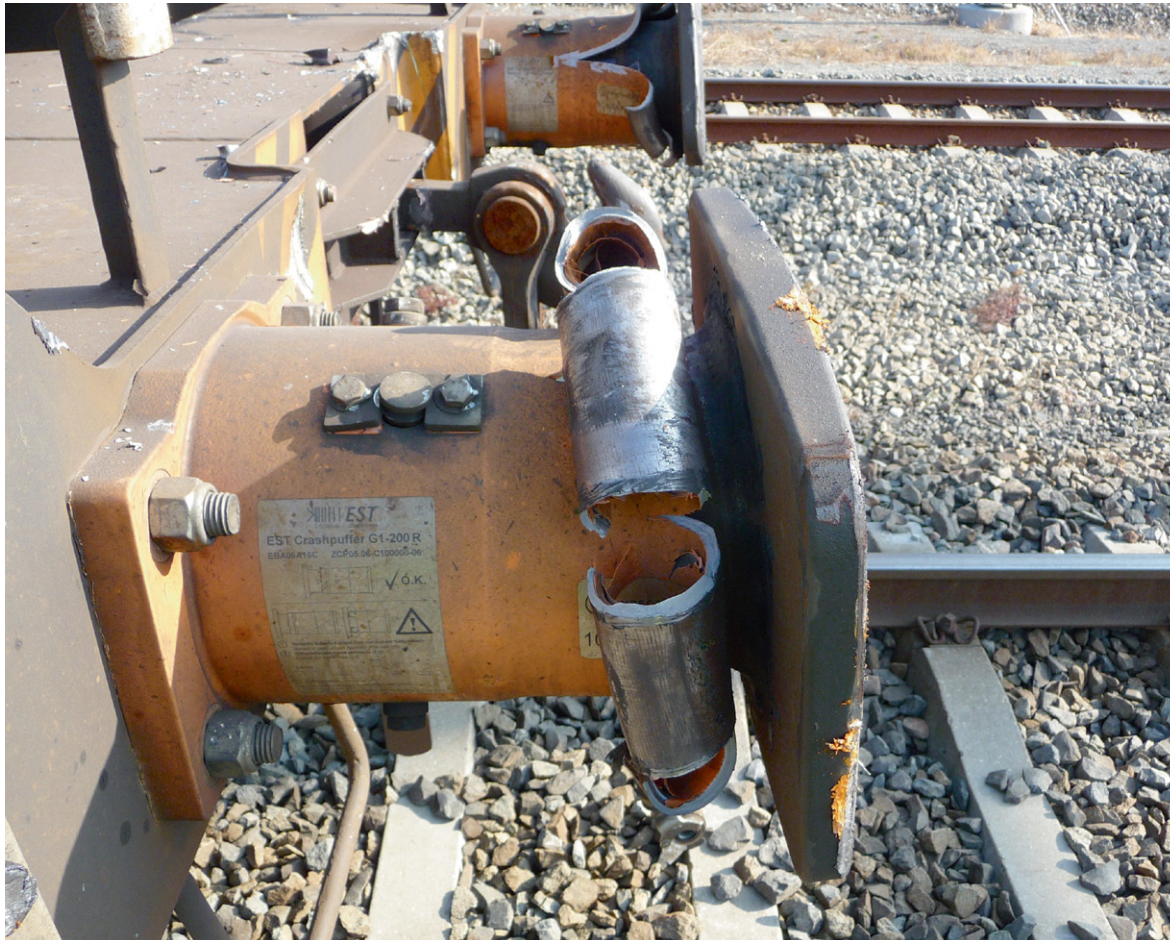
Figure 44: This photograph shows crash buffers with external absorption elements (the orange tubes) which as a result of a collision have torn and curled up, thereby absorbing energy. (Photo: Dutch Safety Board)

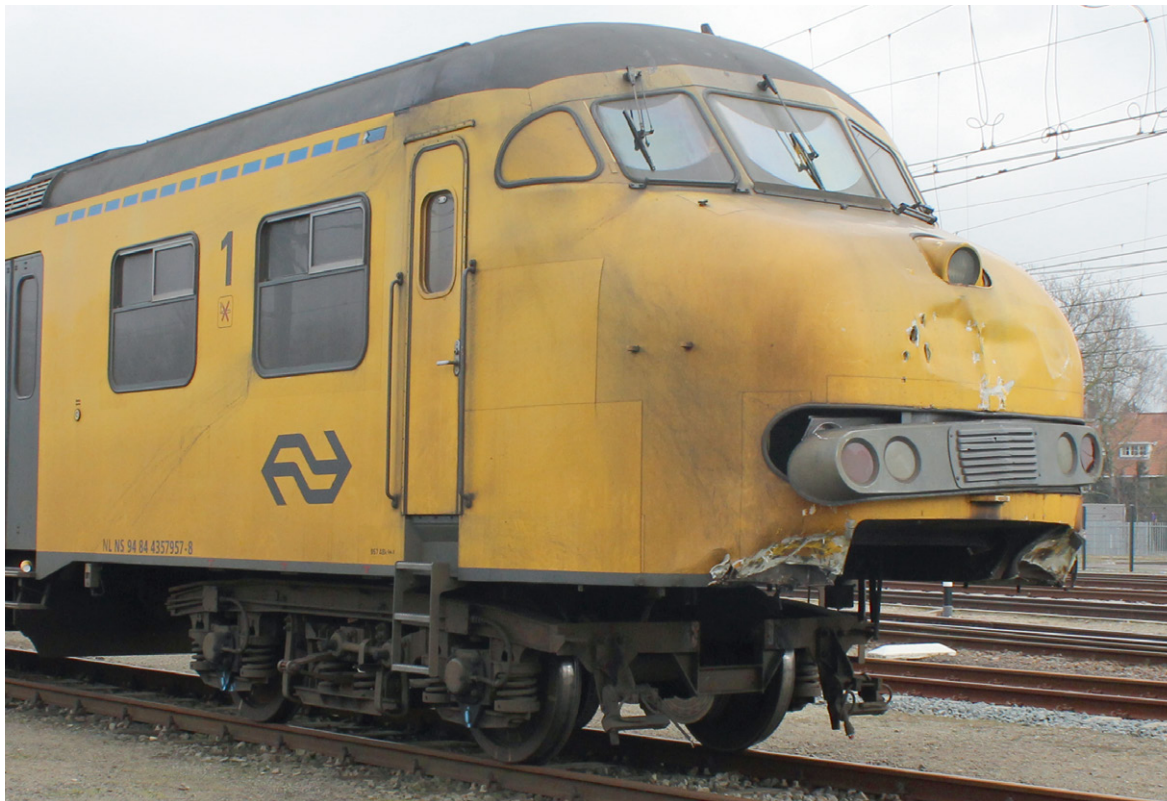
Figure 47: This photograph shows the damage to the front of the passenger train (Mat'64) involved in the accident in Tilburg. When the photograph was taken, the automatic coupler, which was seriously deformed, had already been removed. (Photo: police)
