Quarterly Aviation Report

October - December 2023

Q4 2023

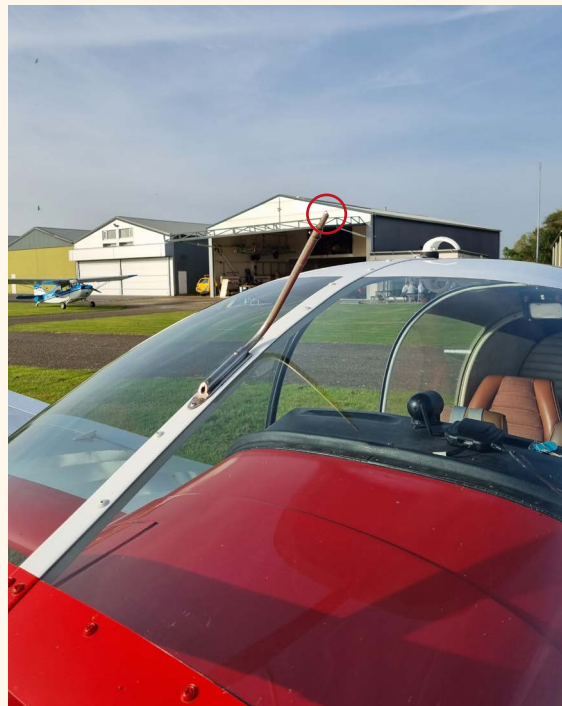
At the entry point of the aerodrome traffic circuit of Midden Zeeland Airport, the Cessna passed the Robin overhead at a close distance. After landing, the Robin's rear-view mirror appeared to have disappeared.

- ▶ The Robin with missing rear view mirror (circled in red).
(Source: Dutch Aviation Police)

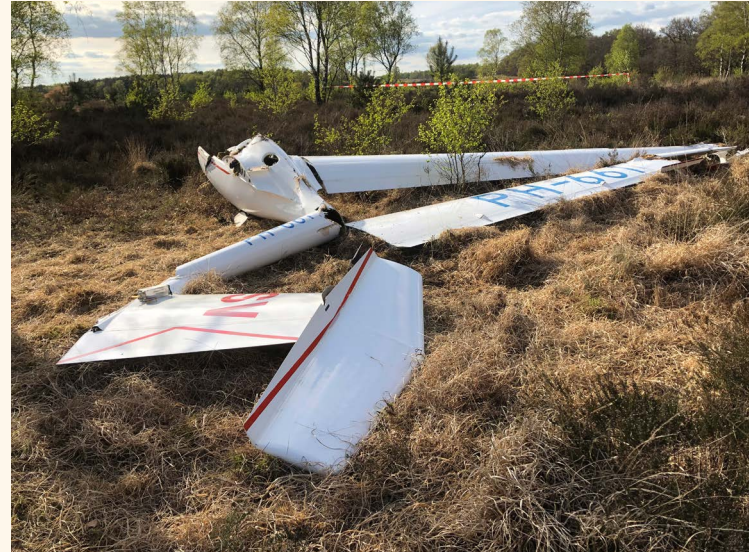
The Dutch Safety Board conducted an investigation at the scene of the accident. The left wing was found detached from the aircraft, the fuselage broken in two places, the nose broken off and the cockpit destroyed. The canopy and the horizontal stabiliser were found detached and intact. Investigation has further shown that the lever for operating the flaperons⁷ was in the landing position (+ 16°). The right flaperon's L'Hotellier connector was found separated, fitted with locking wire. The right airbrake's L'Hotellier connector was found attached, without locking wire. The L'Hotellier connectors of the flaperon and airbrake of the detached left wing were fitted with locking wire and were found separated. The ball that broke off from the steering mechanism in the fuselage (to which the rod is connected with a L'Hotellier connector) was found in the sleeve at the end of the rod connected with the left flaperon. This indicates that the L'Hotellier connector of the left flaperon was attached.

▲ The crashed aircraft (after it had been turned over during rescue operations).

A closer inspection of the glider wreckage did not show any defects that could have played a role in the occurrence of the accident. It was not possible to determine with certainty whether the right flaperon's L'Hotellier connector was already loose before the start of the flight. The weight and centre of gravity of the glider were within the specified limits.

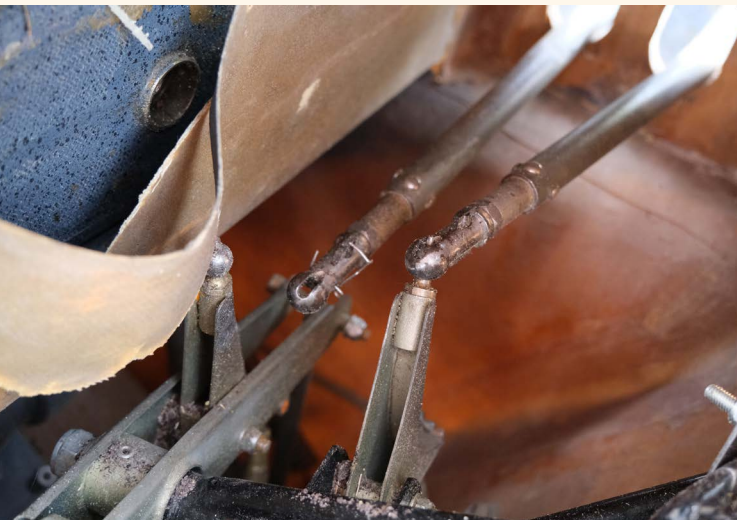
▲ The L'Hotellier connectors found on the right flaperon (separated) and the right airbrake (attached).

a club member during the daily inspection of the PIK-20. It is recommended that this inspection, which includes checking whether the flaperons are correctly connected and secured, is carried out by someone who was not involved in the assembly of the aircraft. The chance that control surfaces are not, or not correctly, connected without this being observed is thus kept to a minimum. The same applies to the securing of control connections.

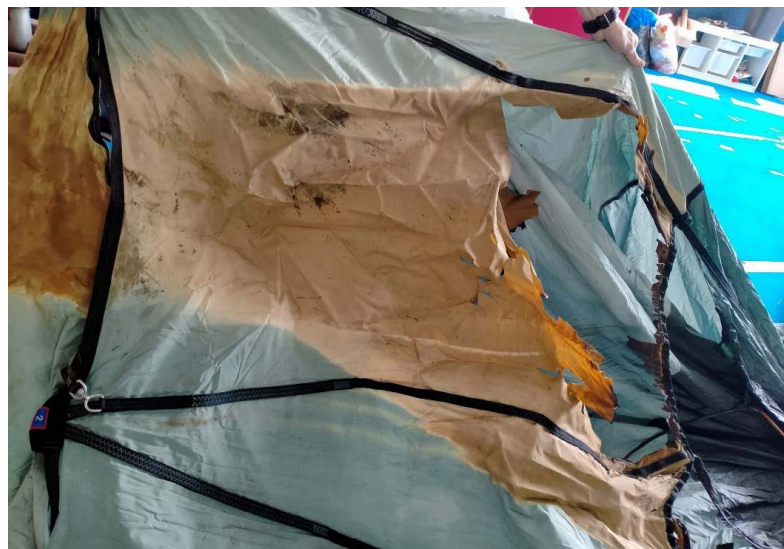
▲ Some burnt panels of the Cameron Balloons Ltd. Z-90.
(Source: student balloonist)

remark as an instruction and deviated from his original plan and immediately continued the descent to land. The student's rapid ripping resulted in a fast descent and upon first contact with the ground, the basket tipped over. The instructor stated that he saw no possibility to correct, as the balloon was low, at a height of about 2 metres. The basket dragged through the meadow and landed in barbed wire and a ditch. In response, an attempt was made to ascend by turning on the burner.¹⁴ However, the balloon had already lost a lot of air due to the rapid ripping during the descent, causing the balloon's "mouth" to close. Therefore, the flame burned directly on the fabric. As a result, some panels and parts of the load tapes¹⁵ got burnt. No one was injured. After the occurrence, the instructor and the student closed the gas bottles and degassed the burners. The balloon was not airworthy anymore after the occurrence.

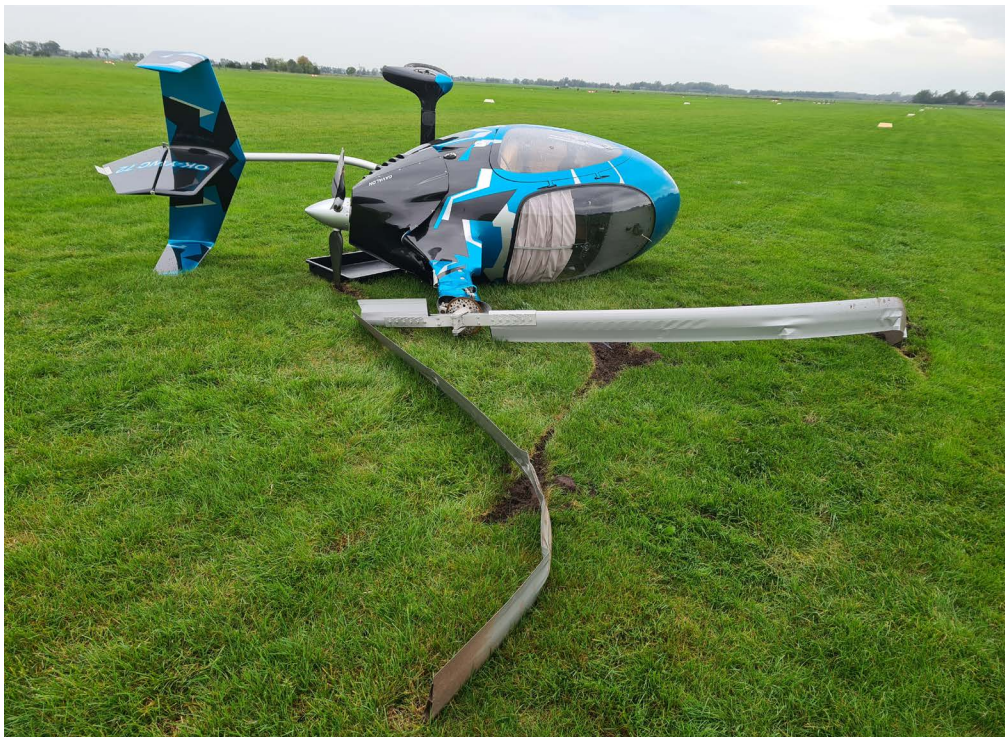
- ◀ The overturned gyroplane. (Source: Dutch Aviation Police)

approach went without any problems. At the end of the landing roll, just before he wanted to move the control stick fully forward to level-off the rotor, a wind gust tipped the gyrocopter to the right which then overturned. It suffered severe damage. Both occupants were unharmed. The pilot stated that he should have moved the rotor into the wind earlier, even though the landing had not yet been completed.
