DUTCH
SAFETY BOARD

Shipping Occurrences Report

July - December 2023

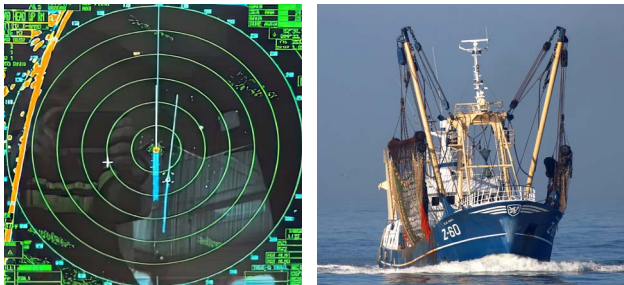
The cause of the collision between the Belgian trawler Z60 Blue Angel and the Dutch cargo ship Amadeus Aquamarijn in the traffic separation scheme above the Wadden Sea on 23 December 2021 was that the mate of the Z60 Blue Angel failed to see the Amadeus Aquamarijn and therefore did not divert.

The visibility of the Amadeus Aquamarijn was reduced by a combination of disrupted night vision, the low position of the Amadeus Aquamarijn in the water and the fact that both the trim and the masts of the Z60 Blue Angel partially obscured visibility looking forward. It is conceivable that the Amadeus Aquamarijn was visible on systems such as radar and the AIS overlay on the chart plotter during the mate's shift on the Z60 Blue Angel. It appears that fatigue and the fact that the CPA alarm was not switched on were the reasons that the mate did not see the Amadeus Aquamarijn. The mate of the Amadeus Aquamarijn alerted the Z60 Blue Angel based on his own observations, but did not receive a response. He did not subsequently check whether the Z60 Blue Angel adjusted its course.

▼ *Figure 7 Radar image port side Z60. (Source: Maritime Police)*

Several factors led to the collision. The Dutch Safety Board calls on ship owners and maritime training institutes to address reduced alertness due to fatigue. It is also important that the crew of fishing boats remember to switch navigation and warning equipment back on after fishing. The CPA alarm goes off repeatedly while fishing. Because this can be considered bothersome, crew members switch off the alarm while fishing. Furthermore, the shipping industry should pay more attention to practicing non-standard situations. They can do this using a simulator, for instance.

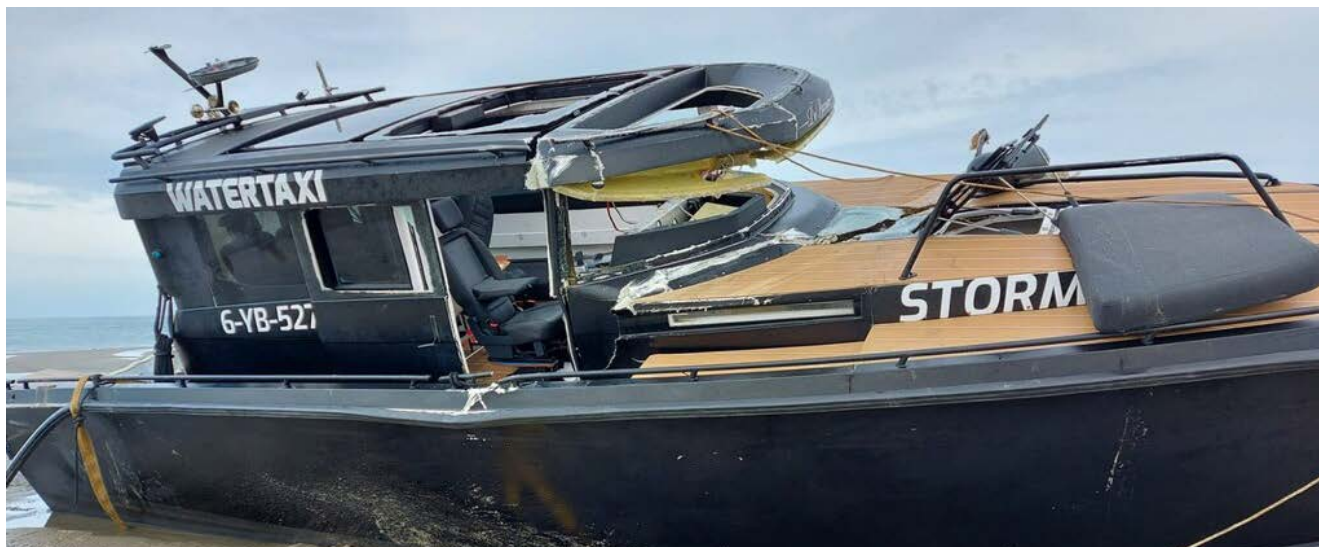
On 21 October 2022, the water taxi Stormloper and the express boat Tiger (a fast ferry) collided off the Schuitengat near Terschelling. Four people were injured, three people died and one person went missing. The Dutch Safety Board's investigation revealed that the water taxi and ferry involved were both travelling too fast, communicated unclearly with each other and did not adhere to the prevailing sailing rules. This investigation shows that the safety on the Wadden Sea can be improved, particularly in terms of sailing behaviour and legislation and regulations. Islanders and other passengers depend on the transport between the islands and the mainland and must be able to rely on the fact that this is done safely. The competent authority and the entrepreneurs have a joint responsibility to ensure this. All parties involved encounter each other in this area. The actions that have already been initiated and the recommendations of this report can facilitate increased safety and this will be strengthened if the parties give concrete form and content to this together.

▼ *Figure 11 The water taxi after the collision. (Source: maritime police)*

The accident left a lasting impression on all parties concerned. The Dutch Safety Board therefore recommends that the existing community spirit be used and strengthened to increase the safety of shipping traffic on the Wadden Sea. The parties involved can use each other's expertise and jointly develop activities such as practicing scenarios, simulator training and training activities on the Wadden Sea. The shipping operator and water taxi company involved have since indicated that various improvement actions have been initiated. The Dutch Safety Board also recommended that the Minister of Infrastructure and Water Management set clearly defined rules with respect to commercial transport carrying 12 or fewer passengers and to adapt the legislation and regulations on enforcement.

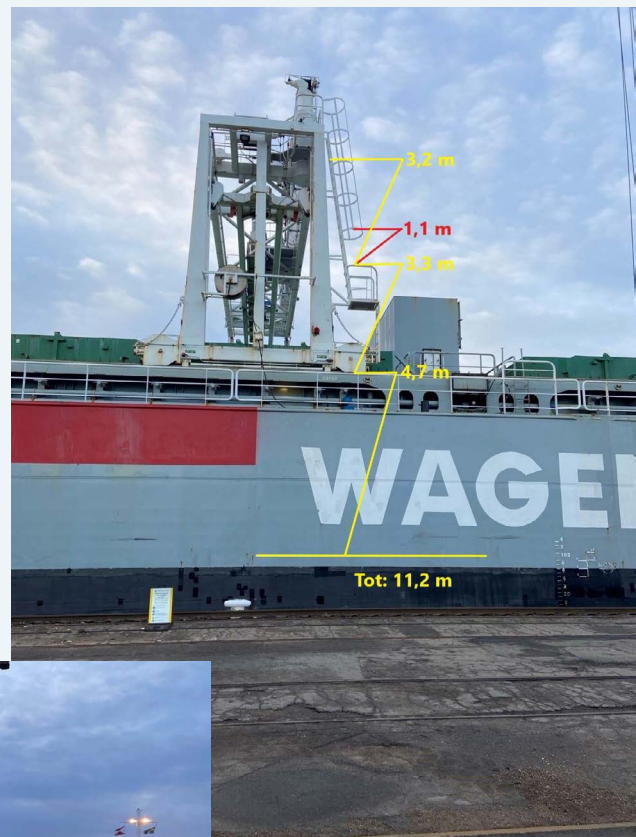
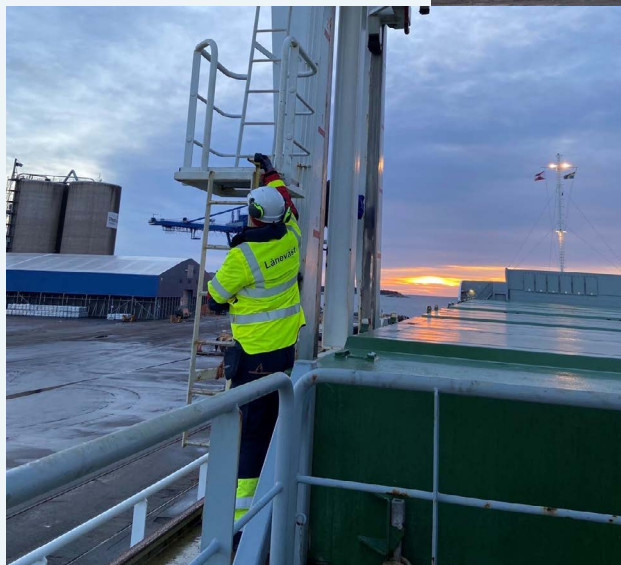
▼ Figure 13a and 13b location of Roerborg accident.
(Source: Swedish Accident Investigation Authority)

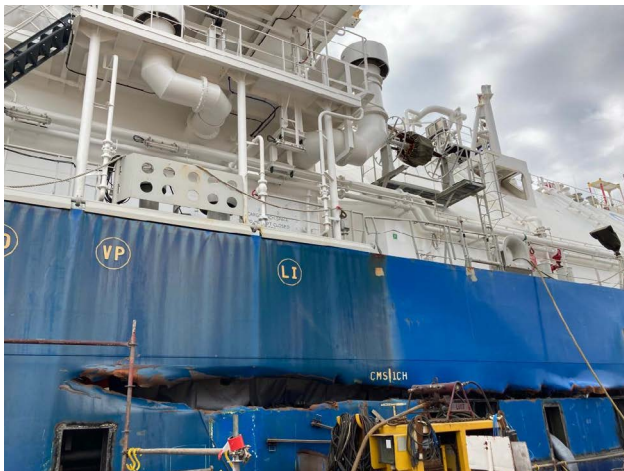
▼ *Figure 15 Damage Kairos.*

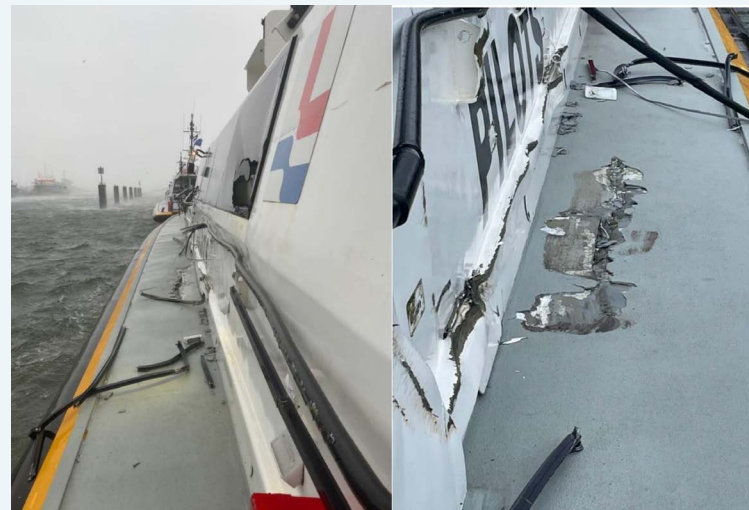
The Dutch pilot tender Lacerta was transferring a pilot sailing with the LNG bunkering tanker Kairos (see previous incident). The manoeuvre to transfer the pilot was interrupted as the Kairos lost control due to strong winds and there was a potential threat of a collision. The evasive manoeuvre was to no avail and the subsequent collision seriously damaged the Lacerta. No one was injured.

▼ *Figure 16 Damage Lacerta. (Source: Loodswezen)*

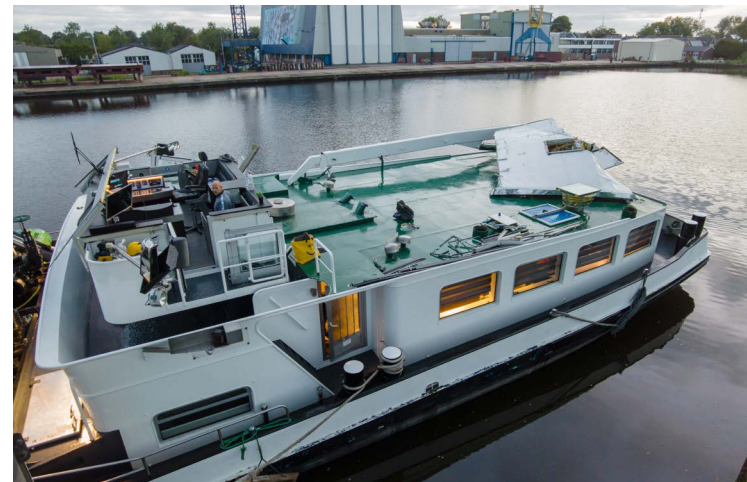
On Thursday 17 August, at around 02.30 hours, MTS Marlou, loaded with rapeseed oil, collided with Stroobos bridge. The inland tanker collided with the closed swing bridge, causing the roof of the wheelhouse to be torn off and to land at the back of the deck. The dinghy landed in the water. The collision did not cause any injuries or spillage. The skipper stated that he thought he could pass under the bridge, which in retrospect was an error of judgement.

▼ *Figure 17 Damage to wheelhouse after bridge collision.*
(Source: Camjomedia)

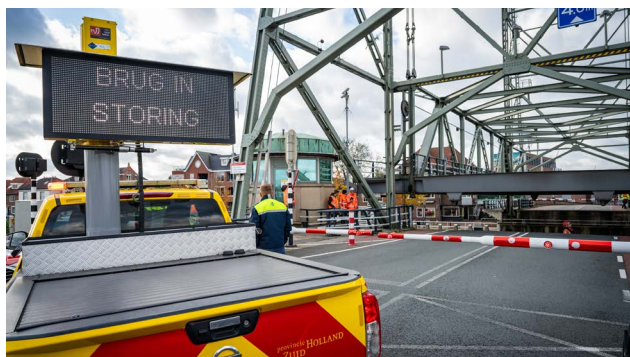
On Tuesday morning 7 November, the inland cargo ship Sophia collided with the lift bridge over the Gouwe at Waddinxveen. The bridge was damaged and traffic over and under the bridge was blocked. Traffic over the bridge could be resumed from Wednesday. Shipping was temporarily blocked during repair work. According to the skipper, the bridge opened too slowly and he was unable to stop in time.

▼ *Figure 18 Bridge near Waddinxveen. (Source: ANP)*

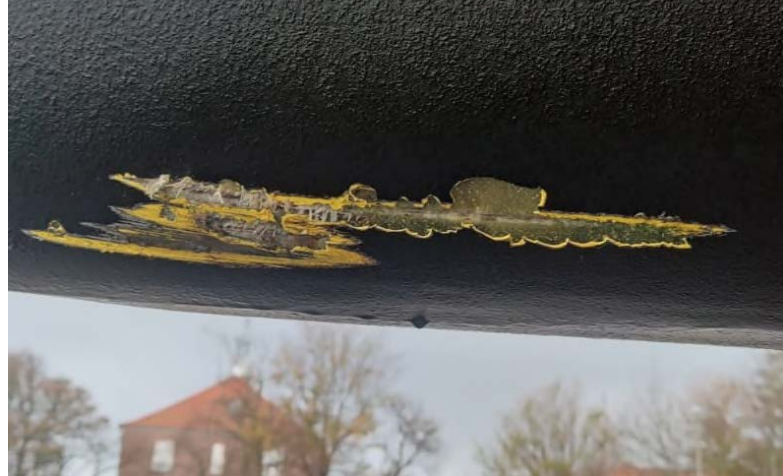
▲ *Figure 19 Damage to the hull. (Source: Sima Charters)*

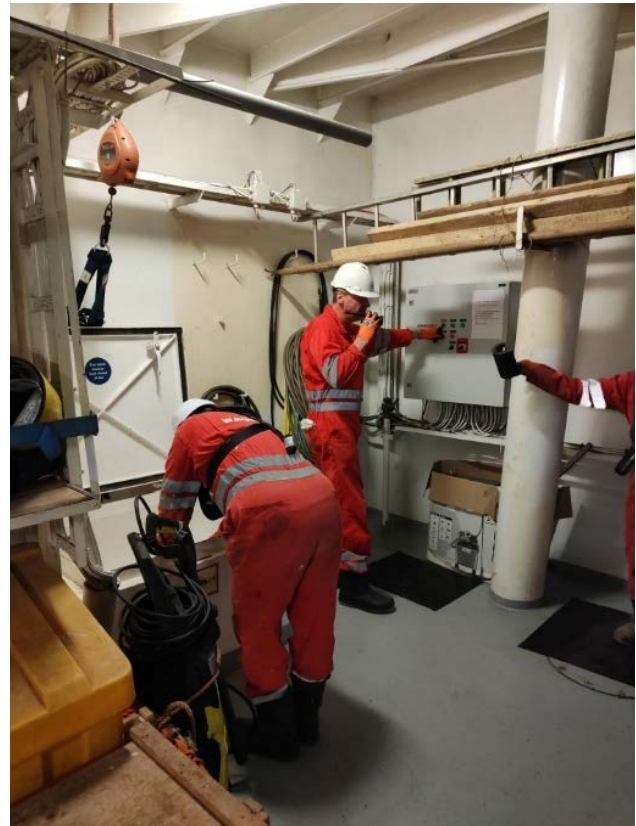
At 12.30 hours local time on 14 July 2023, the high level bilge alarm sounded in the bow thruster room. In response, the crew decided to carry out an inspection. The chief engineer and the third engineer opened the hatch to the bow thruster room at 13.00 hours. The hatch was not properly secured (due to the lack of a proper locking system) and a wave caused the hatch to fall on the third engineer's arm. His arm broke as a result. He remained on board for another day until the ship reached the Kieler Channel. He disembarked here and the fracture was diagnosed, preventing him from continuing his work.

▼ *Figure 20 Location of accident Geulborg. (Source: Wagenborg)*

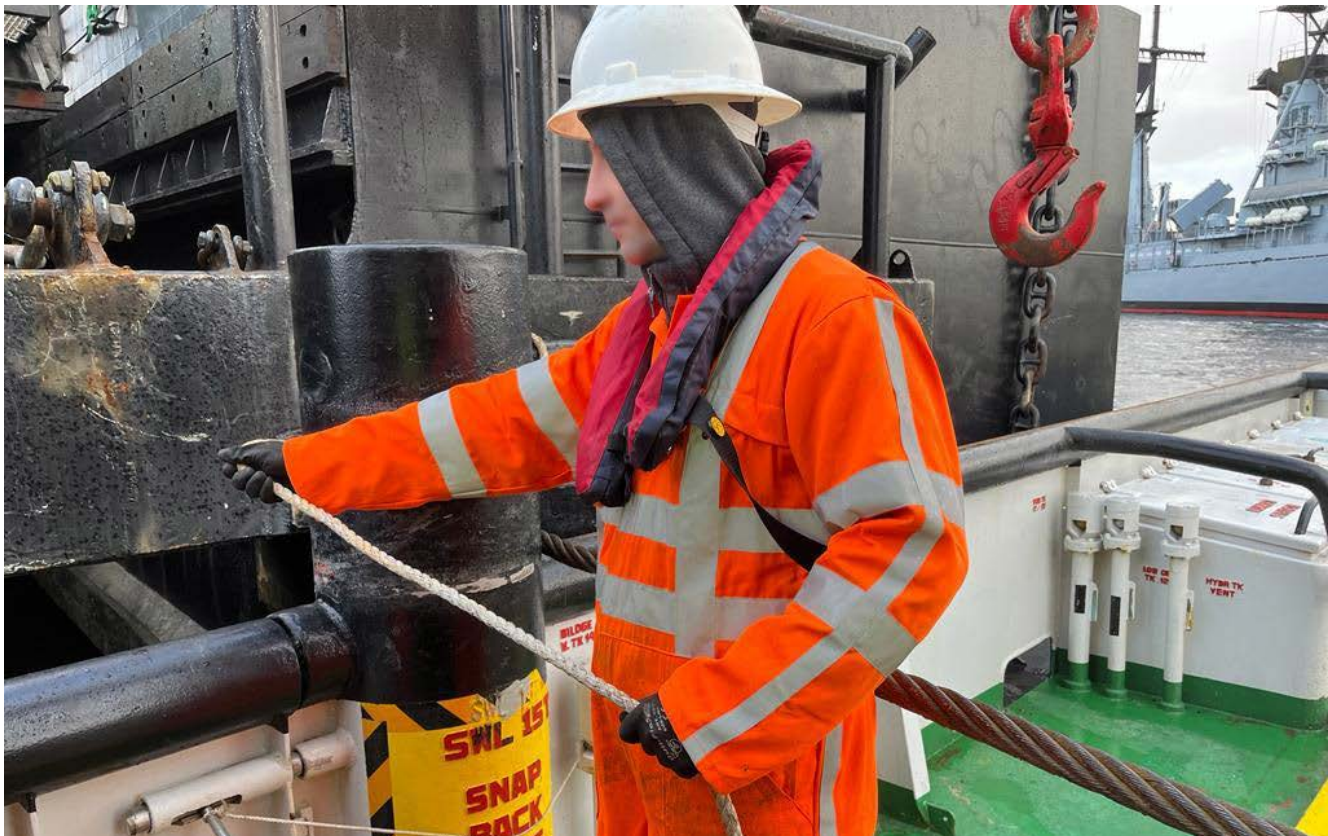
the yoke slid into the water and the tow rope came under tension. The deckhand was standing with his back towards the towline and did not see that he was standing too close. The tensioning of the tow rope caused the wire to hit the deckhand, who consequently made a move and tripped over a wooden support block. In the process, he broke his leg.

▼ *Figure 21 Location of deckhand on board the Wil S.*
(Source: GSS marine services)

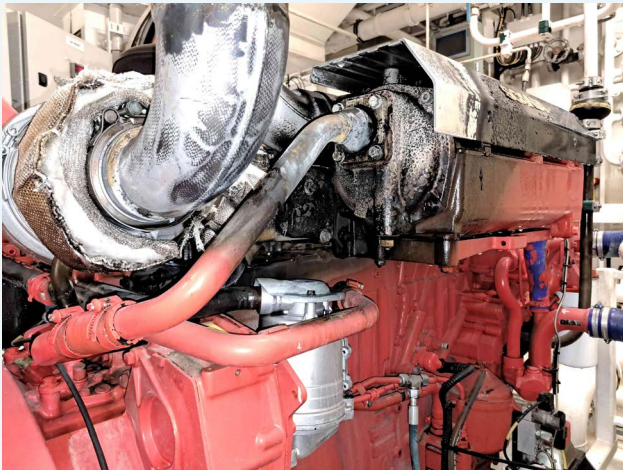
A fire started in the turbo of the auxiliary engine as the ship approached the lock in Goole at around 19.30 hours local time. The fire was extinguished by the crew, with the assistance of the fire brigade. Damage was limited to the auxiliary engine. As the auxiliary engine no longer worked, the vessel's bow thruster also no longer worked and it had to be towed to the unloading quay by a tugboat. The ship was granted permission by the classification society to proceed to its next port for repairs to the auxiliary engine.

▼ *Figure 22 Fire in the auxiliary engine. (Source: Wijnne Barends)*

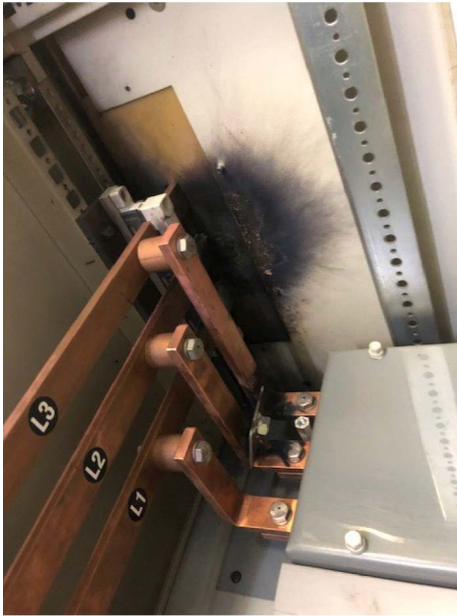
▲ Figure 23 Fire in Switch panel. (Source: MV Jade)

The Dutch cargo ship Jade suffered a short circuit in the switch panel at around 04.30 hours local time on 20 October. This caused a small fire.

After a blackout occurred at around 04.30 hours, the maritime officer went to the engine room to restore power. He noticed that smoke was coming out of the switch panel, and upon opening the panel, flames were visible. The fire alarm was activated and the fire in the switch panel was extinguished with CO₂. Another blackout occurred when the engine was restarted. When the busbar cover was opened it was observed that a mounting plate had been welded between two conductors, which probably caused the short

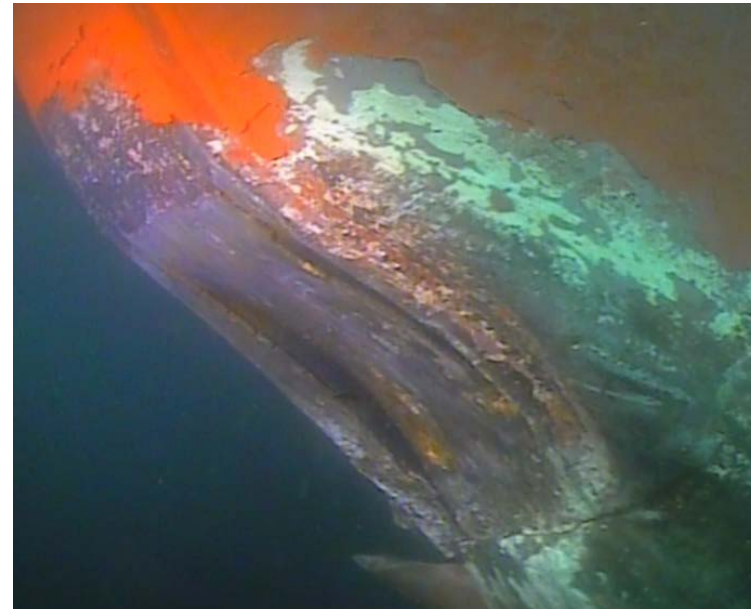
▼ *Figure 24 Damage to the keel. (Source: Swan Expeditions)*

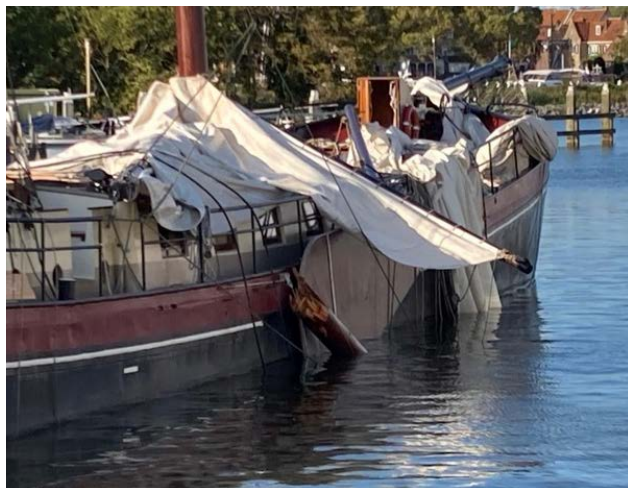
▼ *Figure 26 Broken Mast Eenhoorn.*

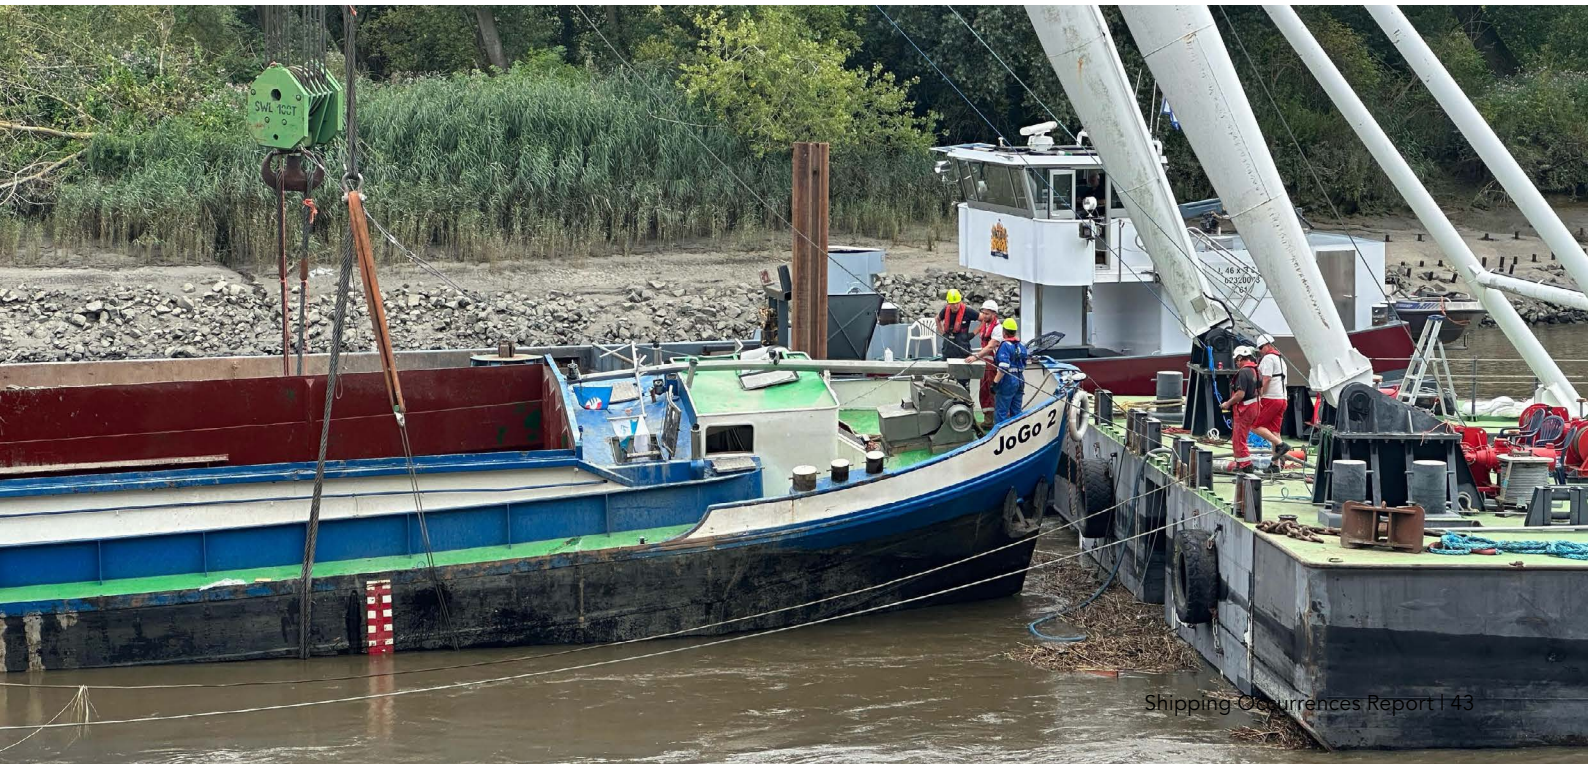
▼ Figure 27 Salvage of the vessel *JoGo 2*. (Source: ANP)
