Crashed, Blackshape S.p.A. BS 115, Zwarte Meer, 28 June 2022

Aviation Investigation Preliminary Report

General Information	
Date & Time:	28 June 2022, approx. 09.04 UTC
Location:	Zwarte Meer, near Genemuiden, NL
Aircraft:	Blackshape BS 115, model BK 160
Registration:	PH-TRC
Classification:	Accident
Injuries:	Fatal (2)
Aircraft damage:	Destroyed
DSB reference:	2022077

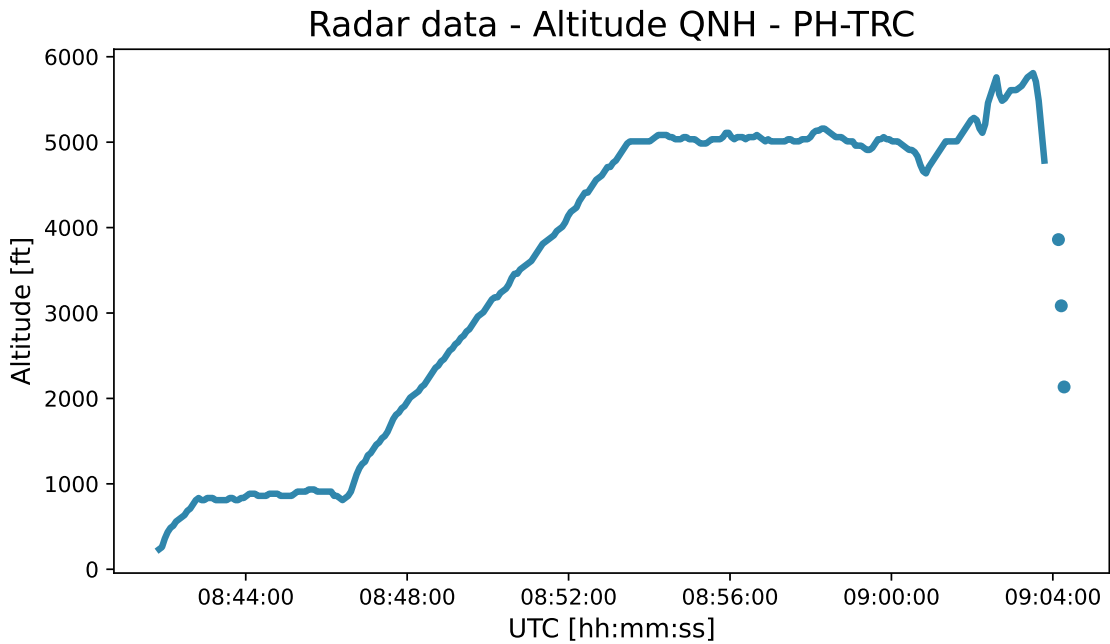
Maintaining a north-easterly course at approximately 4,900 feet, the aircraft executed a left 180° turn above Hasselt, followed by a right turn towards a north-westerly direction. The aircraft climbed to around 5,500 feet. At 09.03 hrs, a 180-degree descending right turn was initiated, descending from 5,800 feet to 5,200 feet. At 09.04 hrs, the EDM ceased recording data from the on board Garmin GTN650 system. Radar contact was lost shortly after. The last few radar readings indicate a descent to 2,130 feet.⁵

▲ Figure 2: Altitude of the aircraft, expressed in feet above sea level. (Source: radar data LVNL)
