DUTCH  
SAFETY BOARD

# Oven overheat in aft galley

*The Hague, June 2024*

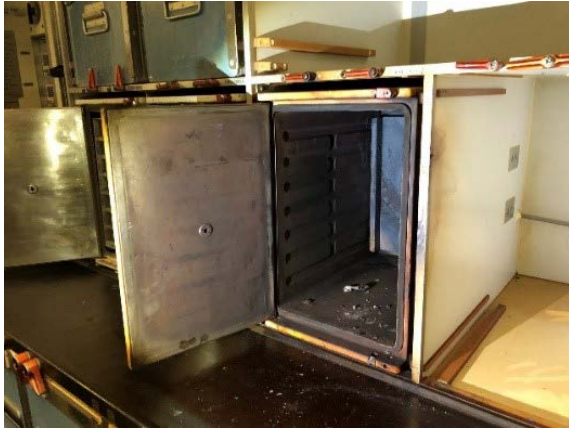
The oven suffered overheat damage, consisting of a melted aluminium fan and damage of the entire inner side. During the incident, the insert of the oven together with its trays was removed and placed on the galley floor. The galley floor sustained heat damage from the hot insert through melting of the contact surface.

◀ Figure 2: The failed oven.

Molten aluminium parts of the fan were found on the bottom of the oven and on the back wall near the heating elements. The complete inside of the oven was covered with a brownish substance. Also, the outside walls of the oven were covered with a brownish substance. The inside parts of the oven sustained severe heat damage, especially near the heating elements as well as the power control board on the back of the oven.

Despite the fact that the oven faced an overheat situation and smoke was emitted, there were no signs of an oven component related fire. The outer metal covering for the oven showed no signs of heat damage.

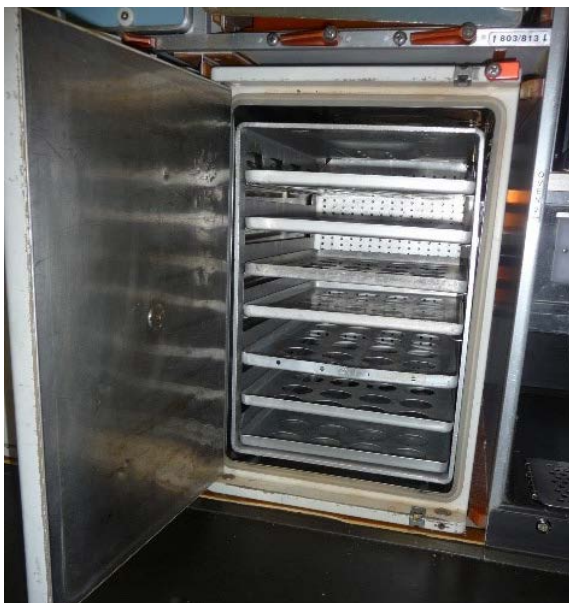
The meal tray carrier mostly had a closed perforated backside (see Figure 3, left). As a result, the heating time of the oven was significantly extended because of the disturbed airflow of the fan and heating elements. Confirmed by previous investigations of the manufacturer, this increased the temperature of the area behind the baffle plate as the closed backside reduced the heat distribution to the meals inside the carrier.

▲ Figure 3: Left, carrier with meal trays and mostly closed perforated backside in oven.

The use of an aftermarket meal tray carrier with a mostly closed perforated backside had a negative effect on the reliability of the oven, as well as placing the oven at a higher risk for an overheat condition.

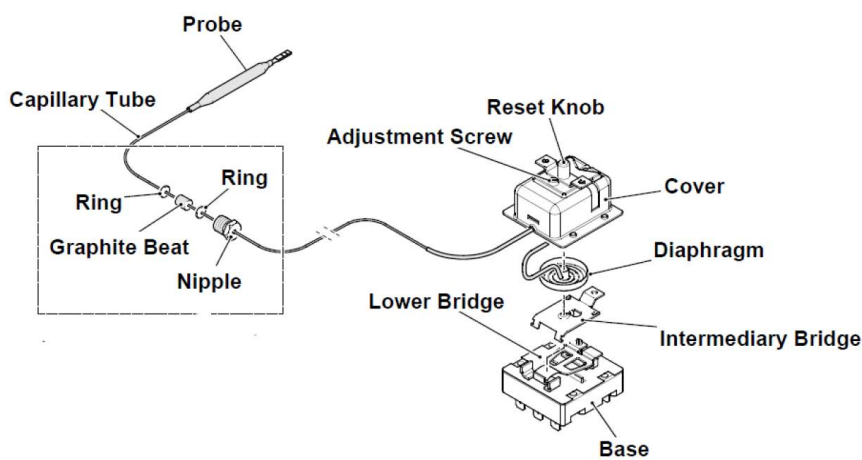
Some time prior to this event, the 3-phase safety device's capillary tube was damaged by the heating element. This is evident from the fact that the ends of the line are fused, the damage to the surface of the heating elements, and the observation that the 3-phase safety device activation indicator did not show the device had been triggered by the overheat event.

▲ Figure 4: 3-Phase Safety Device Exploded View. (Source: B/E Aerospace)

A SIL for the 3-phase safety device, concerning a recommended maintenance program, was issued on 2 December 2013 and amended on 20 April 2022. This SIL with number H0212-25-0164 recommends that the 3-phase safety device is checked every 18-24 months or 6,000-8,000 flight hours whichever comes first and every 36-42 months or 12,000-14,000 flight hours whichever comes first. It also recommends to replace the 3-phase safety device every five years for all units that have not incorporated SB 2000-25-0001.

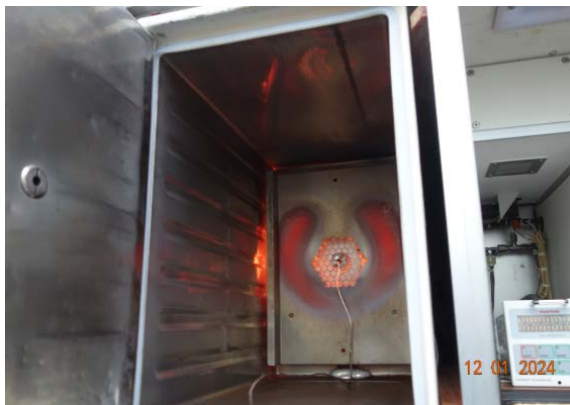
In Houten, during the testing of the oven in an overheat condition, the same damage to the oven as the incident oven could be reproduced. During this test, the failure of the heating elements happened approximately 20 minutes after continued electrical powering.

◀ Figure 6: The inside of the test oven at maximum temperature. (Source: B/E Aerospace)

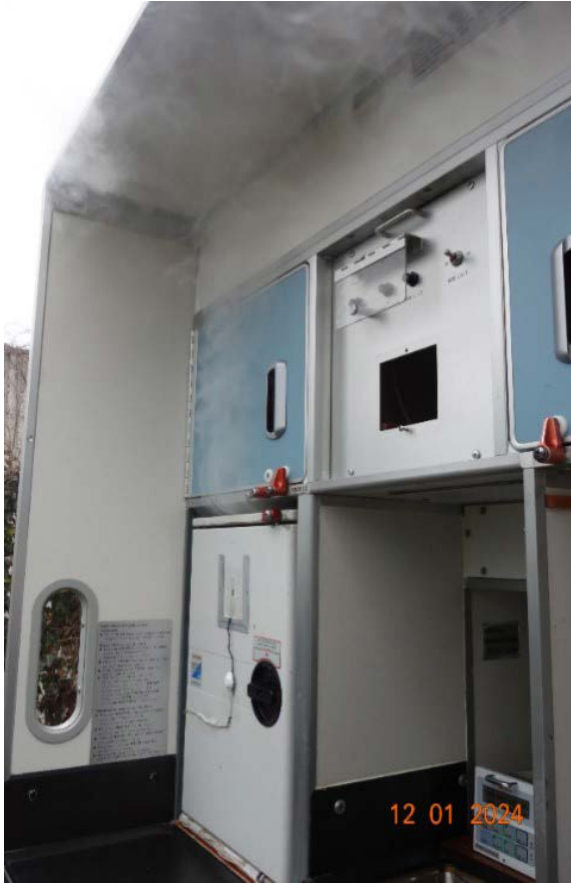
◀ Figure 7: Smoke coming from the oven in the test setup.  
(Source: B/E Aerospace)
