Crashed, Blackshape S.p.A. BS 115, Zwarte Meer, 28 June 2022

Aviation Investigation Preliminary Report

| General Information | |
|---|---|
| Aircraft: | Blackshape BS 115, model BK 160 |
| DSB reference: | 2022077 |

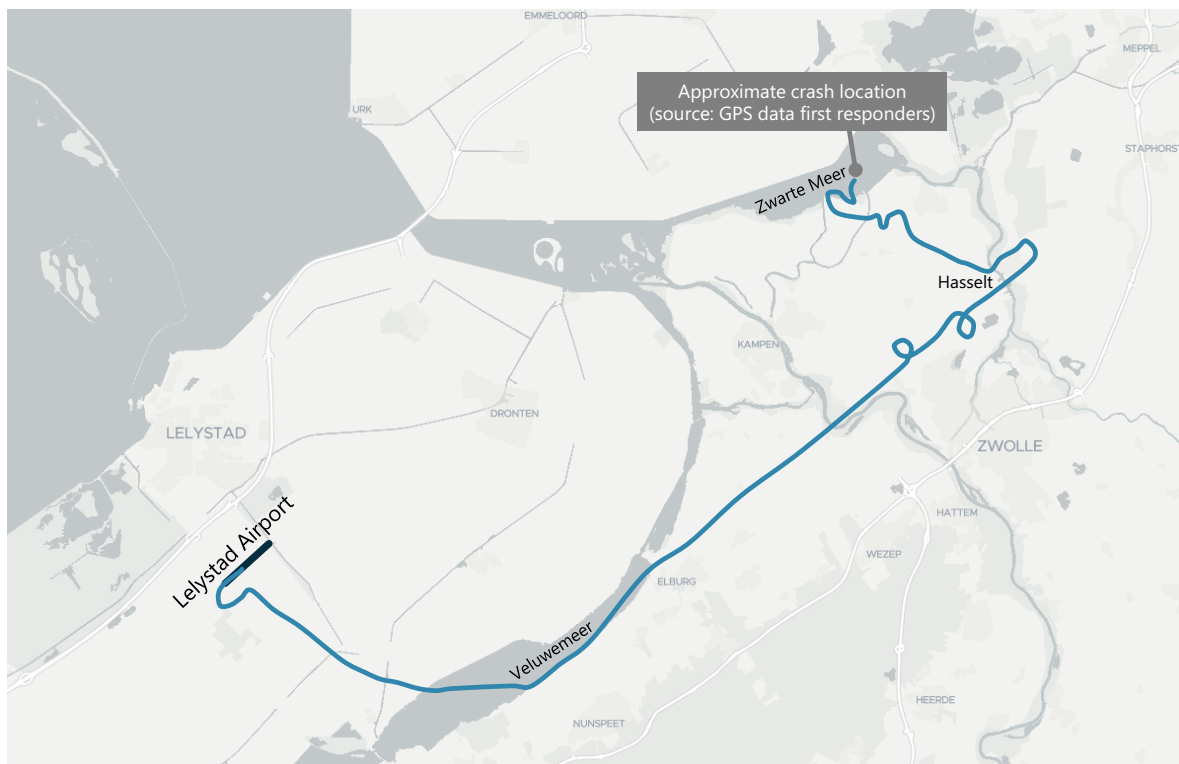
The flight path was reconstructed using radar data and on board Engine Data Monitoring (EDM) system data.³ According to the data, after passing reporting point Bravo, the aircraft flew in a north-easterly direction. North-west of Zwolle, at 08.56 hrs, the aircraft made a left 360° turn at an altitude of approximately 5,000 feet⁴, followed by a right 360° turn.

Maintaining a north-easterly course at approximately 4,900 feet, the aircraft executed a left 180° turn above Hasselt, followed by a right turn towards a north-westerly direction. The aircraft climbed to around 5,500 feet. At 09.03 hrs, a 180-degree descending right turn was initiated, descending from 5,800 feet to 5,200 feet. At 09.04 hrs, the EDM ceased recording data from the on board Garmin GTN650 system. Radar contact was lost shortly after. The last few radar readings indicate a descent to 2,130 feet.⁵

▲ Figure 1: The flight of the aircraft and crash site in the Zwarte Meer. (Source: radar data LVNL)

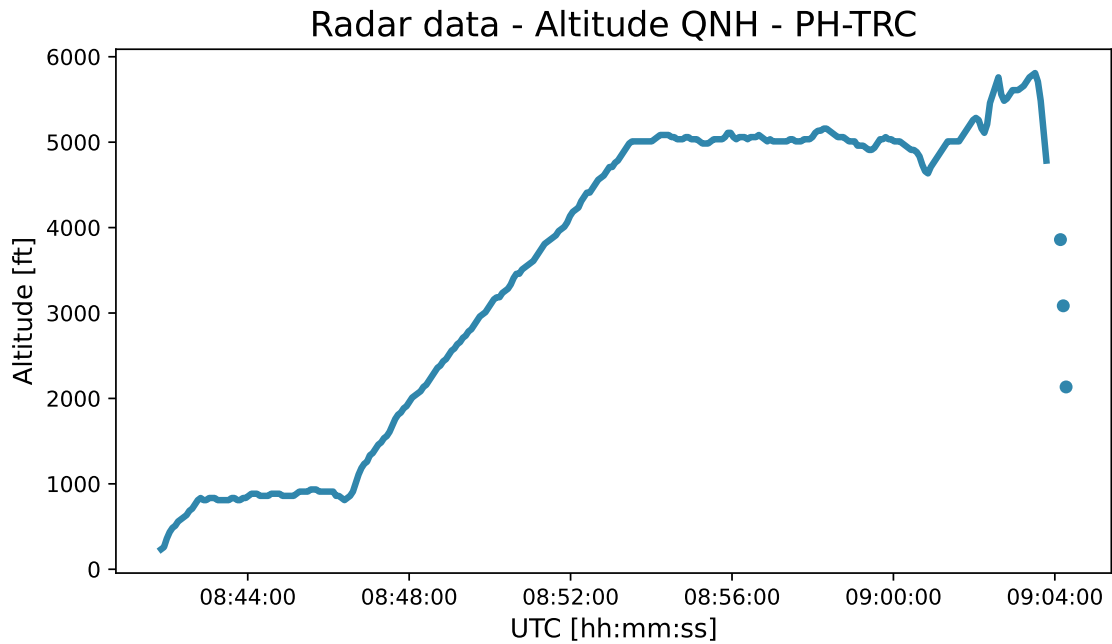
▲ Figure 2: Altitude of the aircraft, expressed in feet above sea level. (Source: radar data LVNL)

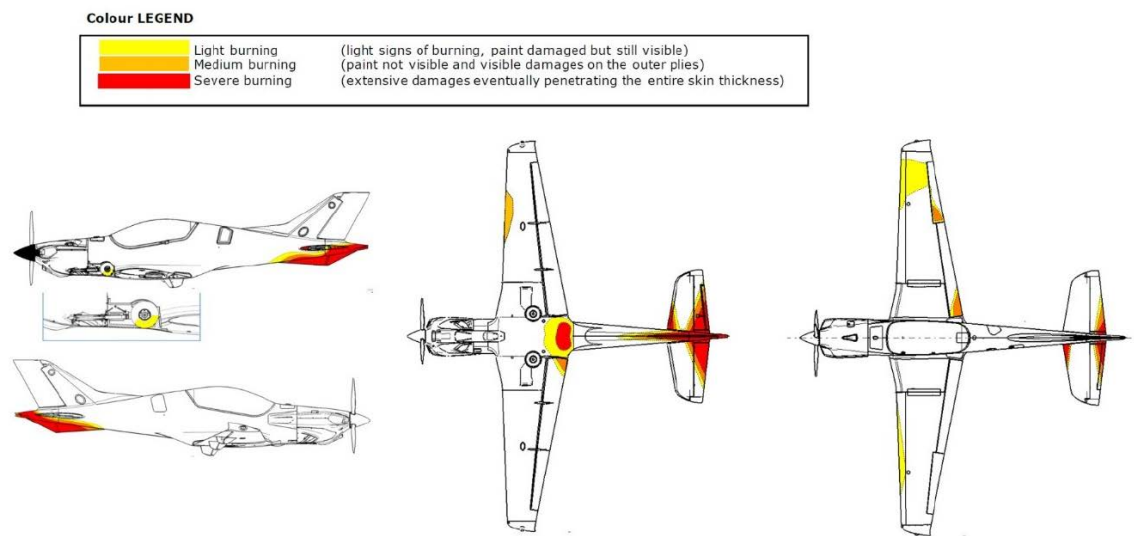
Examination of the wreckage by Dutch Safety Board investigators revealed burn marks, predominantly on the exterior surfaces, see Figure 3.⁶ Notable areas affected include the nose wheel, the upper side of the right wing flap and aileron, and the lower side of the left wing's leading edge. The tail cone, horizontal tail plane (stabilizer), elevator, and the central panel of the lower fuselage section show significant burn damage. The composite material was completely dry, i.e. no visual traces of resin remained, and the fibres in the composite material were splintered.

Only fragments of the Plexiglas canopy were found, with the canopy closing system remaining intact and devoid of burn signs.

▲ Figure 3: General overview of the burn marks on the aircraft wreckage. (Source: Blackshape)

Further inspection revealed that the right and left aileron control rods showed signs of impact-induced failure and plastic deformation. The vertical tail and rudder remained intact, without signs of burning, maintaining structural connection through the upper hinge. The elevator welded assembly, linking the right hand and left elevators, displayed only superficial burn marks. Both elevators remained attached to the assembly, although the right-hand elevator completely burned at the inboard rib, disconnecting it mechanically from the control, due to the complete destruction of the carbon fibre plies at the attachment location. The elevator control push-pull rod, most likely deformed by the impact, partly showed superficial burning.
