DUTCH  
SAFETY BOARD

# Failure of aileron flight control cable Boeing 737-804

*The Hague, July 2024*

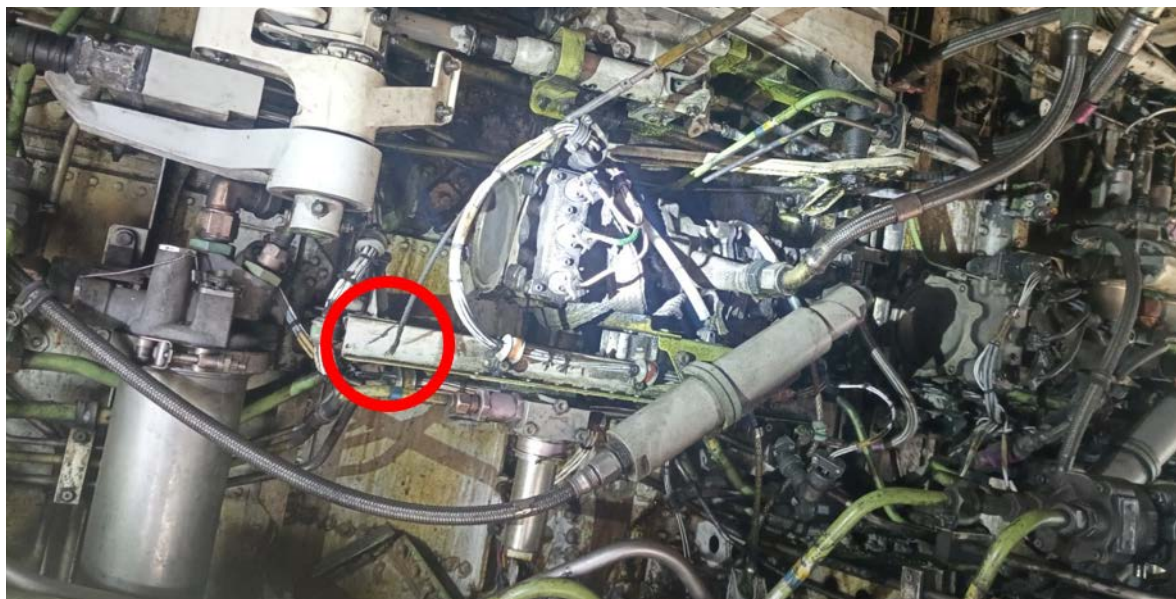
After the flight, a passenger showed the flight crew a video recorded on a mobile phone showing the left aileron in an upward position. Post flight troubleshooting by a ground engineer immediately after arrival at Athens revealed that a cable of the left aileron of the flight control system - cable ABSA-L1 - was broken, see Figure 1. There was no other damage to the aircraft.

▲ Figure 1: One side of the broken aileron control cable, see circle. (Source: local ground engineer at Athens)

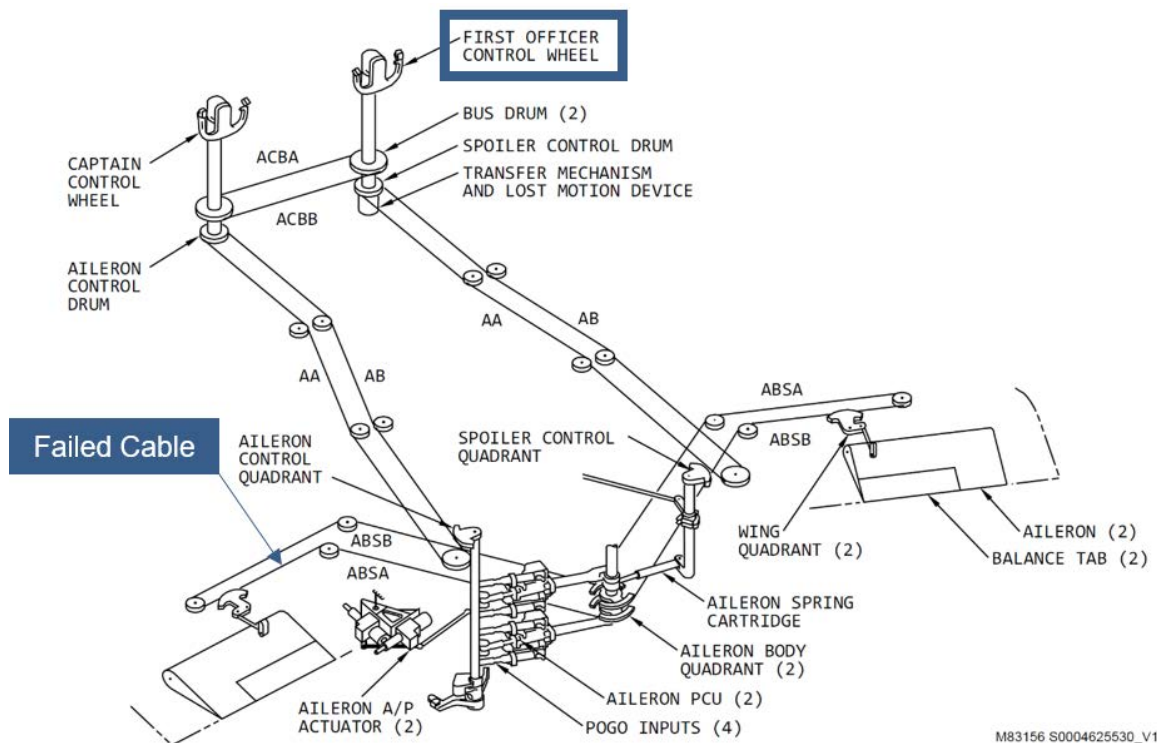
The aileron cable system consists of two paired cables per wing, where one cable (ABSB) pulls the aileron up and the other (ABSA) pulls it down. The location of the cable ABSA-L1 failure is depicted in Figure 3.

▲ Figure 3: Schematic for aileron (roll) control. The aileron feel and centering unit is not shown. The location of the cable failure is indicated in the picture. (Source: Boeing. Image Copyright © Boeing. Reproduced with permission.)

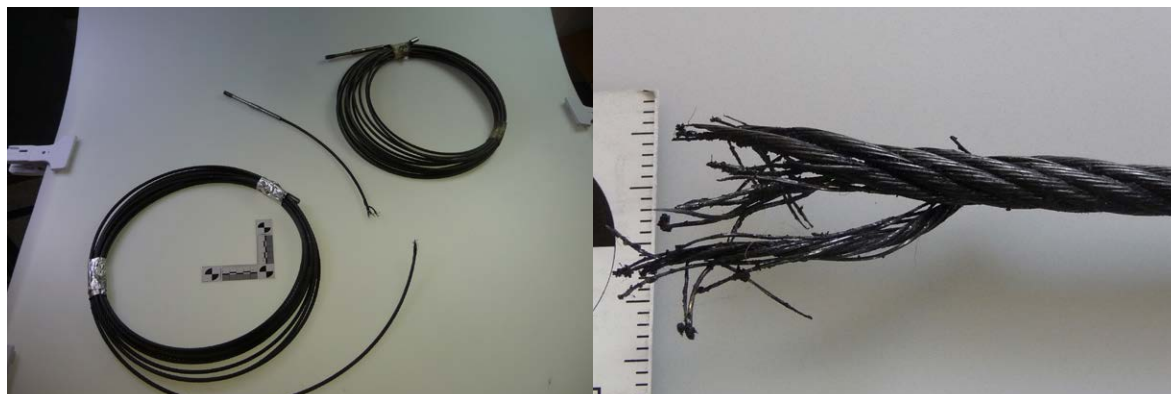
Both the broken and the paired cable of the left wing (ABSA-L1 and ABSB-L1) and the pulley closest to the cable fracture position were removed from the aircraft for further examination. The cables, as shown below in Figure 6, were sent to the laboratory for metallurgical examination<sup>11</sup>. Section 2.7.1 describes the findings of the metallurgic examination with reference to the terminal of the concerned cable. Appendix D describes the findings in more detail. In Chapter 3 the Dutch Safety Board uses the findings of the laboratory for its own analysis on how the cable failed and which factors contributed to this failure.

▲ Figure 6: Left, the two cables to be examined in the laboratory; Right, one part of the failed cable in detail.

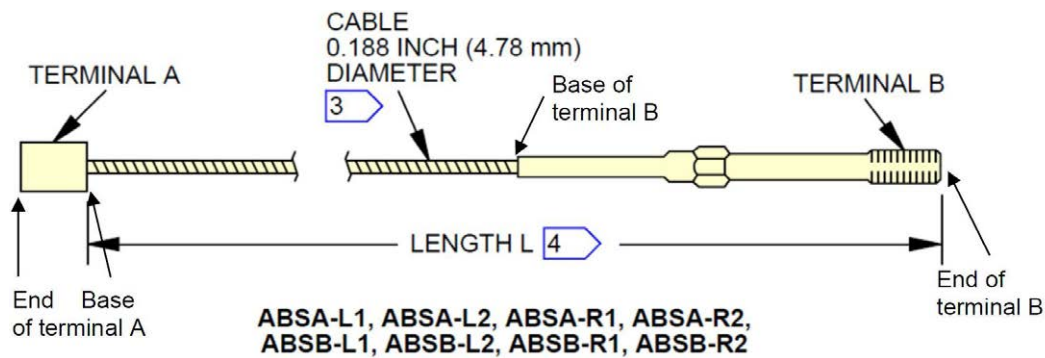
The laboratory measured the fracture of the cable at 1,081 cm distance from the terminal A, see figure 7. Figures 8 and 9 show broken wires and deformation due to squeezing at different positions on this cable. For the complete list of measurements of the failed cable (ABSA-L1) and the paired cable (ABSB-L1), which had not failed, see Appendix D.

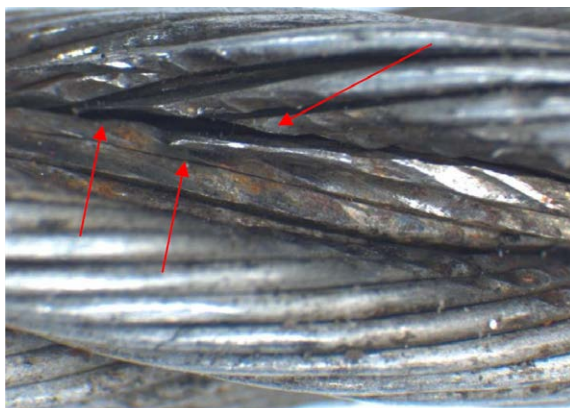
At the position of the cable fracture, both squeezed and worn wires were observed. Most observed broken wires were squeezed to very thin thicknesses.

The report further states that in case of insufficient lubrication, frictional resistance between the strands increases. If corrosion also occurs between the strands, they will become fixed relative to each other. When the cable is heavily loaded or must bend over a pulley, the strands may experience difficulty shifting over each other. As a result, high compression forces will occur between the strands. The laboratory concludes that these compressive forces squeezed the individual strands, deforming them into very thin wires.

▲ Figure 8: Failed cable at position 1,020 cm from the terminal reference position. The wires were broken (arrows) at the thinnest positions. (Source: Laboratory)

- ▶ As far as could still be determined, the cables originally conformed to specification.
- ▶ Both examined cables were affected by corrosion, and over their length parts had also been affected by significant abrasive wear (including squeezing) on contact with a pulley.
- ▶ Evidence was also found of increased wear due to one or more pulleys that have not been properly rotating<sup>13</sup>.
- ▶ The occurred abrasive wear and squeezing of wires has finally led to cable fracture.
- ▶ The root cause of the occurred failure is lack of proper lubrication (greasing) of the cable and pulleys.

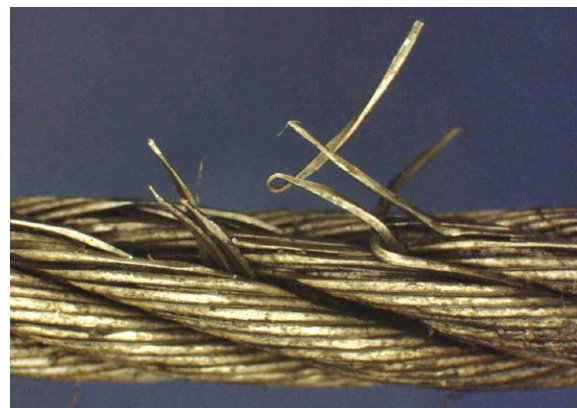
▲ Figure 9: Broken cable at position 832 cm from the reference position. (Source: Laboratory)

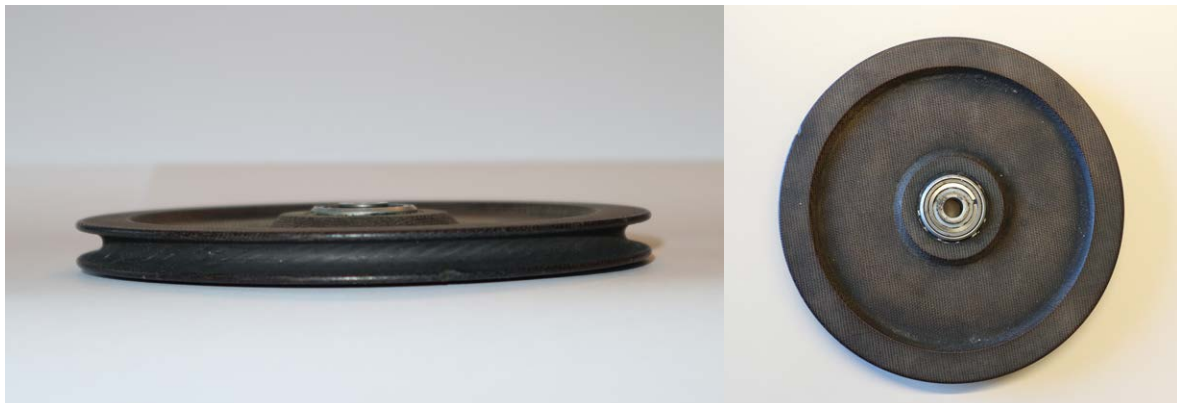
The pulley closest to the position of the fracture was removed preventively on behalf of the operator and made available for investigation by the Dutch Safety Board, see below in Figure 10. According to the operator the pulley has not been replaced since the aircraft got into service in May 2012.

▲ Figure 10: The removed pulley located near the cable fracture.

The Dutch Safety Board assessed the pulley in accordance with the Boeing 737 Aircraft Maintenance Manual (AMM)<sup>14</sup>. The AMM describes different wear patterns for the pulley, see Figure 11. Detailed visual examination of the pulley at the office of the Dutch Safety Board showed that the pulley rotated freely with normal wear patterns, as indicated in the framed figure below. It is noted that the functioning of the pulley ‘as installed’ – when it rotated under the load of the aileron cable being under tension - is unknown.<sup>15</sup>

Referring to Section 2.7.2, as the DSB assessed the pulley itself (hence, the pulley was not sent to the laboratory for examination), the DSB needs to address the conclusion of the laboratory that the pulley near the cable fracture was not properly rotating. Since the operator had the aircraft in service from May 2012, the assessed pulley had been installed at least more than 10 years. The DSB found that a normal contact pattern of the aileron cable was in accordance with the AMM. It is therefore assumed that the assessed pulley had no adverse effect on the cable other than that cable displacement over the pulley affected normal wear. The history of the pulley(s) and the effect on the condition of the aileron cable were not further investigated, as it would not explain the lack of lubrication of the aileron cable anyway.
