# Quarterly Aviation Report

April - June 2024

# Investigations

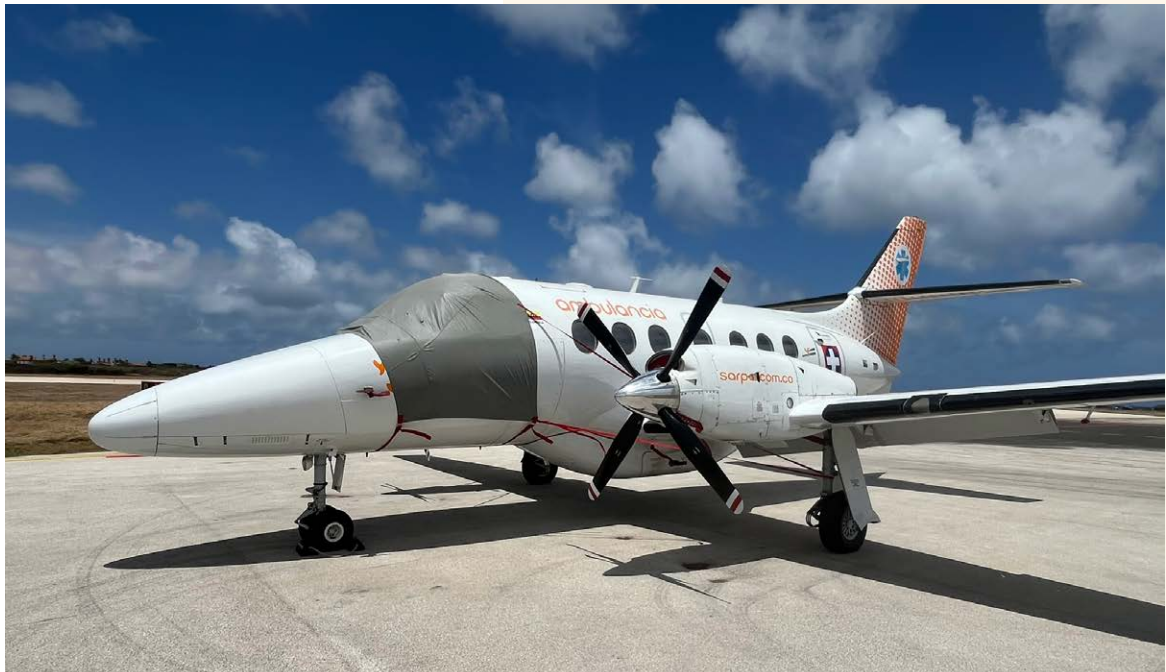
During take-off from Runway 10 at Bonaire International Airport (TNCB) in Caribbean Netherlands, the nose landing gear hit several runway edge lights. The flight continued. The aircraft suffered minor damage to a tire of the nose landing gear.

▼ *The Jetstream 32.*

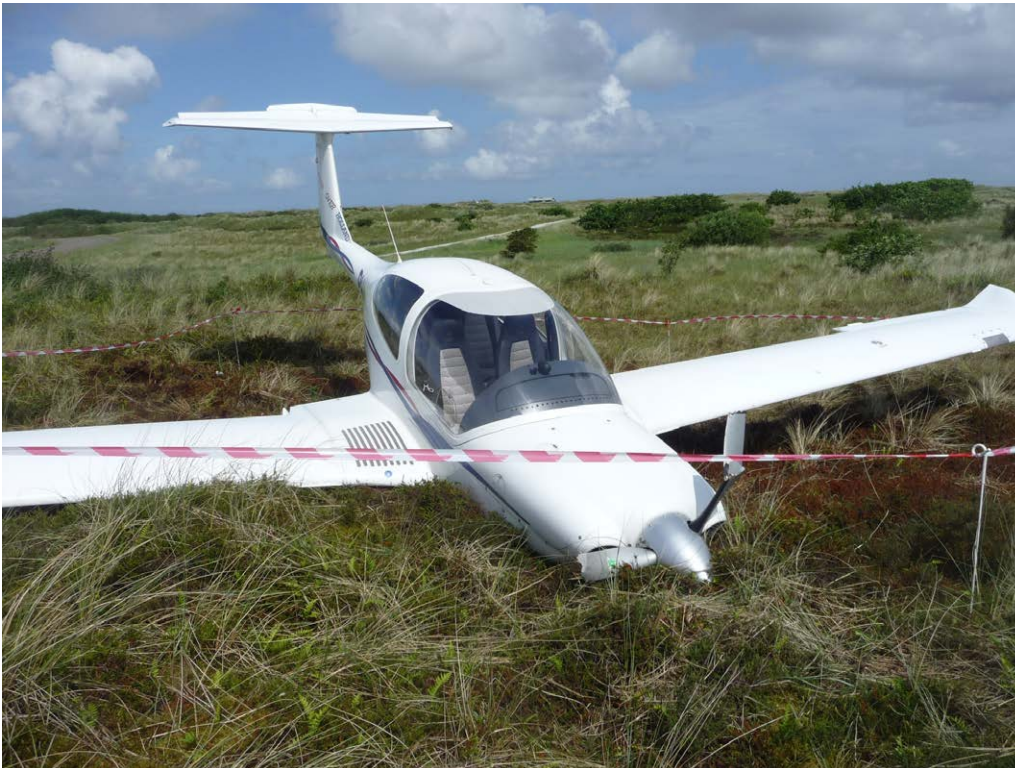
During the take-off from Runway 08 at Ameland Airport (EHAL), the aircraft did not accelerate sufficiently and did not come off the runway. It eventually passed the runway threshold, shot through the airport fence and came to rest in the dune area behind it. The four occupants were unharmed and the aircraft was severely damaged.

▼ *The Diamond DA 40 after the runway excursion.*

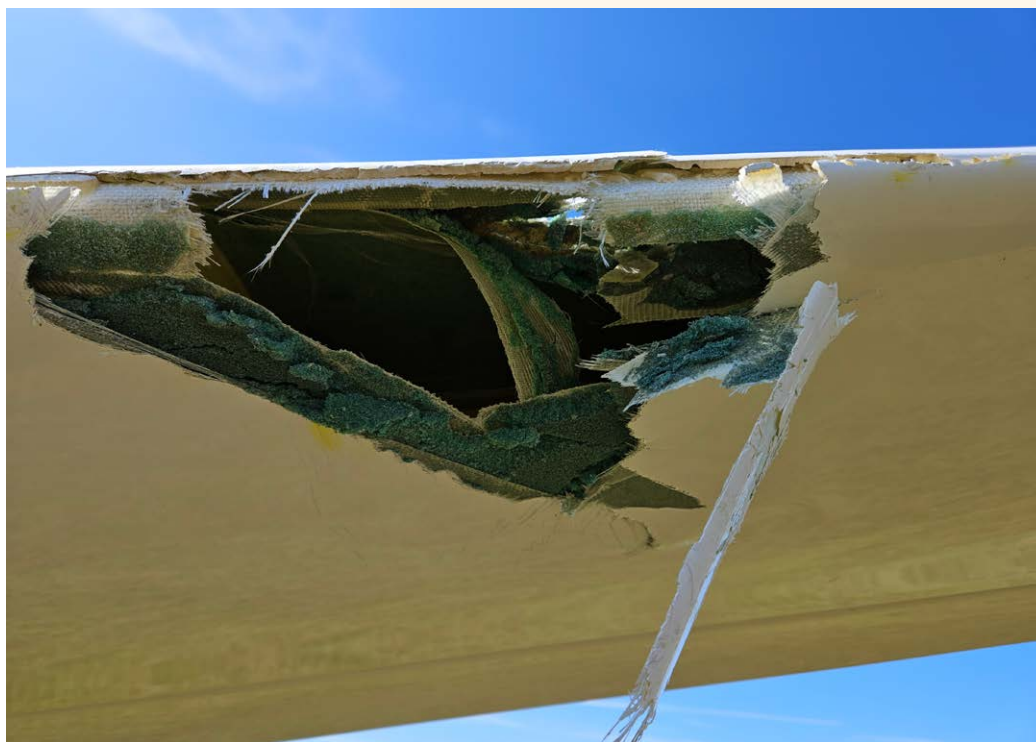
On final, the pilot lowered the nose of the glider to increase the speed. When he raised the nose again, the left wing came into contact with a small tree and a barbed wire fence. The pilot then made a safe landing. The left wing suffered damage.

▼ *Damage to the left wing. (Source: Glider club)*

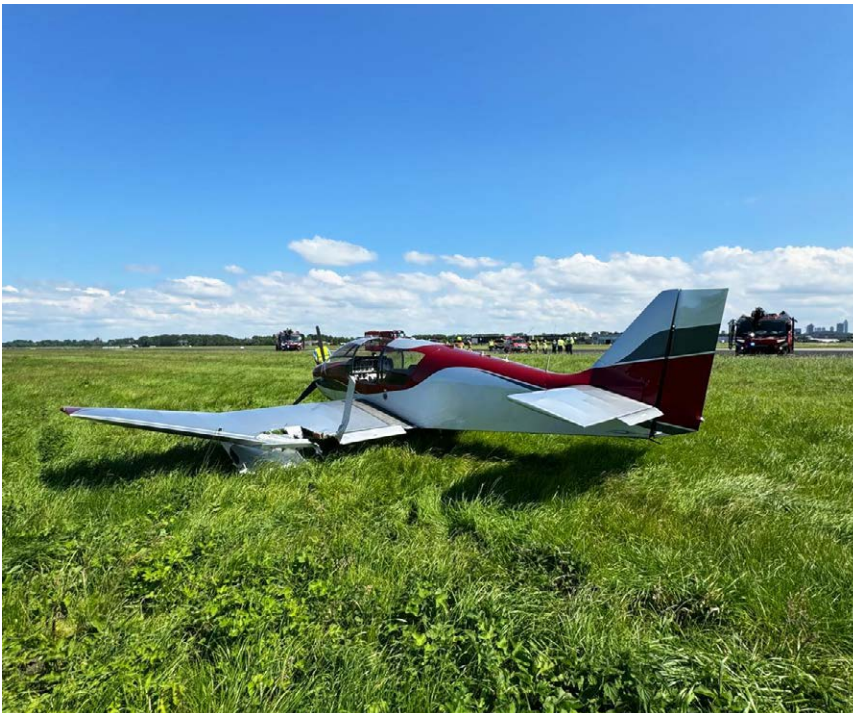
During take-off, the DR 400 veered off the runway and hit a Precision Approach Path Indicator (PAPI) lamp with its left wing. The aircraft suffered damage to this wing.

- ▼ *The DR 400 after the runway excursion.*  
(Source: Rotterdam The Hague Airport)

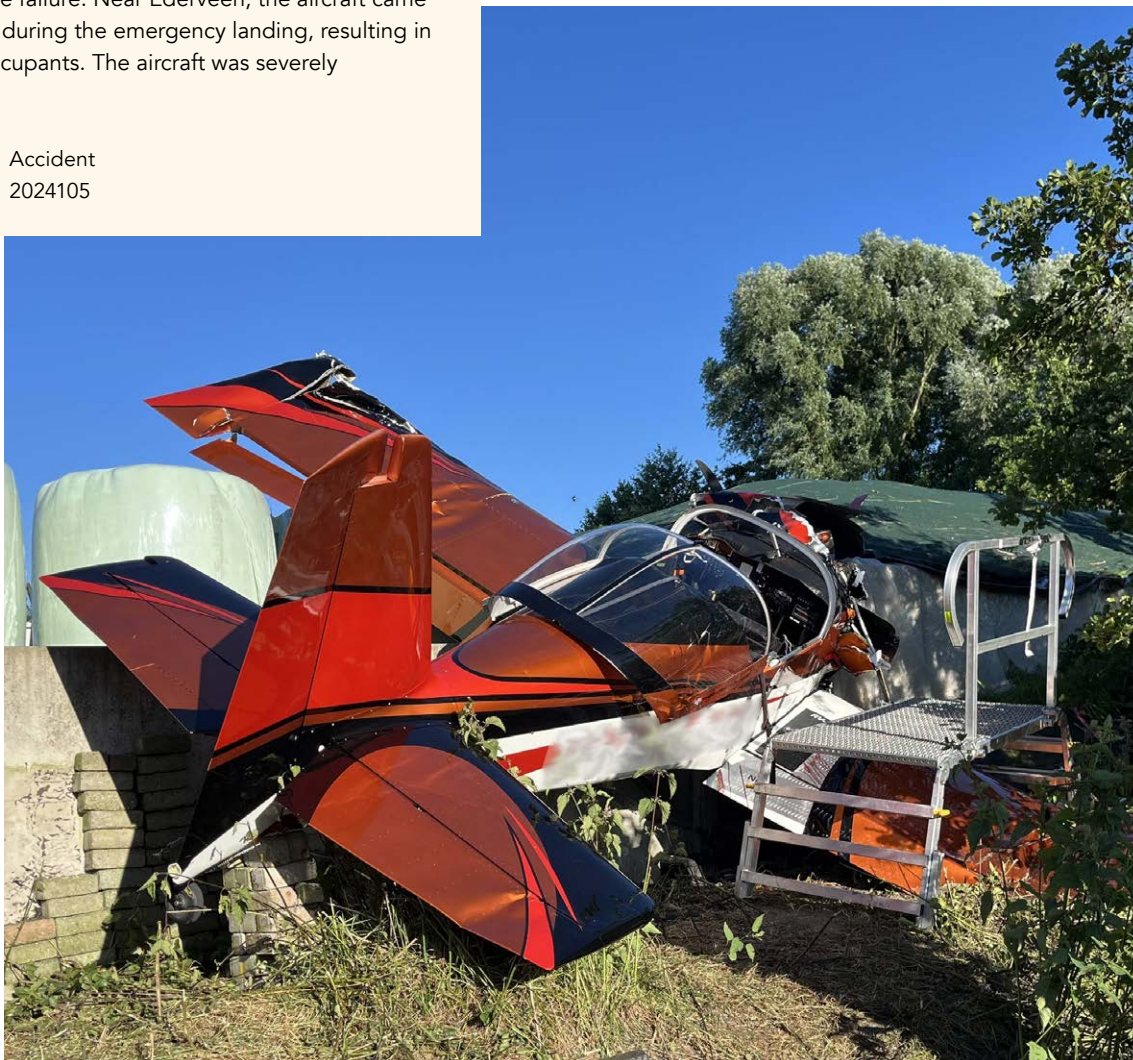
The Van's RV-7 – a home-built aircraft – had departed from Teuge International Airport (EHTE) for a local flight. On board were the pilot and a passenger. After some time, the pilot reported an engine failure. Near Ederveen, the aircraft came to a halt on a wall during the emergency landing, resulting in injuries to both occupants. The aircraft was severely damaged.

▼ *The crashed RV-7.*

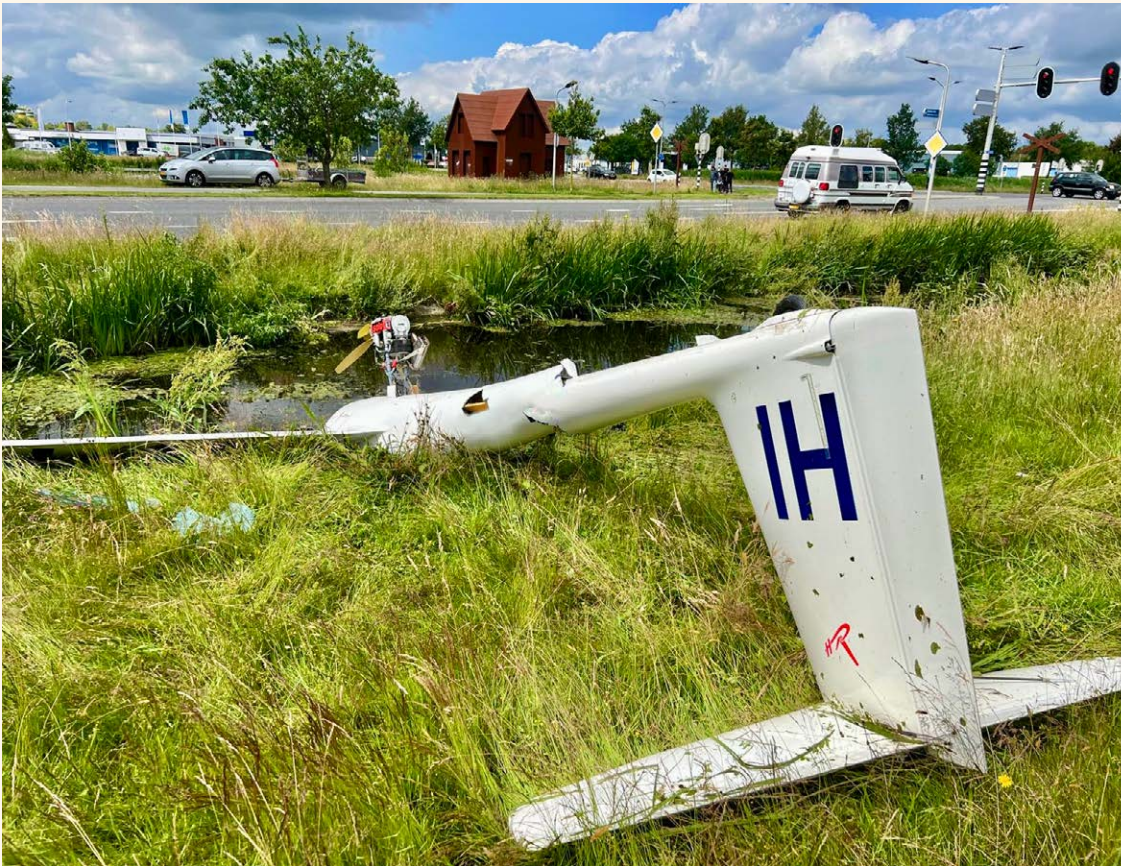
extended. Just outside the airport, the right wing hit a lamppost, causing the aircraft to rotate around its vertical axis and come to a stop on the edge of a ditch. The pilot was uninjured. The glider sustained severe damage.

▼ *The crashed Discus-2T. (Source: pilot)*

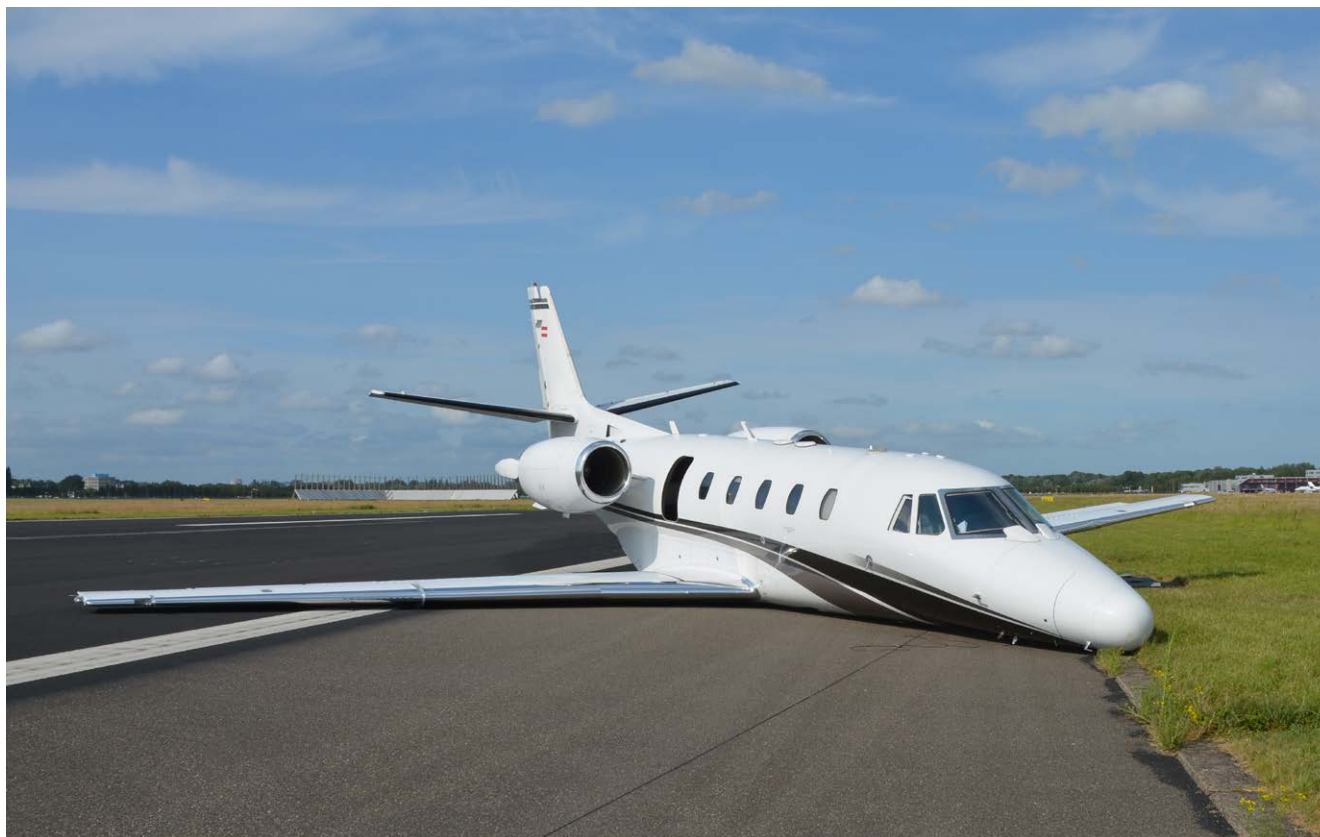
The Cessna Citation had departed from Oxford Airport in the United Kingdom (EGTK) for a ferry flight to Amsterdam Airport Schiphol (EHAM). On board were two pilots and one flight attendant. During the landing, the aircraft encountered an issue with its landing gear, causing it to slide off the runway. None of the occupants sustained injuries.

▼ *The Cessna Citation after the runway excursion.*

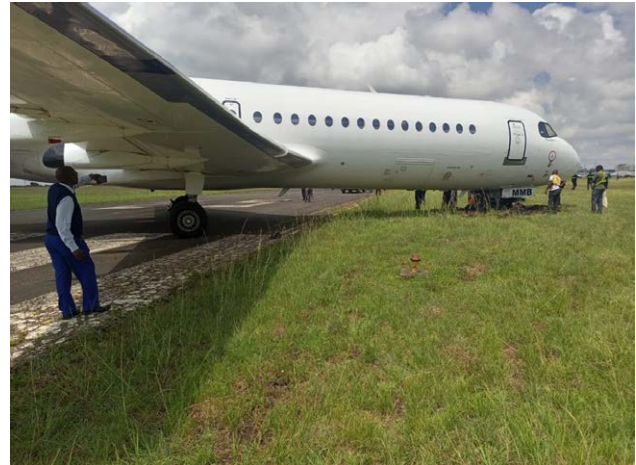
During landing, the Fokker 70 veered off the runway and came to a stop with its nose wheel in the grass. The three occupants were unharmed.

▲ *De Fokker 70 after the runway excursion. (Bron: Aircraft Accident Investigation Department, the Republic of Kenya)*

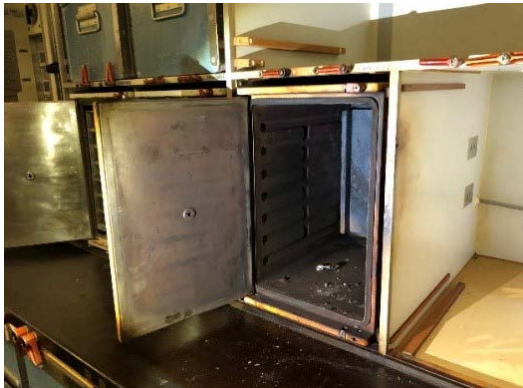
▲ *The failed oven.*

The investigation into this serious incident revealed that the use of a meal tray carrier with a mostly closed backside extended the heating time of the oven significantly and disturbed the airflow in it. This led to a raised temperature behind the oven, inadvertently influencing the electronic control circuitry in such a way that the heating elements of the oven were commanded on. It caused the temperature behind the oven to increase even further and kept the power control board in a faulty condition. At this point, the 3-phase safety device was already damaged and inoperable and could not disconnect the electrical power to the oven. Consequently, the temperature inside the oven continued to rise to such a degree that it overheated and smoke was emitted from the oven into the galley.

As a result of the failure of the heating elements by the prolonged heating at maximum temperature, the temperature behind the oven dropped significantly so that the power control board functioned correctly again. Then, the oven control module transmitted the commanded 'off' signal to the heating elements. The oven overheat event thus stopped. All heat damage remained limited to the inside of the oven and did not cause damage to the surrounding area of the oven.

No flames were observed inside the oven. The amount of smoke generated by the overheat event, especially the smoke coming from the cavity between the oven and the galley board, let the cabin crew believe that a fire must have been present. For the cabin crew this justified the use of Halon fire extinguishers. The application of Halon into the oven did not provide any cooling effect and increased the emission of smoke. The Halon gas was exposed to temperatures above its decomposition temperature and became toxic. In the case of a fire, Halon shall be used to extinguish it. It will extinguish the fire quickly. As a result, the temperature will not become as high as in the incident oven and the decomposition temperature of Halon is not reached. The use of a Halon fire extinguisher agent aggravated the circumstances during the oven overheat event and was therefore inappropriate.

The operator indicated that Service Information Letter H0212-25-0164 (as incorporated in the Components Maintenance Manual), issued by the oven manufacturer, had not been incorporated in maintenance procedures. This service information letter gives additional instructions for the checking of the 3-phase safety device and its replacement every five years.

Service Bulletin 2000-25-0001, which is also issued by the oven manufacturer, recommends the incorporation of an improved power module, motor, fan, and heating elements among other upgrades, and had not been incorporated either by the operator. The incorporation of this service bulletin has been proven to prevent a potential failure of the power control board from controlling the temperature in the oven. The implementation of this service bulletin was deemed unsuitable by the operator due to certification requirements of the modification and limitations on the use of the oven.

During the investigation, the operator was already alerted by the Dutch Safety Board on the importance of the implementation into the crew procedures of a check that all power to a failed oven has indeed been switched off. Also, the importance of keeping the oven door shut during an overheat event was pointed out by the Dutch Safety Board during the investigation, as the oven is designed to confine high temperatures to the inside of the oven.

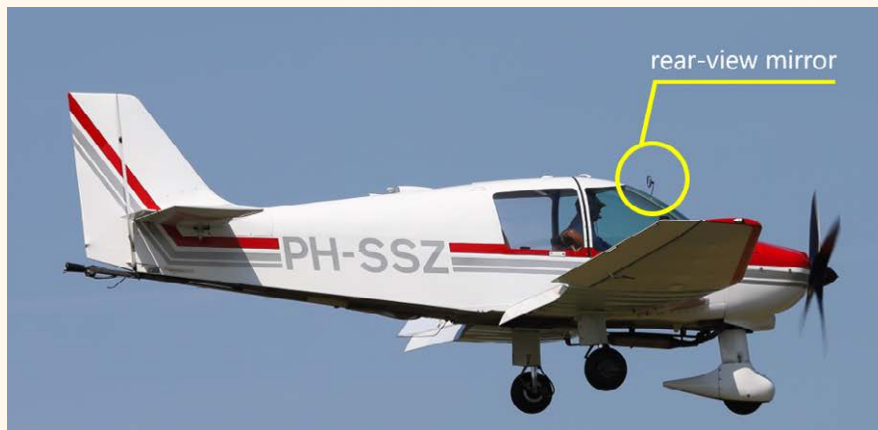
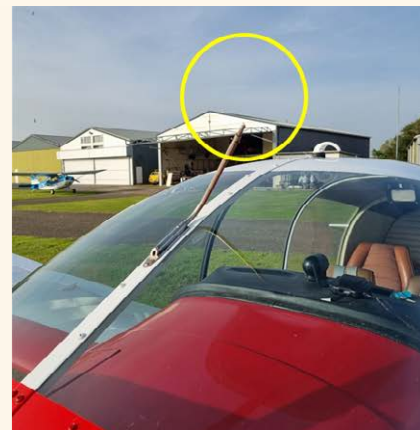
- ▼ *Left: archive picture of the Robin DR 400/180, showing the position of the rear-view mirror. (Source: Werner Verbogt)*  
*Right: view of the Robin DR 400/180's windscreen divider with the rear-view mirror missing after the occurrence. (Source: Police, Aviation Supervision Team)*

The Robin was equipped with two mirrors. One mirror was attached to the canopy's windscreen divider. This allowed the pilot to view the glider during the tow. The second mirror was attached to the left wing. This also offered the pilot a view of the glider, as well as a view of the person holding the wingtip during the beginning of the take-off, when on the ground. After the occurrence, it was found that the Robin's canopy mirror had detached. Furthermore, the left wing tip mirror was cracked, with paint damage visible on the wing around the mirror. No damage was found on the Cessna.
