DUTCH
SAFETY BOARD

Flare launched with fatal consequences

The Hague, 25 September 2024

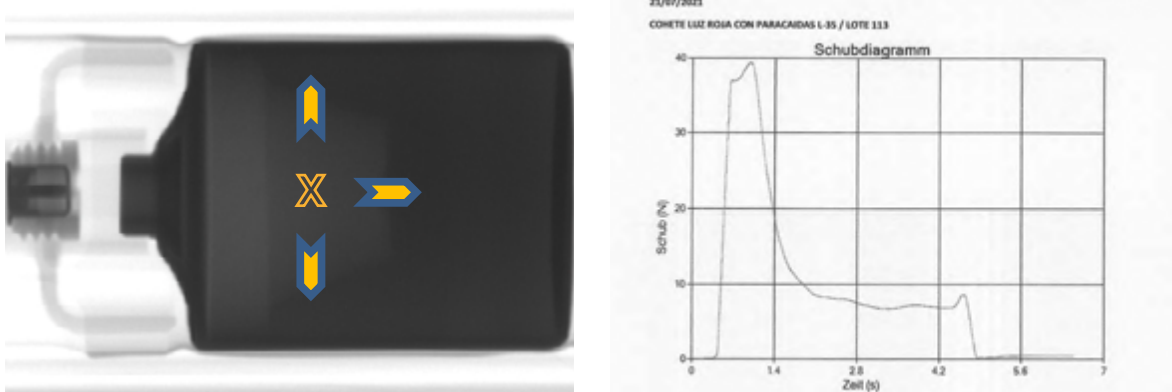
▲ Figure 2 (left): X-ray of one of the flares from batch 113 (edited). X marks the starting point of the combustion of the solid propellant. Three arrows indicate the direction of combustion. (X-ray © Gendarmerie France).

▲ Figure 3 (right): Pressure/time diagram from power test on batch 113. (Source: © Lecea).

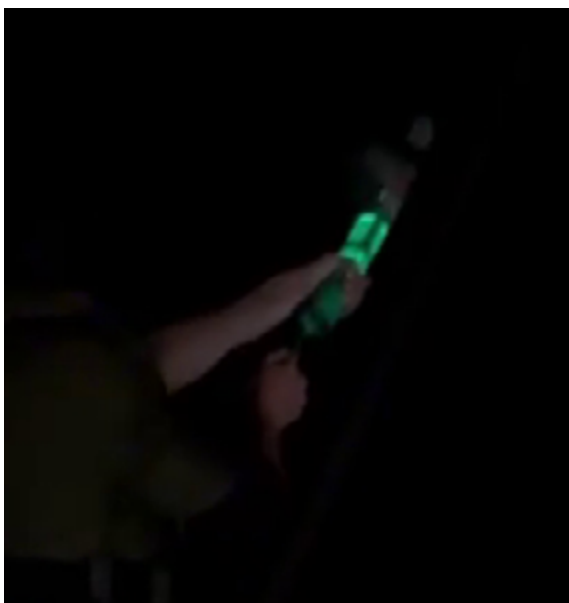
Videos of the flare being launched were recorded. Based on these, it has been determined that after activation of the igniter, the solid propellant in the motor ignited as expected. (See Figure 4) The succeeding video fragments¹⁵ (not included in this report) reveal that the explosion took place in two stages. The motor exploded first, immediately followed [one frame \approx 0.05 second] by the candle unit. Four frames elapsed between ignition of the flare and the explosion, which represents a timespan of approximately $0.2 \approx 0.25$ seconds.

◀ Figure 4: **Still** image of the flare being launched, in which the first stage of combustion of the solid propellant and the start of ejection of the interior are visible. (Source: Bontekoning)

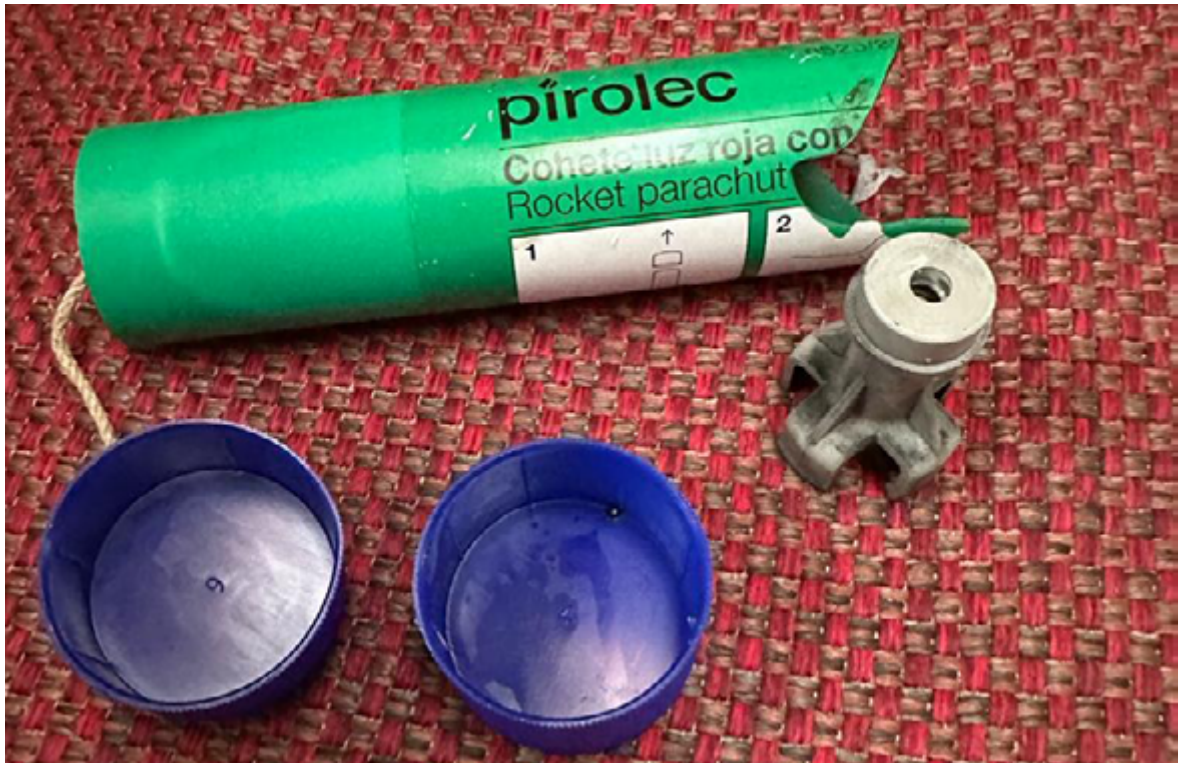
In contrast to the intended usual rapid combustion behaviour, the combustion became so excessive that it led to an excessive build-up of pressure in the motor, resulting in an explosion. After the explosion, a number of remnants of the exploded flare were recovered on board (see Figure 5).

▲ Figure 5: Recovered remnants of the flare, 1 January 2023. (Source: Bontekoning)

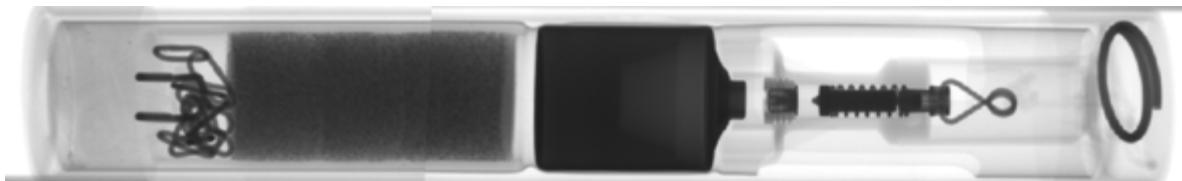
▲ Figure 6: X-ray photo (taken on Tahiti) of one of the flares from batch 113. (Source: Gendarmerie France)

¹⁷ The photos are of a good quality; 'gas bubbles' of >1 mm would be visible but none are observed, which is as it should be.

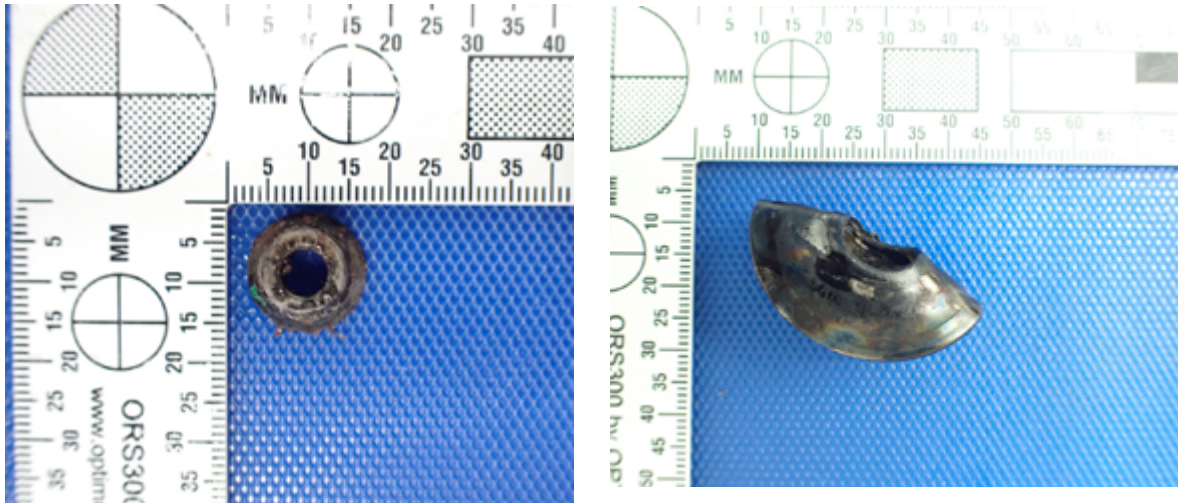
During the postmortem examination of the victim, two foreign bodies were found (see Figure 9). These fragments originated from the flare. They are part of the hemmed¹⁹ lid of the motor. These fragments caused the internal injuries that led to the victim's death. The deformation of the lid fragment and the outward deformation of the pressed-in discharge opening (venturi constriction) from the lid are attributable to the force of the explosion. It is unlikely that the deformation was caused by the impact of these two fragments when penetrating the victim's body.

▲ Figure 9:1 (left): The fragments found in the victim's body, upper section (lid).

▲ Figure 9:2 (right): The pressed-in venturi. (Source: Australian Federal Police).

It can be deduced from the deformation and distribution of the fragments from the top section (see Figure 9) that were found in the victim's body that (too rapid) combustion of the propellant led to excessive pressure and the explosion of the motor.

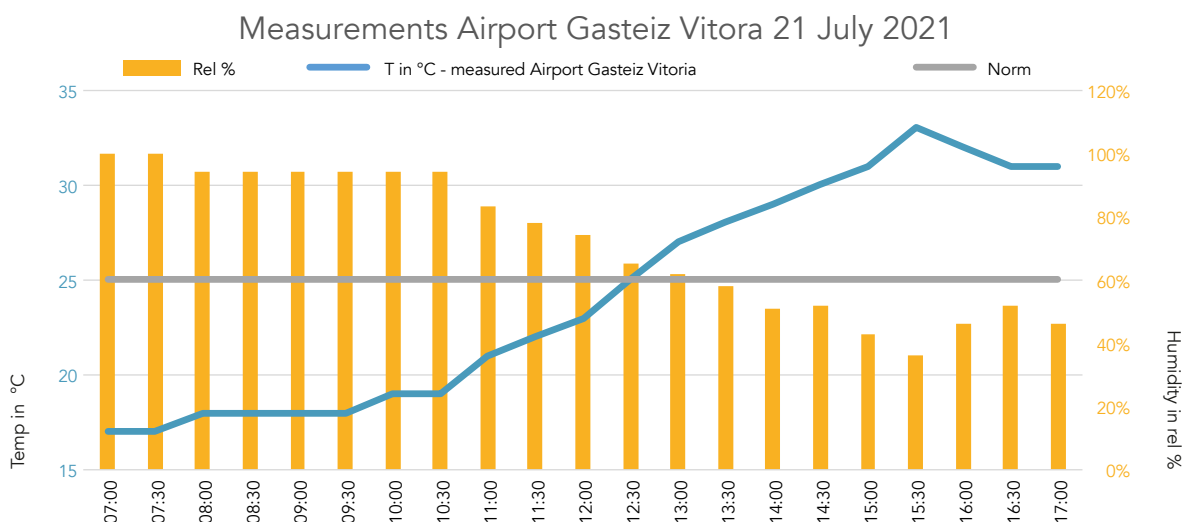
▲ Figure 10: Graph of progression of temperature and humidity on 21 July 2021, see Appendix A.5.
 Source: <https://www.timeanddate.com/weather/@6355286/historic?month=7&year=2021>

Analysis has revealed that during the filling of batch 113, the ambient temperature eventually rose to 33°C at 15.30. Despite the supplier's assertion that its employees are used to producing at higher temperatures, a higher temperature can accelerate the curing process and so increase the risk of non-conformities. Small cavities, in particular, but also small cracks, can arise unnoticed in this phase during pressing.

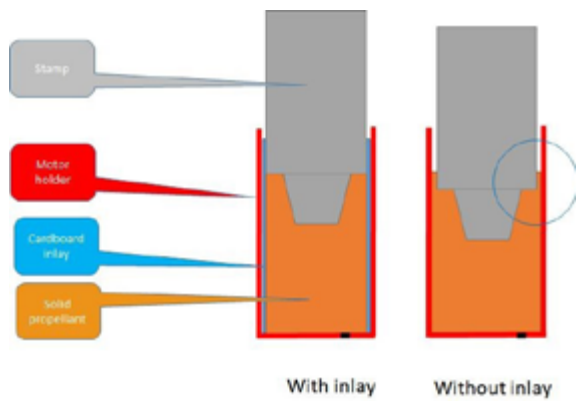
If the propellant in the motor unit is pressed without a cardboard inlay, then the top edge will not be pressed so as to have the same diameter as the motor unit, causing an unwanted edge. As a result, (micro) cracks and cavities can arise in this edge during the curing stage, which can result in additional combustion surface area.

◀ Figure 11: Cross-section drawing of motor unit during pressing, showing effect seen with and without cardboard inlay.

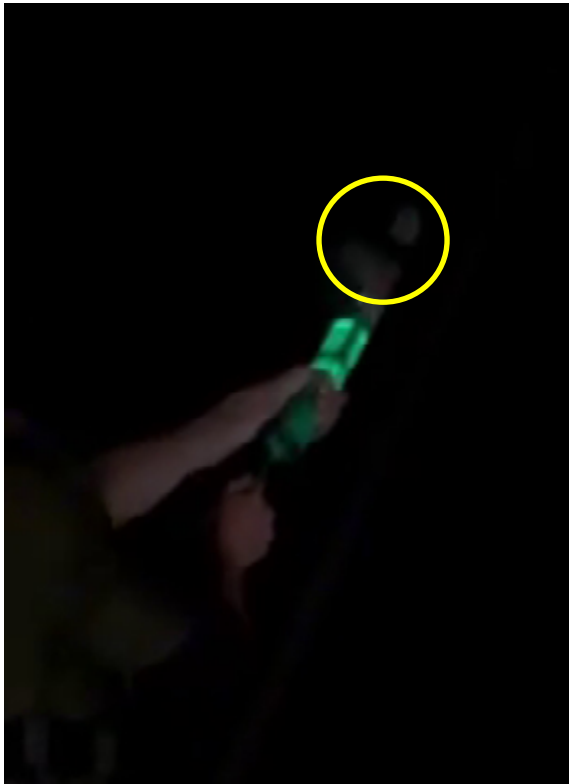
What TNO finds notable is a black area between two visible grey areas (see Figure 12). In TNO's view, these details are not explicable by the normal functioning of the flare. The candle unit itself contains magnesium in order to achieve the intended effect. Compositions containing magnesium²¹ can produce hydrogen gas if they come into contact with moisture. The possible presence and ignition of hydrogen gas, for example as a result of static electricity, could have ignited the candle unit and the motor simultaneously, via the hole at the top of the motor. Simultaneous ignition of the solid propellant at the

bottom and top of the motor could also have resulted in excessive pressure build-up and the explosion of the motor.

▲ Figure 12: The non-visible part.
