DUTCH  
SAFETY BOARD

# Near mid-air collision in the Rotterdam Control Zone

15 June 2022

*The Hague, November 2024*

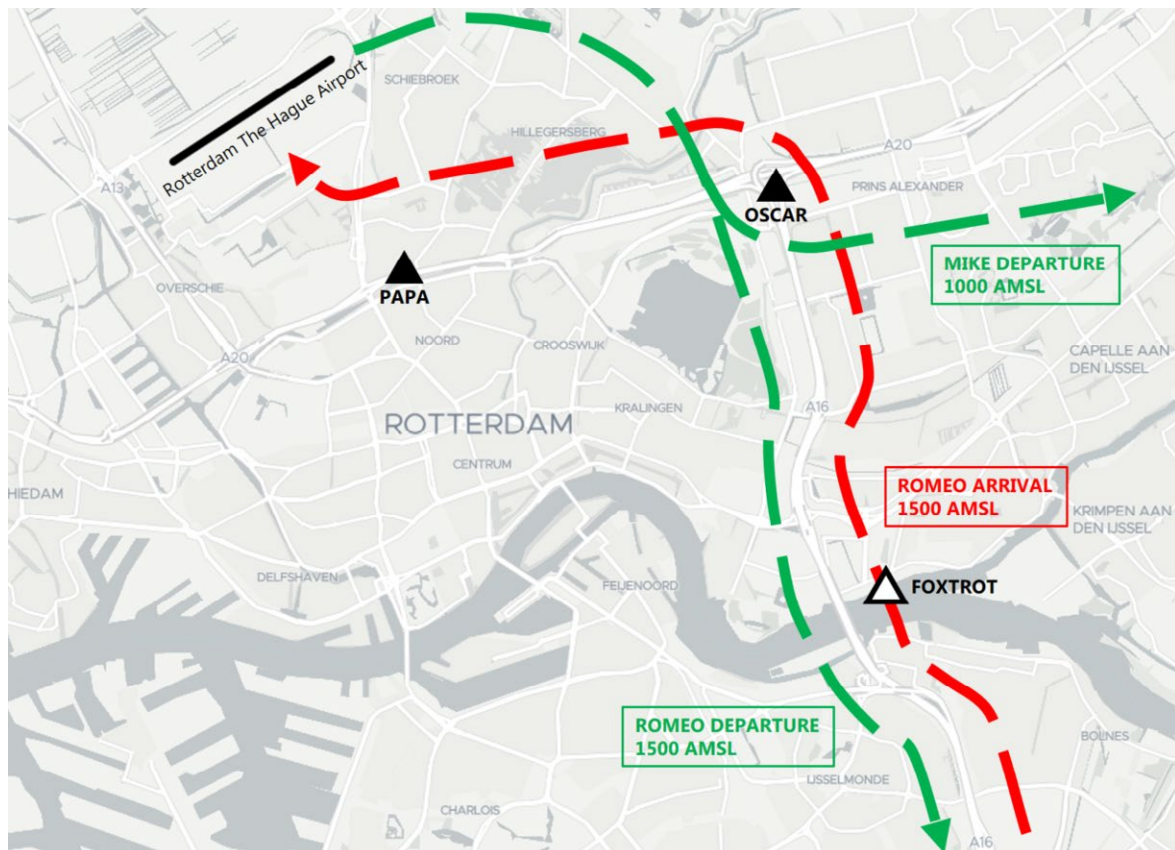
▲ Figure 1: The ROMEO arrival route for D-EBTO and the available MIKE and ROMEO departure routes for N98825. (Source map: based on AIP the Netherlands, modified by Dutch Safety Board)

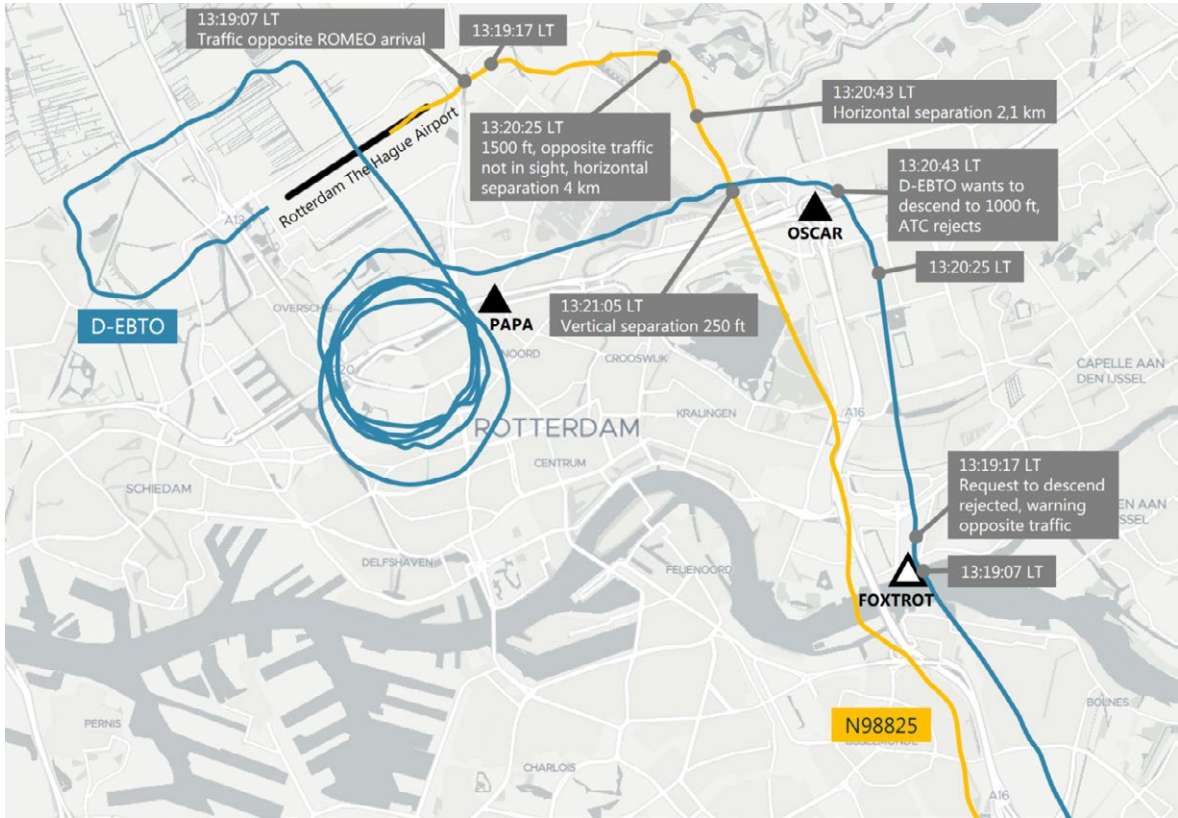
▲ Figure 2: Flight track (and holds flown) of D-EBTO (blue) and flight track of N98825 (yellow). (Source radar data: LVNL)

Radar data (see figures 2 and 3) indicate that around 13.21:05 hrs the minimum vertical separation was 250 feet and the minimum horizontal separation was 200 metres. Shortly after, the pilot of D-EBTO reported to be back at 1,500 feet and that he had a near miss with other traffic. Radar data showed that at the moment depicted in figures 2 and 3, no other VFR traffic nor IFR<sup>4</sup> traffic was present in the vicinity of D-EBTO nor N98825.

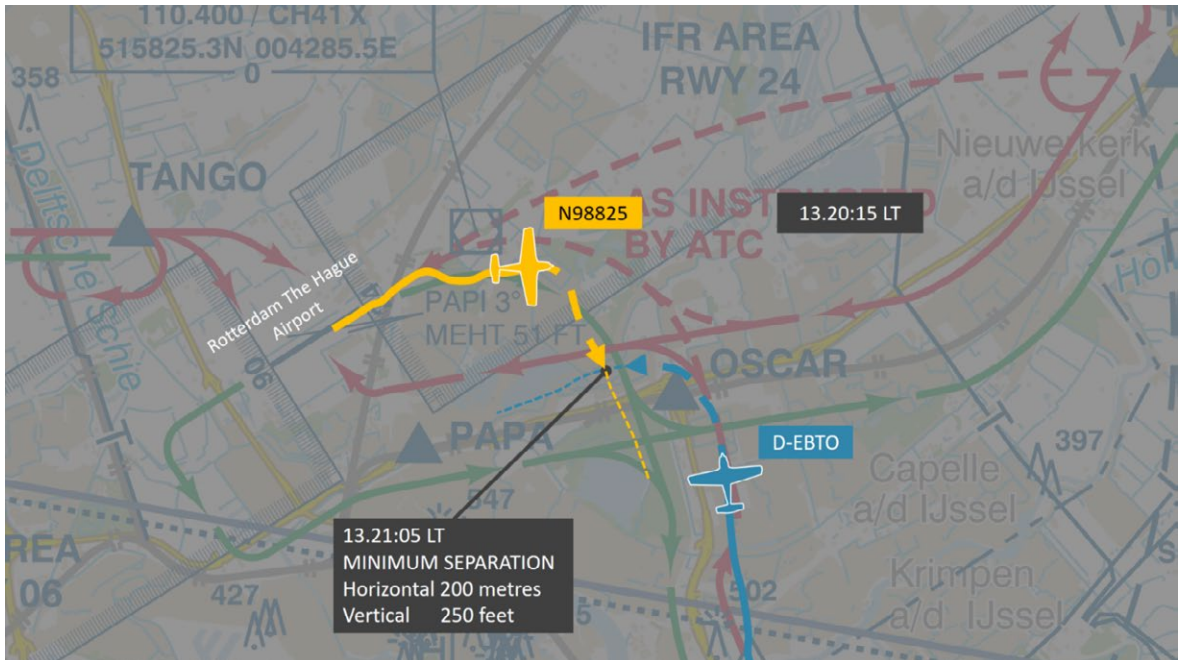
▲ Figure 3: Trajectories of both aircraft and point of minimum separation. (Source radar data: LVNL)

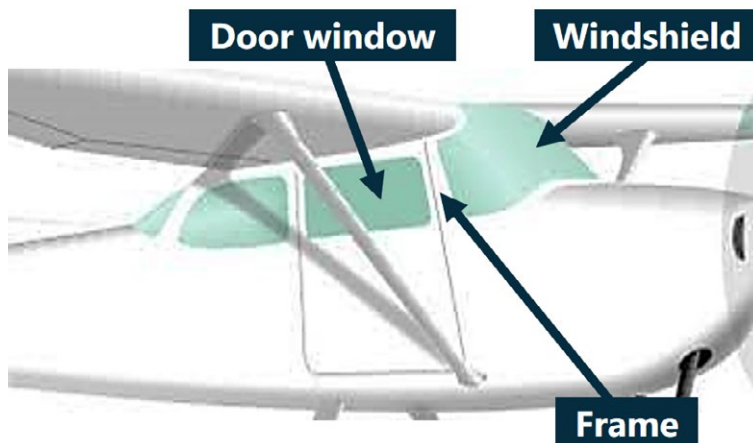
The aircraft have a windshield for a forward field of vision and a window in both left and right entrance doors, allowing field of vision to each side along the lower side of the wings (see figure 4). The frame, in which the windshield and doors are installed, limits the free field of view. During turns (due to the roll movement) of high wing aircraft, the lower wing obstructs the field of view.

▲ Figure 4: Cessna 172 windows and windscreen. (Source: Great Lakes Aero Products)

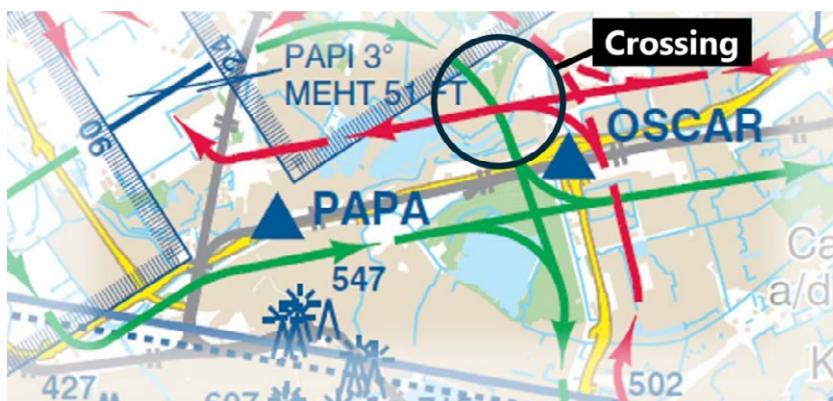
The situation in which arrivals and departures intersect at the same altitude only occurs when Runway 06 is in use (see figure 6). Because of prevailing westerly winds, Runway 06 at EHRD is in use<sup>21</sup> approximately 34% of the time.

▲ Figure 6: Visual approach chart with a partial view of the ROMEO departure route (in green) and ROMEO arrival route (in red), marking their crossing with a circle. (Source chart: AIP The Netherlands)
