Quarterly Aviation Report

July - September 2024

Q3 2024

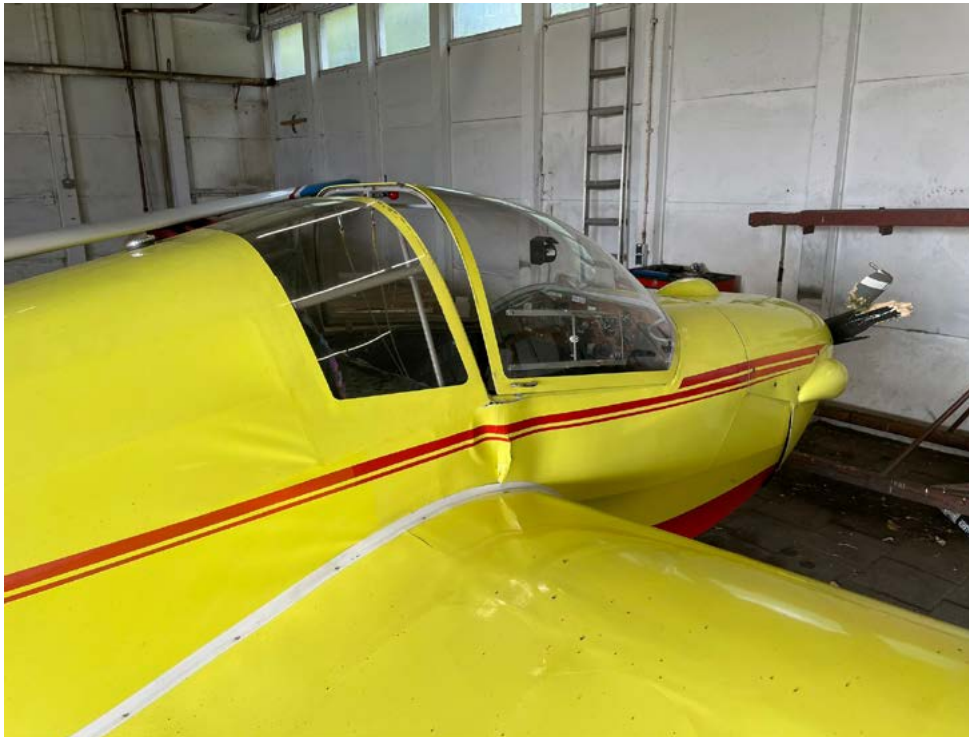
In the course of a training flight, the motor glider stalled immediately after take-off during an engine failure exercise. The aircraft then made a hard landing and was heavily damaged. The occupants were unharmed.

▼ *The damaged SF 25 B. (Source: student)*

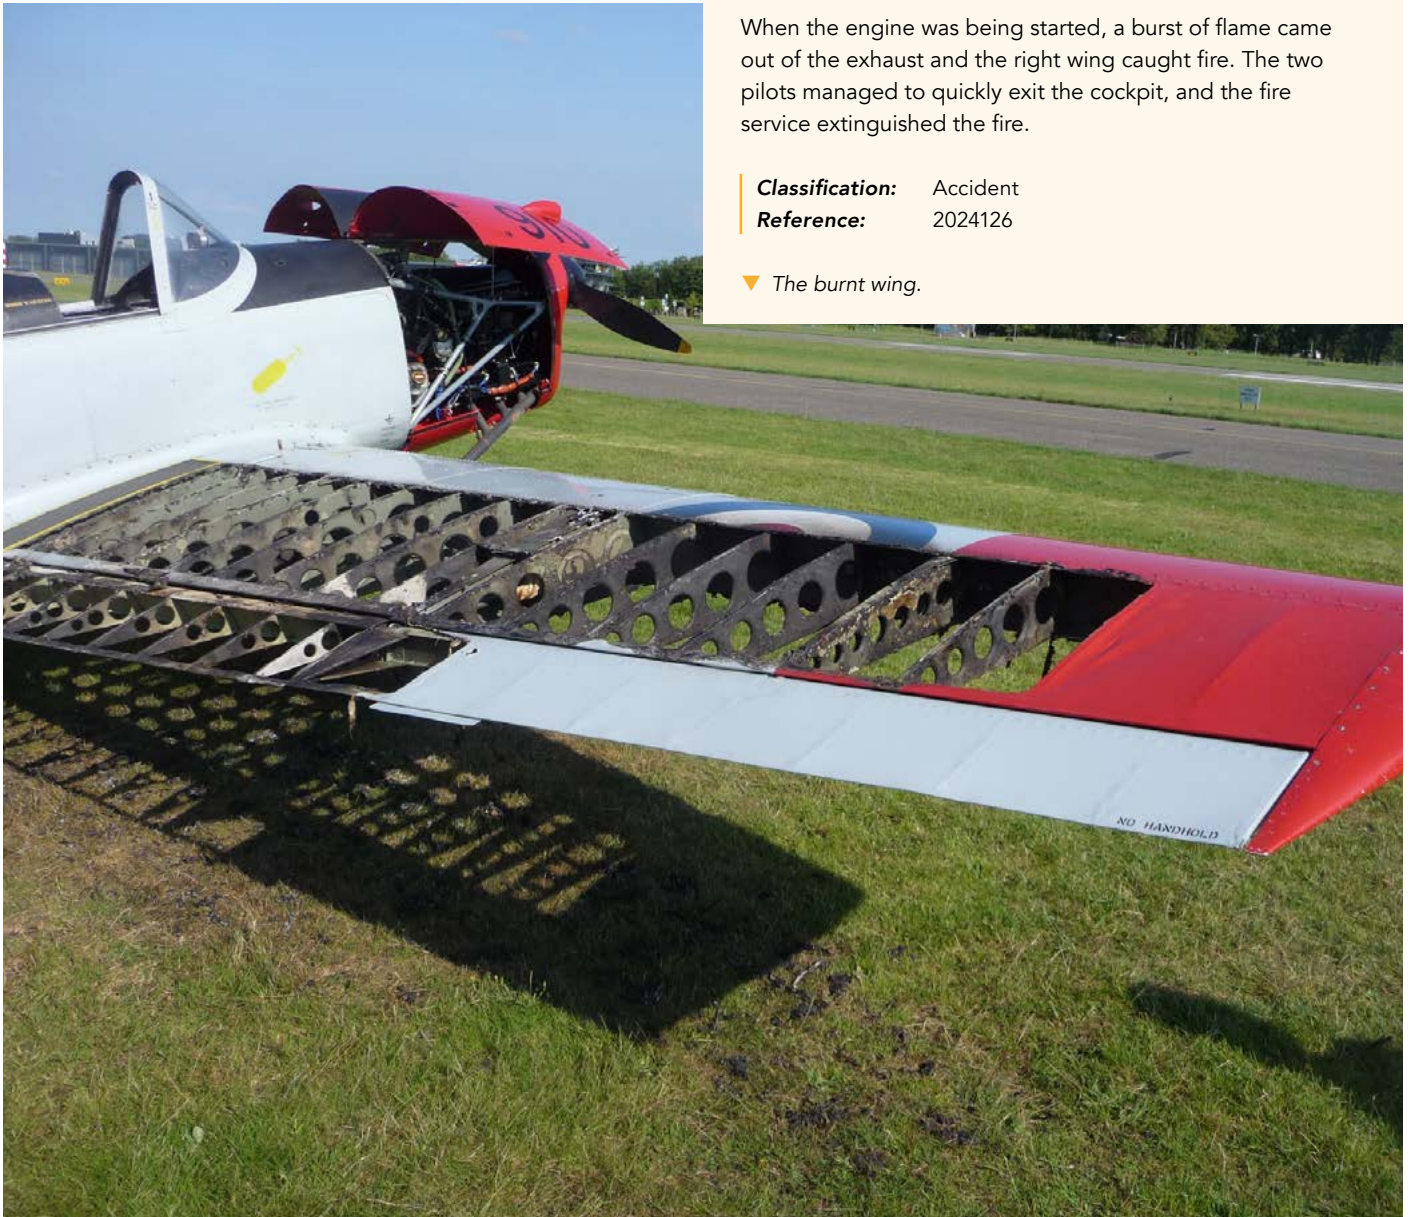
When the engine was being started, a burst of flame came out of the exhaust and the right wing caught fire. The two pilots managed to quickly exit the cockpit, and the fire service extinguished the fire.

▼ *The burnt wing.*

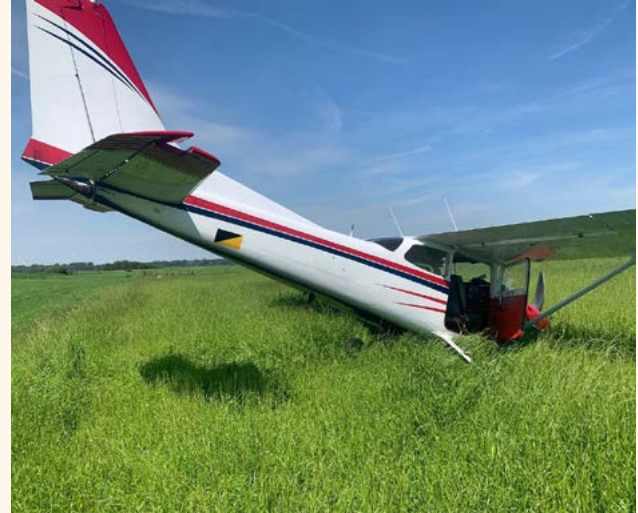
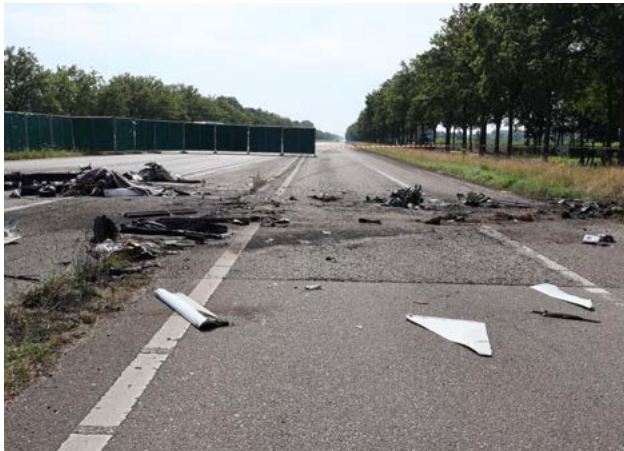
During a flying lesson, an instructor and a student experienced an engine failure after a touch-and-go at Lelystad Airport. Despite efforts to resolve the problem, engine performance deteriorated, leading to an emergency landing in a field near the town of Nunspeet. The aircraft was damaged; this included the nose landing gear collapsing. Both pilots were unharmed.

► *The F172N in the field. (Source: Police, Aviation Supervision Team)*

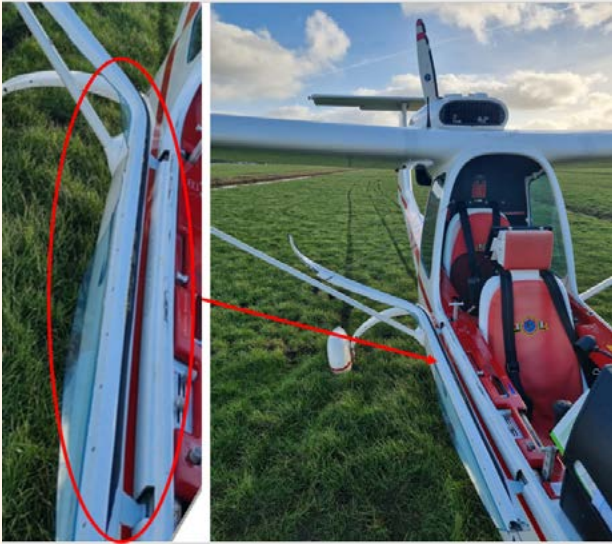
The canopy opened up as the aircraft descended. In the process, the canopy smashed into pieces against the wing strut. Parts of the canopy entered the engine, which was located behind the wing. This caused abnormal engine readings. Parts of the canopy also struck the propeller and the vertical stabiliser.

plexiglass was still attached to the aircraft by the hinge (see Figure 1). Dutch Safety Board investigators examined the canopy pieces. There were no signs indicating foreign object damage (FOD), such as from a bird strike. Human blood was found on the canopy and other parts of the aircraft. Given the pilot's injury, this was very probably his blood.

▲ Figure 1: The aircraft after the emergency landing. A small part of the canopy was still attached to the aircraft by means of the hinge.

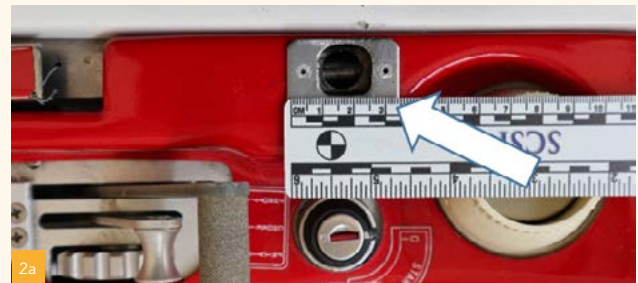
▼ Figure 2a: The front pin-and-hole connection, indicated by an arrow.

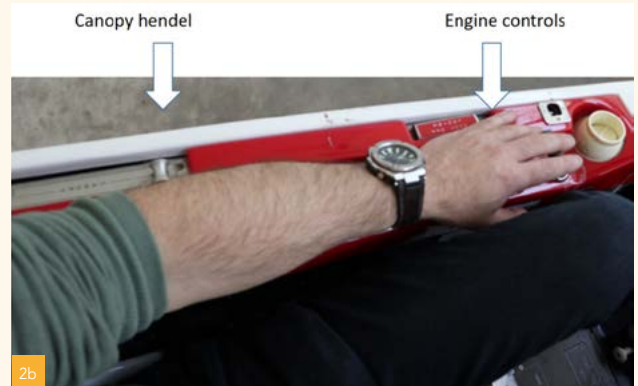
▼ Figure 2b: The locking mechanism handle (indicated by an arrow) is positioned a bit to the rear of the engine controls. It is pushed forwards to lock the canopy and pulled backwards to open it.

- The canopy handle is located at the height of the pilot's elbow and the other engine controls are near his left hand. To operate the canopy handle, the pilot must turn his shoulders. It therefore seems unlikely that the pilot accidentally operated the canopy handle instead of one of the engine controls.

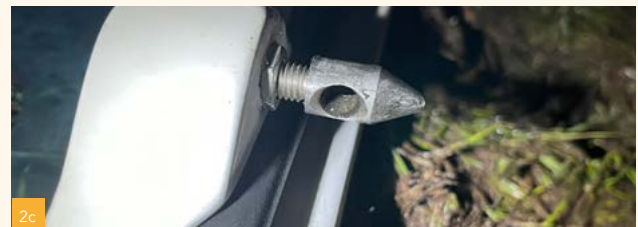
▼ Figure 2c: One of the two canopy pins.

- The handle has an over-centring mechanism, which prevents the position of the handle being altered by a slight touch or a movement of the aircraft.
- When the handle is in the closed position, the locking pins on the aircraft side pass a long way through the holes in the canopy pins, preventing them from slipping loose.
