DUTCH  
SAFETY BOARD

# Fatal Allision with Drilling Rig in Botlek Harbour

*The Hague, 26 February 2025*

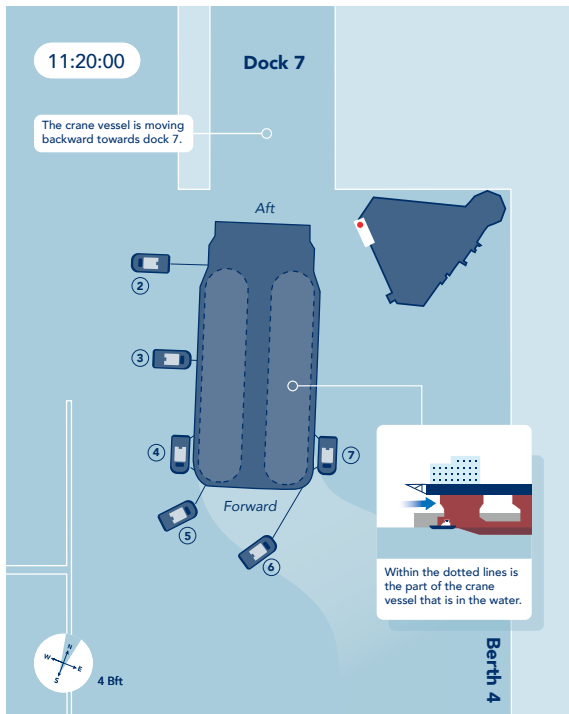
Figure 4 shows the situation at 11.20 hours. The crane vessel is lying stable in front of the dock entrance. The two tugs to port and starboard of the crane vessel (tugs No. 7 and 4 in Figure 4) moved forwards to slow down the crane vessel heading towards the dock. At that point, the other tugs were doing virtually nothing. At about 11.21 hours (Figure 5), the bow of the vessel began to swing to port, towards the jack-up drilling rig.

▲ Figure 4: The crane vessel is lying stable in front of the dock entrance. The stern is lying closest to the dock.

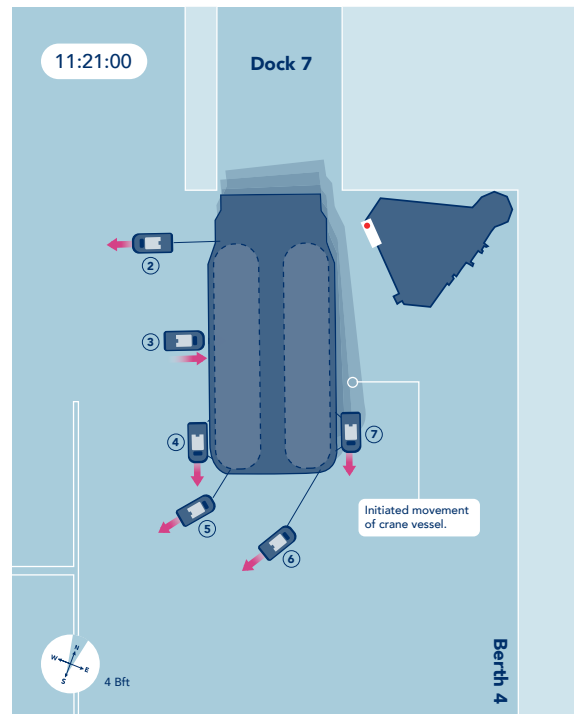
▲ Figure 5: The bow of the vessel begins to veer to port.

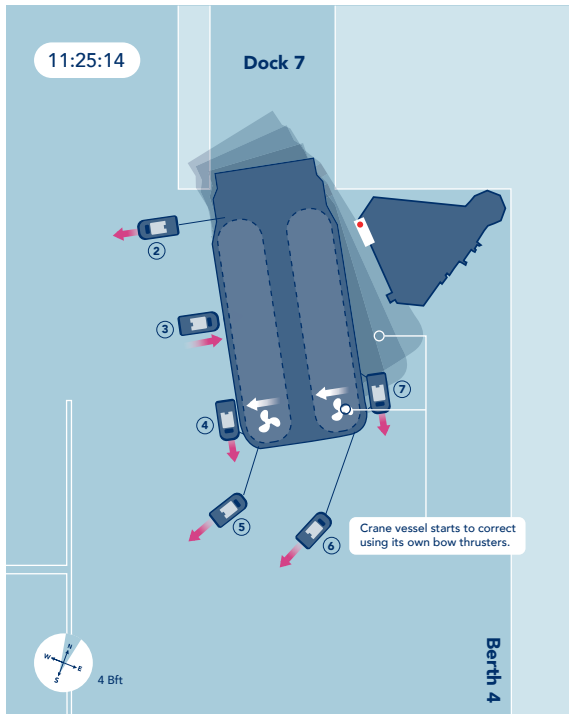
▲ Figure 6: The pilot and captain correct the movement of the bow with the portside tug (No. 6) and the bow thrusters.

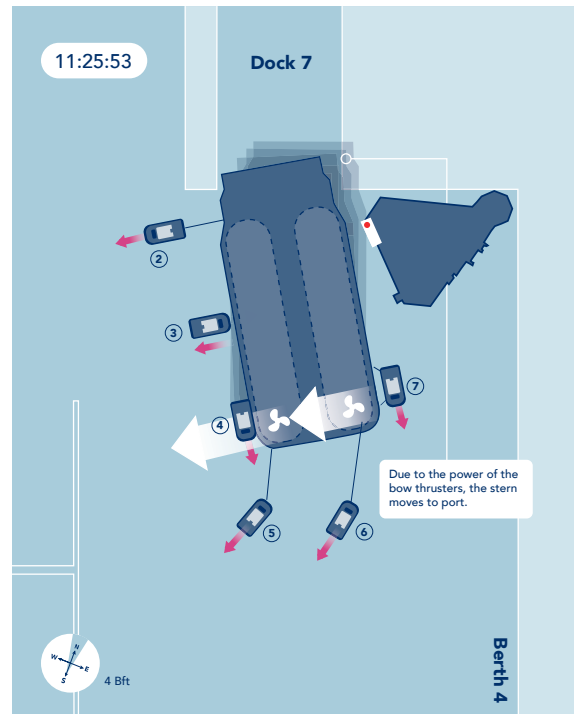
The pilot did not respond immediately to the movement of the bow of the vessel to port and the captain nor one of his crew members notified the pilot they were veering off course. At about 11.24 hours, the linesmen brought the docking lines with their boats to the crane vessel. About a minute later, the pilot instructed the tug that was positioned forward on the port side (tug No. 6) to pull at three-quarter power in an attempt to correct the movement to port. This was followed by the instruction to the tug to start pulling with full power. At 11.25:14 hours, the pilot, through the captain, then instructed the officers on the bridge to turn on the bow thrusters to starboard so as to get the bow back in position (Figure 6). The bow began to swing back to starboard at 11.25:53 hours, with the stern being moved to port by using the bow thrusters (Figure 7).

▲ Figure 7: The bow swings back to starboard resulting in the stern swinging to port.

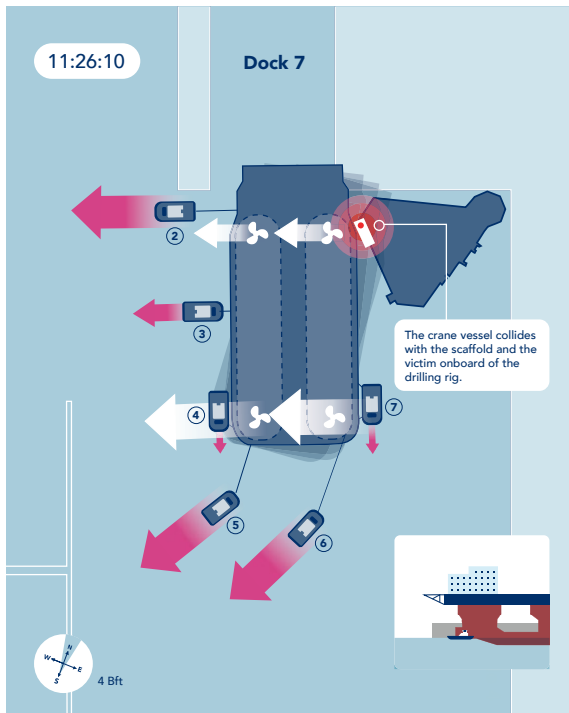
At 11.26:10 hours the crane vessel then allided with the jack-up drilling rig. Just before the allision, the captain ordered the officers to activate the stern thrusters full to starboard in an attempt to keep the stern clear of the drilling rig. The starboard tugs were also ordered to exert full pulling power. This can be seen in Figure 8. As a result, the crane vessel came clear of the drilling rig again and assumed a stable position in front of the dock entrance (Figure 9). When it became clear that a person had fallen into the water, the docking operation was aborted.

▲ Figure 8: The stern thrusters are activated and the starboard tugs are instructed to pull with full power.

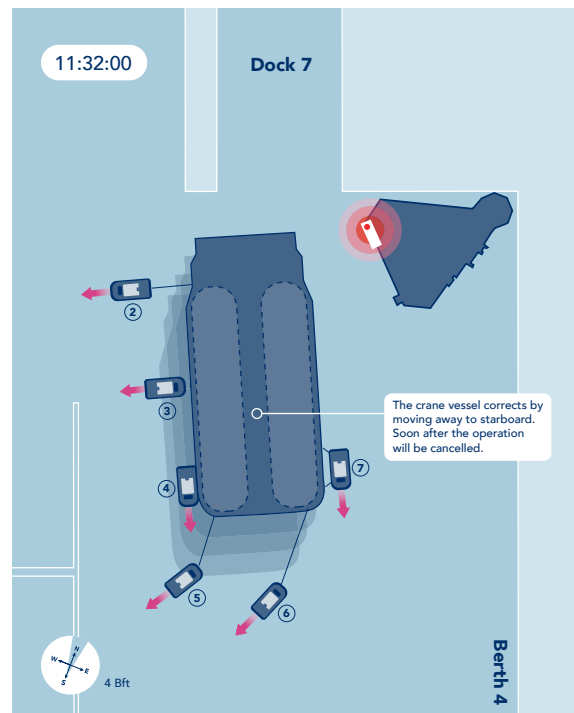
▲ Figure 9: The crane vessel comes clear of the drilling rig again and resumes its position in front of the dock entrance.

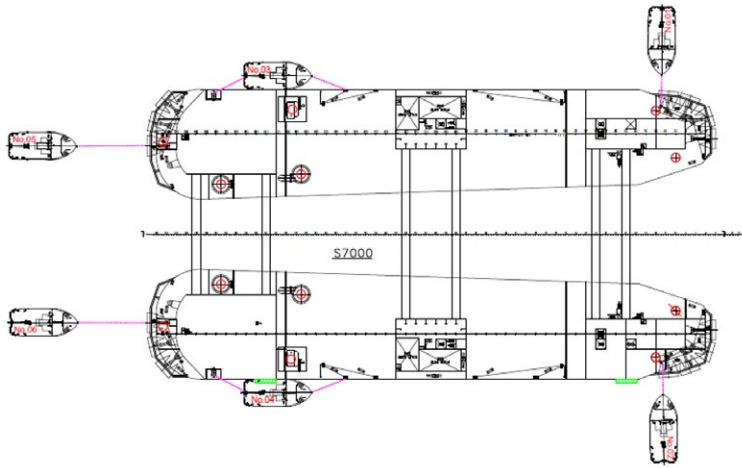
That amounts to a total of 390 tonnes of pulling power. In the 2024 plan, only the distribution of the tugs are described, not the bollard pull. Figure 11 shows the original distribution of the tugs. Table 4 shows the distribution of bollard pull as envisaged in 2017 and as actually implemented in 2024. The total bollard pull utilised in the docking operation was 391,1 tonnes. The tugs are dealt with in greater detail in Paragraph 3.2.1.

▲ Figure 11: The tugs in the original configuration in the 2024 step-by-step plan. (Source: Damen Shiprepair Rotterdam)

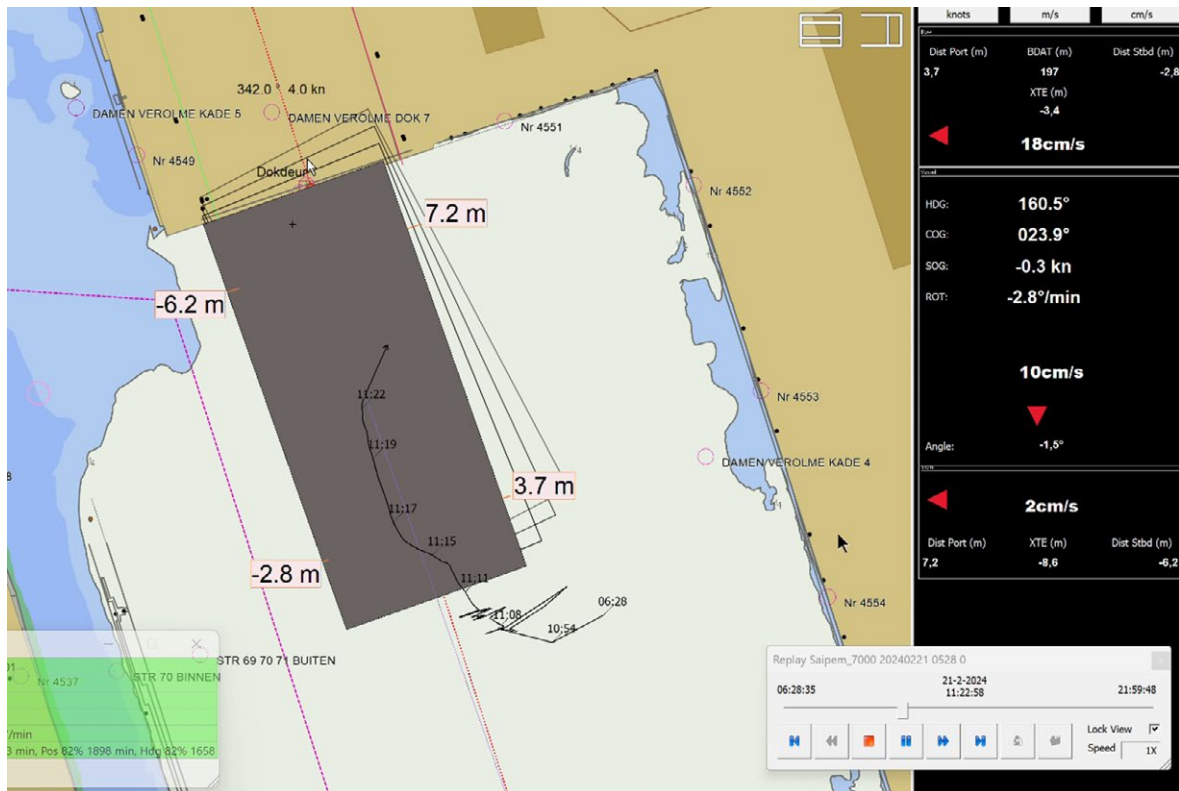
swinging away to port. This can be seen in Figure 12, which shows a snapshot of the NMS. This figure indicates with red arrows that the speed astern was 10 cm/s, the speed of the bow to port was 18 cm/s, and the speed of the stern to port was 2 cm/s. The drift to port of the bow was therefore increasing faster than the drift of the stern. The movement to port continued for three minutes.

The captain, the two pilots, and the Chief DPO had an NMS screen available at their position on which both the vessel's drift and turn and the prediction of its movement were visible. The captain and the pilot both looked at the NMS during the manoeuvre. Once close to the dock entrance, the pilot manoeuvred by sight. Based on interviews it was established that the captain and pilot considered this as more reliable. The data of the NMS show that the movement of the bow of the crane vessel to port started around 11.22:46 hours. The prediction of this movement could be seen two minutes earlier. Other information (CCTV footage and the VDR) shows that tug No. 6 in Figure 3 starts pulling to starboard at around 11.24 hours to get the crane vessel back in line of the dock. This did not have the desired effect and two minutes after the bow of the vessel started moving to port, the captain gave the command to turn on the bow thrusters at 10%. Fifteen seconds later this was increased to 15% and another 10 seconds later to full power. The movement of the bow of the vessel to port decreased and at 11.26 hours the bow started moving to starboard. The prediction on the NMS showed that the aft of the crane vessel was going to move to port as a result of the movement to starboard of the bow. This shows that the information provided by the NMS was not optimally utilised during a period of four minutes.

▲ Figure 12: A snapshot of the NMS at 11:22:58 hours. The image shows the grey contour of the crane vessel with the prediction lines next to it. It is only the position of the drilling rig's GPS antenna that can be seen; its contours are missing. (Source: Rotterdam-Rijnmond Regional Maritime Pilots Corporation)

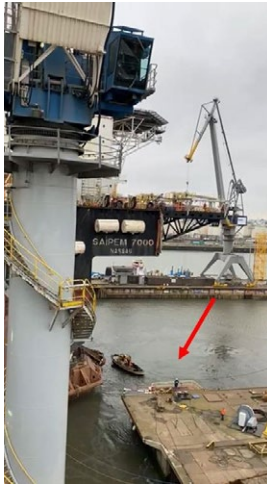
because otherwise, the lines could fall into the water and damage the dock gate. The Dutch Safety Board finds it plausible that this communication distracted the pilot's attention from the fact that the bow was turning away. Figure 13 shows the point when the linesmen's launch brought the docking line from the dock entrance to the vessel.

◀ Figure 13: This photo shows the point (11.24:52 hours) when the port rear docking line was taken to the crane vessel by a linesman's launch (red arrow). (Source: Noble Corporation)

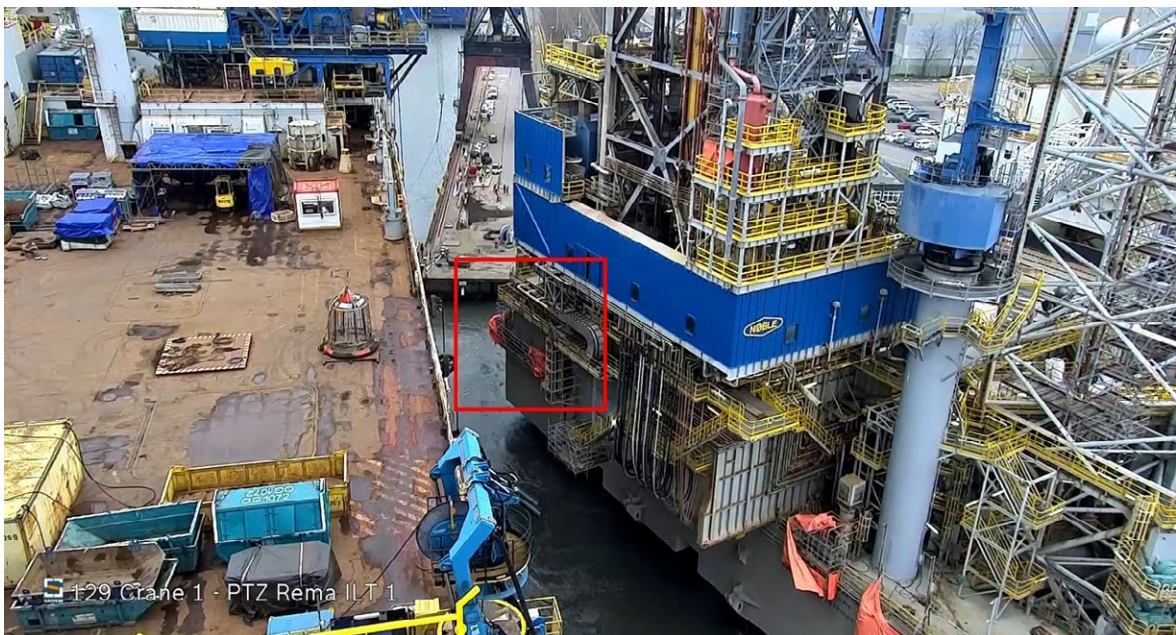
On the bridge, the Chief DPO had however noticed the movement based on various camera images. Figure 14 shows the drift to port as seen by a camera on the crane vessel. The view from this camera on the crane vessel was from fore to aft. The first pilot and the captain were high up on the stern and could not see past the vessel into the dock. The Chief DPO on the bridge did not provide feedback to the captain about what he saw. He also did not know whether the movement formed part of the manoeuvre.

▲ Figure 14: Drift to port as seen by a camera on the crane vessel. Same point in time as in Figure 13. The red square indicates the location of the hanging scaffold. (Source: SPCM, CCTV camera 129 Crane 1 – PTZ Rema ILT 1)

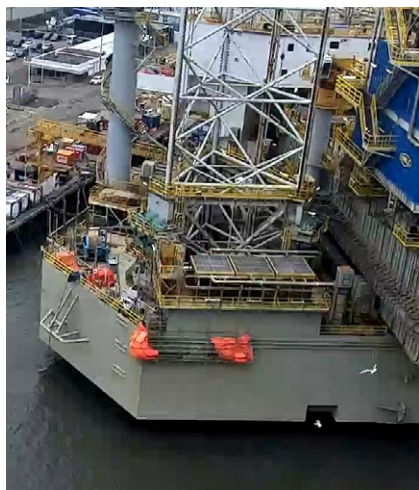
On the outside of the drilling rig, shipyard employees were carrying out repairs to the pipework at four locations (described further in Paragraph 2.2.2). This involved replacing a number of sections of pipework. The sections of pipework that were to be replaced had to be prepared by pipe fitters and finally welded into position by welders. Figure 15 shows the location of the hanging scaffold on the drilling rig.

▲ Figure 15: The location of the hanging scaffold on which the welder was present. (Source: SPCM, CCTV camera 507 Lifeboat Station)
