DUTCH  
SAFETY BOARD

# Quarterly Aviation Report

October - December 2024

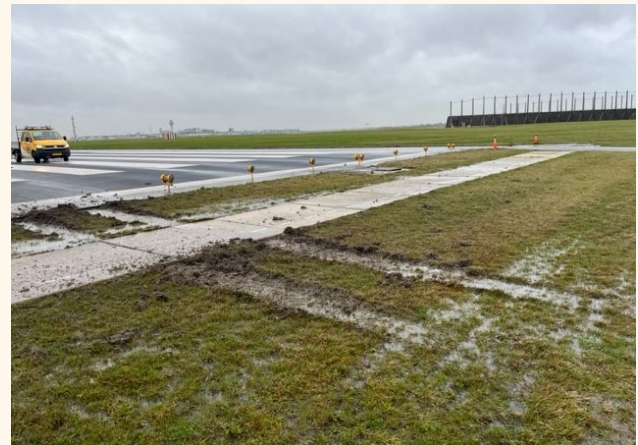
▲ Tracks before the threshold of Runway 22.  
(Source: Amsterdam Airport Schiphol)

**Manual control and trajectory alteration:** The captain manually controlled the aircraft's flight path after disengaging the autopilot at 240 ft radio altitude, allowing a descent below the ILS glide slope and PAPI glide path. This led to compromised safety margins intended to prevent undershoots.

**Environmental challenges:** The aircraft encountered a wind gust and downdraft at approximately 60 ft above ground level, altering its trajectory and leading to an early touchdown before the runway threshold.

**ILS and PAPI system limitations:** The ILS and PAPI system on Runway 22, designed for smaller aircraft, did not meet the International Civil Aviation Organisation (ICAO) and European Union Aviation Safety Agency (EASA) criteria for a minimum threshold crossing height for the A330-300's main landing gear, contributing to the reduced safety margin.

Restrict the use of Runway 22 for Eye-to-Wheel Height Category 4 aircraft landings, until adjustments have been made to ensure the minimum threshold clearance for such aircraft can be achieved.

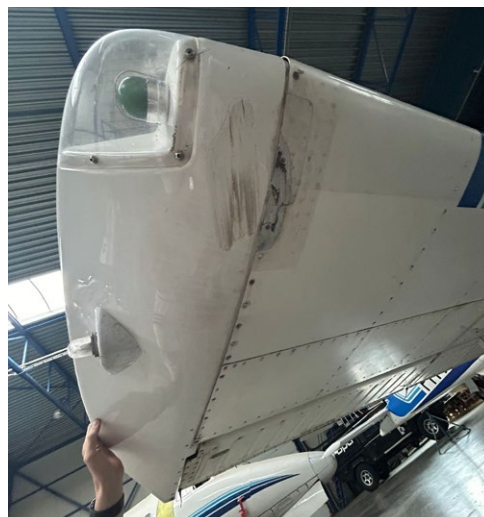
The TB 9 left Lelystad Airport (EHLE) at 15.15 hours for a VFR cross-country flight. Upon its return, the aircraft experienced wind gusts during landing at around 16.35 hours. As a result, the pilot lost control of the aircraft and its right wing tip struck the runway. The aircraft ended up next to the runway and the wing tip was slightly damaged. The pilot and his passenger were unharmed.

▲ The damaged wing tip. (Source: flying school)

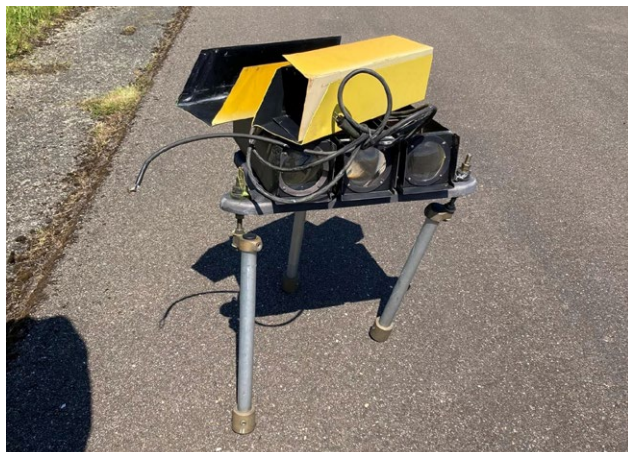
The pilot wanted to make a flight in the DR 400 from Rotterdam The Hague Airport (EHRD) to Breda International Airport (EHSE) to practice landings. During the take-off roll from Runway 06 on EHRD, the aircraft veered off the left side of the runway. This caused the aircraft to hit a Precision Approach Path Indicator (PAPI), resulting in damage to the left wing and the PAPI. The pilot was uninjured.

▲ The PAPI after the runway excursion. (Source: Rotterdam The Hague Airport)

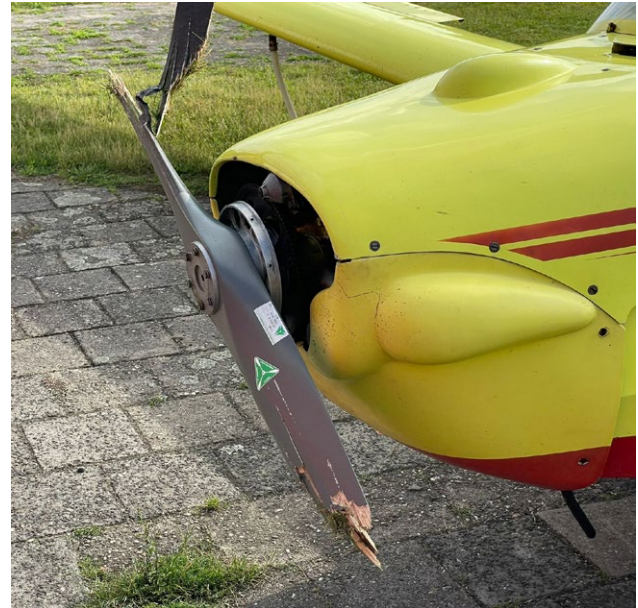
A Touring Motor Glider (TMG) – with a student and an instructor on board – took off from Hilversum Airfield’s Runway 25 for a training flight at about 17.45 hours. Shortly after lift-off, the instructor simulated an engine failure (EFATO)<sup>4</sup> by returning engine power to idle. The instructor’s intention during the EFATO was for the student to land the aircraft on the remaining part of the runway. During the exercise, the aircraft stalled. Despite the nose down manoeuvre that the instructor performed, the aircraft failed to recover from the stall in time. It came down hard on the runway and was badly damaged. The two occupants remained unharmed.

During his flight training, the student had flown about 40 hours and had practised the EFATO exercise regularly. This was the first time that he was supposed to land the aircraft on the remaining part of the runway. During his training, the student had completed most of his flying hours and all his solo hours in a different TMG of the same type. That other TMG had better engine performance, enabling the post-take-off climb to be flown with a higher pitch attitude. During the accident flight, the student may have adopted the pitch attitude that he was used to in the other TMG. The aircraft stalled due to the combination of a high pitch attitude and the reduction in the power of its engine. The TMG was not equipped with a stall warning system.

▼ The damaged SF 25 B. (Source: student)

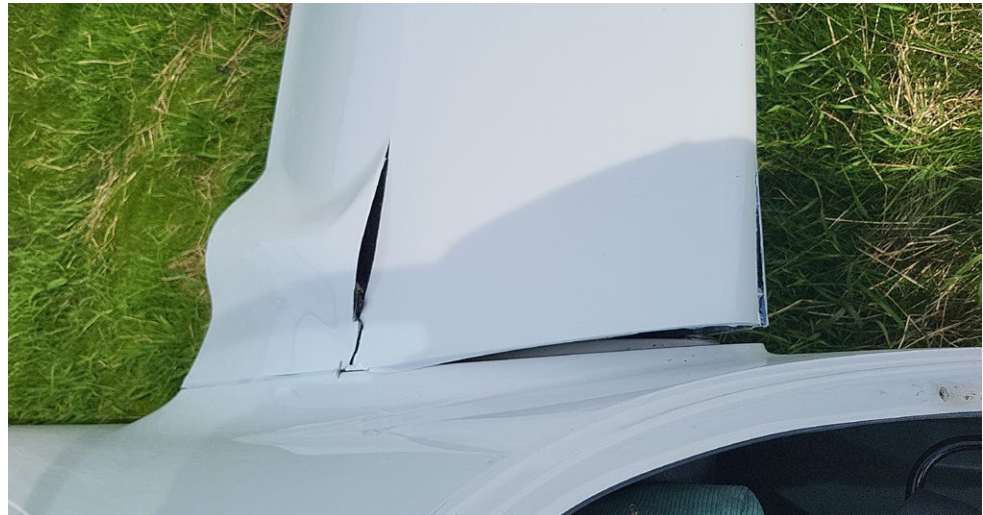
During the landing, the left wing struck a wooden pole, which was in the tall grass beside the ditch and had not been noticed by the pilot. The glider then ground-looped and came to a stop. The pilot was uninjured. The left wing was substantially damaged.

▼ *Damage to the left wing. (Source: pilot)*

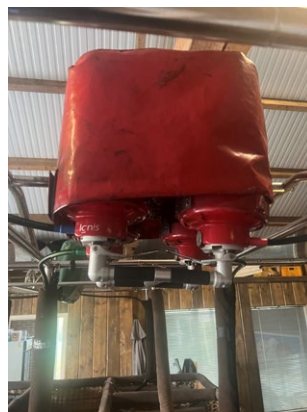
The pilot informed passengers and bystanders that he would test the burners so that they would not be startled by the noise and heat. After that, the pilot performed the burner test to verify if the burners were working correctly and to read the gas pressure on the pressure gauge. During the burner test, the pilot was standing in the basket, right under the red burners. The pilot ignited the pilot light of burner 1 and after that the main valve was opened and liquid gas ignited. However, the red transport cover was still over the burners, pushing some of the liquid gas down and igniting it. Due to the pressure of the gas, the transport cover flew off the burners. The pilot released the valve and dove away. Nevertheless, the pilot suffered first and possibly second degree burns to the face caused by the burner flame and received medical treatment.

The removal of the burner cover was not part of the pre-flight checklist. Normally the pilot or a crew member, dependent on who thinks of it first, removes the burner cover. The pilot stated that he asked for a transponder while performing his checks. A crew member brought this to him. As a result the pilot was distracted and therefore he performed the burner test without removing the burner cover.

▲ Red transport cover over the red burners.  
(Source: Pilot)

The pilot states that the balloon company has the intention to change the burner cover, such that both the burners and valves are covered and to adjust the risk analysis at the end of the balloon season.

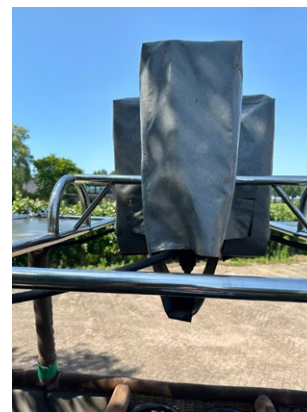
▲ Grey transport cover over red burners and valves.  
(Source: Pilot)

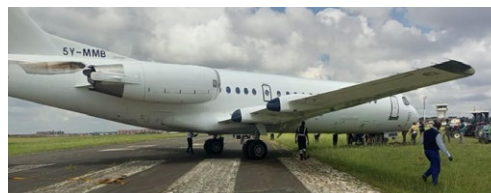
After landing on Runway 07 at Wilson Airport (HKNW), the crew intended to turn the aircraft 180 degrees and then taxi to a taxiway. While turning, the Fokker 70 left the runway and came to a standstill with its nose wheel in the grass. The three occupants were unharmed. The width of the runway (24 metres) was sufficient to perform the planned manoeuvre; for the Fokker 70, the minimum required width for this is 18.87 metres.

▲ The Fokker 70 after the runway excursion. (Source: Aircraft Accident Investigation Department, Kenya)
