DUTCH
SAFETY BOARD

Engine failure followed by emergency landing

Diamond DA 50 RG, Kempen Airport

The Hague, April 2025

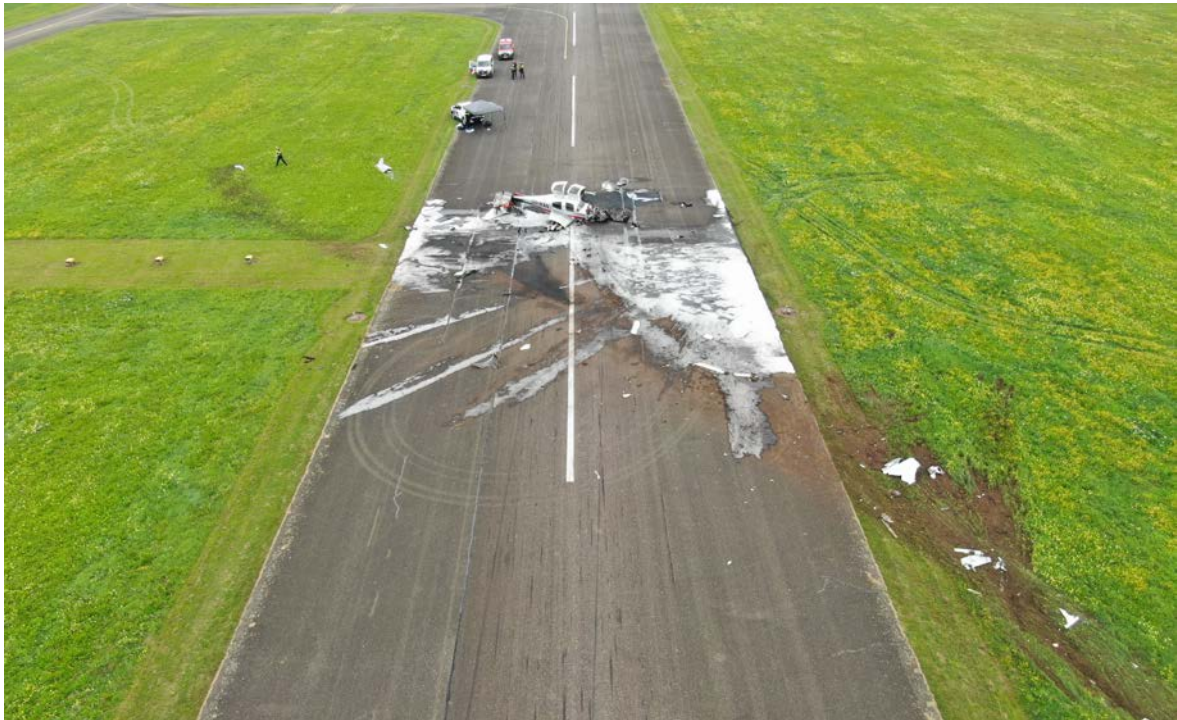
Ultimately, the pilot believed a normal landing became unachievable due to insufficient airspeed. The aircraft crashed on the grass to the right of the runway.

After impact, the right wing was detached and the aircraft spun 180 degrees before coming to rest on the runway surface. The aircraft was destroyed.

▲ Figure 2: Accident location. (Source: Dutch Aviation Police)

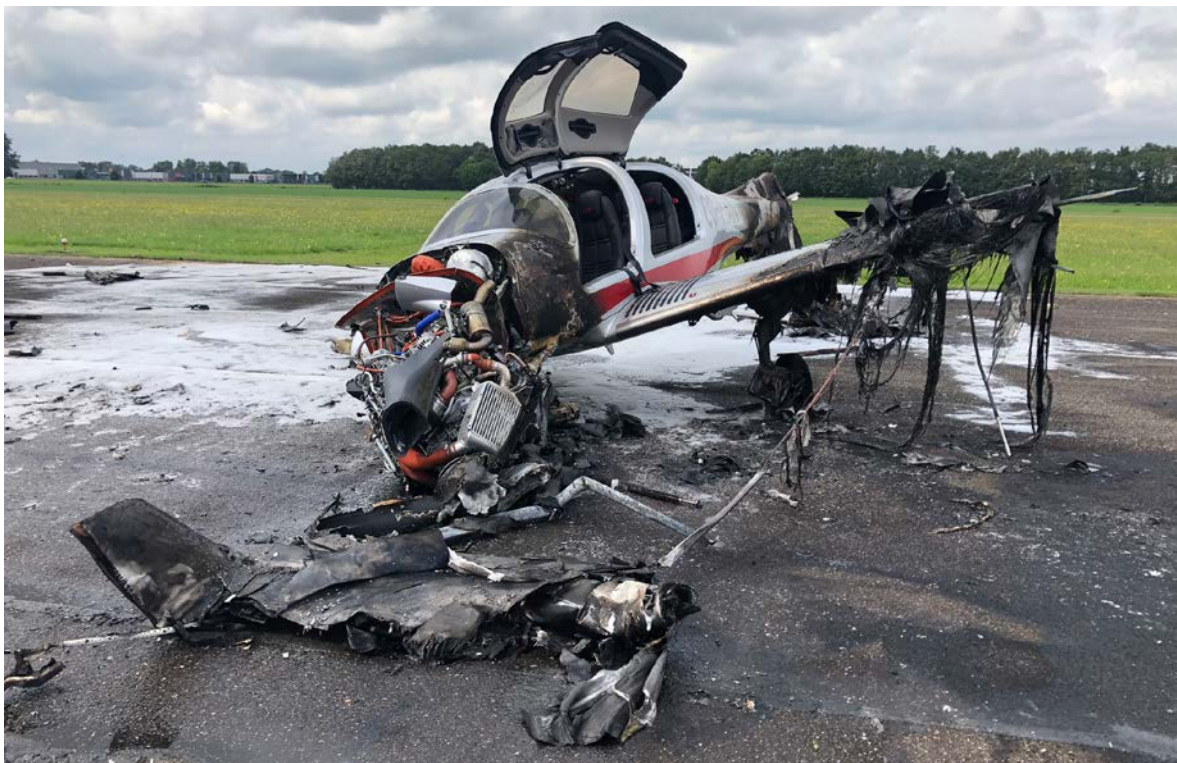
The aircraft was destroyed from both the impact and the fire. The right wing detached from the fuselage and showed significant charring. The outer half of the left wing was almost entirely destroyed, while the inboard part of the left wing is mostly intact. The tail section had broken forward of the rudder and was inverted relative to the fuselage, but remained largely intact, though with visible fire damage on the right side.

The fuselage exhibited heavy scorching and soot, with the forward section near the cockpit showing significant crushing and fragmentation. Despite this, the cockpit structure itself remained intact. The pilot had opened the cockpit door and the cabin doors were found open.

Extinguishing foam covered much of the ground around the wreckage. Scorch marks and blackened areas on the runway and surrounding terrain indicated the extent of the post-impact fire. Remnants of the landing gear were visible, appearing crushed or detached, with debris scattered along the runway.

▲ Figure 3: Aircraft wreckage

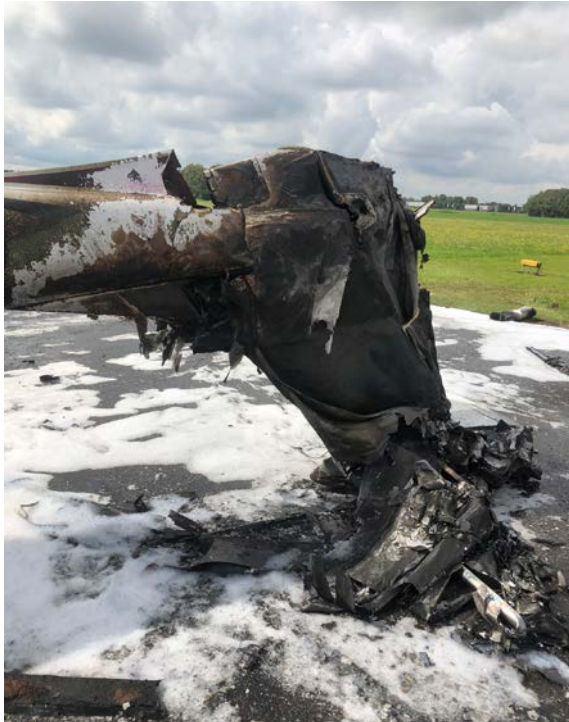
The fuel tank located within the right wing ruptured, resulting in fuel spillage on the runway. The spilled fuel, combined with other combustible materials and sources of ignition present at the scene, led to a fire that damaged the left wing (see Figure 3) and tail section (see Figure 5 and Figure 6). The fire persisted for several minutes before being successfully extinguished by the airport's fire service.

▲ Figure 5: Right side of tail

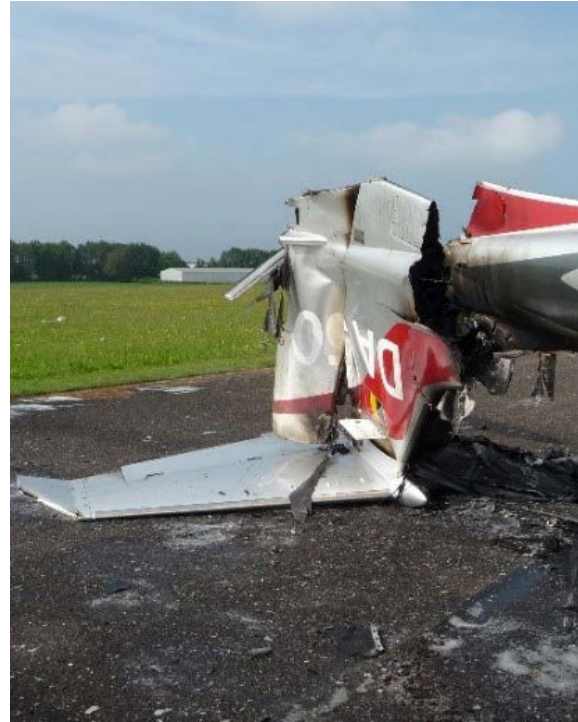
▲ Figure 6: Left side of tail

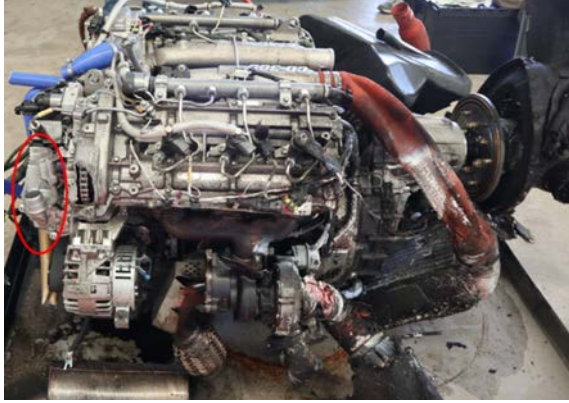
The Dutch Safety Board conducted a field investigation of the engine. Investigators found that the crankshaft could not be rotated. Several areas of damage were observed, including holes in the engine crankcase (see Figure 11) and oil pan (see Figure 10). The engine oil filter and its bowl were not found during multiple search attempts, with evidence indicating that the filter bowl had torn off (see Figure 7 and Figure 9).

▲ Figure 7: Teared off filter bowl

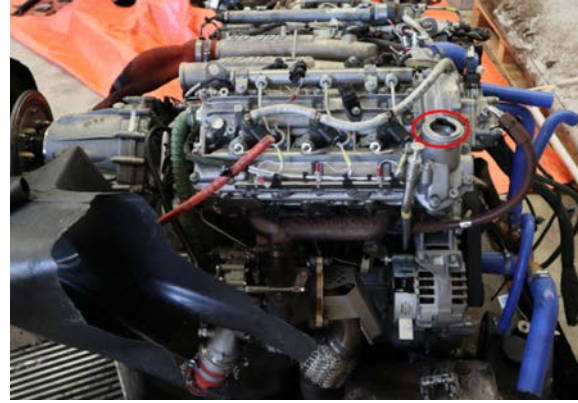
Additionally, the oil filler cap was also missing and could not be located (see Figure 8). In spite of these findings, no traces of engine oil were observed on the exterior of the engine.

▲ Figure 8: Missing oil filler cap

Although the oil sump was empty following the accident, this was attributed to a hole in the oil pan caused by ground impact. The absence of oil traces on the exterior of the engine makes it unlikely that the missing oil filler cap contributed to the loss of oil, oil pressure or lubrication failure.

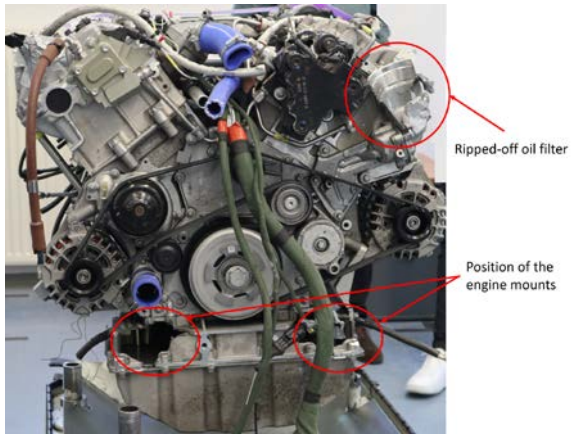
▲ Figure 9: Damaged oil filter bowl and oil pan

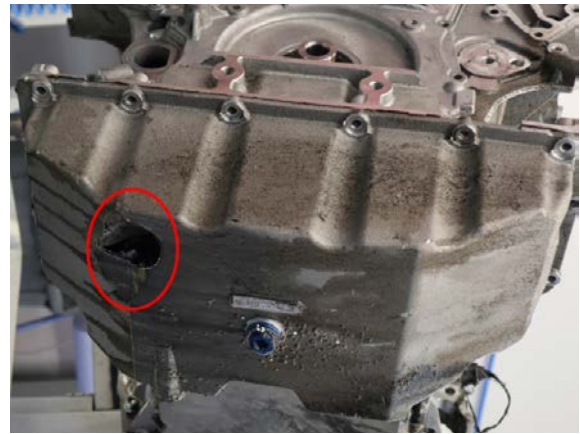
- ▶ Two holes were observed in the upper oil pan, caused by the tearing off of the engine rear mounts.
- ▶ Several holes were found in the crankcase.
- ▶ A hole was noted in the bottom oil pan⁶, with no oil remaining in the sump.

▲ Figure 10: Hole in oil pan

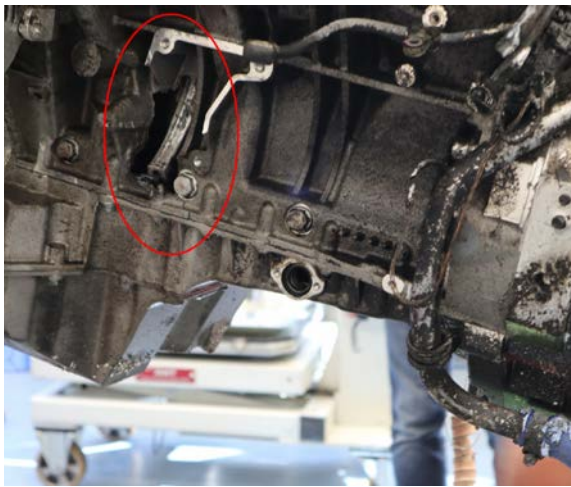
▲ Figure 11: Damaged crankcase

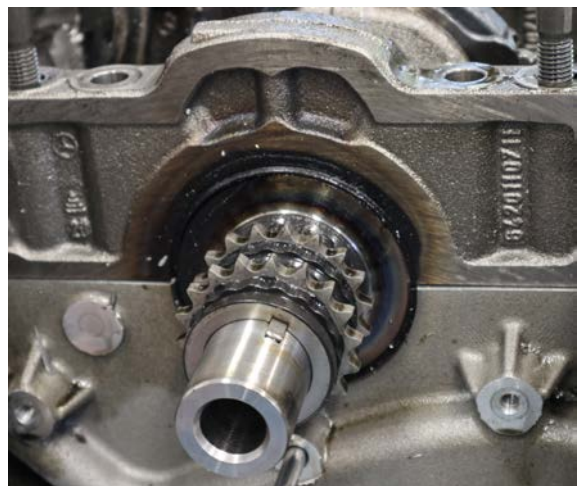
- ▶ The crankshaft could not rotate.
- ▶ Several big-end bearings were damaged.
- ▶ Main crankshaft bearings:
 - ▶ Bearing #1 showed fretting marks and a heat imprint (see Figure 12) on the crankcase.

▲ Figure 12: Main #1 bearing heat imprint

The overheating of main bearing #1 was likely a secondary consequence of the loss of oil pressure caused by the initial failure of bearing #2. Once lubrication to the downstream components was disrupted, the entire system rapidly degraded, resulting in mechanical seizure. Metal chips originating from broken engine components inside the engine, caused damage to the engine oil pump. Additionally, insufficient filtration of engine oil can contribute to contamination, but there is no evidence that the oil filter was missing before take-off or that oil impurities played a role in this failure.

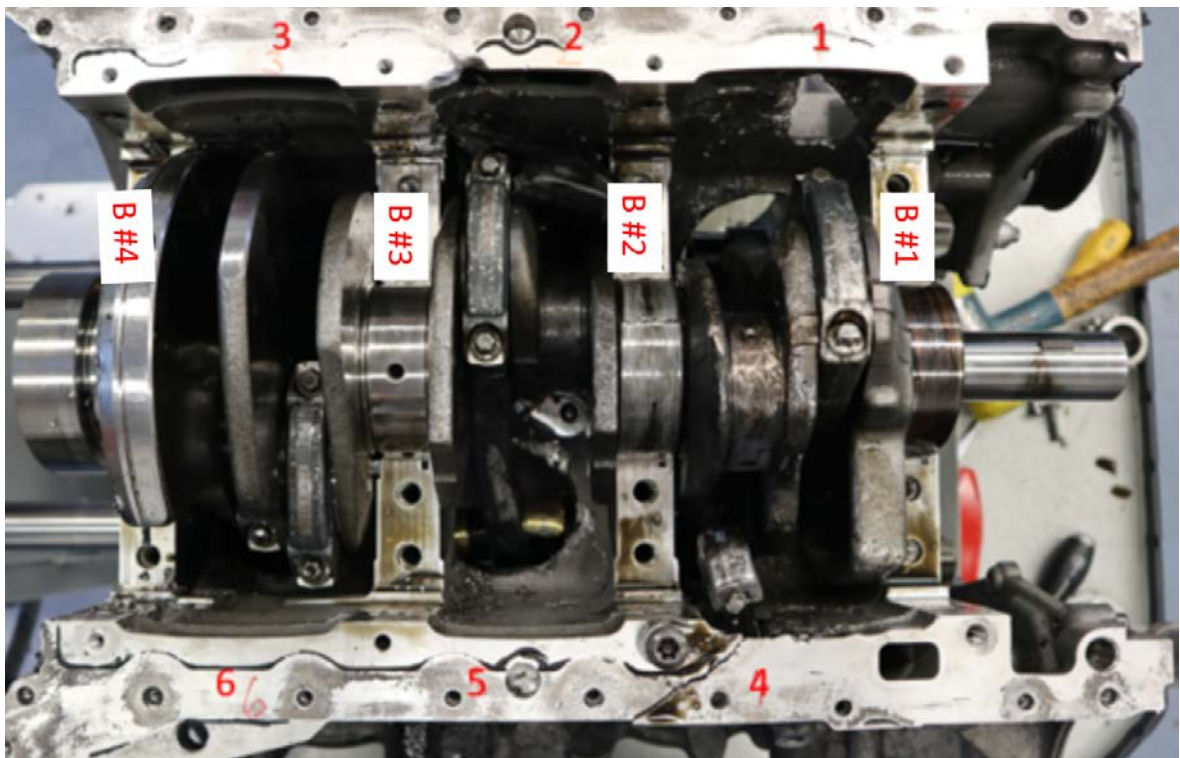
▲ Figure 13: Positions main crankshaft bearings and big ends (bearings)

The destruction of main bearing #2 (see Figure 13) disrupted the lubrication of big-end bearings #2 and #4, causing their failure.

The engine failure that led to the accident resulted from a crankshaft main bearing #2 failure. This main bearing #2 plays a key role in distributing oil to the connecting rod bearings for cylinders #2 and #4 via internal oil channels in the crankshaft. The lubrication to these components was interrupted, leading to their overheating, seizure, and eventual breakage of the connecting rods. Some of the connecting rods protruded through the crankcase.

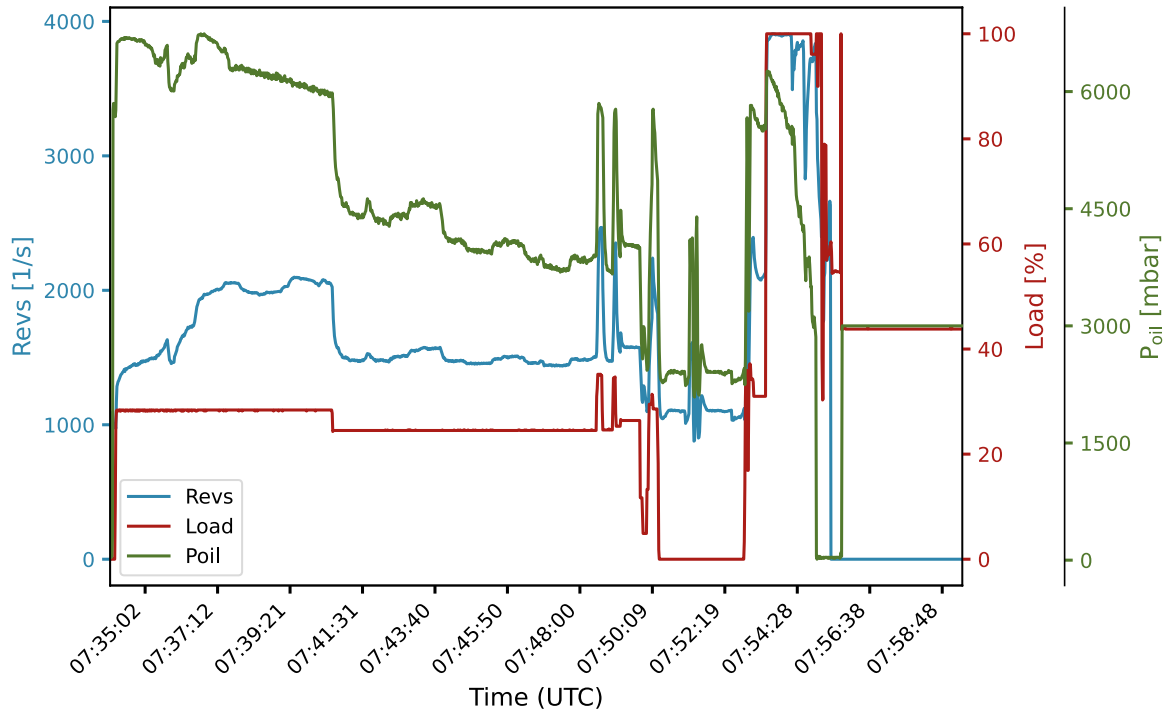
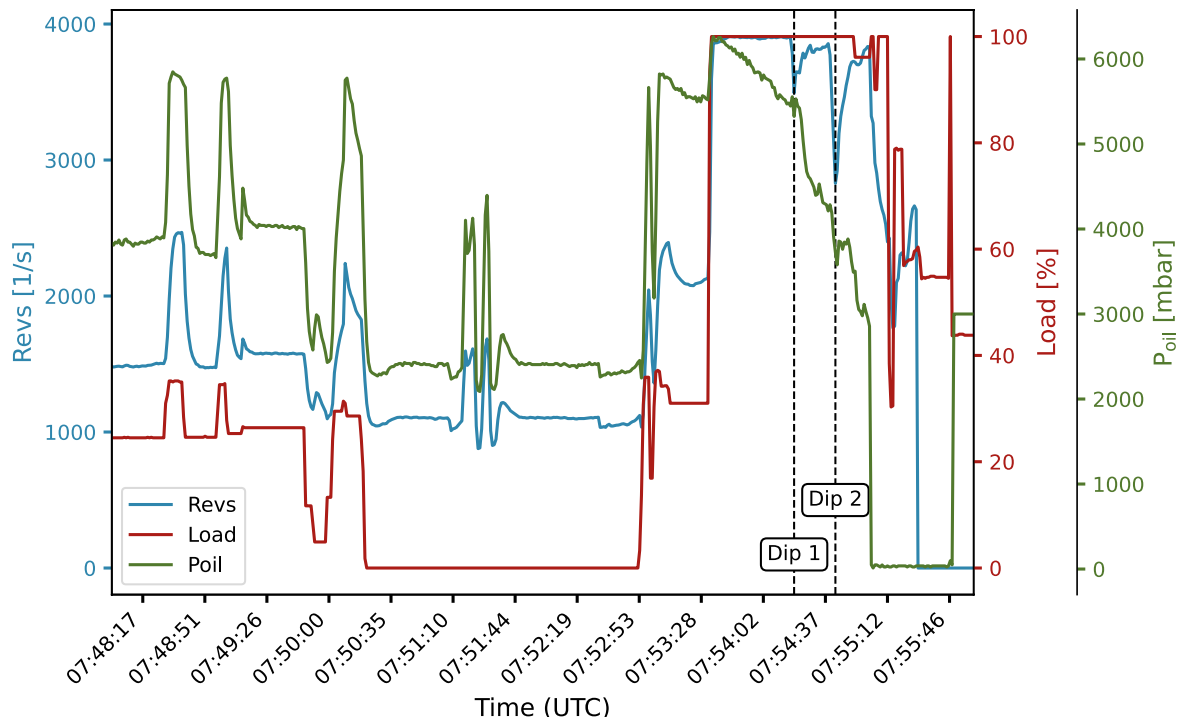
The engine data indicate that shortly after the engine load was set to 100%, the oil pressure began to drop. Additionally, two drops in engine revolutions were recorded, as marked in Appendix C.

The FADEC data from the accident flight recorded two notable drops in engine RPM, followed by a rapid decline in oil pressure to zero. On-site and teardown inspections confirmed extensive internal damage, including holes in the oil pan, a broken gearbox, and the absence of the oil filter and oil cap. The teardown identified main bearing #2 as the likely point of initial failure. This failure disrupted lubrication to connecting rod bearings #2 and #4, causing them to overheat and seize.

▲ Figure 15: FADEC data of OO-HAN on 2 September 2023

▲ Figure 16: Part of FADEC data of OO-HAN on 2 September 2023 indicating dips in engine revolutions
