DUTCH
SAFETY BOARD

Shipping Occurrences Report

July 2024 – December 2024

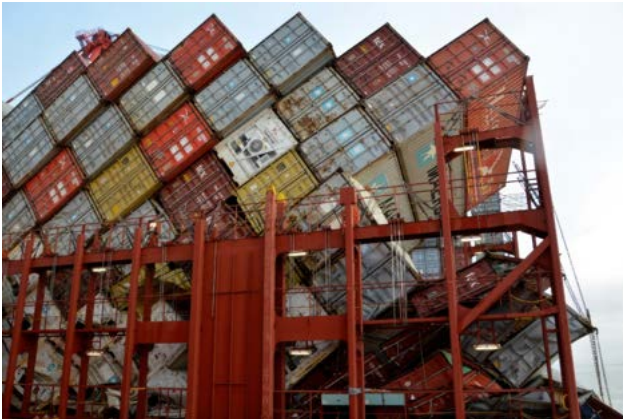
The investigation into the circumstances showed that the main cause of the loss of containers were extreme forces exerted on the vessel and its lashing systems by the northwesterly storm. It was also determined that taking the relatively shallow southern shipping lane to the north of the Wadden Islands entailed a risk of seabed contact due to the vessel's combination of vertical and horizontal movements.

▲ *Figure 2: Fallen containers on board MSC Zoe.*

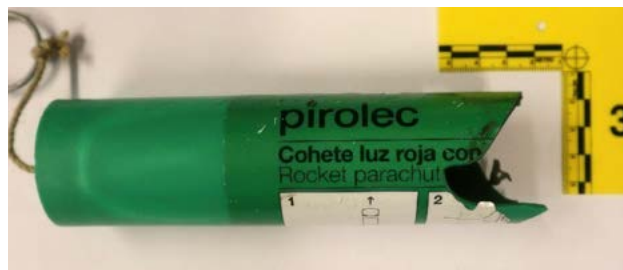
abnormalities were detected. It was determined, however, that the failure mechanism that caused the flare to explode was the direct result of excessive combustion of the solid propellant. This led to the build-up of extreme, excessive pressure, causing the motor to burst open explosively.

▼ *Figure 10: Recovered remnants of the exploded flare.*
(Source: Bontekoning)

The Safety Board made recommendations to both the manufacturer and the inspection body responsible for the type approval.

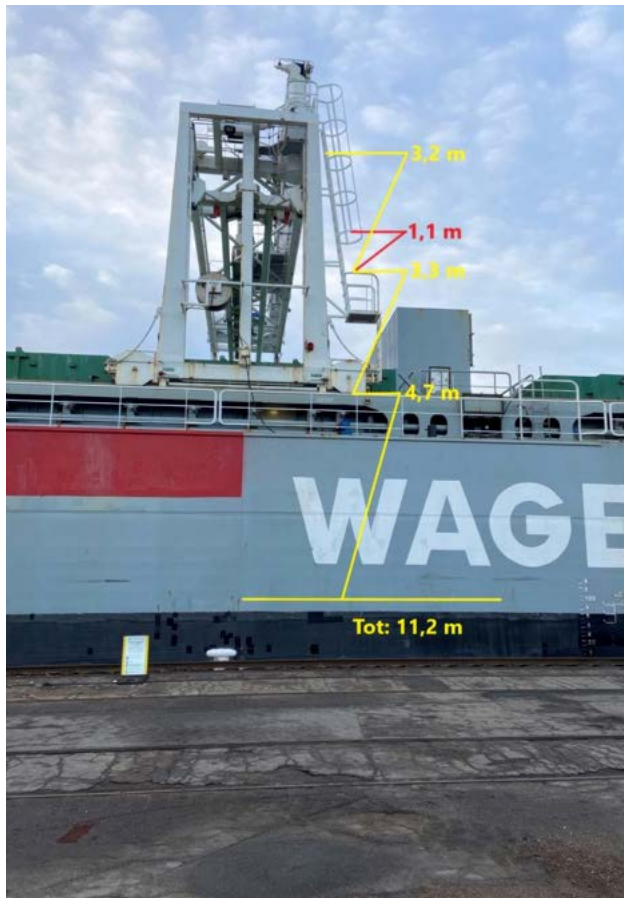
◀ Figure 11: The photo shows how the person fell down onto the quayside. Yellow lines and figures indicate the heights of the various stages of the fall. Red figures and lines mark the opening that was present between the ladder's protective cage and the railing on the narrow platform. The photo was taken on a different occasion when the draught of the vessel was different. The bottom yellow horizontal line marks the height of the quayside at the time of the accident. (Source: Statens Haverikommission)

The report shows that there were deficiencies in the fall protection arrangements on the hatch crane. The upper part of the ladder was equipped with a protective cage that seems to have worked as intended. However, the platform under the ladder was too small or did not have surrounding protection that was high enough to catch the falling crew member. At the time of the accident the person was wearing several layers of clothing and a helmet with a chinstrap. The clothing and personal protective equipment probably mitigated the consequences.

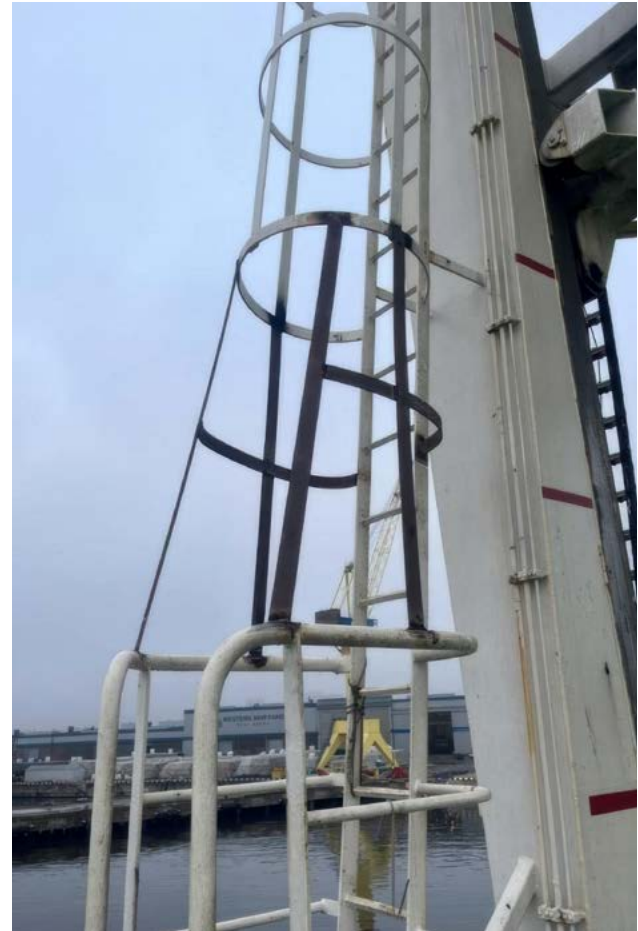
▼ *Figure 12: The photo shows the additional protection that was added between the platform railing and the ladder's protective cage. (Source: Wagenborg Shipping)*

The measures taken by the shipping company after the accident were considered sufficient and the SHK saw no need to issue any recommendations.

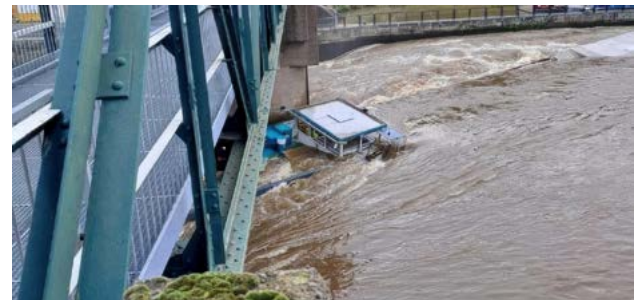
The vessel became trapped with its stern under the shipping opening of the weir, which initially led to a rise in the water level in the River Meuse. The salvage operation proved difficult. On 18 October, the vessel was successfully pumped empty and extracted from under the weir. The fact that the weir was open for almost a week caused the water level in the Meuse to fall considerably, causing problems for nearby houseboats and harbours. After the vessel had been removed, the weir could be closed again. The water level could then be restored, after which shipping traffic was able to resume on 19 October.

▼ *Figure 15: The Humadivi under the weir at Borgharen. (Source: RWS)*

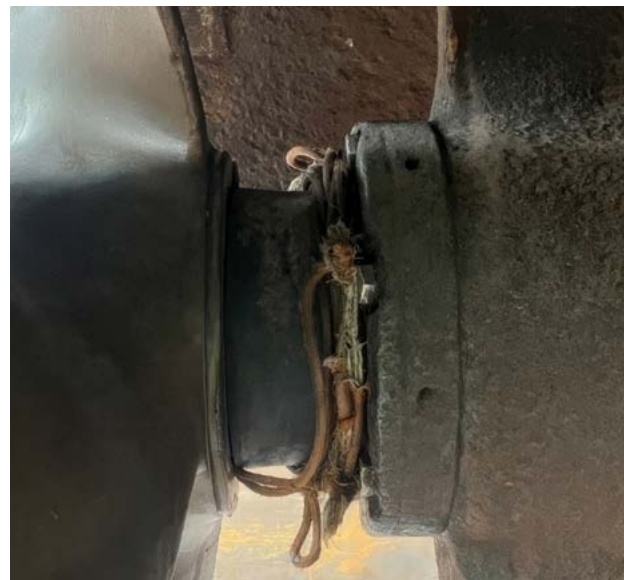
▼ *Figure 16: Mooring line in the propeller of the Humadivi.*

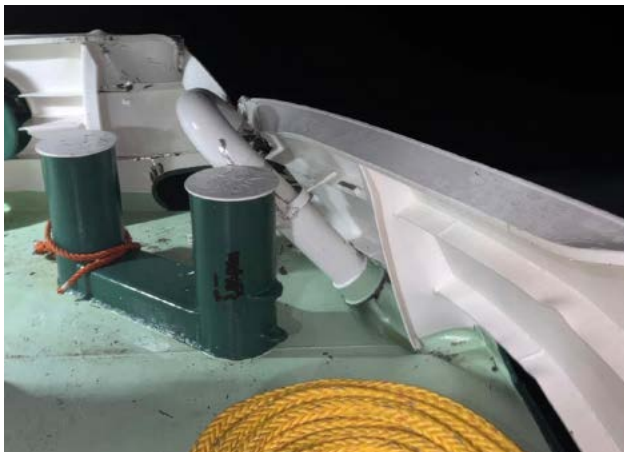
▼ *Figure 17: Damage to the stern part of the Amadeus Saffier.*
(Source: De Bock Maritiem)

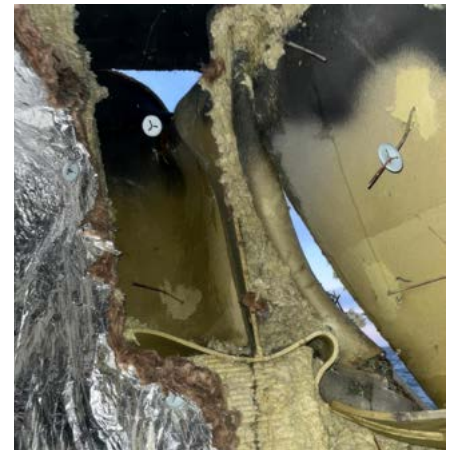
► *Figure 18: Damage to the Amadeus Saffier, interior view.*
(Source: De Bock Maritiem)

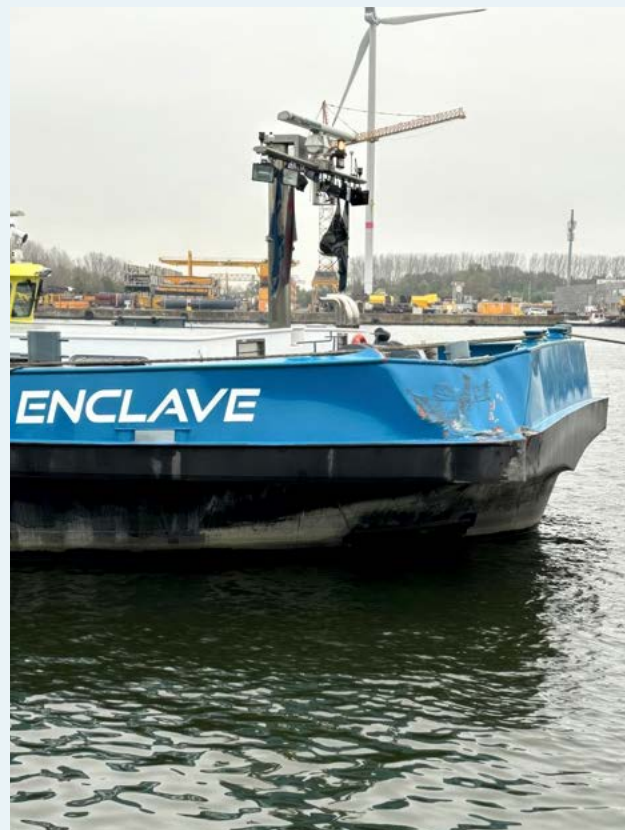
- ▶ *Figure 19: Damage to the dry cargo tanker Enclave. (Source: VT Group)*

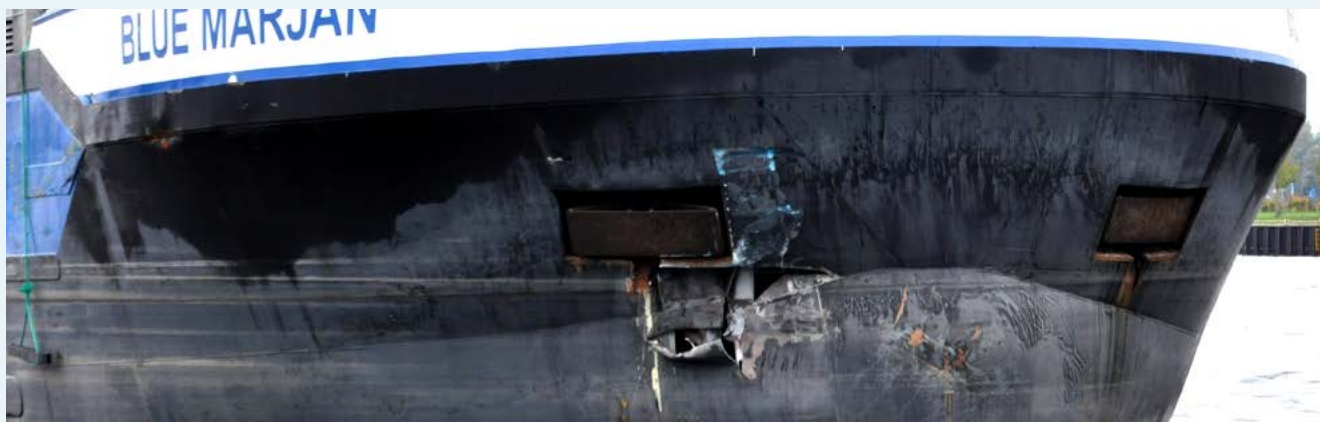
- ▼ *Figure 20: Damage to the Blue Marjan. (Source: Adri v.d. Wege)*

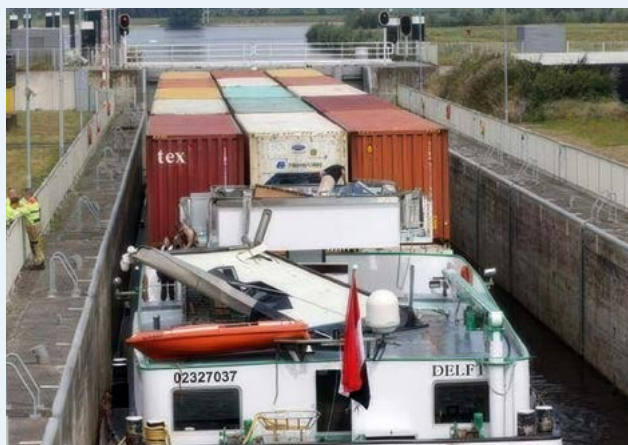
▲ *Figure 23: The Alfa Nero in the Empel lock after the collision.*
(Source: Schuttevaer)

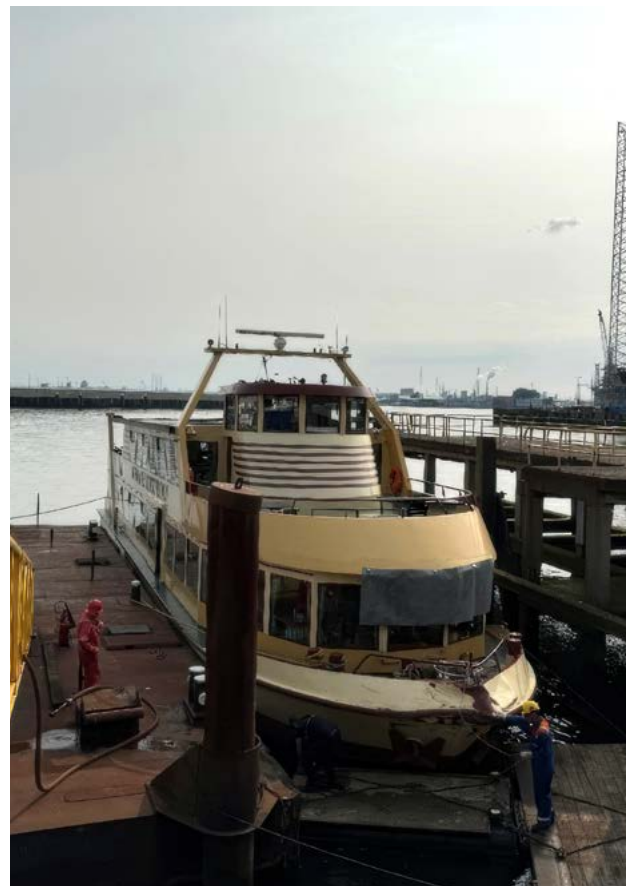
▼ *Figure 24: Pannenkoekenboot II undergoing repair.*
(Source: RLG)

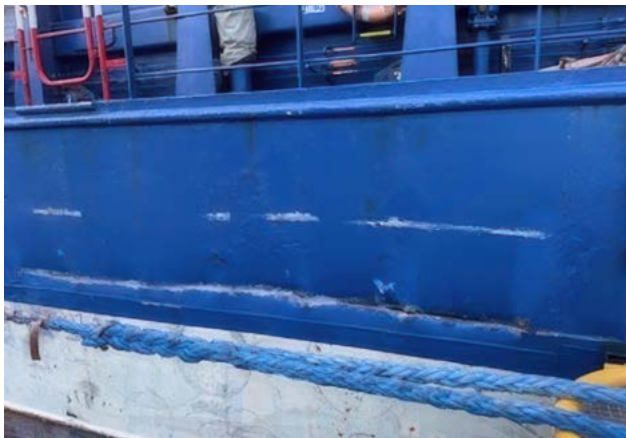
▲ Figure 25: Damage to the Wilson Dublin. (Source: Wessels Reederei)

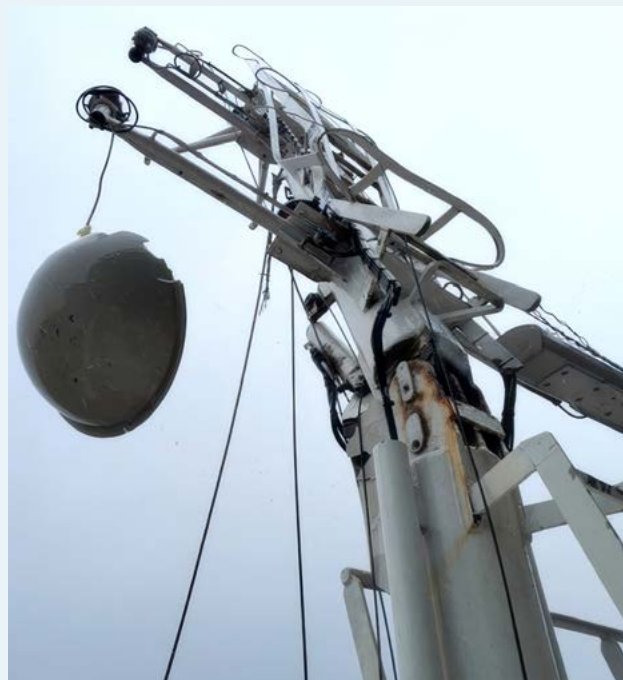
▼ Figure 26: Damage to rear mast of the Eikborg. (Source: Wagenborg)

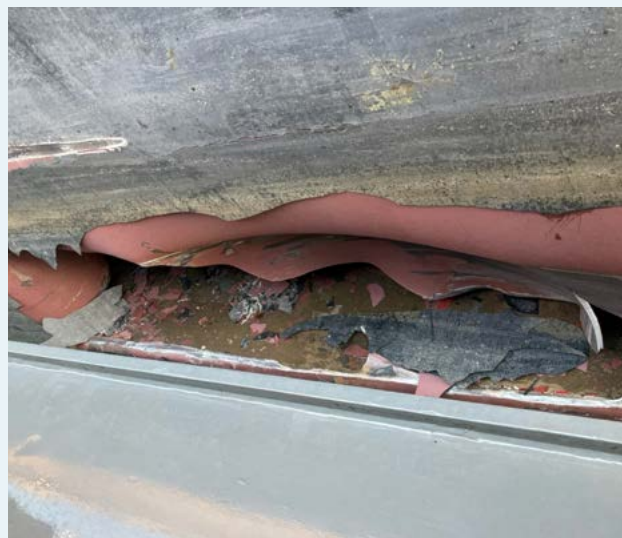
▲ Figure 28: Tear in the starboard side of the hull, 1 metre long and 50 centimetres wide. (Source: Union Shipping)

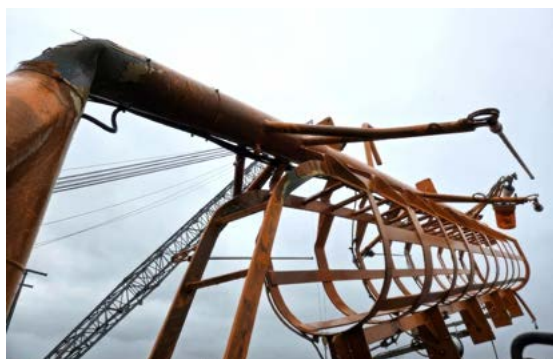
▲ Figure 29: Damage to the mast of the Eems Warrior. (Source: Amasus Shipping)

The Dutch tugboat Eems Warrior allided with the Botlek Bridge on the Oude Maas at 06:53. In response to this allision, the speed of the vessel was reduced. Despite this, a second minor allision with the Oude Spijkenisse Bridge at 07:00 could not be avoided and the tugboat's mast was badly damaged. Both bridges sustained minor damage. An investigation by the shipping company revealed that the necessary height of the bridges had not been included when preparing for the journey, perhaps because the vessel had previously passed under these bridges without any problems. It also became clear that the nautical publications had not been installed and that there were no printed copies on board. After an inspection, the tugboat was able to proceed to a shipyard for repairs. There were no injuries.

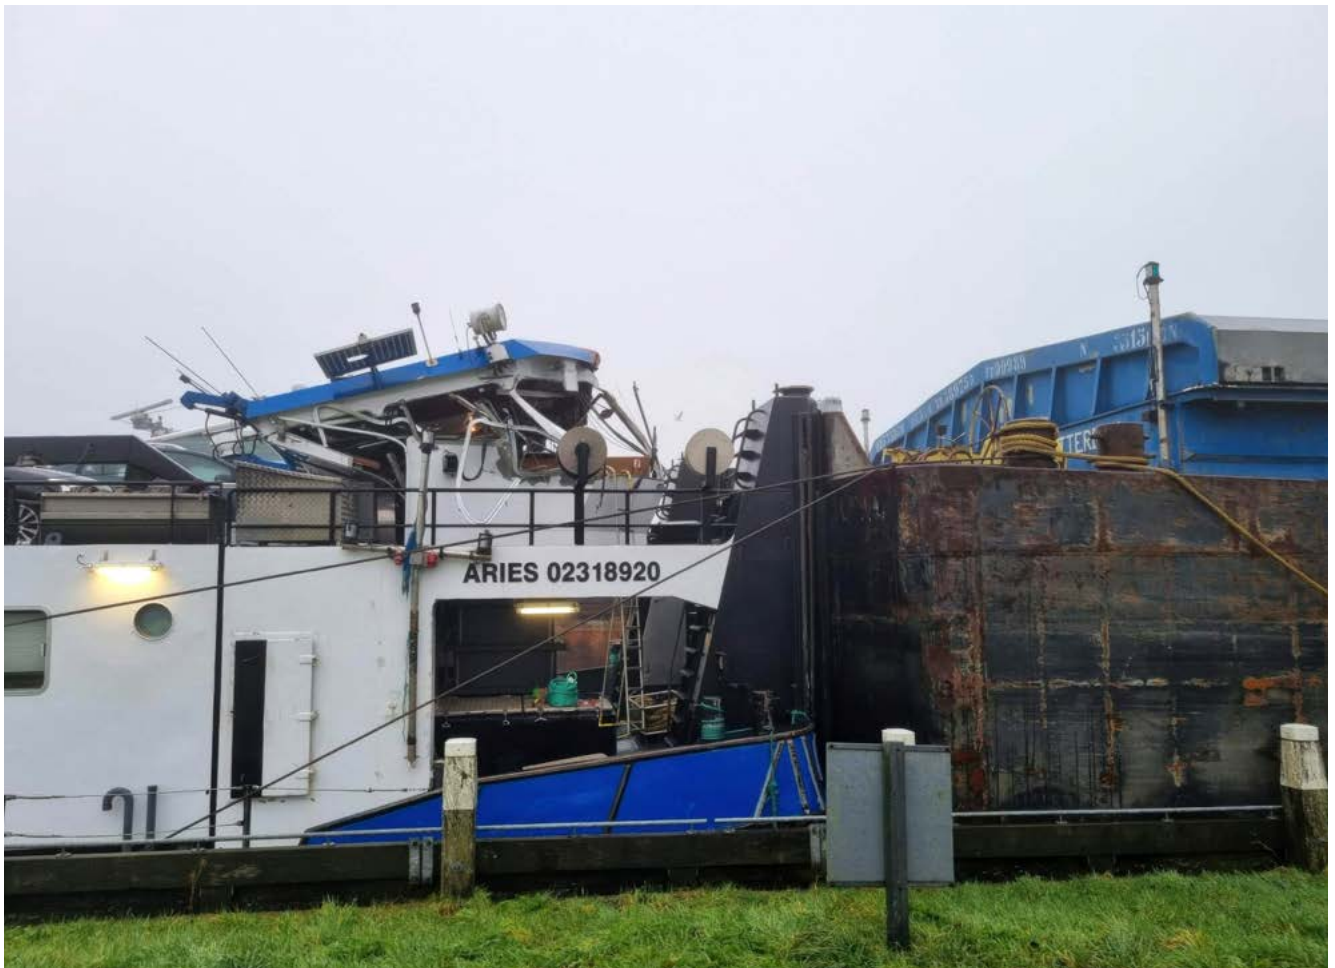
▼ *Figure 30: Damage to the wheelhouse of the Aries.
(Source: Police)*

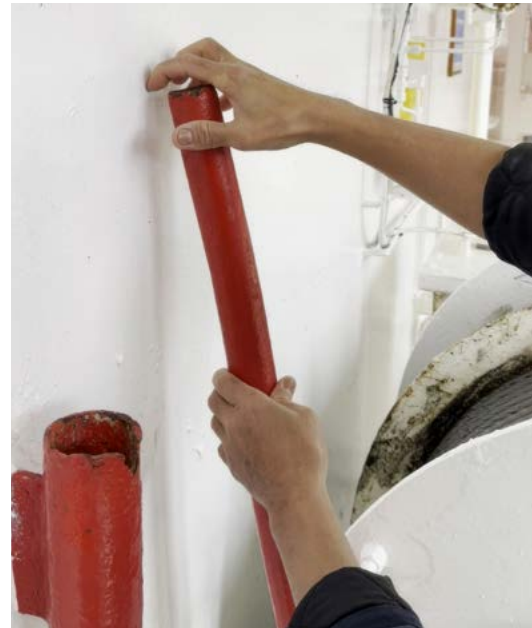
▲ Figure 32: Simulation of how the winch was operated. At the time of the accident, the crew member was in fact wearing gloves. (Source: HAL)

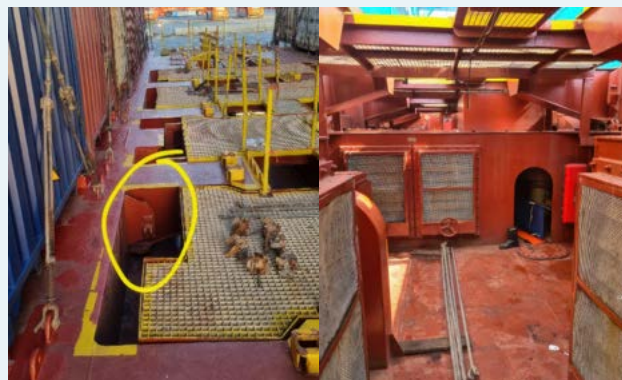
- ▼ *Figure 33 (left): The opening on the upper deck of the Nordica (Source: Nordica)*
- ▼ *Figure 34 (right): Walkway under the platform on the Nordica (Source: Police)*

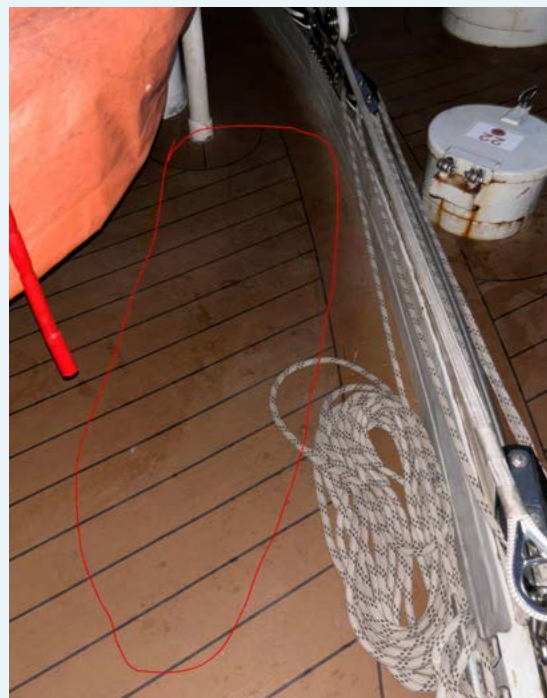
▼ Figure 37: Location on board where the crew member fell.
(Source: Stichting Eendracht)

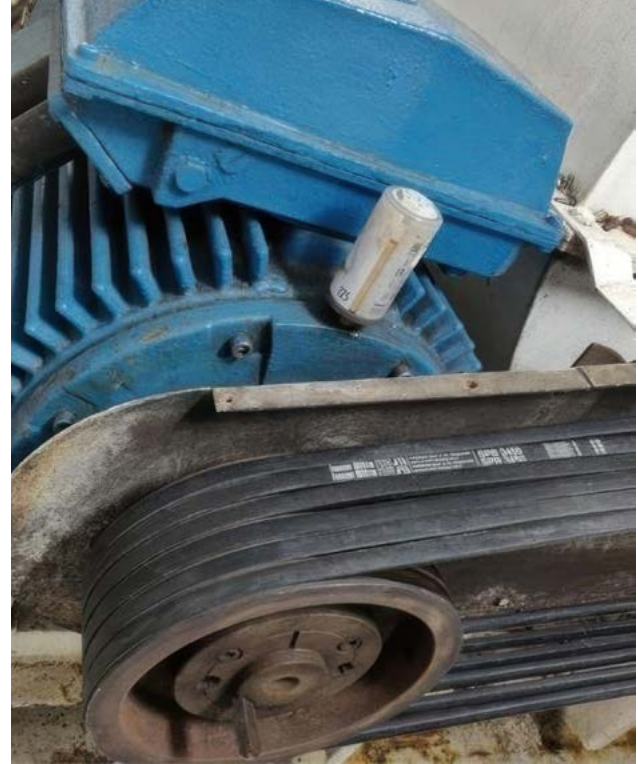
► *Figure 38: The fan belts concerned (V-belts). (Source: HAL)*

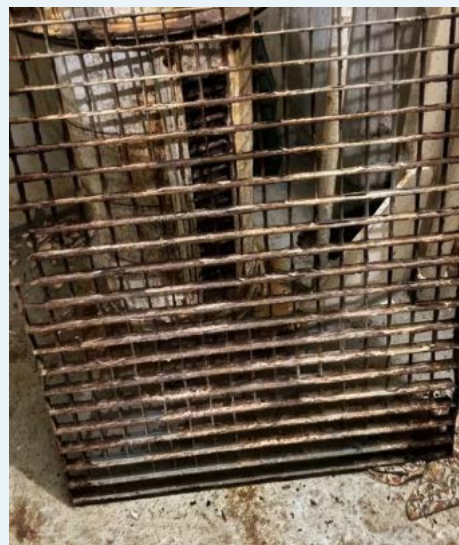
▼ *Figure 40: Walk grate in the cargo hold that collapsed.*
(Source: *Wagenborg*)

moreover, the vessel was twenty-five years old. During the 25-year Special Survey in 2024, the classification agency (external), the company's own Fleet Management Department, and the crew (both internal) all failed to notice this condition of the gratings. The deckhands had reported the state of the grating to the shipping company, but the latter had not taken any action.

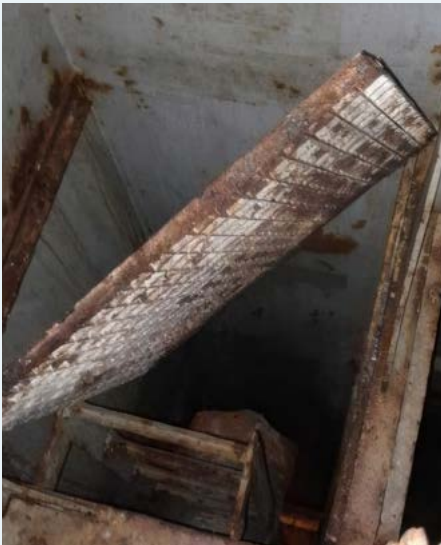
▼ *Figure 41: Situation after the incident.*

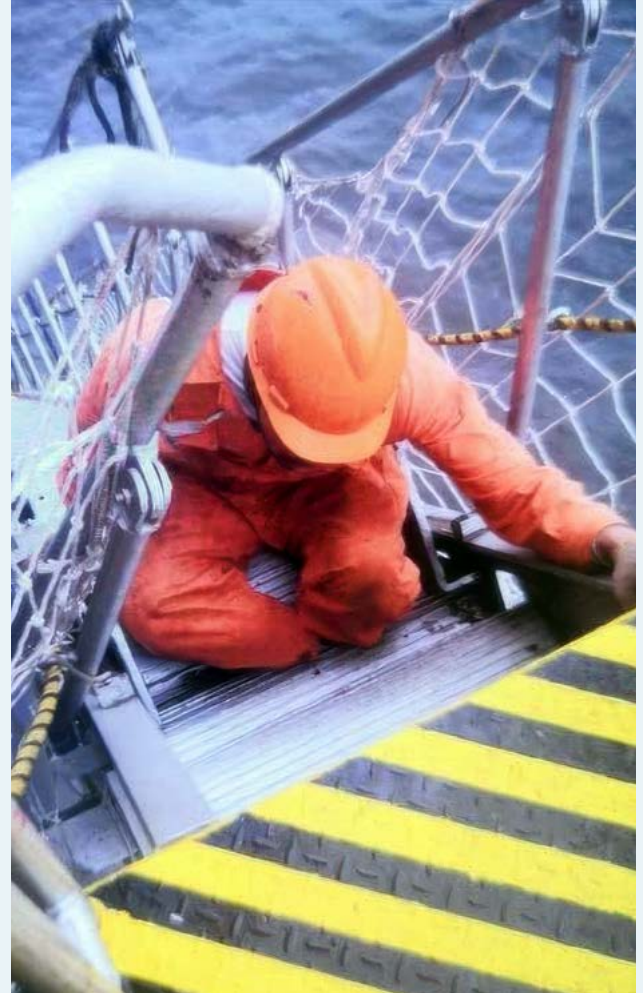
▲ Figure 43: Simulation of accident on gangway on board the *Alma*. (Source: Blue Planet Shipping)

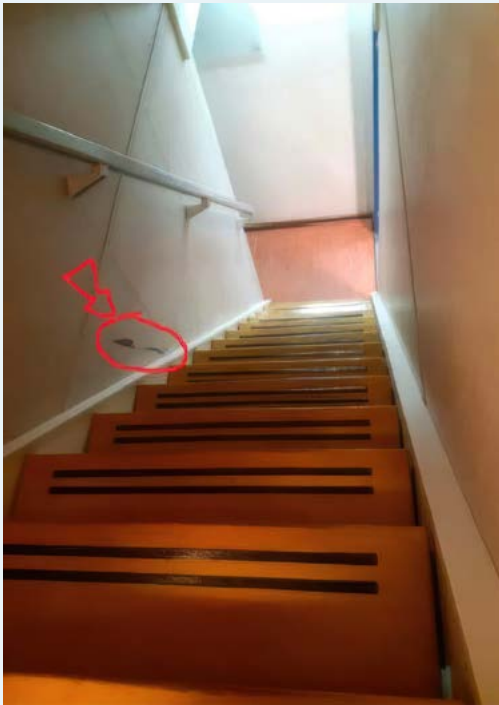
▼ *Figuur 44: Marks on the wall.*
(Source: Kroezen-Ship Support)

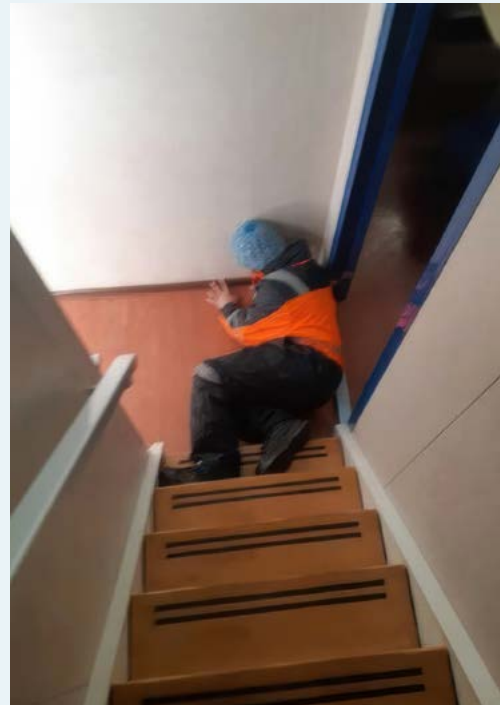
▼ *Figure 45: Reconstruction of the position of the casualty after his fall.* (Source: Kroezen-Ship Support)

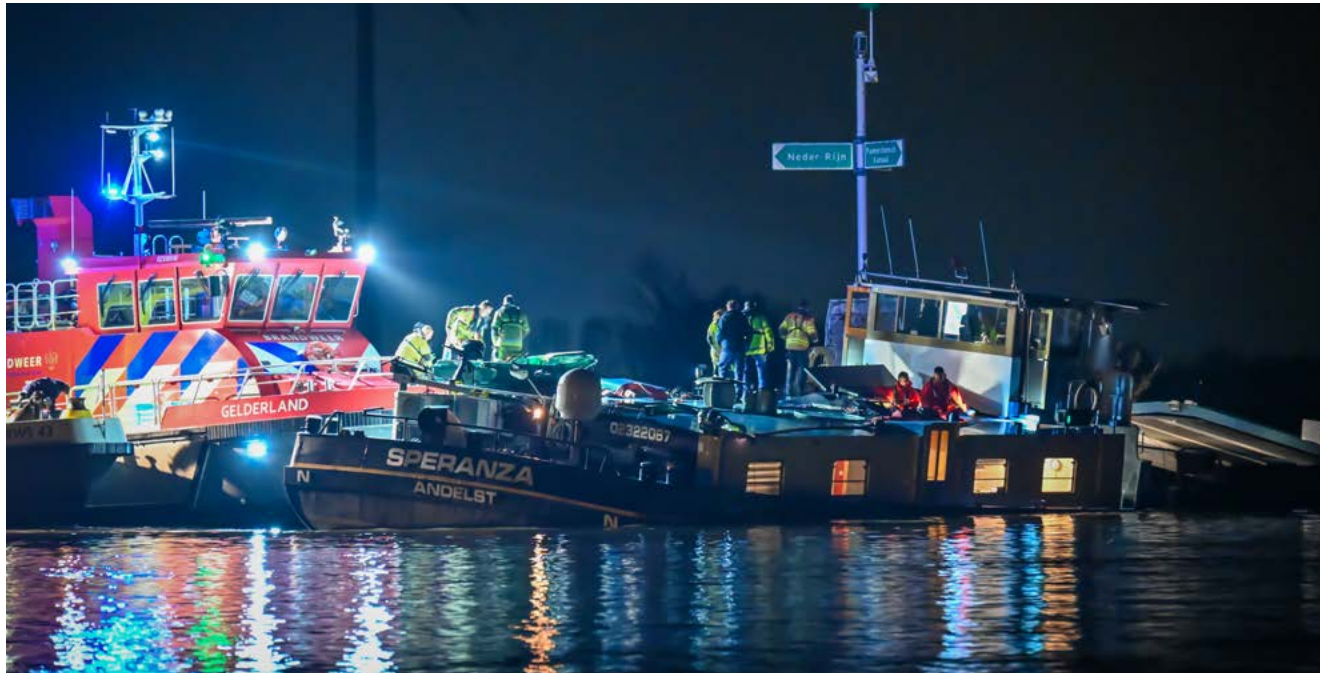
▼ *Figure 50: The Speranza taking on water. (Source: Persbureau Heitink)*
