Quarterly Aviation Report

January - March 2025

Q1 2025

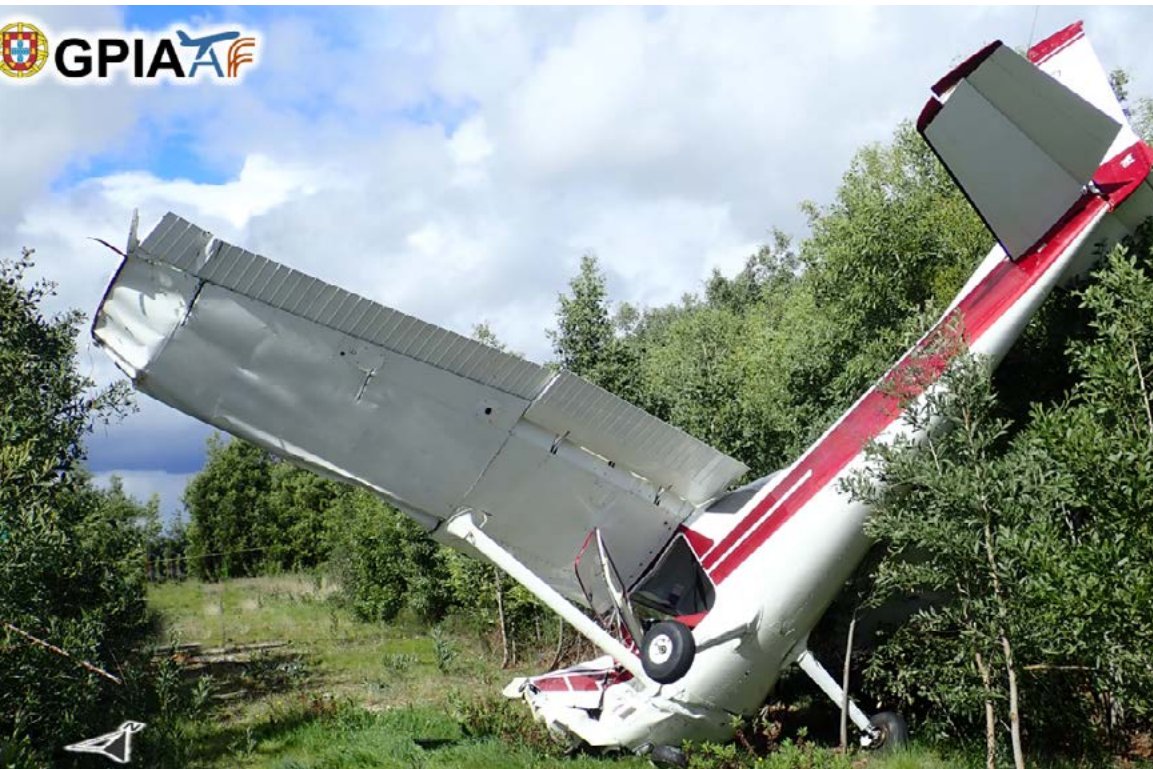
◀ The crashed Cessna 152.
(Source: GPIAAF)

The Dutch-registered Cessna 152 was conducting a training flight as part of an ATPL(A) training programme. On board were a Portuguese instructor and a Danish trainee. During an approach to Runway 16 at Coimbra Airport (LPCO), with the instructor having reduced engine power to idle, the aircraft struck a tree just outside the airport. The two occupants remained unharmed. The aircraft was badly damaged.

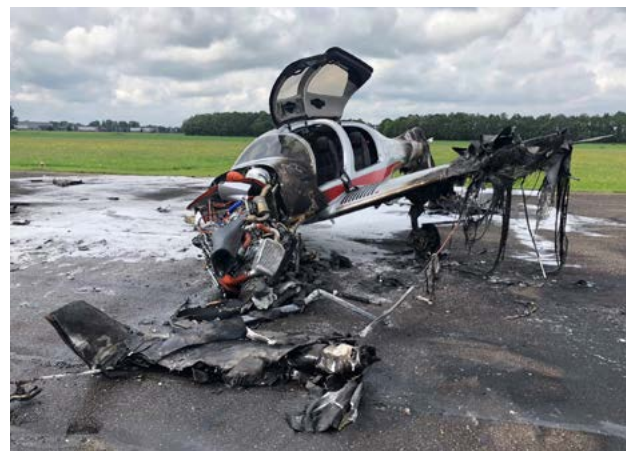
Despite the pilot's attempts to glide the aircraft towards the runway, the high rate of descent at low altitude resulted in the aircraft impacting the terrain short of the intended runway. Upon impact, the right wing detached from the fuselage, rupturing the integrated fuel tank. The ensuing fuel spillage ignited, causing a fire that consumed significant portions of the aircraft, including the left wing and the tail section.

▲ Aircraft wreckage.

The investigation identified that the engine failure was caused by the destruction of crankshaft main bearing #2, which led to overheating and seizure of other critical engine components. Why bearing #2 failed could not be determined. However, residues of casting sand embedded in the casting within the engine's oil gallery – likely originating from the manufacturing process – were considered a potential contributing factor to the bearing failure. The manufacturer deemed this contamination a single incident, as no structural deficiencies or recurring issues were identified during the analysis of similar engines. To mitigate contamination risks in future engines, the manufacturer enhanced its cleaning protocols by incorporating measures such as an ultrasonic bath and residual dirt analysis.

Although the aircraft complied with EASA Certification Specifications (CS) 23 for fuel system integrity, the forces exerted during the crash exceeded these design standards. The right wing's detachment led to a rupture of the fuel tank, directly contributing to the post-impact fire. However, the structure of the cockpit remained intact, significantly increasing the pilot's chances of survival.

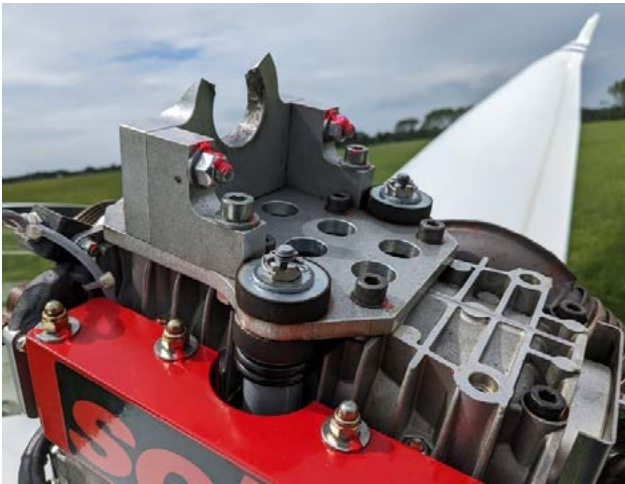
During a cross-country flight, the pilot found no more thermals and decided to start the reciprocating piston-driven engine of the Duo Discus T at an altitude of just over 300 metres. During the subsequent climb, the propeller separated from the engine at approximately 600 metres altitude. The pilot closed the fuel selector and checked whether the glider still responded to input from the flight controls. The glider turned out to be responding well, allowing the pilot to gain altitude in different thermals along the way. Salland glider airfield came within gliding range, where the pilot made a precautionary landing with the engine extended. After landing, it appeared that the whole hub had ripped off. This hub holds the rod, the bearing and the propeller in place.

▲ The location at the engine where the hub was ripped off.
(Source: gliding club)

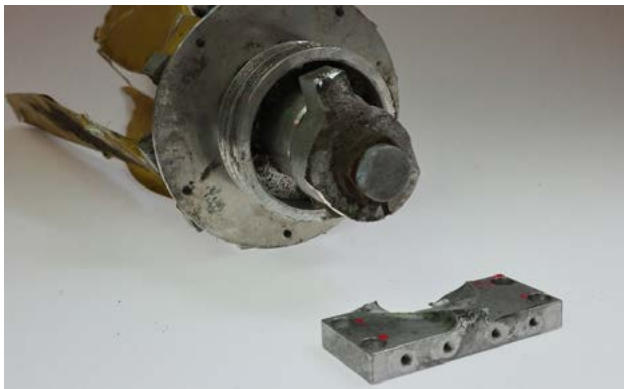
The Dutch Safety Board had the fracture surface examined by a laboratory to determine the nature of the failure of the propeller hub. The findings were:

- The material of the hub did not meet the compositional requirements for alloy type EN AW-7022 and was identified as alloy type EN AW-7075 T6.
- The hub component from the propeller failed due to a fatigue fracture.
- The repeated alternating loads needed for the fatigue fracture were likely relatively small (vibrational) loads during flight and normal use of the propeller.

▲ The propeller with the fractured hub.

The investigation report prepared by the laboratory yields fatigue cracking as causal reason for the failure of the hub, but finds “No clear initiation area or indication of overload areas were observed.” It is also stated that “Initiation was likely in the radius at the edge of the fracture surface, despite that it could not be confirmed during the examination.” The

report finds that material used is not exactly the one that the manufacturer states as per design (EN AW-7075 instead of EN AW-7022). The reason for this has not been determined. Nevertheless, the material properties are very similar and therefore susceptibility to fatigue is not significantly different between the two. The root cause of the fatigue fracture has not been determined. Furthermore, while there have been some failures in these engine models, the failure mode in the present case is new and so far singular.

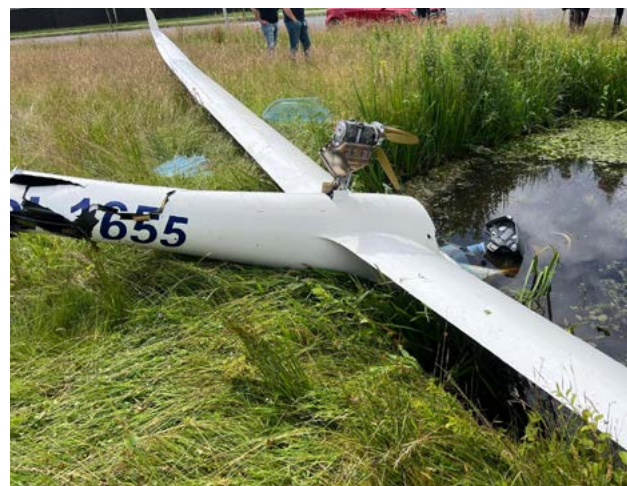
As he approached the airfield, the pilot realised that he did not have sufficient height to reach the runway, meaning that a landing outside the airfield had become unavoidable. Just outside the airfield, the right wing struck a lamp post. This caused the aircraft to rotate around its vertical axis and come to rest at the edge of a ditch, with only the broken-off tail section upside down. The pilot sustained slight injuries.

▲ The crashed Discus-2T. (Source: Police, Aviation Supervision Team)

The lack of thermals led to his early return to the airfield. The pilot stated that, at the time, he thought that a height of approximately 315 metres was sufficient for starting the engine. Club rules stipulated, however, that the decision to start the engine must be made at 350 metres. The pilot extended the engine but forgot to switch on the ignition. As a result, his attempt to start the engine failed, and he continued flying with the engine still extended. The pilot stated that force of habit may have got the better of him, despite his recent experience with the Discus-2T concerned. In the past, the pilot had also flown aircraft in which only a single switch needed to be flipped instead of two (as part of the procedure for starting the engine) and only a single button needed to be pressed (to extend the engine, switch on the ignition and switch on the fuel pump).

Due to (self-proclaimed) tunnel vision after his failure to start the engine, the pilot continued to focus on the button that operates the fuel pump, assuming that it needed to be held down longer in order to get fuel to the engine. When he realised that he had flown on too far and had stopped trying to start the engine, he turned back in diagonally towards the landing field. However, the airfield was by then out of gliding range, partly due to the drag caused by the engine, which was still extended.

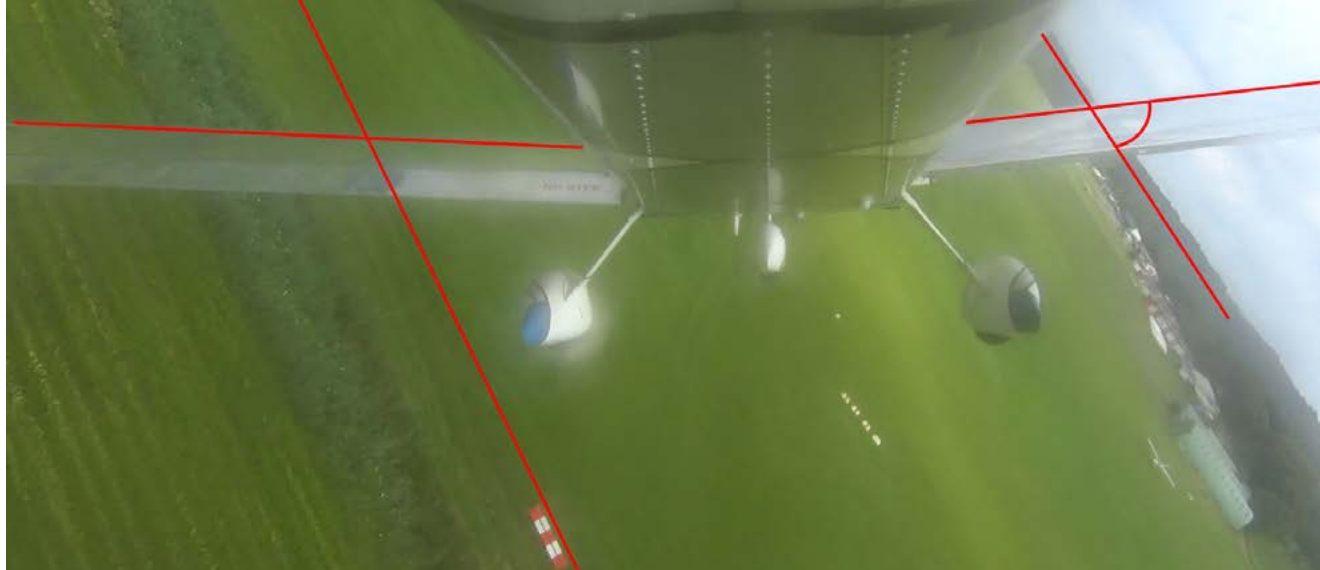
▲ Roll angle of about 70 degrees just before the crash. (Source: video camera underneath the tail (owner))

The checklist present on board did not include any emergency procedures. It also emerged that the Pilot's Operating Handbook did not contain an emergency procedure for the event of an ignition system malfunction, meaning that the pilot was unable to perform a structured malfunction check. He was therefore unaware that part of the ignition system had become defective. Because he was unaware of the cause of the malfunction, the pilot continuously anticipated that the engine might fail completely and incorporated extra margins into his chosen route. During his approach to Hilversum Airfield, the pilot chose to fly high on the final for Runway 30. This resulted in him needing to perform a go-around; on downwind, he then kept flying close to the runway. On the base leg, the aircraft experienced a tailwind component of around 5 knots. So as to then be able to land on Runway 30, the pilot made a steep descending turn to the final. Due to the large banking angle, the aircraft reached a high rate of descent and the pilot subsequently lost control of the aircraft.

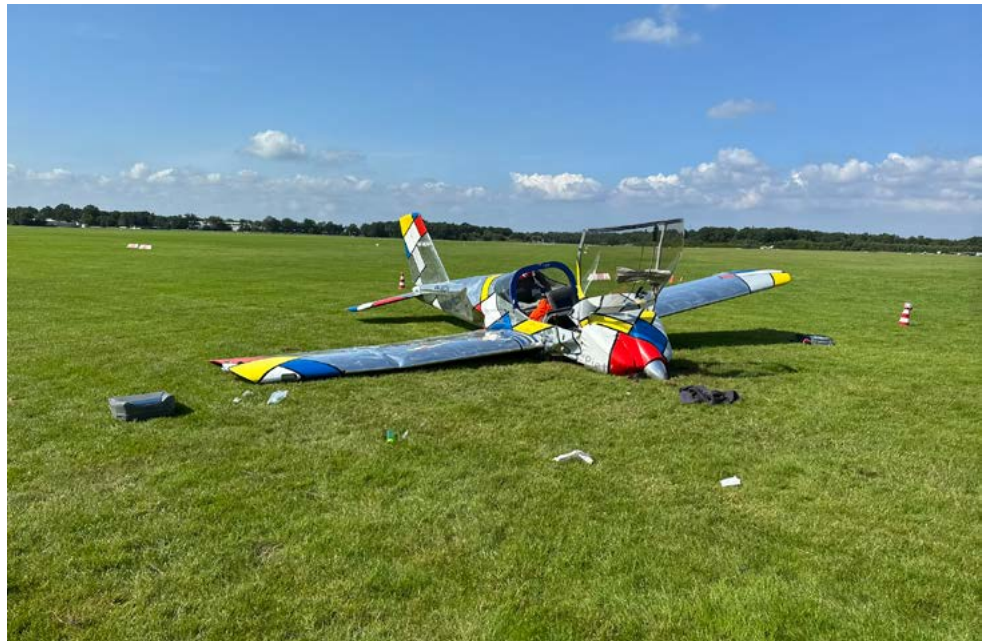
Due to the impact, the pilot was knocked unconscious and the aircraft was severely damaged. The passenger was able to leave the aircraft unaided. Because of the deformations of the fuselage, the pilot had to be freed from the aircraft by the emergency services. Both occupants were taken to hospital with injuries.

Apart from the impact damage, investigators at the site did not observe any abnormalities regarding the Rotax 912 ULS engine. The engine was later examined by a maintenance technician at Middenmeer Airfield. He found that the engine was functioning, except for one of the two ignition systems, which was not functioning due to a defective ignition unit. This had resulted in a reduction in engine power. Images from the cockpit show that the engine speed was about 4300 RPM at the time of the engine failure. Normally, this is about 5000 RPM.

The engine trouble was caused by one of the two ignition systems being defective. As a result, the engine delivered less power, but enough to maintain altitude, reach the destination and perform a go-around there.

► *The crashed aircraft.*

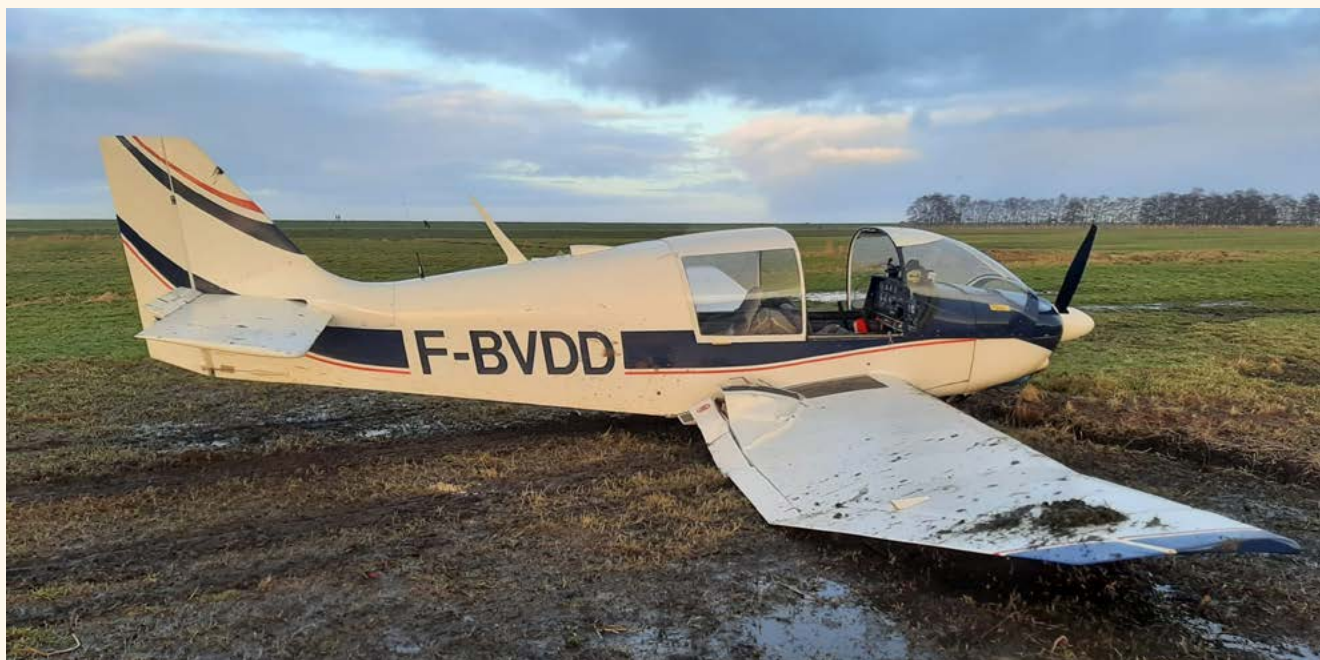
▲ The Robin after the emergency landing. (Source: passenger)

The pilot was able to see the Marken peninsula and decided to make an emergency landing there. He could not remember whether he had selected flaps during the approach. His focus at that point was on reaching the peninsula. When he succeeded in doing so, he made a left turn and landed the aircraft in an east-northeast direction in a meadow. The wind at ground level was from direction 340 at 7 knots, gusting to 13 knots. During the ground roll, the aircraft passed over two ditches, sustaining damage to the landing gear, the propeller and the

The temperature at an altitude of 1300 feet was 1 degree Celsius, and the dew point temperature at ground level along the route followed varied between 1.4 and 1.7 degrees Celsius. This indicates high humidity. Under such circumstances, ice can form in the carburettor, but other possible causes for the loss of engine power cannot be ruled out.

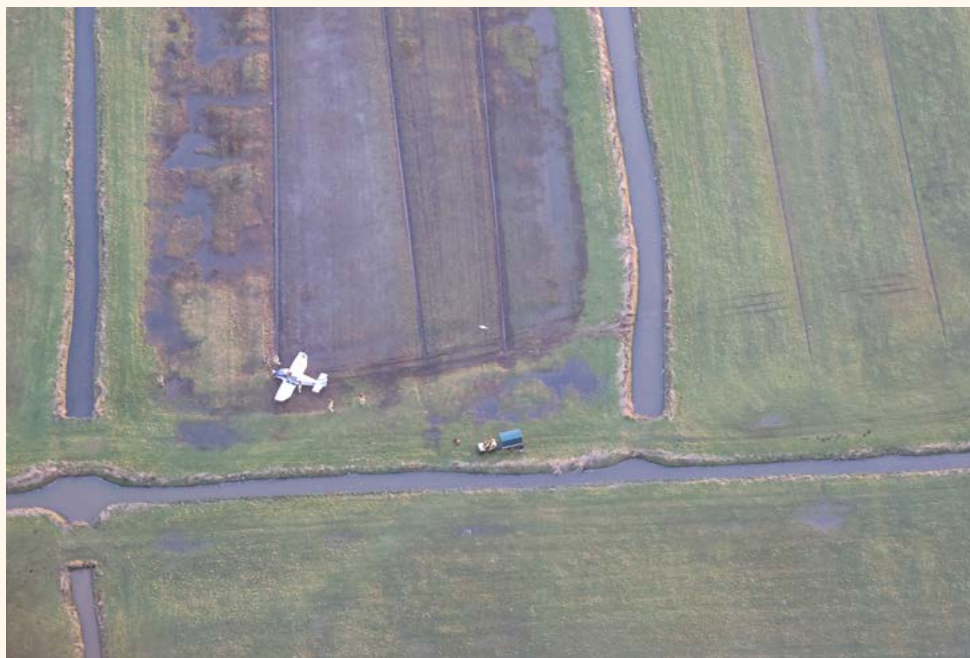
◀ Aerial photo of the Robin after the emergency landing. (Source: Police, Aviation Supervision Team)
