THE DUTCH
SAFETY BOARD

Emergency landing at sea with Britten-Norman
Islander near Bonaire on 22 October 2009

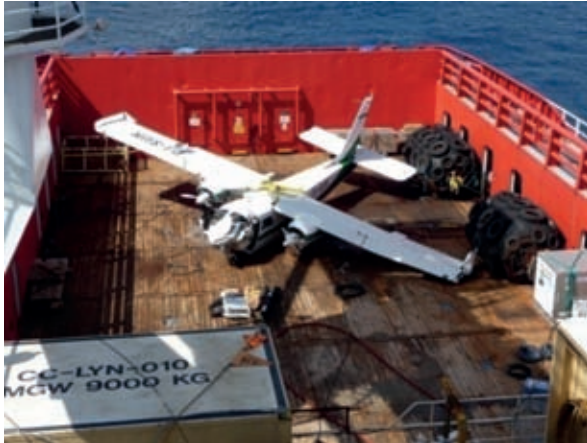
Figure 2: PJ-SUN after it was salvaged

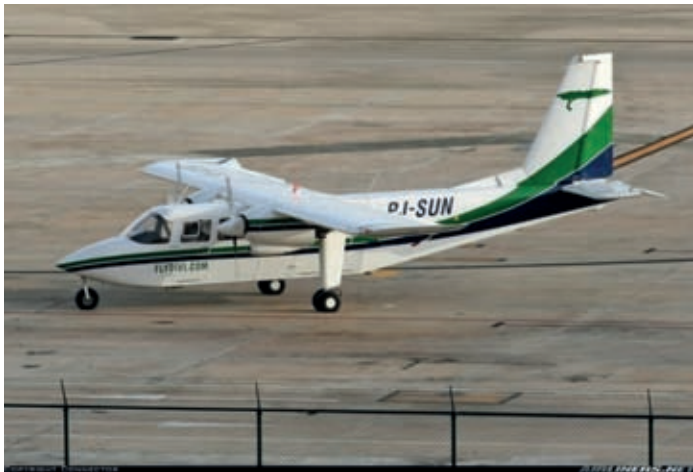
Figure 3: archive photo of PJ-SUN

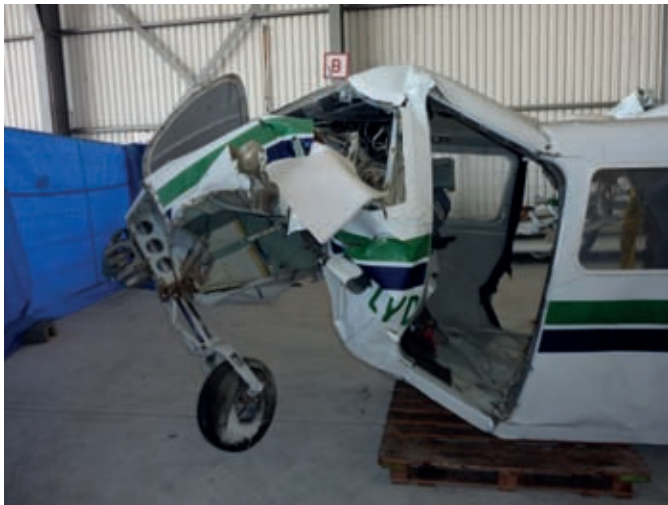
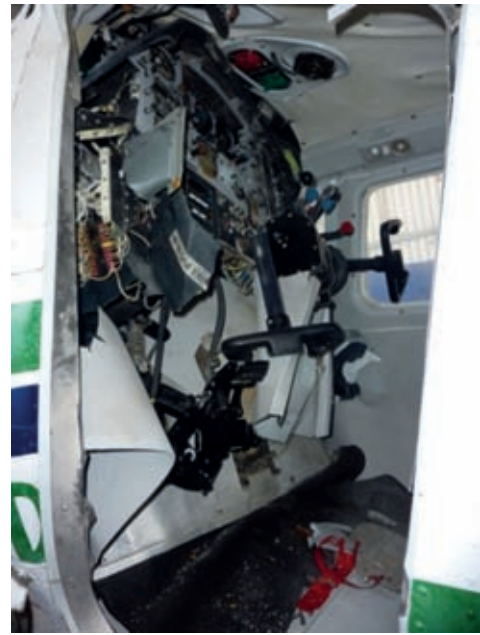
*Figures 5 and 6: side view of the deformation of the aircraft nose and cockpit (seats removed)
Left: damage to aircraft nose, cockpit floor twisted upwards. Right: instrument panel against the roof.*

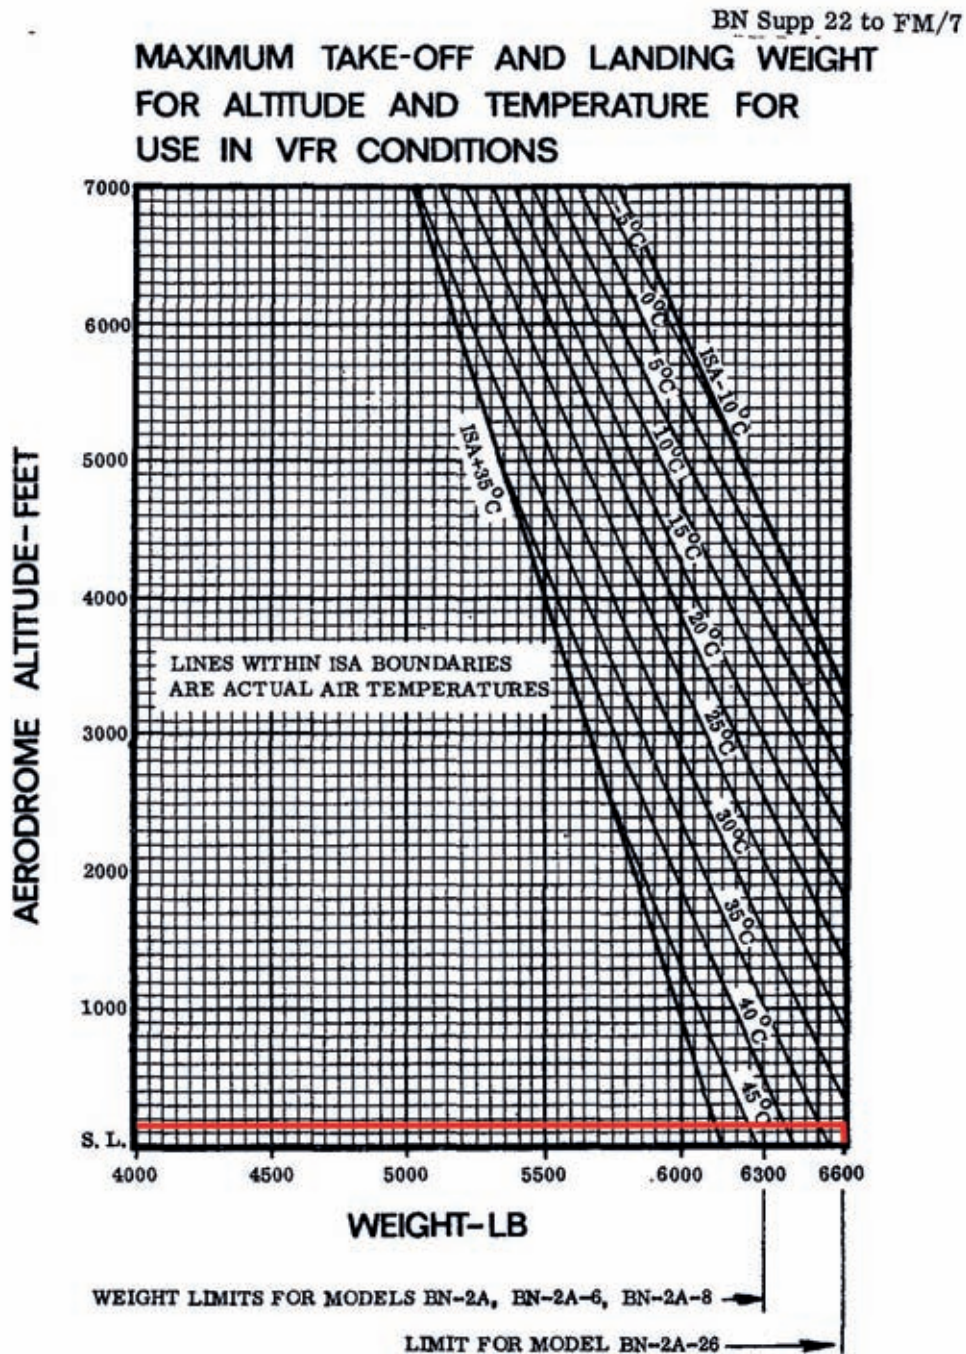
APPENDIX D: FLIGHT DVR014 LOAD AND BALANCE SHEET

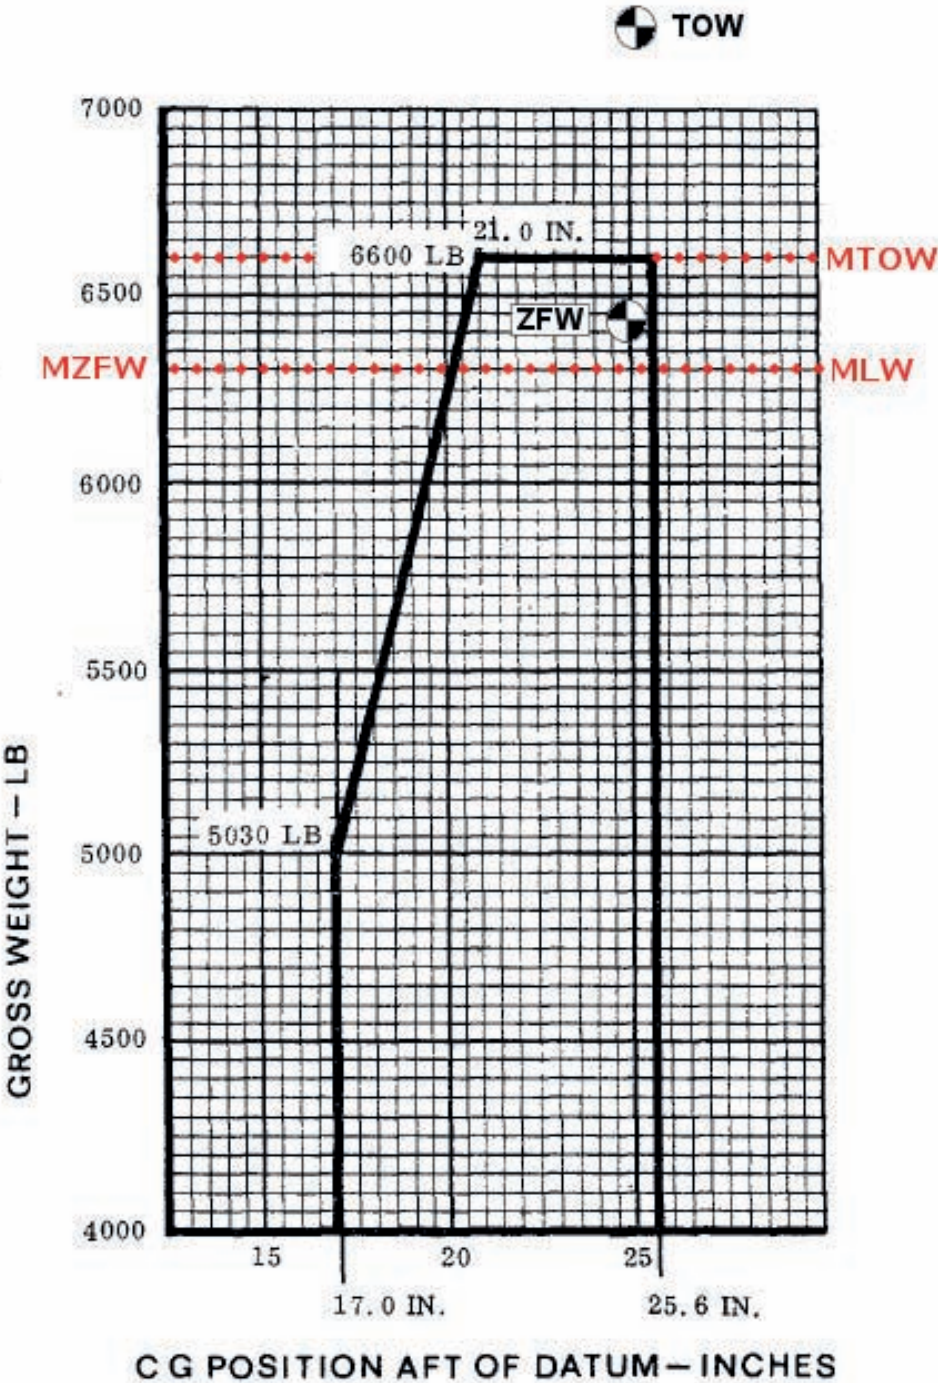
APPENDIX M: RATE OF CLIMB WITH ONE ENGINE
