### Anchor loads and rate of turn M.S. Planet V

Part II: Rate of turn analysis

Report No. : 26405-1-mscn-rev.1  
Date : October 15, 2012

Ordered by : Dutch Safety Board

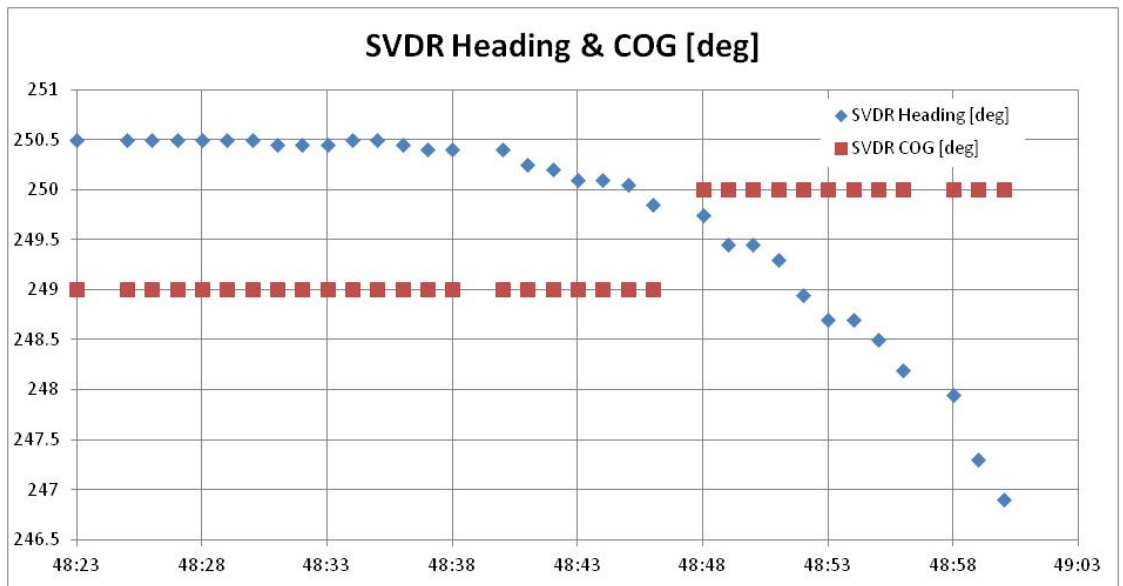
Figure 2-1 Heading and Course over Ground (t=0 is time of black-out)

From these graphs it becomes clear that approximately 14 seconds after the recorded time of black-out the vessel starts to turn to port. The heading data was used to construct the turning rate of the Planet V. This is shown in Figure 2-2.

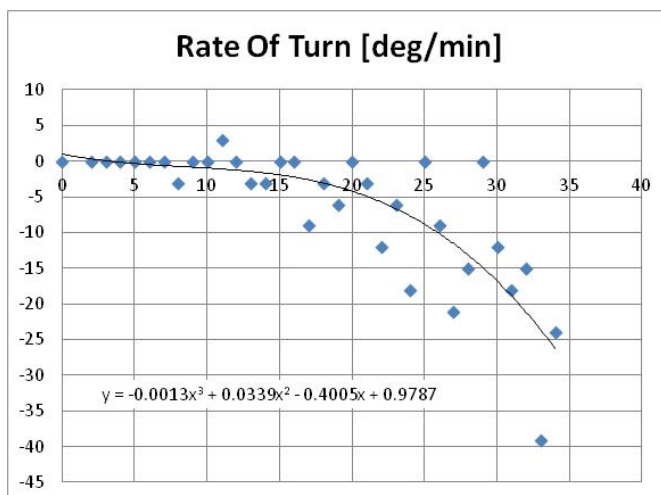
Figure 2-2 Rate of turn (t=0 is time of black-out)

This graph only shows the development of the rate of turn in the first 35 seconds. Since there is no on board data available after 17:49:00 the heading of the vessel was also estimated from the radar pictures (see Table 2-1). This may not be the most accurate method, but the results look very plausible and are confirmed by the picture taken just before the collision.

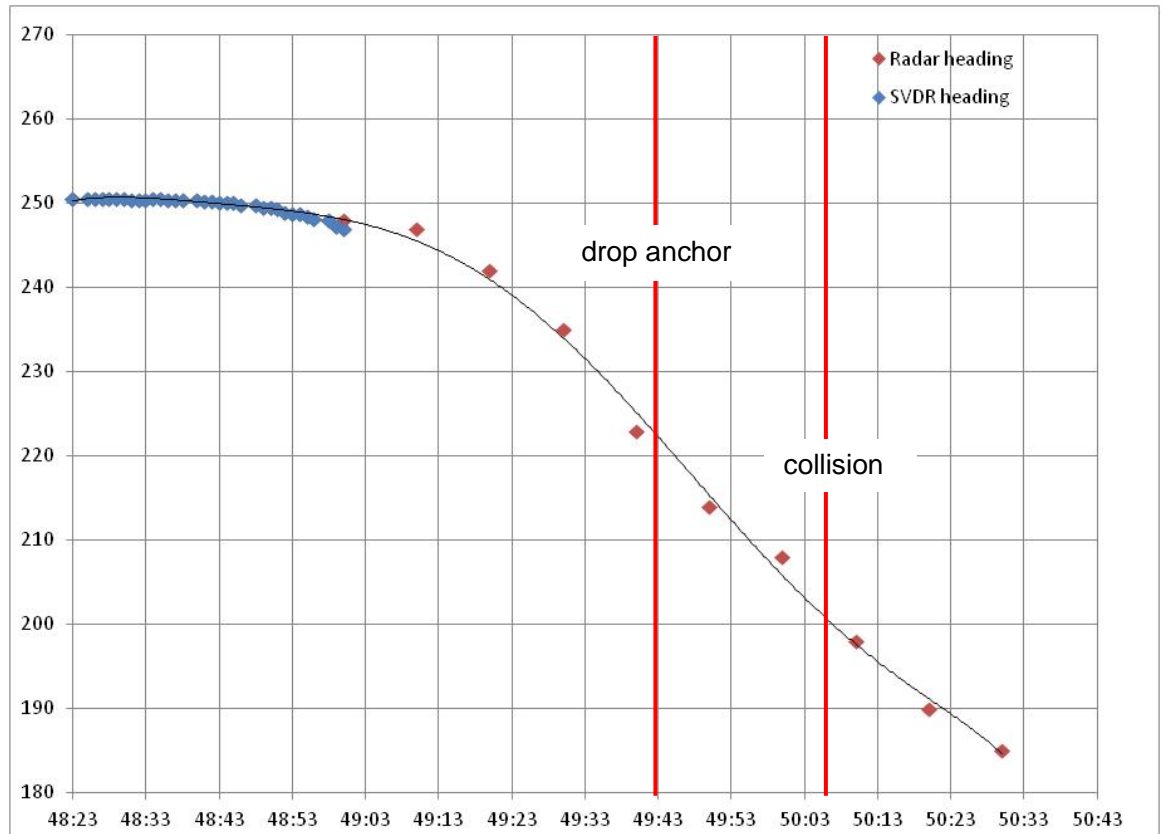
When the headings measured with the SVDR and the estimated headings from the radar picture are joined together, the following figure can be created (see Figure 2-3). The time of black-out, the time the anchor was dropped and the time the collision took place are indicated in this figure.

**Figure 2-3 Heading Planet V [deg]**

From Figure 2-3 the rate of turn could be determined. Table 2-2 shows the development of the rate of turn from the moment of the black-out. The first 30 seconds after the recorded time of black-out the rate of turn remains low, than it increases rapidly, until it reaches its maximum of 57 deg/min at 17:49:43. Than it gradually decreases again.

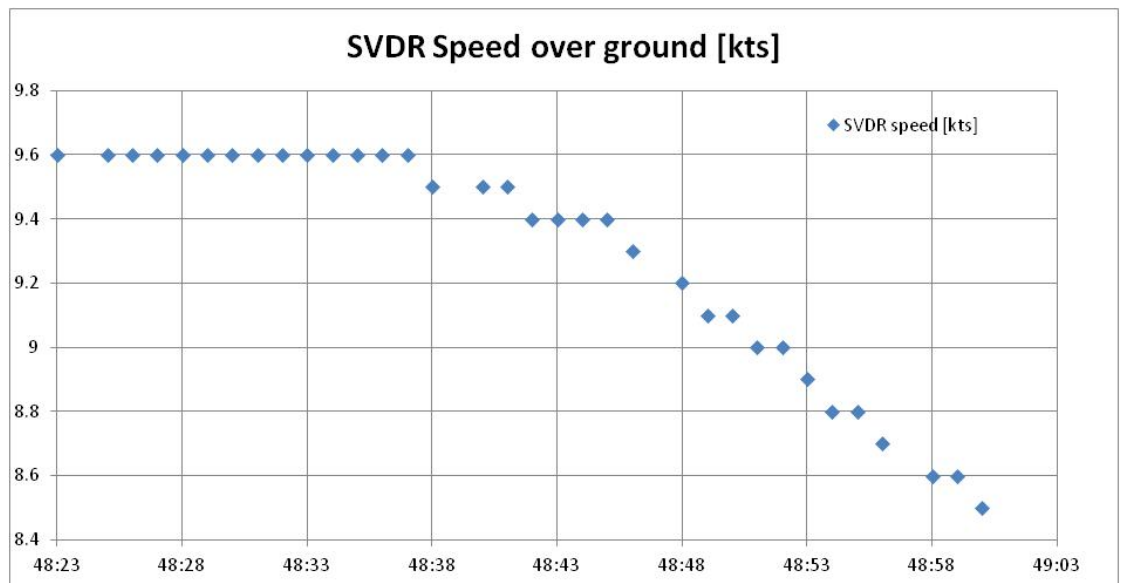
**Figure 2-4 Speed over ground in knots (t=0 is time of black-out)**

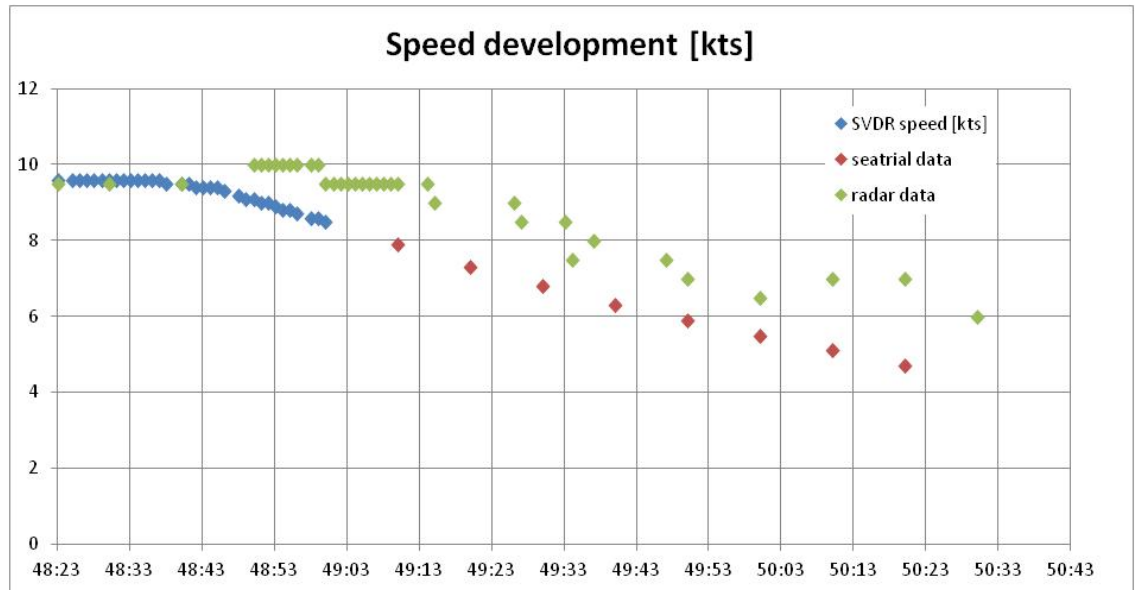
**Figure 2-5** Speed development from different sources

What can be concluded from Figure 2-5 is that it takes 14 seconds before the Planet V starts to decrease speed. Therefore the time of the black-out given in the communication abstract may be erroneous. Careful study of the SVDR tapes reveal that at 17:48:23 the noise level drops, but it is difficult to assess if the main motor hum decreases in revolutions. It may be that first some auxiliary machinery stops, and that the main engine and shaft revolutions react somewhat later. If we define the black-out as the moment the shaft revolutions start to decrease the most likely time of black-out should be corrected to: 17:48:37.

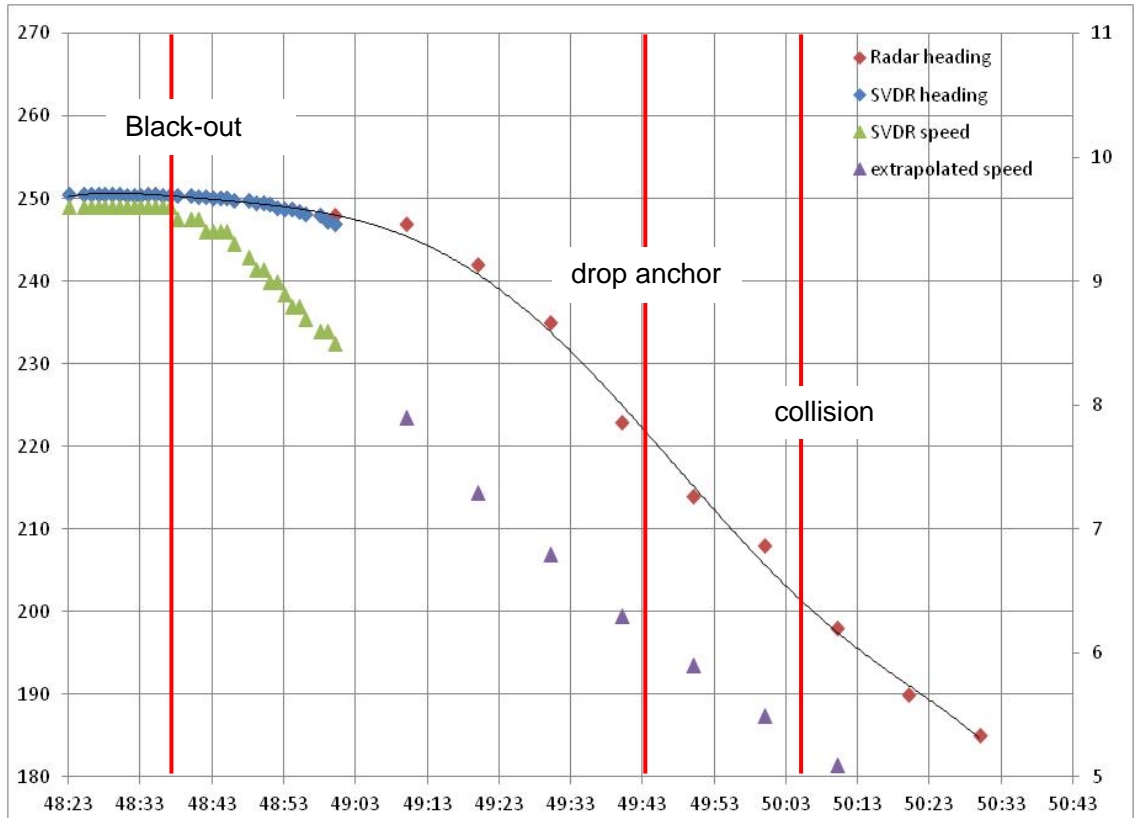
An overview of the speed and heading development is given in Figure 2-6. The time of black-out, the moment the anchor is dropped and the time of collision are indicated in this figure. On the left axis the heading scale is in degrees, on the right axis the speed scale is in knots.

Figure 2-6 Development of heading and speed

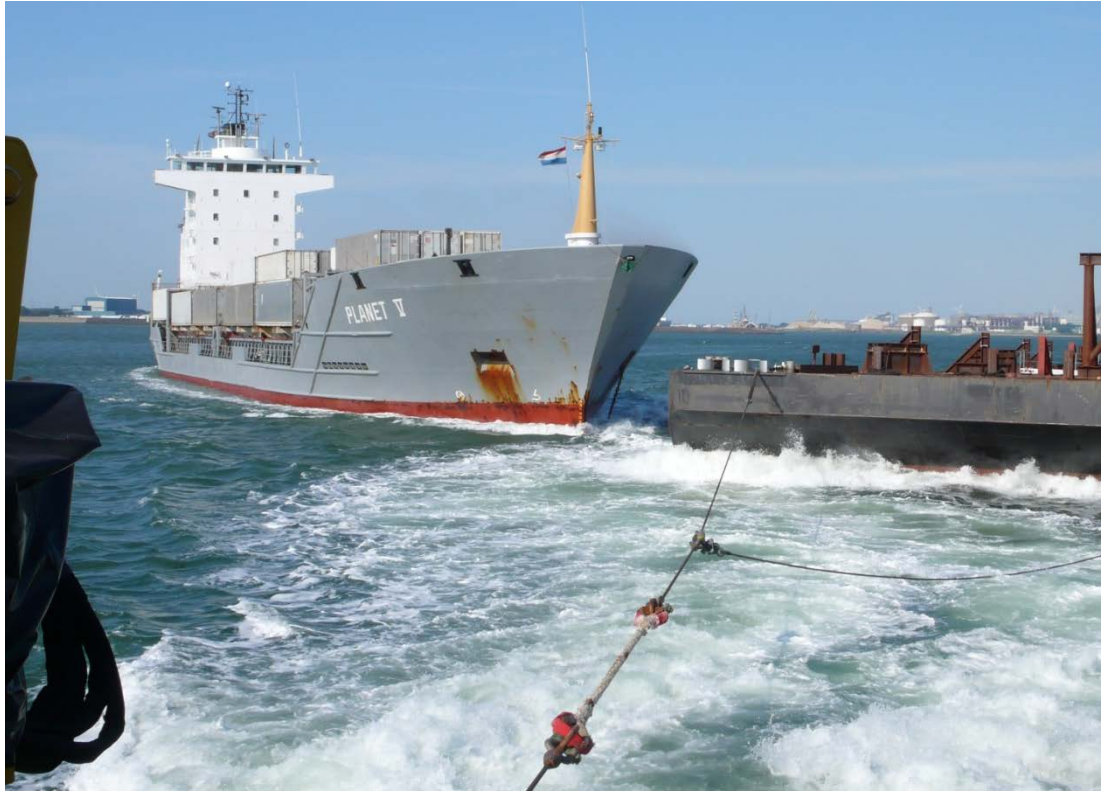
There was simply not enough time (only 25 seconds between the moment the anchor was dropped and the time of collision), to deploy enough chain. Therefore the holding power of the anchor was too low to be of any influence. This is confirmed by the picture taken just before the collision (Figure 2-7). On this picture it can be seen that the anchor chain is pointing almost straight down, meaning it is not pulling sideways or astern, and is therefore not contributing to the rate of turn and is not slowing down the vessel.

**Figure 2-7**      **Picture taken just before the collision**

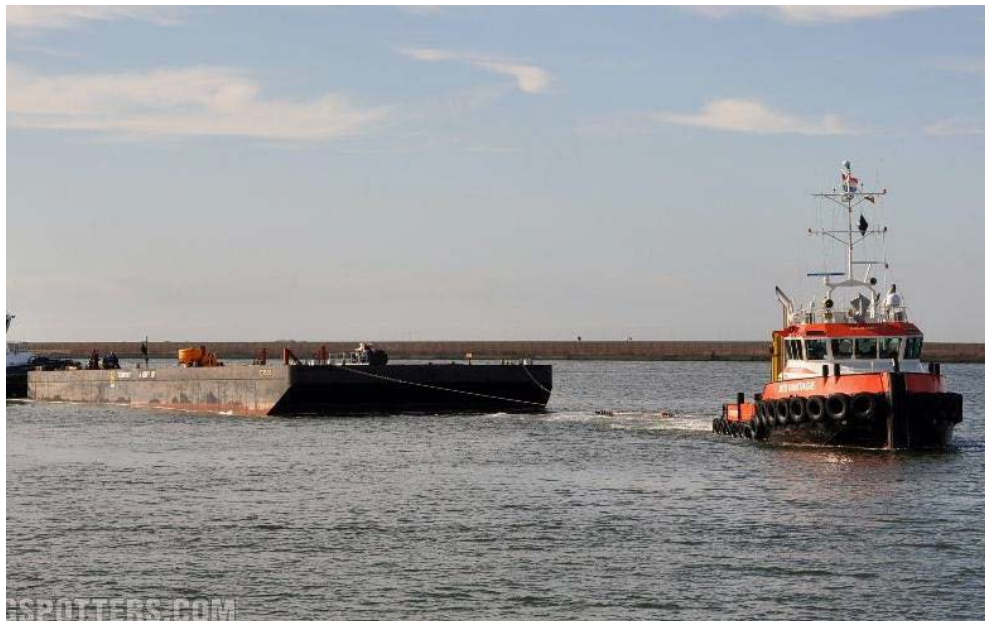
Figure 3-1 MTS Vantage with barge

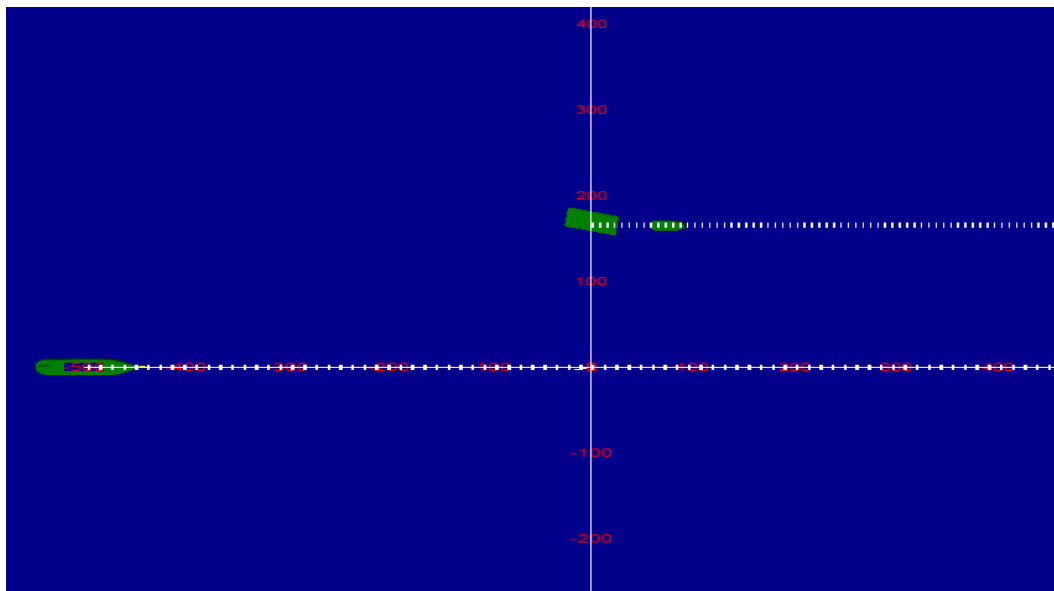
- Water depth 20m;
- STW Planet V 11.5 kts
- STW Tow 7 kts
- The barge makes an angle of 10 degrees with respect to the tug
- Both Ships sail a straight and parallel course
- The CPA is 160 m.

Figure 3-2 base case scenario

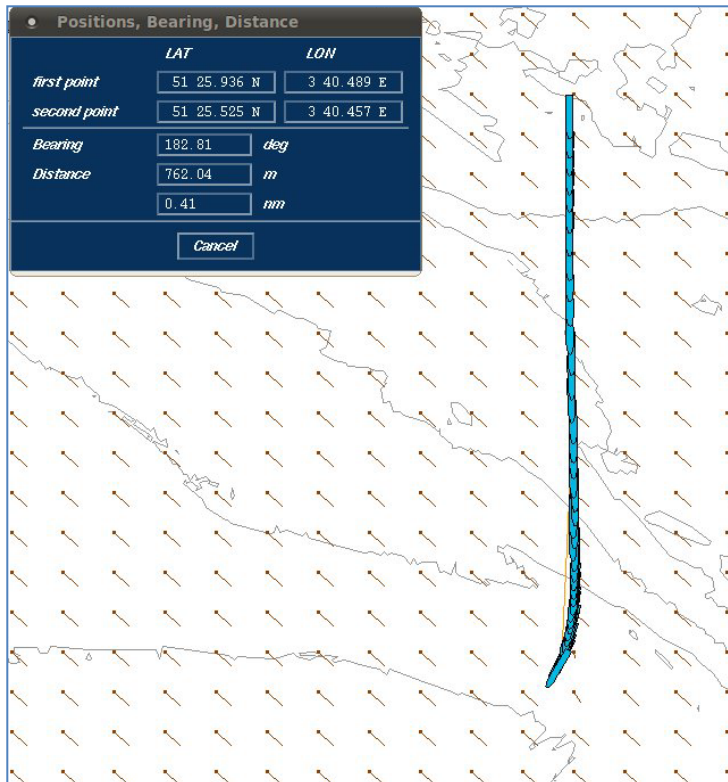
**Figure 4-1 Reconstruction of deceleration test**

Figure 4-1 shows the track of the deceleration test. In this figure the wind is plotted as vanes. Wind is coming from the NW as during the sea trials. Based on these results it was concluded that the deceleration test with the mathematical model had a very good fit with the Planet V in ballast. To reflect the situation at the time of the incident the draft of the model and the wind areas were adjusted. At the time of the incident the Planet V was loaded with two layers of containers.

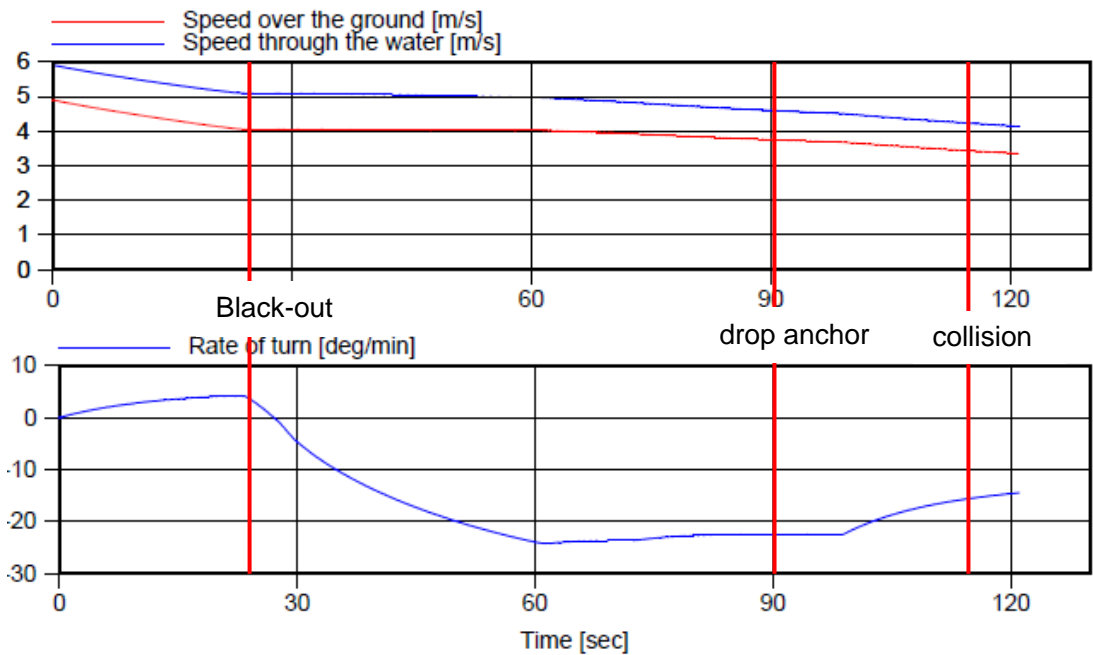
Figure 4-8 Development of speed and rate of turn during run 3
