**Accidents involving lorries
manoeuvring in the dark**

Safety Study

The Hague, 2003

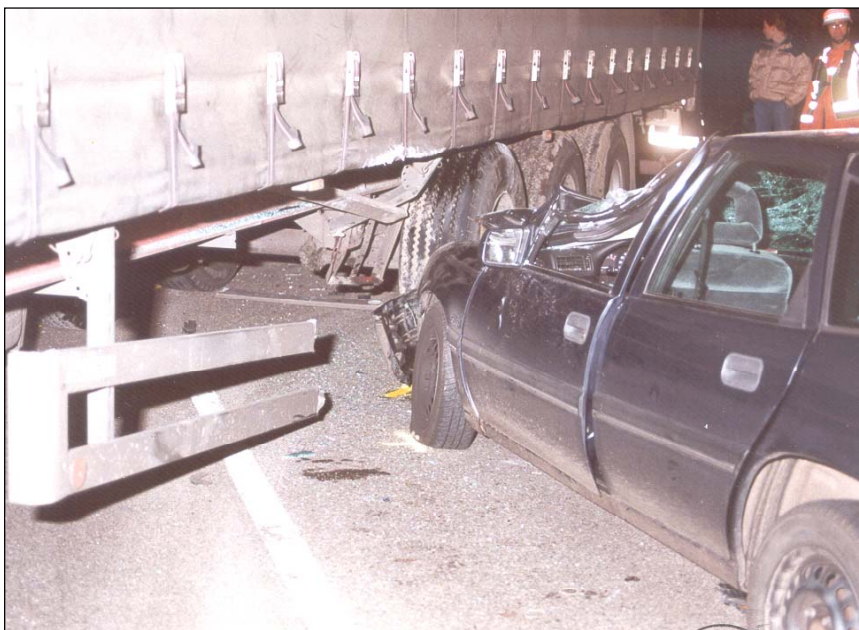
This photo does not show that most of the serious damage to the passenger car was on the right front side. This was caused by the right corner of the car hitting the foremost left wheel of the trailer. For the same reason, after the crash, the car was thrown back to the left rear, and came to a halt next to the skid marks. (See illustration 1).

Illustration 2: Vehicles damaged in the accident in Marknesse. (Source: Flevoland Region Police)

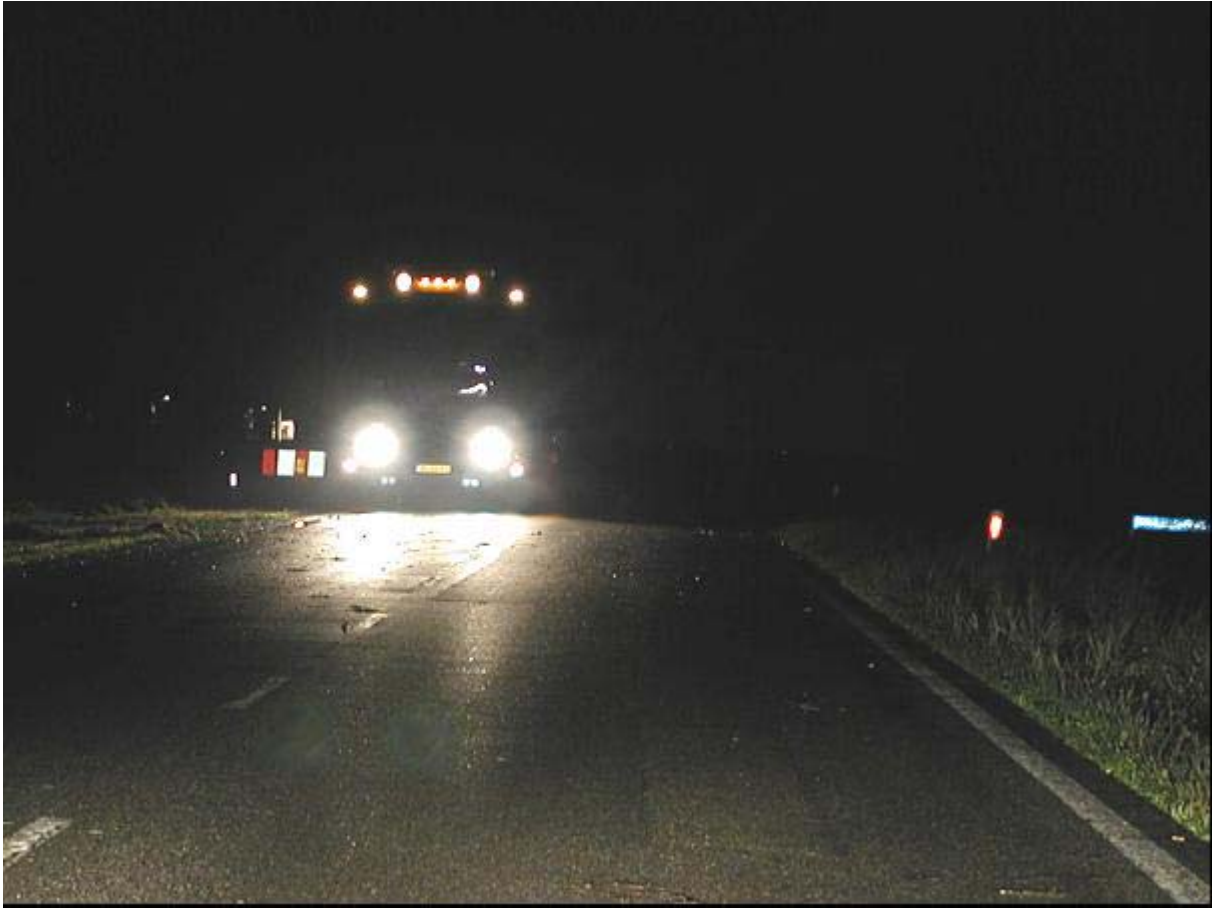
The tests showed that the standard side reflectors on lorries could be seen well, if they were at an angle of at least 70 degrees in relation to the direction from which they were being seen. This means that for a lorry standing almost perpendicular to the road, the reflectors are clearly visible at a distance of over 200 m for a motorist approaching (using dipped lights). However, when the observation angle was smaller, the detection distance decreased significantly. The calculations showed that at an angle of 50 degrees, the detection distance – even under such favourable conditions as dry windshields – was only sufficient for a motorist with an approach speed of 80 km/h to come to a halt by braking relatively hard. It should be noted in this respect, that manoeuvres such as entering and leaving driveways or side streets involve considerably smaller observation angles than the limiting value of approximately 50 degrees mentioned above. The tests showed that the lorry already blocked the road totally when the angle between the trailer and the road axis was only 15 degrees. In this position, the detection distance was less than 40 m; the reflectors were visible at the moment that the other, non-reflective, parts of the vehicle could be seen.

Illustration 6: photograph of a test situation using side reflectors. (Source: TNO-TM)

Therefore, if the lorry's position is not approximately perpendicular, but rather diagonal to the road, the reflectors do not make an actual contribution to its level of conspicuity for approaching traffic. Put in a different way, if a lorry is standing diagonally across a road, its reflectors are not able – at least in the usual conditions existing outside built-up areas – to make it visible to motorists in good time.

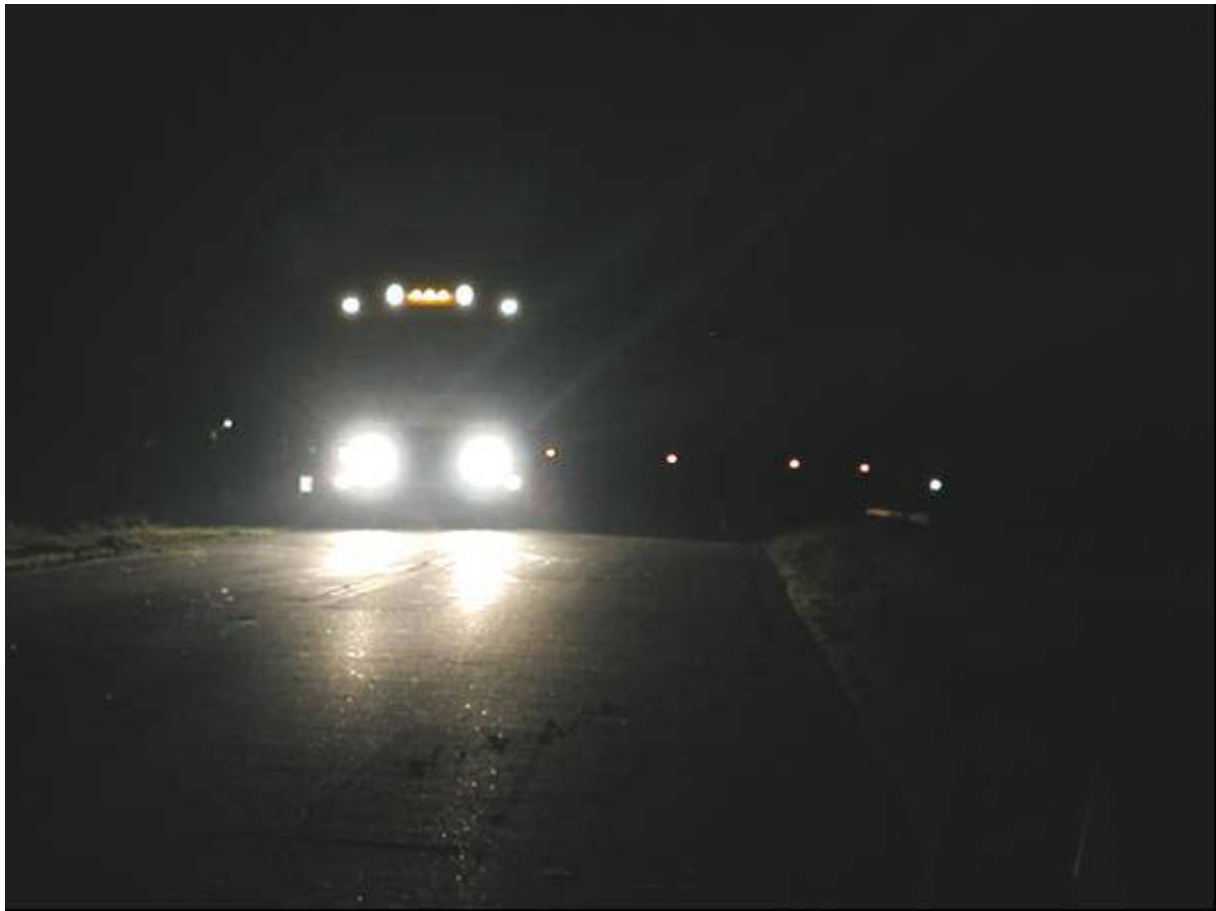
The tests showed that the detection distance for side marking lights was considerable greater than that of side reflectors. This applied to relatively narrow observation angles as well. When the angle between the trailer and the road axis was about 37 degrees, the detection distance appeared to be around 500 m, and when the observation angle was narrowed to around 16 degrees, the detection distance was still about 300 m. The reason the detection distance decreases with a narrower observation angle, is that the strength of the light of the usual side marking lights (just like the reflection level of side reflectors) is highly dependent on direction.

However, the above information on the detection distance concerning side marking lights, should not be read as meaning that the use of side marking lights makes the sides of lorries recognisable in good time under all the relevant conditions. The test subjects stated in fact, that initially, the side marking lights could easily be regarded as reflectors on shoulder posts or lights on the horizon – at least by 'careless' observers. It was only at a distance of about 120 m, according to the test subjects, sufficient reason for concern, was it possible to discern that the lights might belong to a lorry and that there was a danger of an accident occurring. The trailer itself, only became recognisable as such, just like with the reflectors, a distance of about 40 m.

Illustration 7: photograph of a test situation using side marking lights. (Source: TNO-TM)

The reason side markings are not immediately recognisable as such, is largely due to the fact that they are placed at approximately the eye-level of the drivers of passenger cars. For motorists, this means that the lights are always on about the same level as the horizon. This, combined with the relatively weak light they emit, means the markings can easily be mistaken for lights at a much greater distance away.

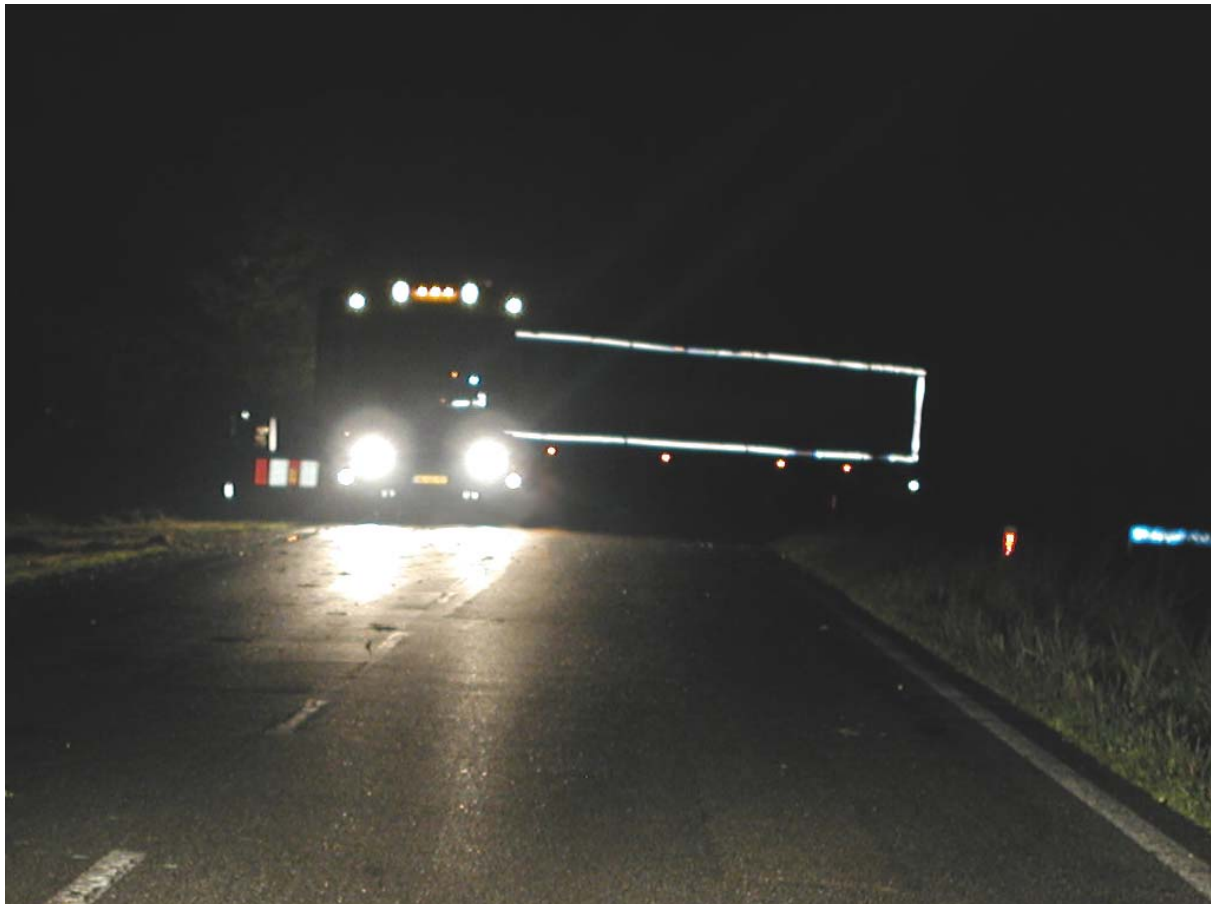
The tests show that trailers with contour marking can be recognised as such at a sufficiently safe distance, even under unfavourable conditions. The distance at which contour marking becomes visible appears to be about the same as that for side marking lights (namely over 500 m at an observation angle 37 degrees with a dry windshield, and about 300 m with a wet windshield). The distance at which the danger of an accident was realised, on the other hand, appeared to be considerably longer than is the case for side marking lights. Even with a wet windshield, the distance at which the test subjects became aware that a trailer was blocking the road was still over 220 m.

Illustration 8: photograph of the test situation with contour marking. (Source: TNO-TM)

Apparently, being able to see the contours was sufficient for the motorists to deduce that a trailer was diagonally blocking the road behind the cab. This is probably due to the fact that the upper section of the contours – at least when seen from the position of an approaching

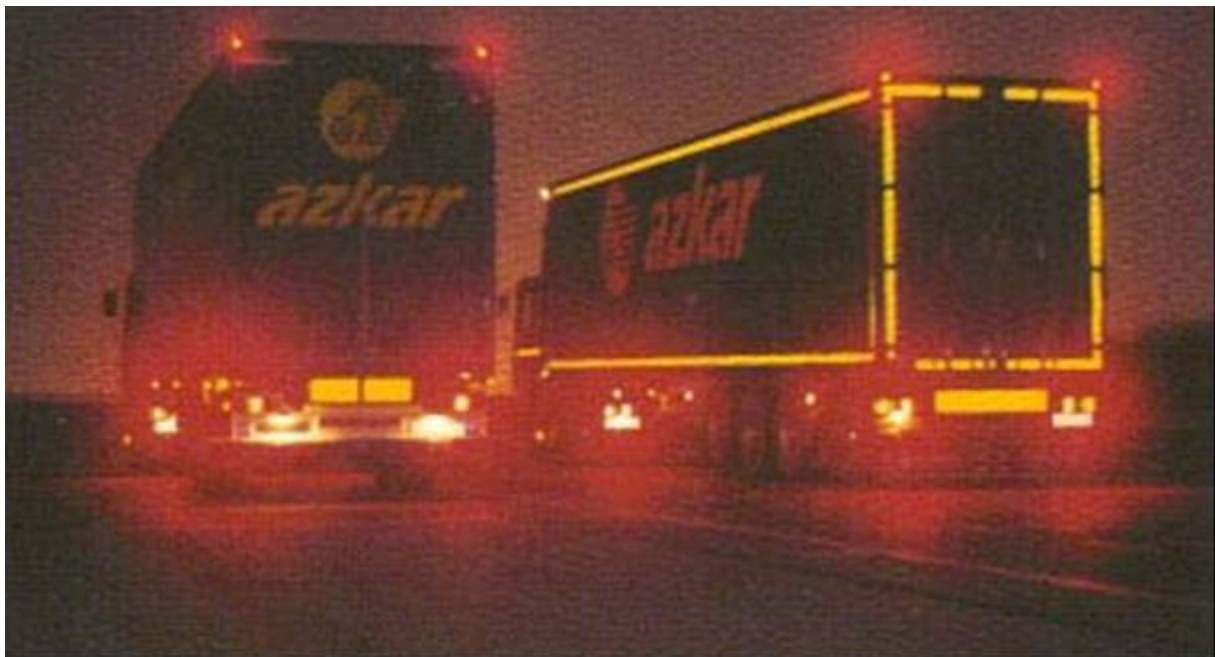
A study of the literature (described in the publications listed under [4], [5] and [6]) showed that the conspicuity problem of lorries in the dark has been thoroughly investigated. It can be noted that retro-reflective contour marking (RRCM) is largely viewed as the solution for the lack of conspicuity. This consists of the application of narrow strips of retro-reflective material along the contours and sides of lorries. The most important argument is that by applying RRCM recognisability is significantly increased (see also the results of the practical tests). Needless to say, marking lights can also be used to accent the contours of vehicles. The advantage of marking lights is that they are conspicuous at greater distances (because they do not need to be hit by light from oncoming traffic but rather generate light themselves). The use of retro-reflective material, on the other hand, appears to have major advantages: due to the linear form, strips of reflective material cannot be confused with other sources of light; secondly, retro-reflective contour marking also functions as when the lorry's lights are switched off or malfunctioning. Furthermore, retro-reflective material, unlike side marking lights, is not malfunction-sensitive.

Illustration 9: photograph of lorries with and without contour marking. (Source: 3M)

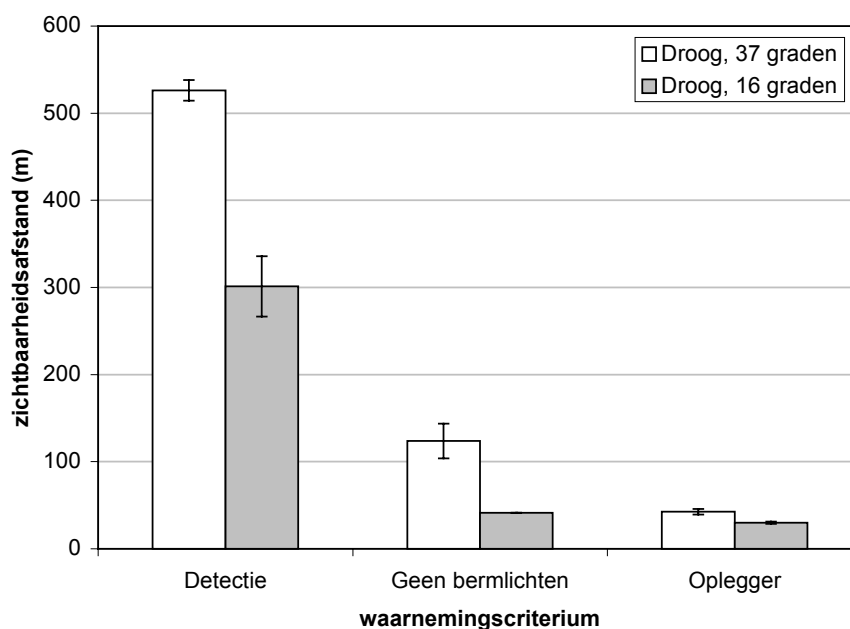
The visibility distances for the three evaluation criteria for side marking lights with a dry windshield. Source: [5].

Zichtbaarheidsafstand = visibility distance, Waarnemingscriterium = observation criterion, Detectie = Detection, Geen bermlichten = No roadside lighting, oplegger = trailer
Droog 37 graden = Dry 37 degrees, Droog 16 graden = Dry 16 degrees

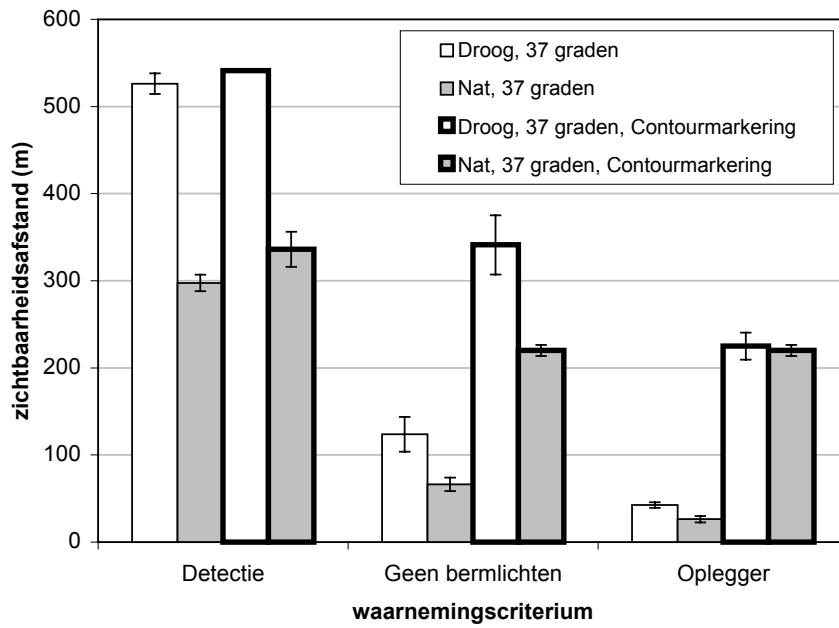
The visibility distances for the three evaluation criteria for side marking lights, and retro-reflective contour marking with dry and wet windshields respectively. Source: [5].
