DUTCH
SAFETY BOARD

Aircraft missing

Cessna accident at Maasvlakte 2

The Hague, May 2013

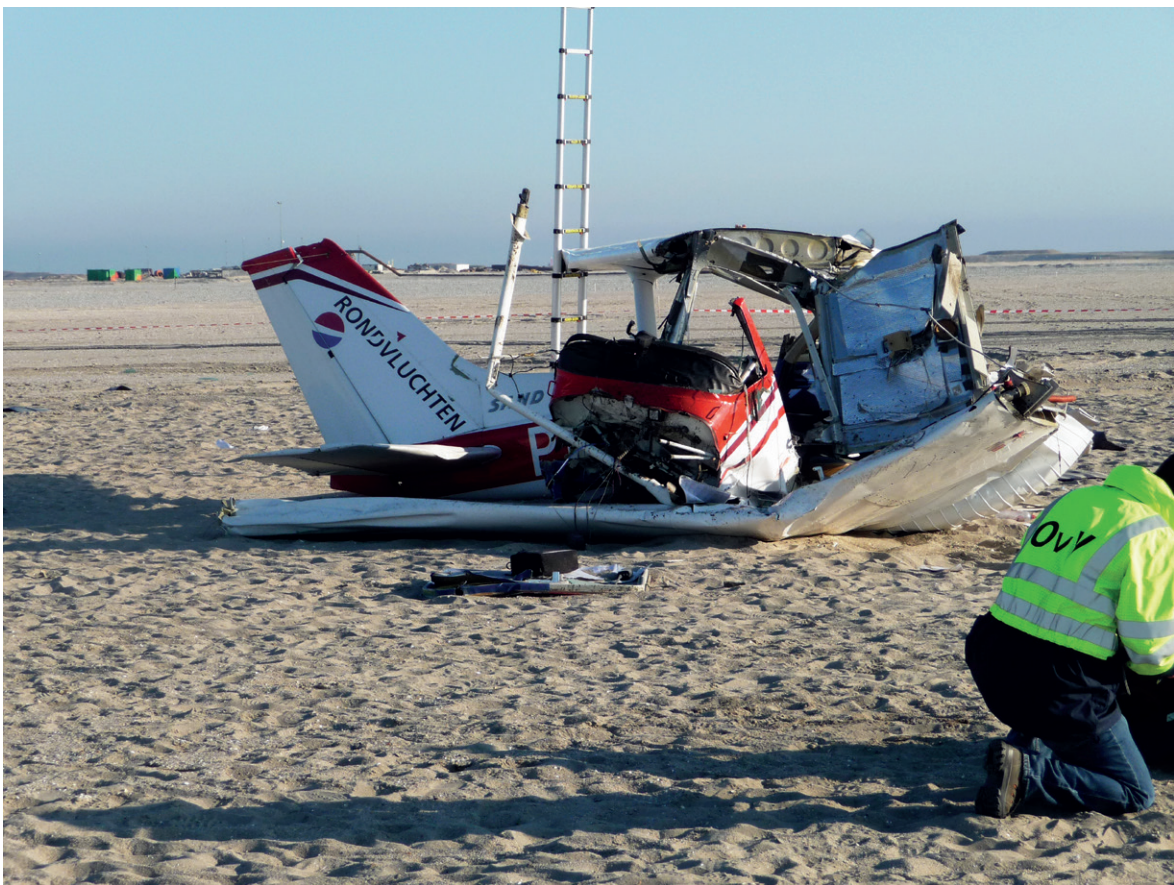
The aircraft involved in the crash (PH-SKJ, Cessna 172M) at Maasvlakte 2. (Source: Dutch Safety Board)
