Fire in a CNG bus

Wassenaar, 29 oktober 2012

The Hague, September 2013 (M2012WV1029-02)

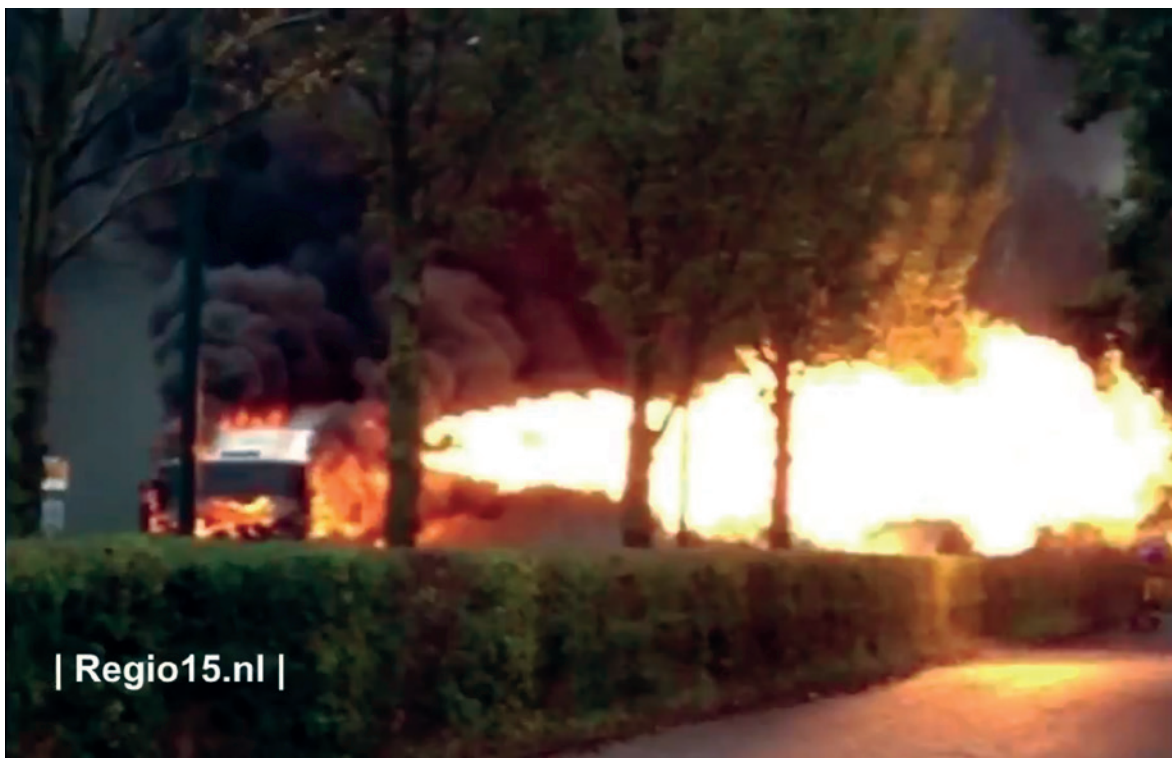
Figure 1: Bus on fire (left) and shooting flame. (Source: Regio15.nl)

Several blow-off valves opened during the fire. The vented natural gas ignited, causing flames to shoot out. As a result of the high pressure in the cylinders and the type of blow-off valves, flames 15 to 20 metres in length shot out. The blow-off valves were located in a position which caused the flames to shoot out in a horizontal and sideward direction (see Figure 1).

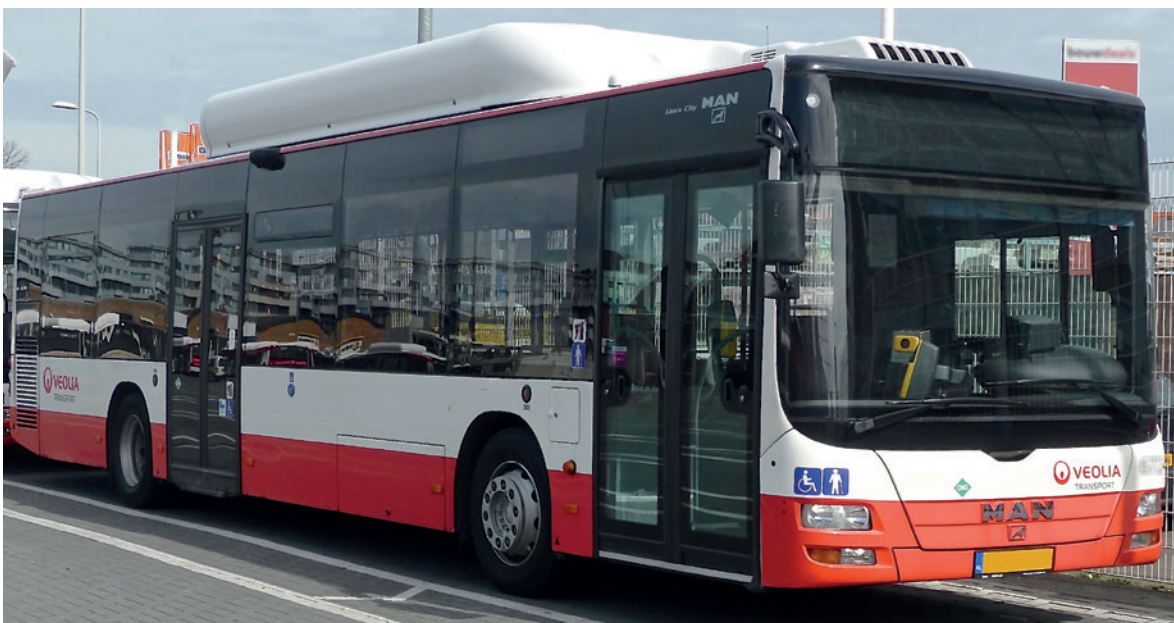
Figure 1: CNG-powered MAN Lion's City bus (with CNG system on the roof)

All CNG-powered MAN 'Lion's City' buses feature a roof-mounted CNG system. This system, which is purchased from an external supplier (Raufoss) rather than manufactured in-house by MAN, basically consists of an aluminium frame with eight adjacent and lateral gas cylinders (see figure 5). The cylinders are used to store natural gas at a pressure of 200 bar. The tanks have a combined capacity of approximately 1,700 litres and can store (under atmospheric pressure) around 350 cubic metres of natural gas in total at a pressure of 200 bar.

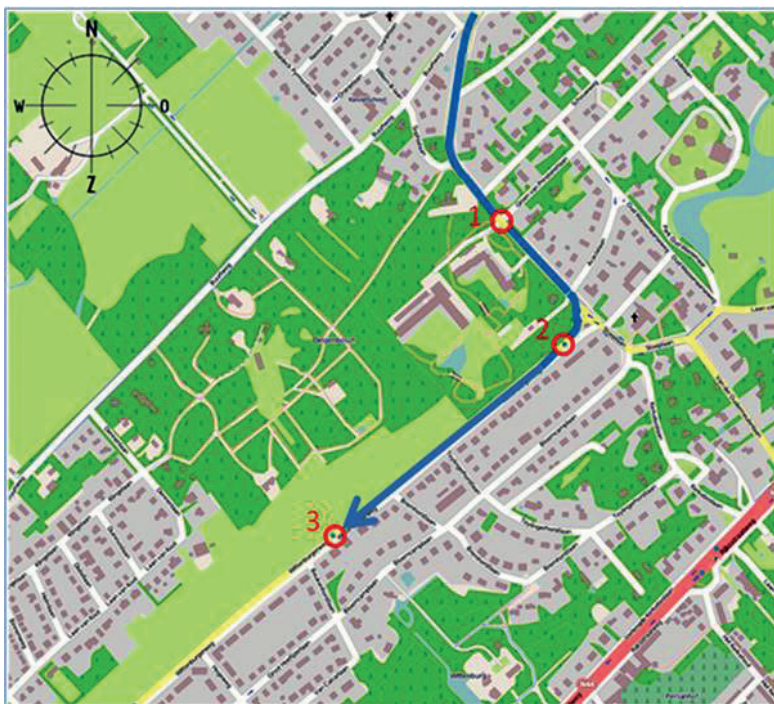
Figure 2: Route used by CNG-powered bus (blue line) in Wassenaar. Position 1: driver notices a burning smell. Position 2: grey smoke visible in rear view mirror. Position 3: driver stops bus at Beukenhorstlaan stop (Wittenburgerweg).

Just before eleven o'clock – on his normal route through Wassenaar (having departed from De Kieviet stop on the Stoeplaan) – the driver smelled something burning as the bus passed the Groen van Prinstererlaan. The driver consulted the dashboard display, but saw no warning signals: The engine temperature was normal and the on-board computer system did not show any special warning signals. The five passengers seated in the bus at the time did not report (to the driver) signs of fire, smoke or any other irregularities. However, the driver saw grey smoke (haze) rising from the left rear corner of the bus in his left rear view mirror as he turned onto the Wittenburgerweg. The driver decided to stop the bus at the nearest suitable location. He eventually stopped at the next bus stop, which was located approximately 600 meters down the road (the Beukenhorstlaan stop on the Wittenburgerweg) (see figure 2).

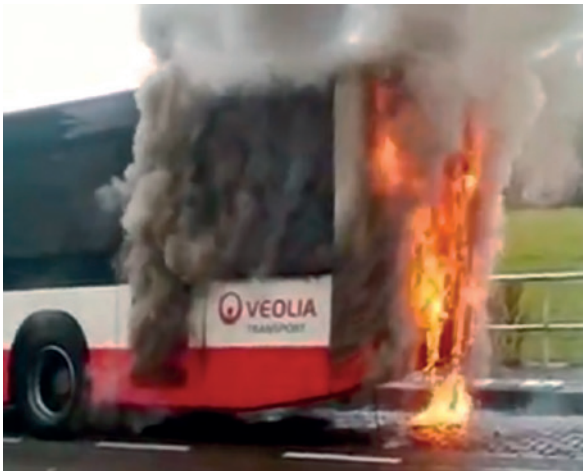
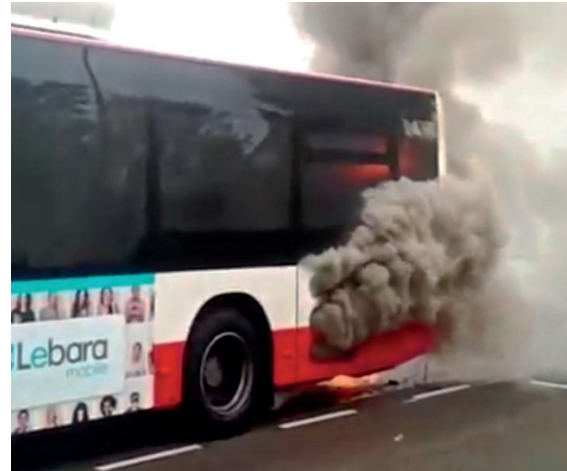
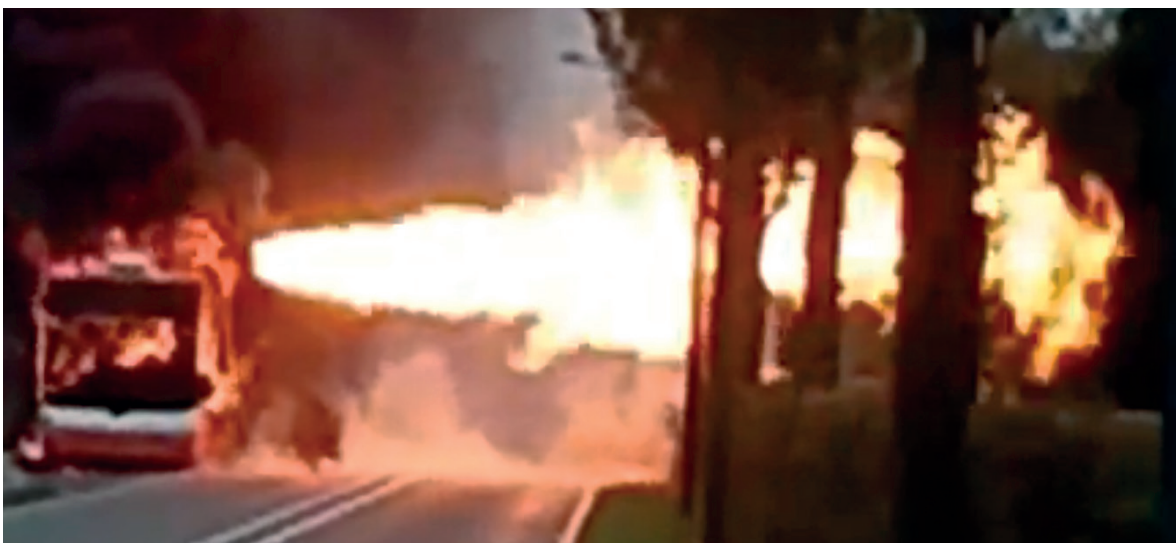
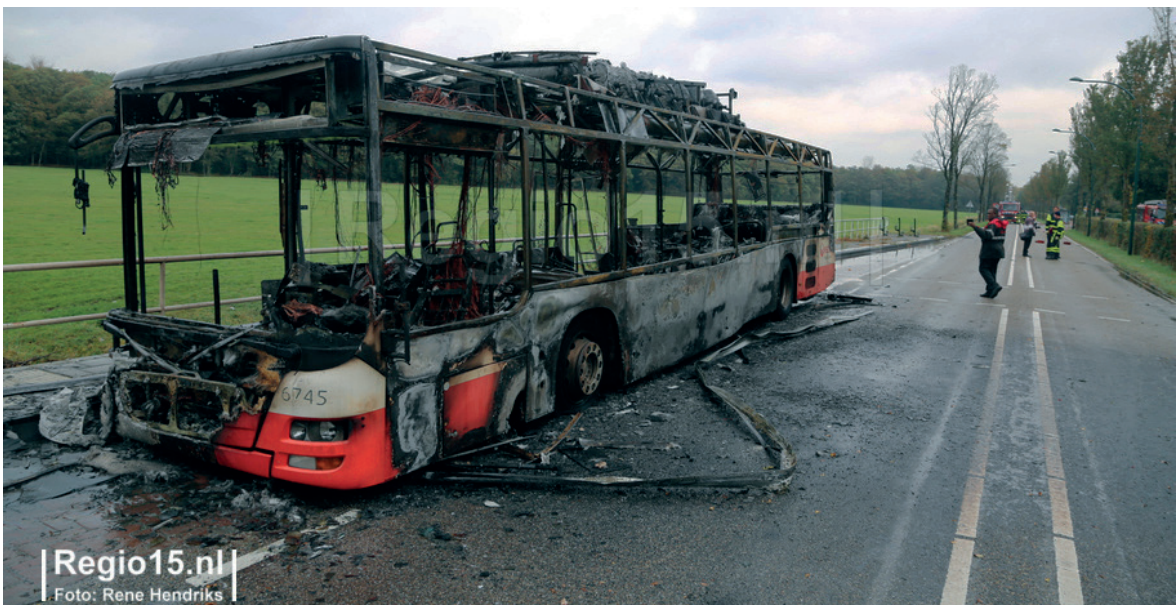
Figure 4: Several photographs of the developing fire and burnt-out bus. (Source: Upper three photos: Christiaan Dekkers, Youtube.com. Source for bottom photograph: Rene Hendriks, Regio15.nl)

- Once the fire had spread to the bus interior, the gas cylinders on the roof heated up further as result of the radiated heat. The bus windows also shattered due to the heat. As a result, the fire also started to spread via the outside of the bus.

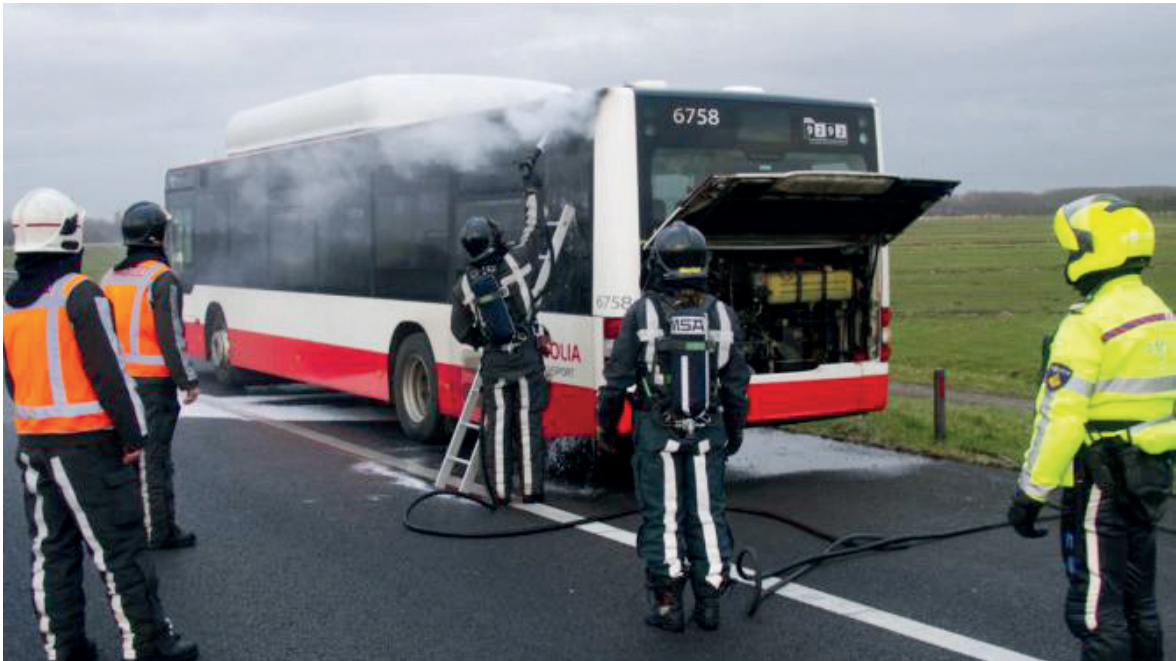
Figure 1: This photograph shows the CNG-powered bus on the A20, with the fire brigade working to extinguish the fire. (Source: Omroepwest.nl)

The police were the first emergency service to arrive at the scene. The driver managed to convince the police that the motorway (A20) should be closed off in both directions in view of the danger that flames would shoot from the bus. The fire brigade, which arrived at the scene with units from several brigades, put out the flames before they could develop into a serious fire. As a result, the fire was restricted to the engine air inlet system and the rear section of the bus interior.

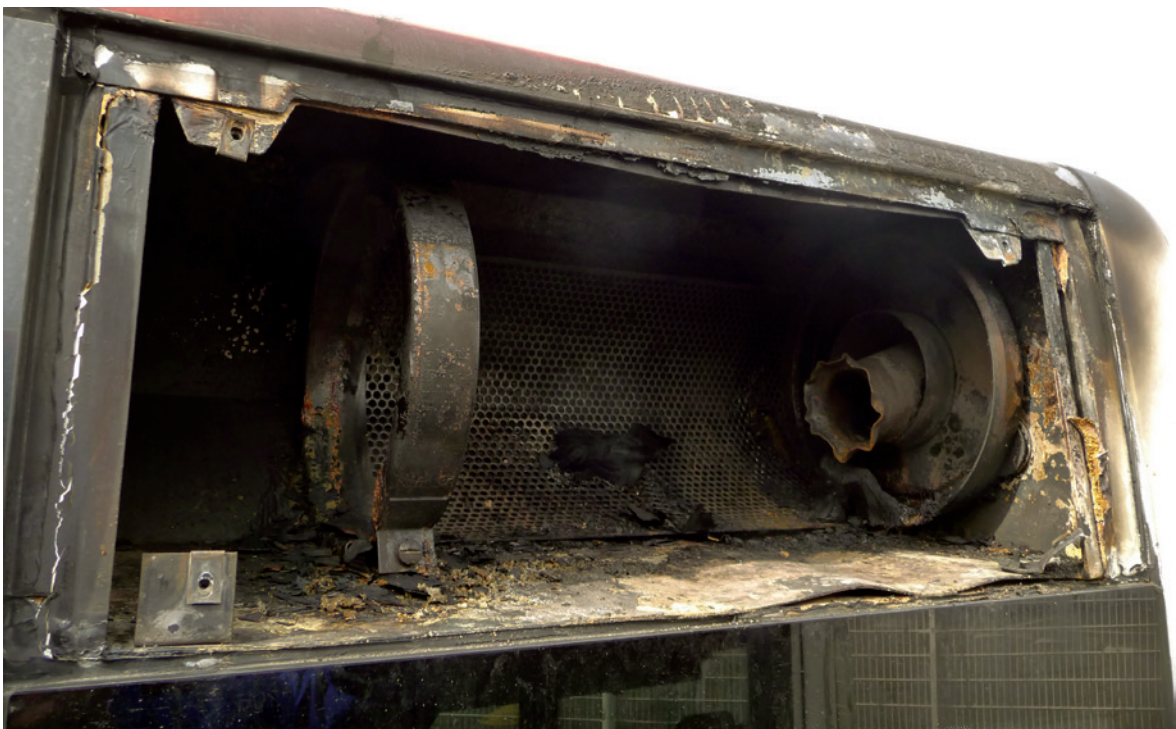
Figure 2: Fire damage to the engine air intake (after removal of safety grille)

The fire was probably caused by a backfire, an incident involving an explosion in the engine air inlet. According to Veolia, this phenomenon has occurred in several of its other buses of the same type. On the day of the incident, the bus in question had experienced engine problems that restricted its maximum speed to 20 km/hour. After repairs had been carried out at a stop near Zanddijk, the bus resumed normal service. Later that day, the bus experienced new engine problems and was temporarily decommissioned and transferred to the garage on the Telexstraat in The Hague. Once the bus had been inspected, repaired and tested, the vehicle was returned to normal service at around four thirty in the afternoon. The fire occurred at around seven pm.

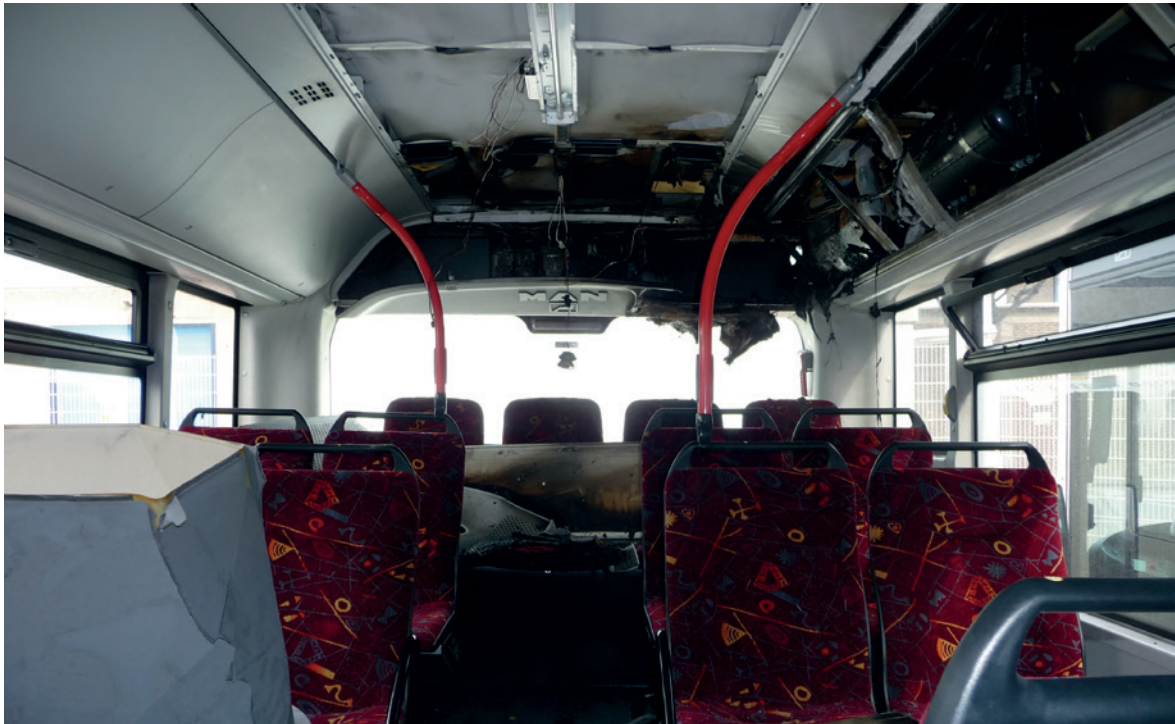
Figure 3: Fire damage to the bus interior.

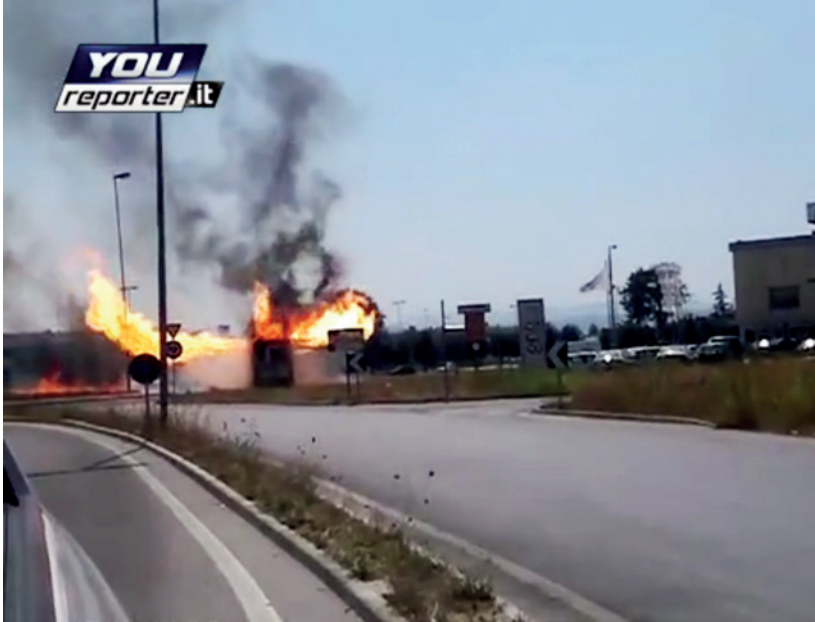
Figure 4: CNG-powered bus fire in Jesi, Italy.

Internet research yielded information on eight fire incidents involving CNG-powered buses. The photos below show three fires during which the blow-off valves were activated.

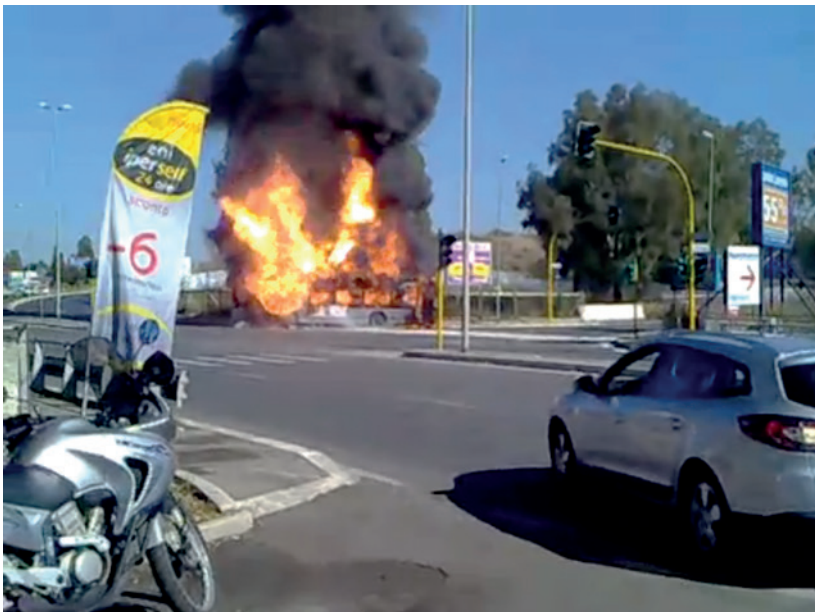
Figure 5: Fire in CNG-powered bus operated by Italian public transport company ATAC.

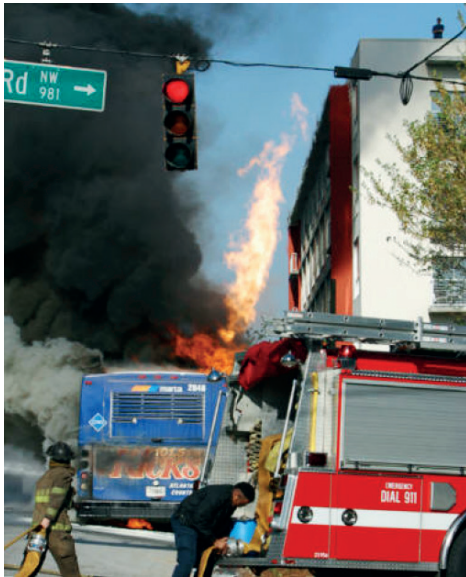
Figure 6: Fire in CNG-powered bus in the US

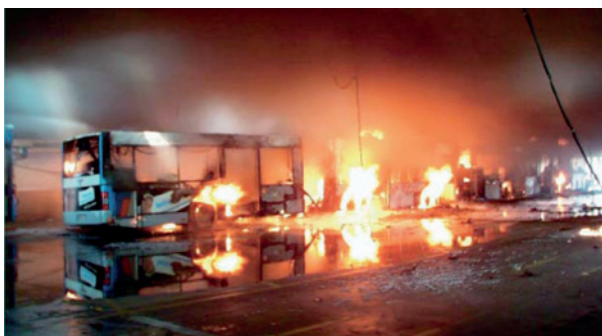
Figure 7: CNG-powered buses on fire in Saarbrücken

On 3 September 2010, a fire occurred in a bus garage in Rome. A total of 24 CNG-powered buses operated by ATAC burnt out during the incident. In May of 2003, two CNG-powered buses parked in a bus garage in Saarbrücken (Germany) burnt out. A natural gas cylinder exploded during this fire. It appeared that the incident was investigated by TÜV-Saarland.
