## **DERAILMENTS AT RANDSTADRAIL**

The Hague, November 2008 (project number M2006RV1129-04)

## DUTCH SAFETY BOARD

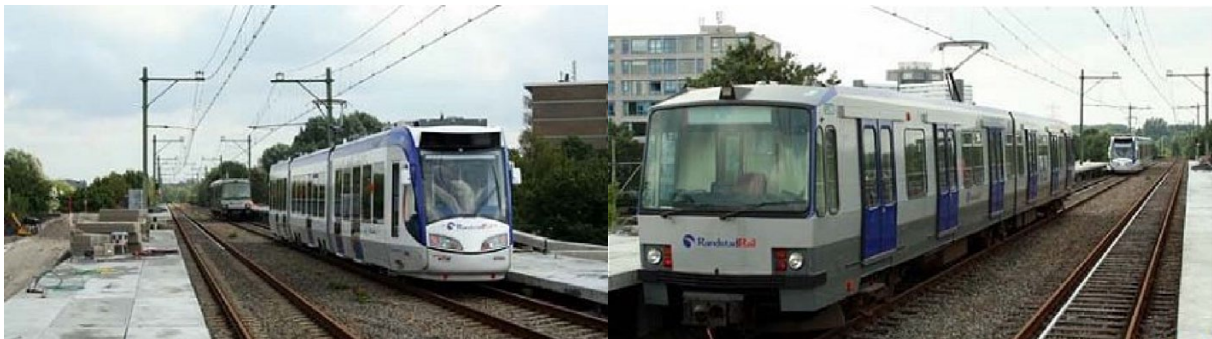
Figure 1 – RandstadRail vehicles<sup>28</sup>

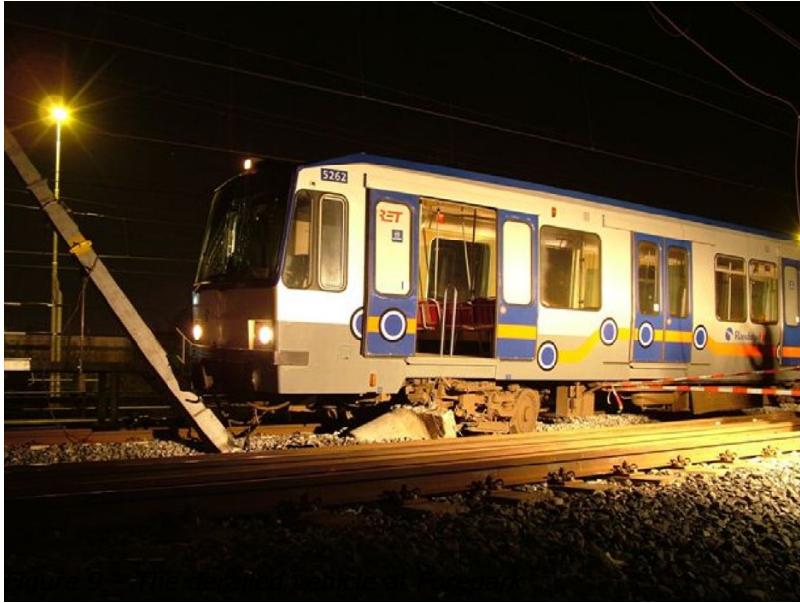
A switch is a special construction that enables a railborne vehicle to switch from one track to another.<sup>200</sup> During the evening peak hour of 29 November 2006, a RandstadRail vehicle belonging to RET and carrying 120 passengers derailed at switch 846 close to the Forepark stop (between Leidschendam-Voorburg and the Zoetermeer/Rotterdam junction). This accident resulted in injury to 17 of the passengers. Partly as a result of this derailment, HTM and RET ceased operations and IVW formally suspended passenger services on part of the RandstadRail network (The Hague Central Station-Zoetermeer/Nootdorp) until further notice. In addition, IVW and HTM/RET launched an investigation into the derailments.

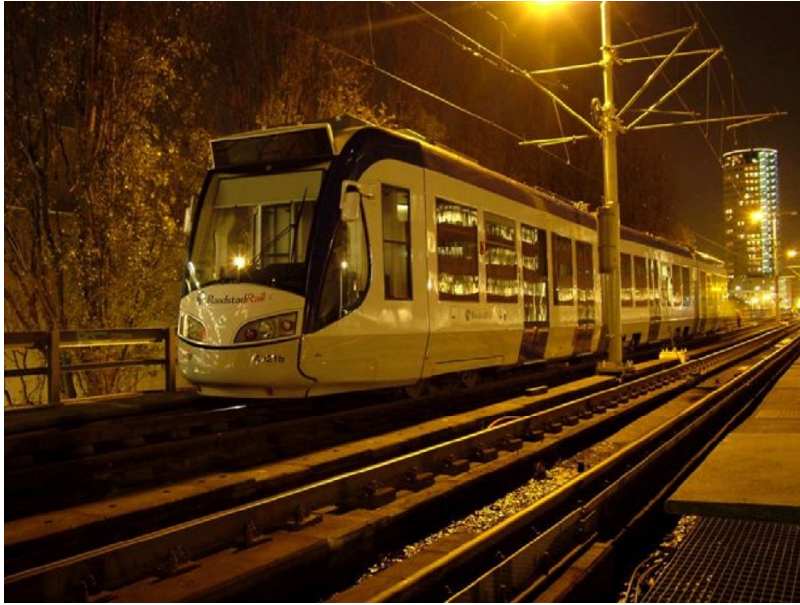
Figure 10 – The derailed vehicle at Ternoot

#### *Situation*

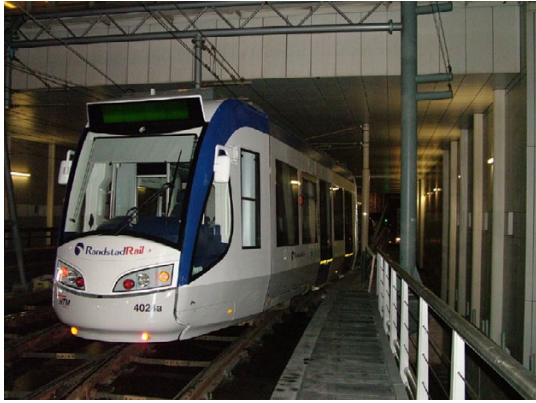
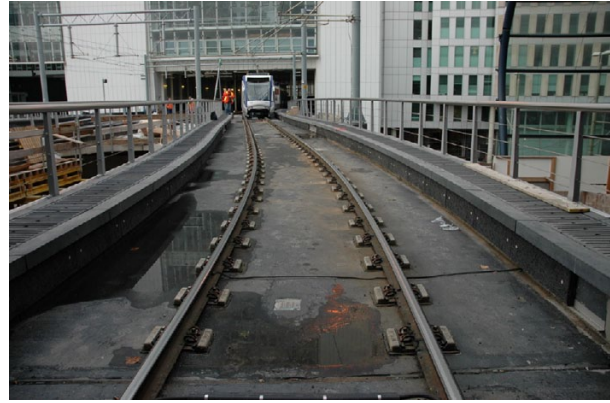
Figure 11 – The derailed vehicles near The Hague Central Station on 3 and 4 November 2006

#### *Situation*

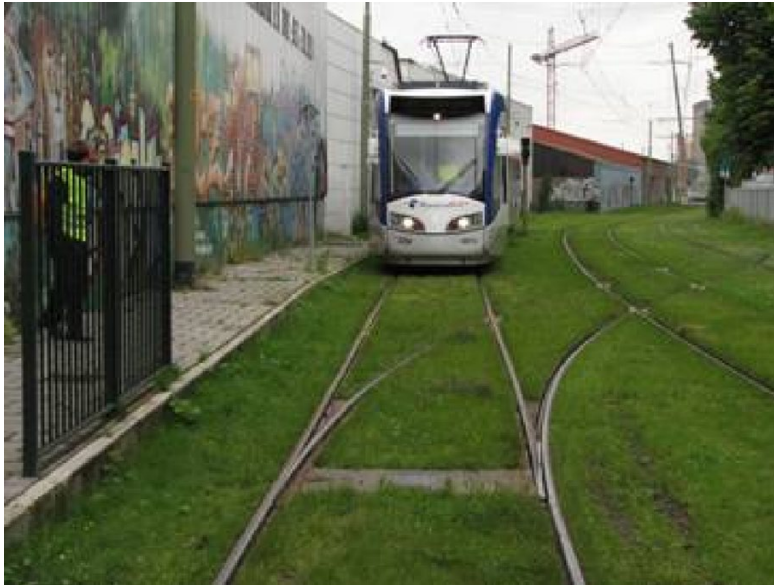
Figure 12- Vehicle approaching an openable switch

On 24 November 2006 and 24 and 26 January, 25 May and 20 July 2007, RandstadRail vehicles belonging to HTM derailed on openable switches in The Hague city tram network.<sup>219</sup> The derailment of 24 November 2006 took place on Monstersestraat, while those of 24 and 26 January 2007 took place at Arnold Spoelplein and those of 25 May and 20 July 2007 occurred on Meppelweg. These derailments did not result in any personal injuries.

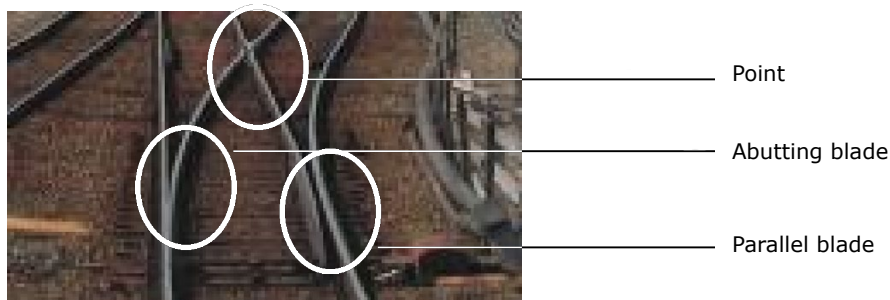
Figure 8 - Switch without movable point

A switch enables railway vehicles to be guided from one railway track to another. A railway vehicle may either be leaving the railway it is on (diverging route) or travelling on a railway that is merging with another (converging route).

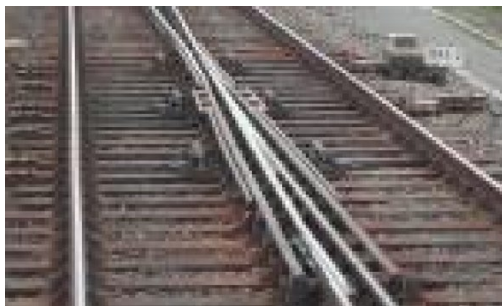
Figure 9 - Movable point

The rails of a switch cross at its point. In order to enable the wheel flange to pass in one direction, a small gap is required in the point in the other direction. In most cases this is not a problem. If the vehicle has small wheels, however, such as in the case of trams, the probability that a wheel will be guided in the wrong direction on a point is relatively high. In terms of passenger comfort, a small gap in the rail is also not desirable at higher speeds. In those cases, use is made of a movable point. In a movable point, blades also move to guide a vehicle to the left or to the right. There is therefore no gap in the direction of travel. This movable point is operated at the same time as the blades at the beginning of the switch.

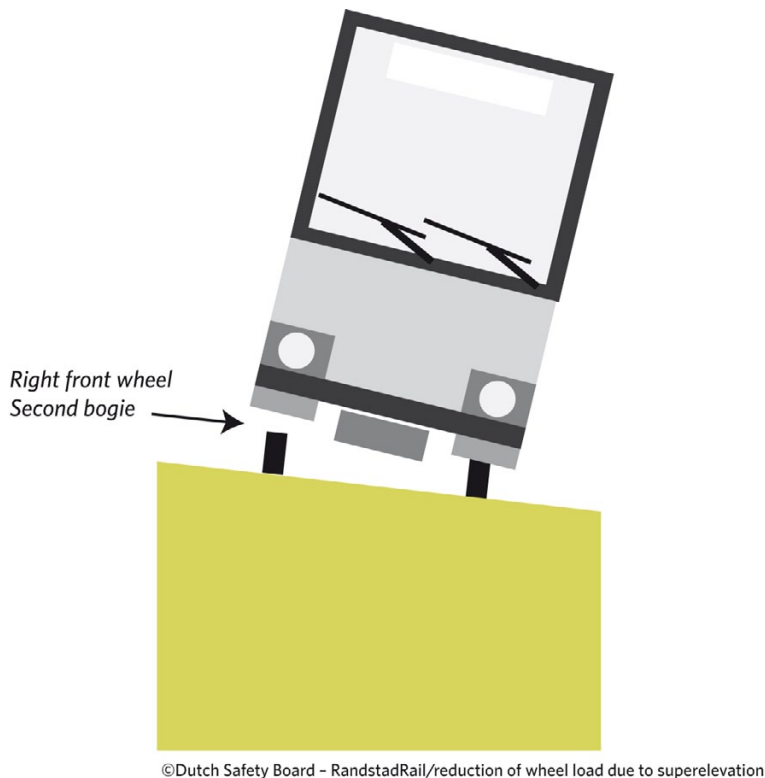
Figure 14 – Reduction of wheel load due to superelevation and distortion (as seen when facing the vehicle)

When a vehicle travels at low speed through a superelevated curve, wheel loads are redistributed: the vehicle's centre of gravity shifts to the inside of the curve, which means that the wheel loads of the outer wheels decrease. Measurements taken of the actual track layout after the derailment on 29 November revealed that the distortion was greater than the permitted maximum (37 mm instead of 20 mm over a length of 10 m<sup>49</sup>). This greater distortion meant that the vehicle was subjected to a greater twisting momentum than anticipated. Given the greater torsion stiffness of the RegioCitadis model, such a vehicle will not follow this twisting momentum but, rather, certain wheels will lose contact with the rail (reduction of wheel load).

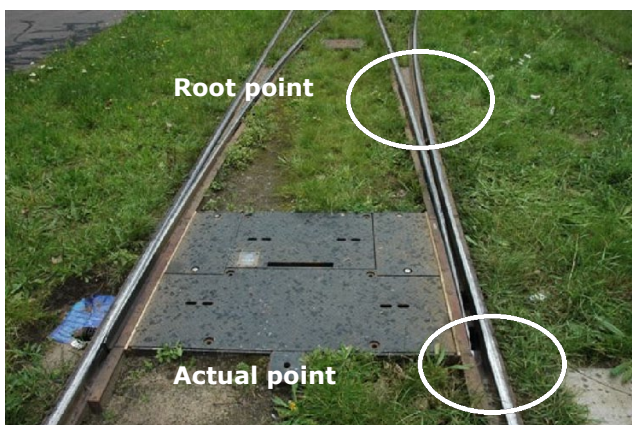
Figure 20 - Root point and actual point of an openable switch's blade

The drivers involved were definite in their statement that, as seen from their position in the driver's cabin, the blades of the switch were in the correct position and that the vehicle nevertheless inexplicably derailed. HTM representatives reported that the log files and trip recording data of the RegioCitadis vehicles clearly showed that when the manoeuvre to switch the direction of travel was being executed, the first axle of the vehicles did *not* pass over the blades. As a possible explanation, it was suggested that the drivers, looking out from behind slightly curved windows, might in fact have been looking at the root point of the blade. Shadows caused by the interplay of darkness and sole illumination of the headlights may have given the drivers the impression that the blade had moved when in fact it had been the root point, which is further away from the blade (see following image).
