## **SAGGING OF A BARGE**

Sagging and partial sinking of a  
barge on 5 July 2004  
in the Middelsluis lock of IJmuiden

The Hague, July 2006

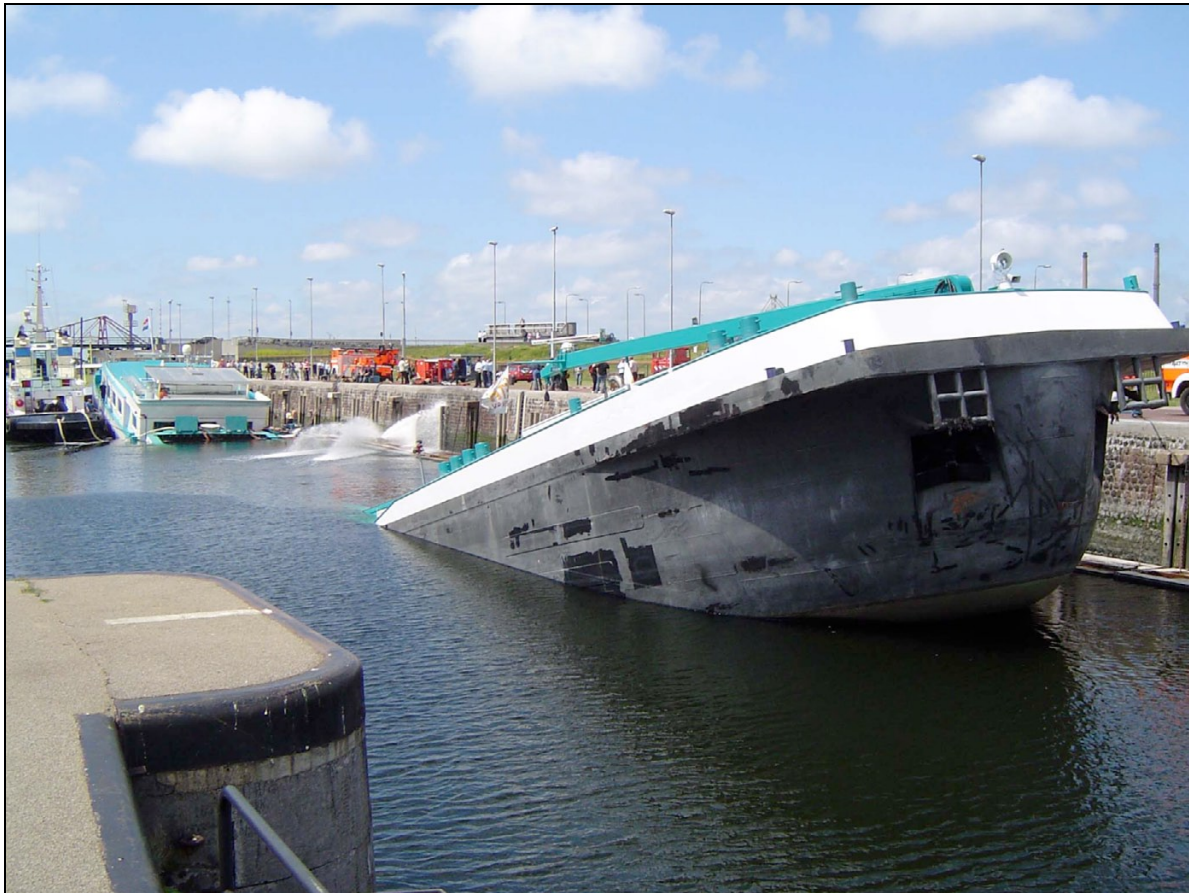
On Monday morning 5 July 2004, a new barge first folded and then partially sank in the Middensluis lock in IJmuiden, the Netherlands. The Middensluis lock connects the Noordzeekanaal with the IJmuiden outer harbour.

*Figure 1: Folded vessel in the Middensluis lock of IJmuiden*

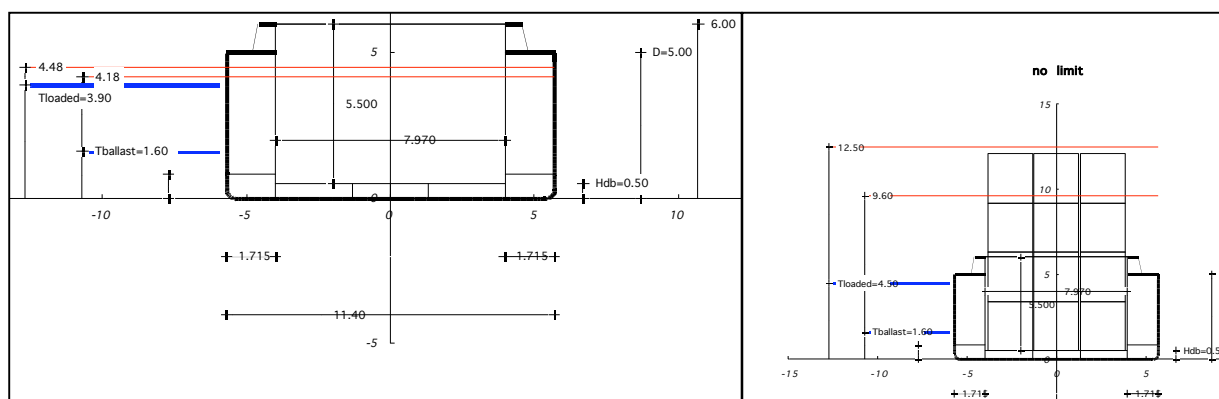
Figure 3: Cross sections of the barge

- The vessel has this design (among other reasons) such that the shape of the hold can also transport other cargo (general cargo and, in particular, containers). The width of the hold is large enough to place three containers next to each other). In addition, a choice was made for a relatively small hold, to create more space for the accommodations.

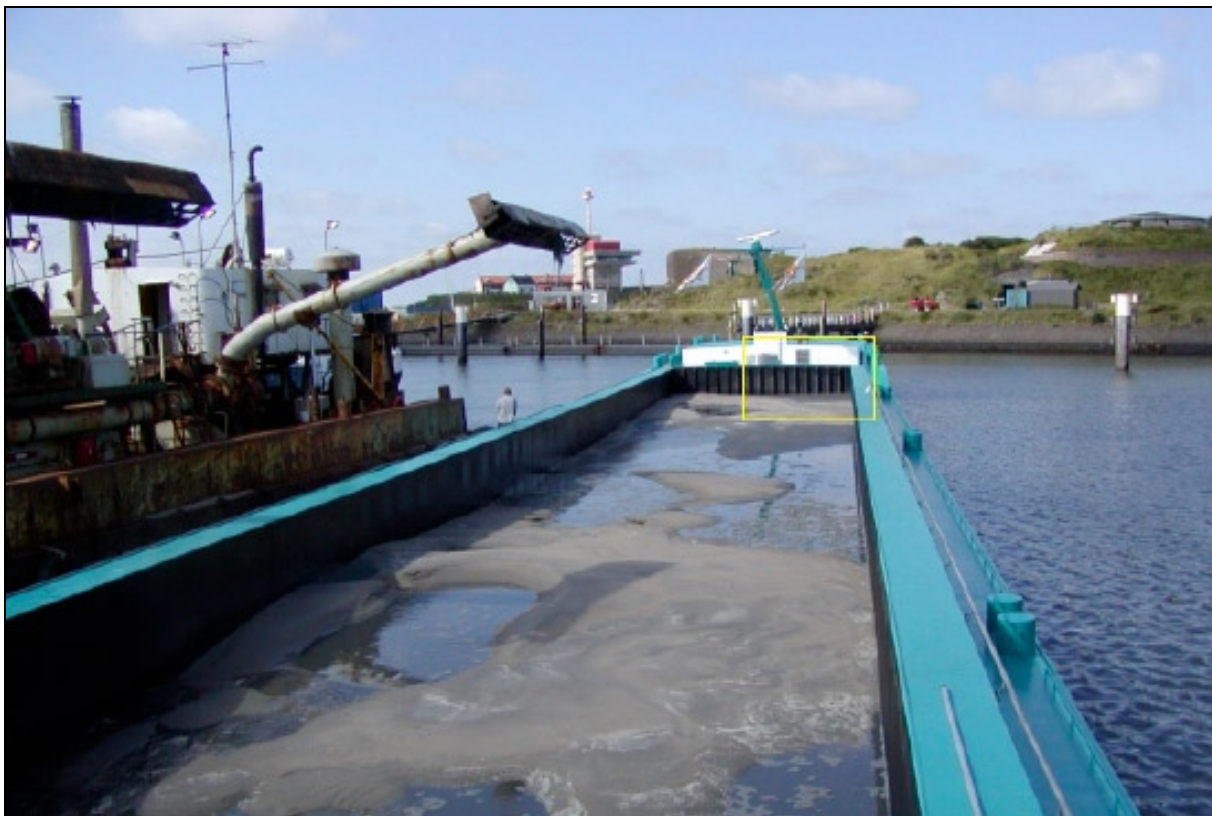
In this context, it is important to state that the level of the white paint of the load lines was incorrect (the level was too high). The National Police Services Agency (KLPD) conducted a criminal investigation into this situation, because there were signs that this was an economic offence. In the context of the investigation, the actual loading condition was of great importance. However, it was determined that the vessel was not overloaded at the time of the accident. In view of the fact that these incorrectly located load lines played no role whatsoever in the occurrence of the accident, this aspect was not taken into further account in the Safety Board's report.

Figure 4: Photo of the barge soon after loading (photo taken by the owner)

- The Safety Board therefore finds that there is sufficient evidence that the sagging of the vessel was not caused by the use of the materials.
- The vessel was overloaded when it sailed  
After the incident, a determination was made of the stress and depth resulting from the load, based on such aspects as various statements from witnesses, information from the KLPD's report, and a photograph taken immediately after loading (made available by the skipper/owner).

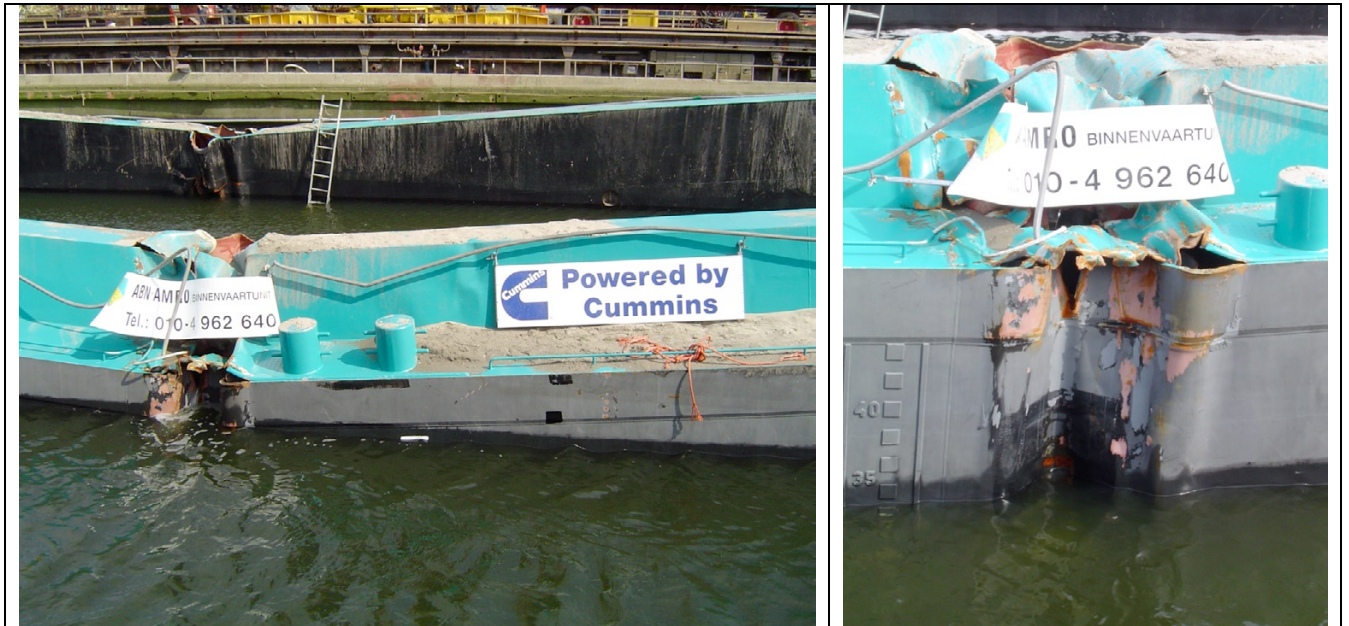
1. .... It is striking that the dent line is not located crossways on the vessel. It was also observed that the front part shifted slightly crossways after the ship was unbent. The dent shape is therefore clearly asymmetrical.
2. The folds in the sidewall were shaped like a pair of trousers.
3. Initially, the vessel was bent, but it gradually straightened out in dry dock when the vessel was fully above water. This process was accompanied by popping noises.”  
(TNO report)

Figure 5 and 6: Photos of the sagging of the side of the ship

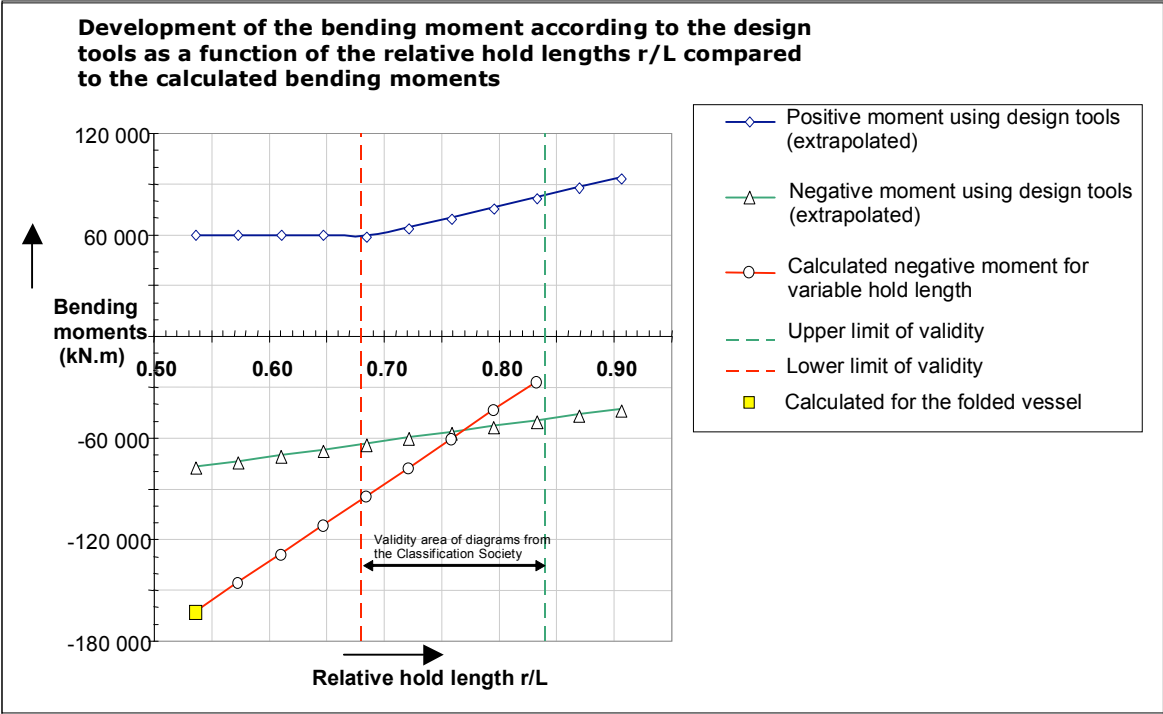
The design tools were examined in further detail by the Safety Board. Diagram 1 shows the deviations that were observed. The calculations that form the basis for this diagram were performed for the depth at which the vessel fractured: 3.90 m with a load volume of approximately 3.495 tons (see also Appendix 2).

It has emerged from the Safety Board’s calculations that the design tools are not satisfactory. For the type of vessel in question, these tools indicate a bending moment that is far too low, also within the validity range of the design tools.

Diagram 1: Development of bending moment according to the design tools compared to the calculated bending moments

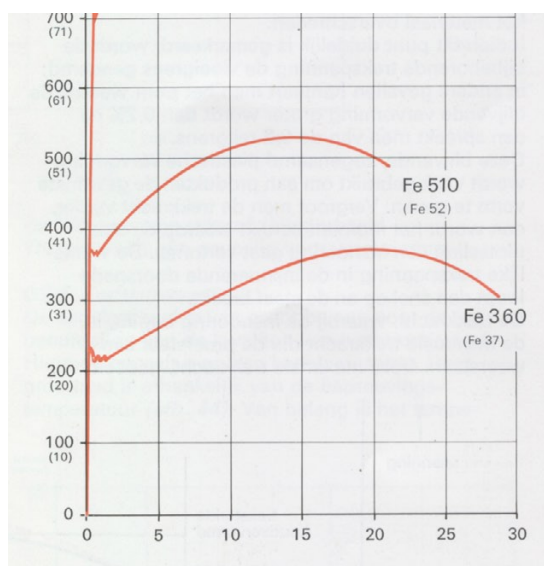
#### Grafiek 2: Spanning op basis rek van twee staalsoorten

In bijgaande grafiek<sup>10</sup> zijn de trekkrommen van twee staalsoorten gegeven, één van een standaard scheepsbouwstaal, Fe 360, en één van een hoogwaardiger staal met een hogere treksterkte, Fe 510. In de grafiek is op de horizontale as de rek van het staafje aangegeven als percentage van de oorspronkelijke lengte en verticaal is aangegeven de spanning in N/mm<sup>2</sup>.

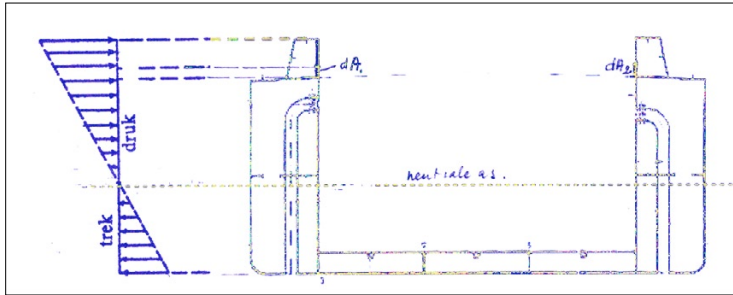
In de laatste uitdrukking herkennen we de definitie van het geometrische zwaartepunt van de doorsnede. Hieruit kunnen we concluderen dat kennelijk de vezel waarin geen rek optreedt, loopt door het zwaartepunt van de dwarsdoorsnede.

**Figuur 8:** Bepalen van zwaartepunt van de dwarsdoorsnede

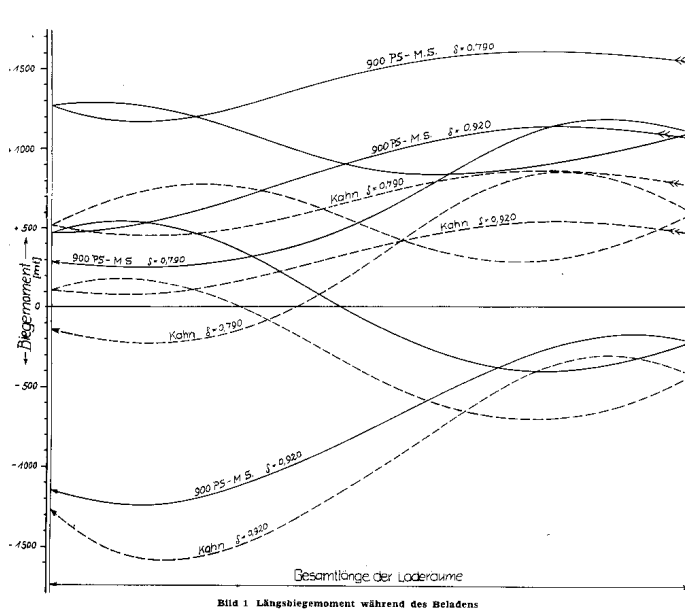
Met deze ladingswijzen zijn systematische berekeningen uitgevoerd. Voorbeelden zijn in de onderstaande figuur afgebeeld<sup>13</sup>. Op de horizontale as staat de ruimtelengte afgebeeld, op de verticale as het buigend moment. Overigens worden deze schepen kennelijk in drie gangen beladen. Te zien is dat bij het beladen van het schip er aanvankelijk een positief buigend moment is, dat naarmate het schip voller beladen wordt, lager wordt en afhankelijk van de volheid van het schip, ook negatief kan worden. Ook is te zien, bijvoorbeeld aan de hand van de Kahn,  $\delta=0.92$ , dat er op driekwart van het beladen er een buigend moment ontstaat, dat hoger is dan het moment in de eindtoestand van de belading. Zou de ontwerper alleen de eindtoestand hebben beoordeeld, dan zou hij een te laag moment in rekening hebben gebracht.

Bild 1 Längsbiegemoment während des Beladens

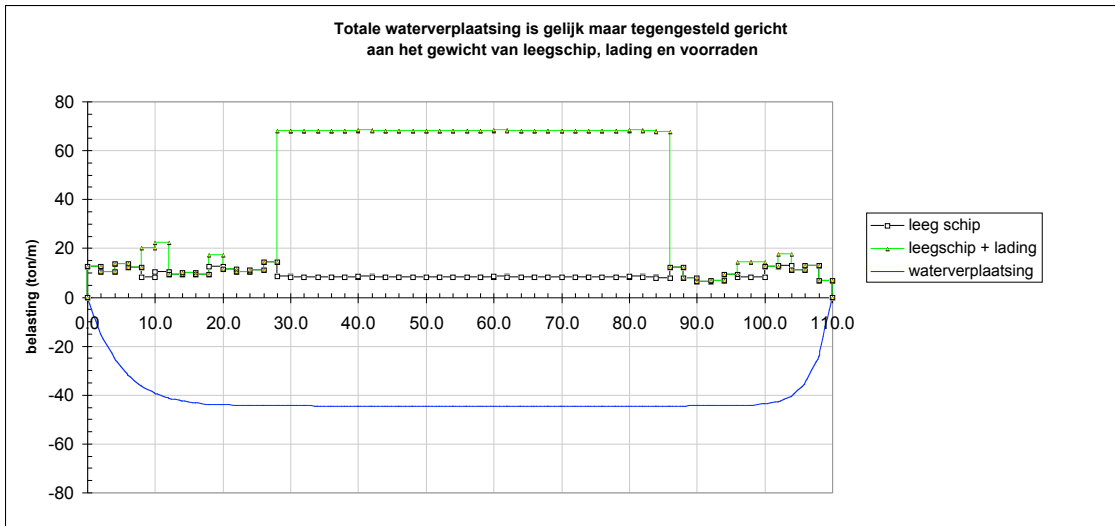
Dat is te zien in onderstaande grafiek, waarbij in zwart de gewichten per meter zijn aangegeven van het lege schip. Daarbovenop is dan geplaatst het gewicht van de lading en de voorraden in groen, ook in tonnen per meter scheepslengte.

**Grafiek 3:** Neerwaarts gericht gewicht van het schip en opwaartse waterdruk

Vervolgens worden de opwaartse krachten op het schip bepaald volgens de wet van Archimedes. De verdeling van de opwaartse krachten over de lengte van het schip verloopt volgens de zogenaamde kromme van spantoppervlakken. Deze is in blauw aangegeven.

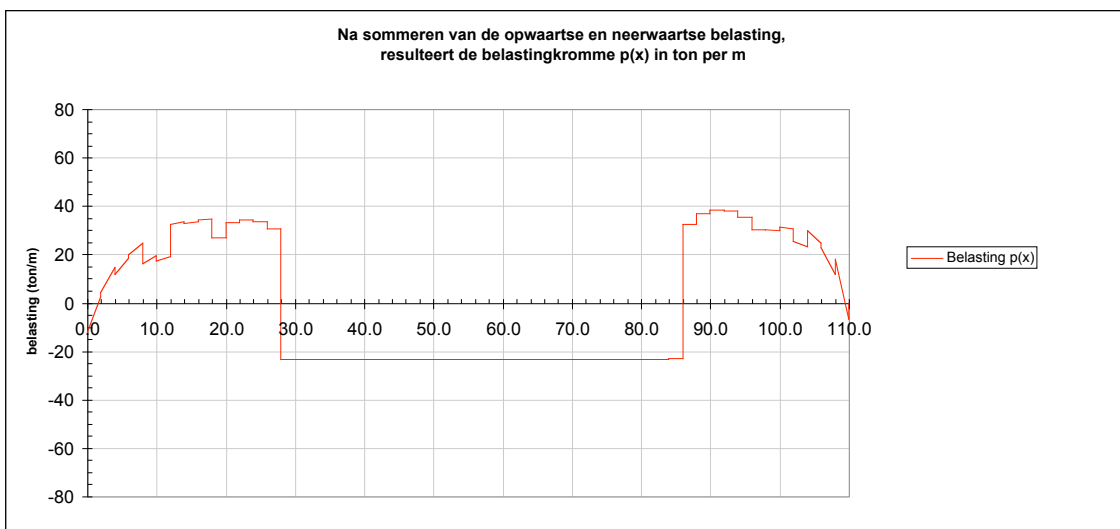
Door per moot van 2 meter het verschil te bepalen tussen de opwaartse en neerwaartse kracht, ontstaat de belasting  $p$  in ton per m op het schip. Dat is geïllustreerd in onderstaande figuur. Duidelijk is te zien dat de lading van het schip als het ware is opgehangen tussen het achterschip en het voorschip, omhoog gehouden moet worden door het achter- en voorschip.

**Grafiek 4:** Opwaartse en neerwaartse belasting gesommeerd

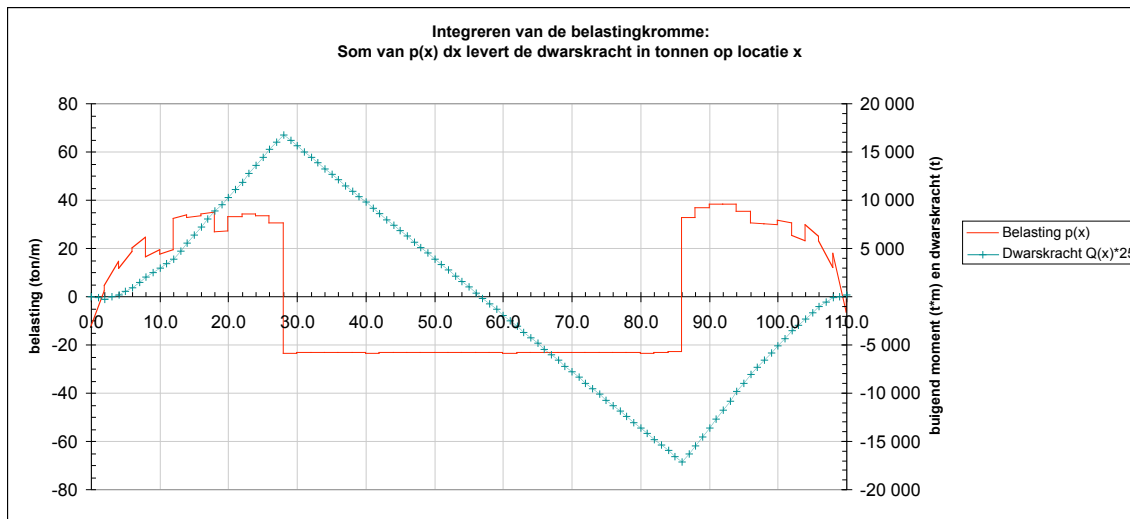
Vervolgens wordt bepaald welke dwarskrachten er optreden in de diverse dwarsdoorsneden van het schip. Hierbij wordt beginnend achteraan met stappen van, in dit geval 2m, een knip te maken in het schip en alle verticale krachten te sommeren. Per doorsnede wordt dan de kracht gevonden die je moet uitoefenen om het schip in evenwicht te houden als je het zou doorknippen in die doorsnede. De verdeling van die dwarskrachten zien we in de volgende grafiek:

**Grafiek 5:** Som belastingen en dwarskracht

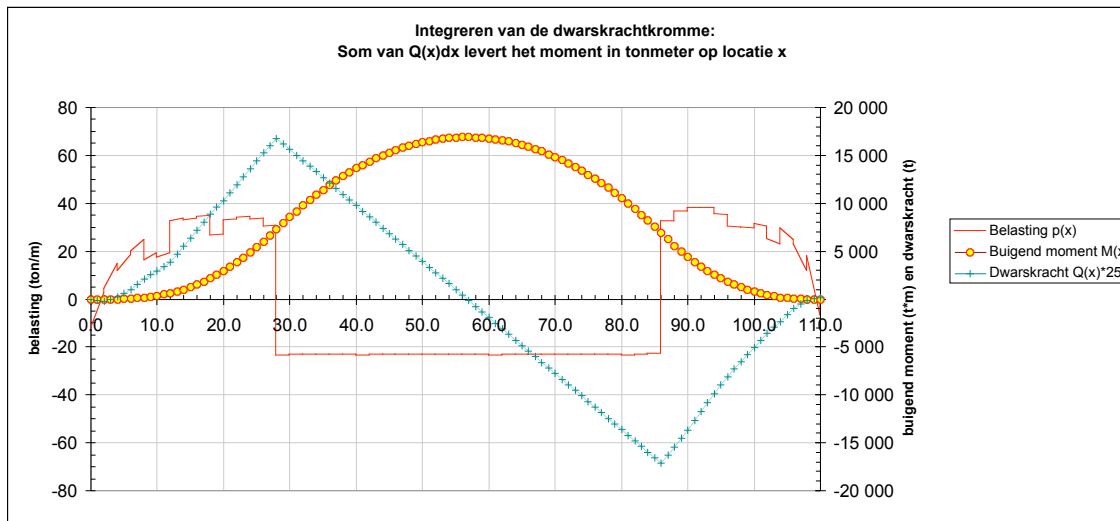
Tenslotte kan het buigende moment voor iedere doorsnede van het schip bepaald worden door het sommeren van de dwarskrachten over de lengte. Het is duidelijk dat er in dit geval een buigend moment optreedt dat het schip in het midden wil doen doorzakken: het schip krijgt een doorgezakte paardenrug. Germanischer Lloyd duidt dit moment aan met een positief moment. Een positief moment resulteert in horizontaal gerichte drukkrachten in het dek en de coaming van het schip en in horizontale trekkrachten in de bodem van het schip. Zou het schip een kattenrug vertonen, dan is er sprake van een negatief moment en dan zullen er trekkrachten optreden in dek en coaming, maar drukkrachten in de bodem.

In het algemeen treedt een paardenrug op bij geladen schepen en een kattenrug bij lege schepen.

**Grafiek 6:** Som belastingen, dwarskracht en buigend moment

Het interessante mechanisme is dat de verticale krachten van gewicht en oprijvende kracht, via dwarskracht en buigend moment weer omgezet worden in horizontale krachten in de constructie: namelijk trek en druk krachten in dek en bodem.

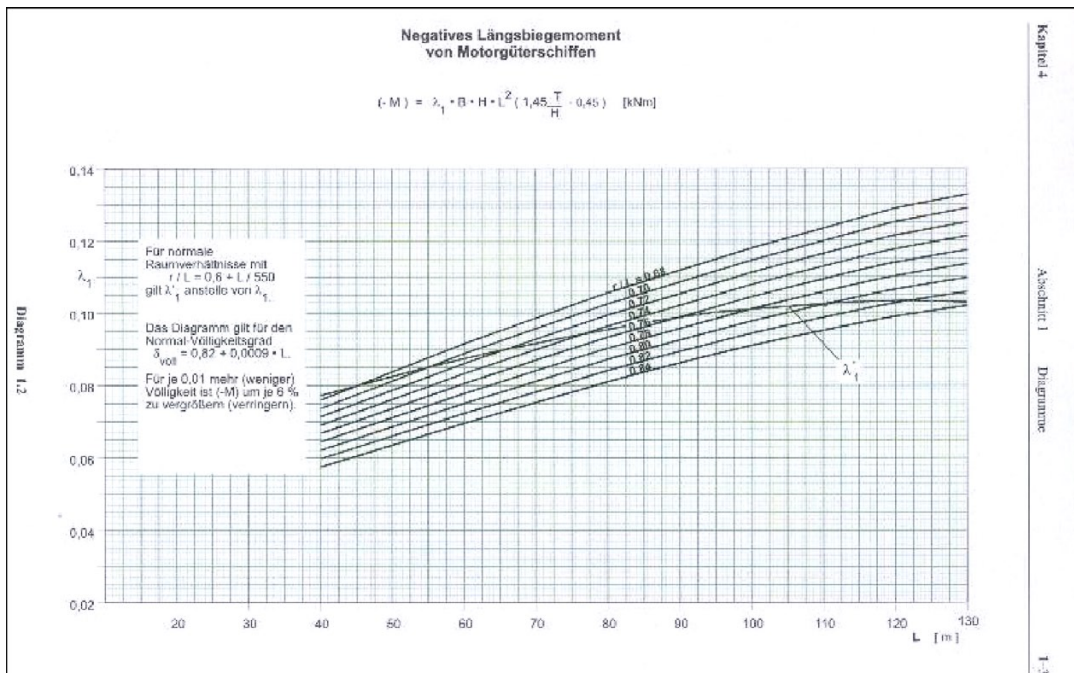
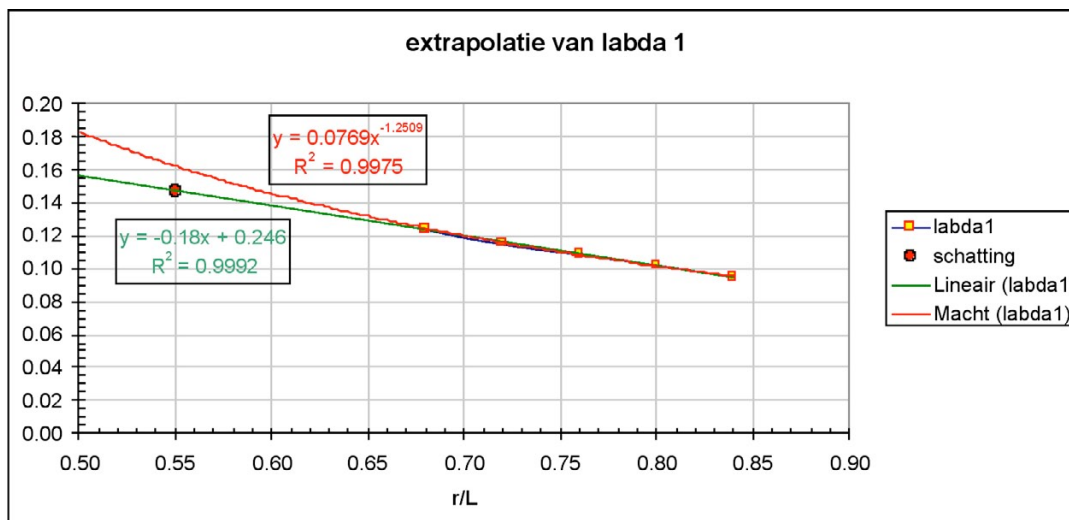
$\lambda_1$  wordt bepaald op basis van  $r/L$ , waarbij  $r$  de ruimtelengte is, uit diagram 2.

Extrapolatie leidt tot een  $\lambda_1$  van 0.147 (tot 0.162). En daarmee het moment  $(-M) = 93\,703$  kNm.

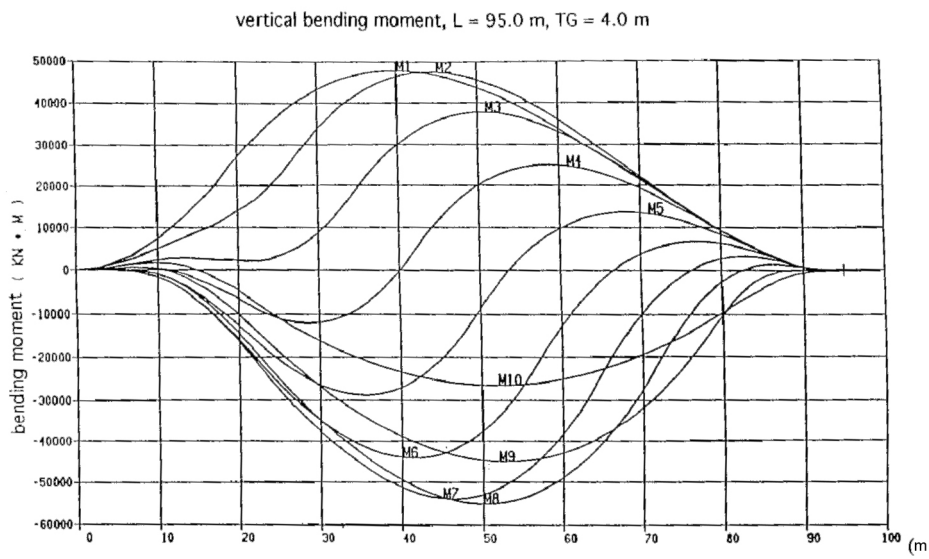
Voorbeeld van de variatie van het buigend moment tijdens het laden en lossen.

Fig. 2: Distribution of longitudinal bending moment for 10 loading conditions (M1-empty Ship with 50% supply, M10-full ship) from /7/

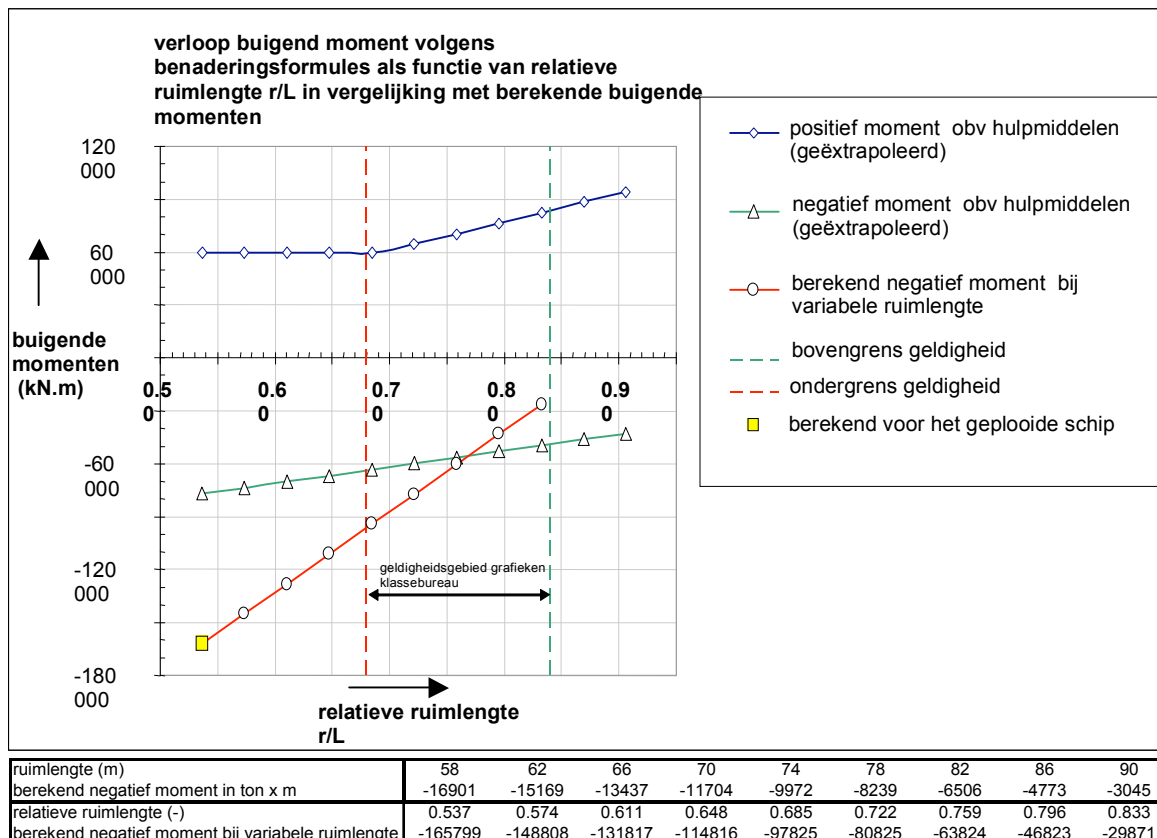
De berekeningen zijn uitgevoerd voor de diepgang van 3.90 m (diepgang ten tijde van het ongeval), met een ladinghoeveelheid van 3468 ton.

In het diagram zijn weergegeven de voorspelling van de formule, die buiten het geldigheidsgebied lineair is geëxtrapeerd. Daarnaast zijn de berekende waarden op grond van de gegevens van het beunschip weergegeven en opvallend is dat de formule slechts op een punt overeenstemt met de werkelijkheid. Beneden een ruimlengte van 75% blijkt dat de berekende waarden beduidend hoger uitpakken dan de geschatte waarden van de formule.

Op de grens van de geldigheid van het diagram, een ruimlengte van 68%, bedraagt de afwijking  $90\ 000/60\ 000=1.50$ . Bij 55% ruimlengte bedraagt de afwijking :  $165\ 000/80\ 000=2.00$ .

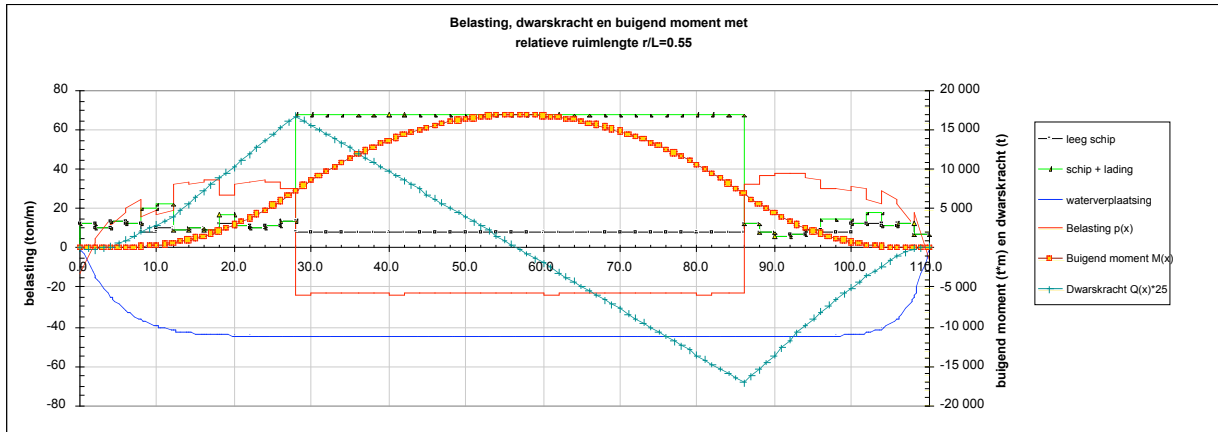
Belasting en buigend moment in beladen toestand met ruim  $r/L=0.55$

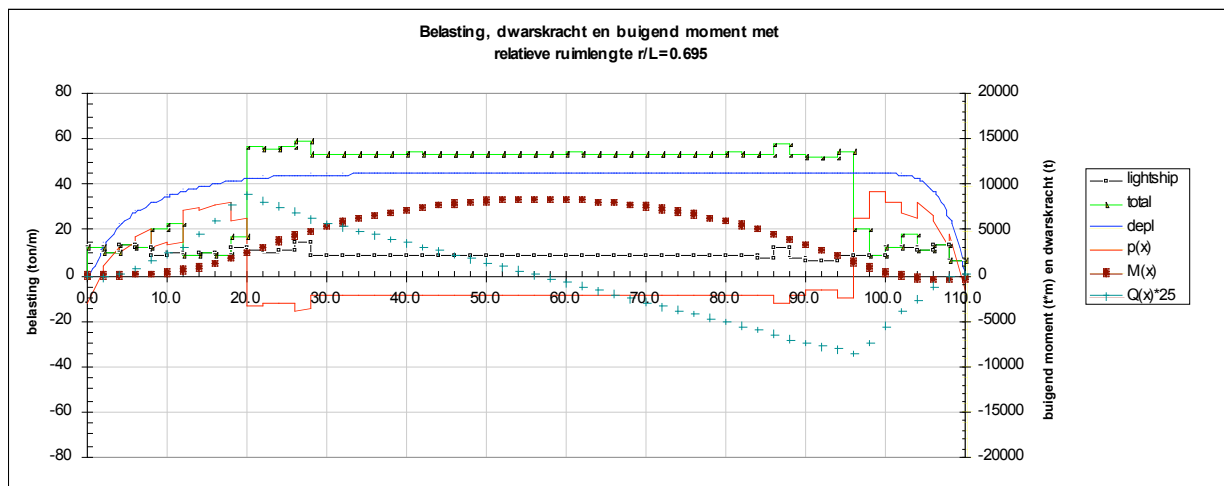
Belasting en buigend moment in beladen toestand met denkbeeldig ruim  $r/L=0.695$
