THE DUTCH
SAFETY BOARD

**Accident involving
a rail grinding train in Stavoren,
the Netherlands,
on 25 July 2010**

The Hague, September 2011

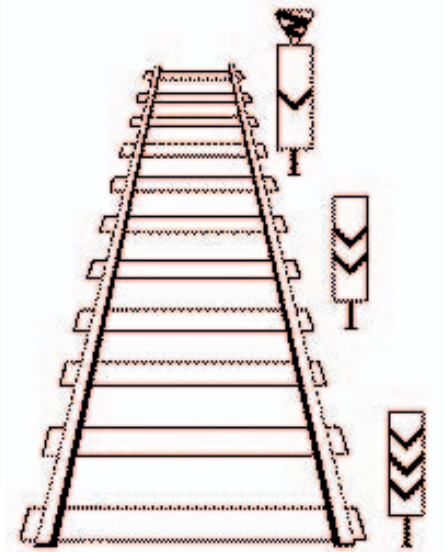
- Stavoren Station does not have the usual light signal entering a railway station. However, a series of approach markers (*keperbaken*) are located alongside the railway track at a distance of approximately twelve hundred metres from the end of the railway track (see figures 4 and 5). These approach markers consist of three signs located alongside the railway track spaced at an intermediate distance of approximately 70 metres from each other. These markers have the same meaning as an amber light signal ('limit speed to 40km/h, or reduce speed as much as is necessary in order to be able to stop at the next signal commanding the train to stop').

Figure 4: Illustration of the approach markers (consisting of a series of three signs with an intermediate distance of approximately 70 metres).

Ensure that the rules relating to the application of uncommon signals and signs (such as the approach markers) are tightened.

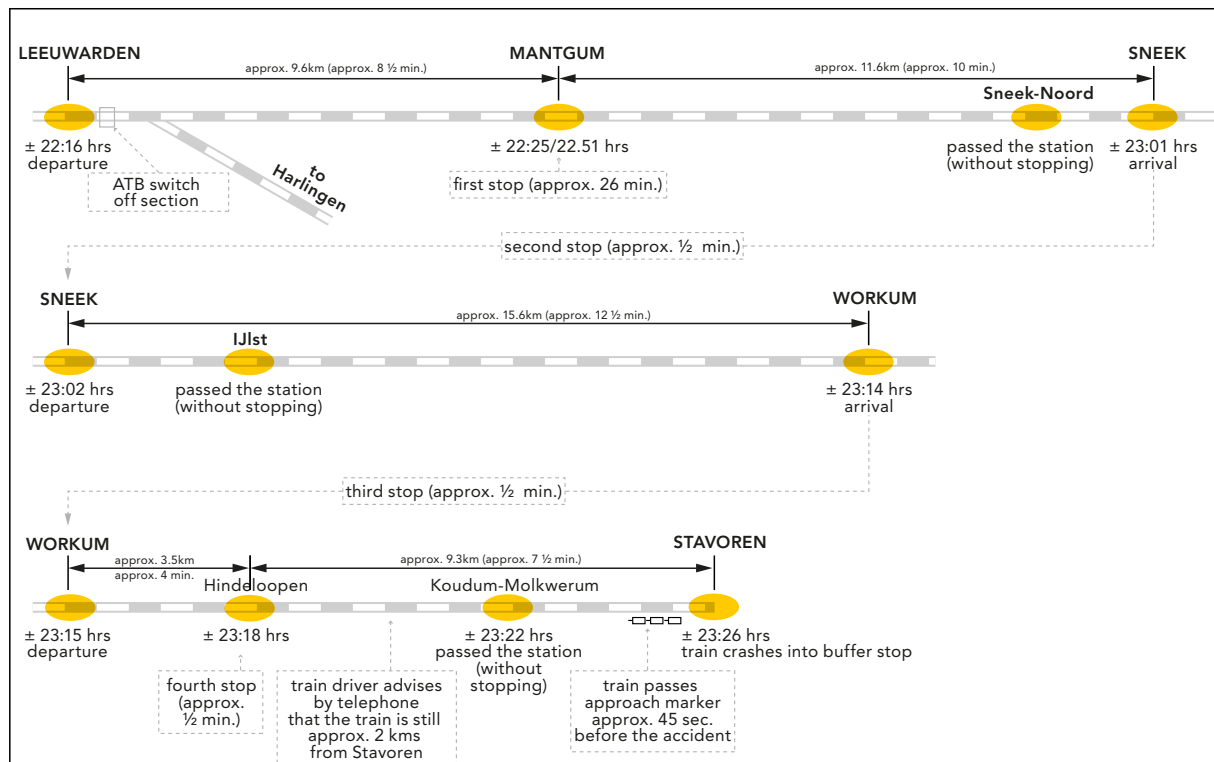
When approaching Stavoren, the rail grinding employee located in the cabin with the train driver and the vehicle operator asked the train driver a question about the rail grinding activities that were to be carried out later. In response to the question, the train driver consulted the visual instructions (a track layout plan) and spoke to the relevant employee (who was located behind him). On account of the language barrier the train driver turned his head in the direction of the Italian rail grinding employee for a number of seconds. As a result, the train driver was temporarily unable to see the section of the railway track in front of the train. The train driver himself estimates that the entire conversation took approximately half a minute. During that period the rail grinding train, which was travelling at a speed of approximately 95km/h, passed three approach markers (*keperbaakborden*) located alongside the railway track approximately 1200 metres from the end of the line. The train driver did not notice the approach markers, or in any event failed to recognise the significance of the approach markers. The Italian vehicle operator was not familiar with the approach markers and maintained the speed of the train (approximately 95km/h).

The 'Koeweg / Kooijweg' level crossing is located approximately 200 metres after the approach marker. This level crossing is well lit and the railway workers who were to carry out the rail grinding activities later on were standing there. When the train failed to reduce speed in passing the railway workers waved their arms in an attempt to attract the attention of the rail grinding train crew. In response to their signals, the rail grinding train employee in the rear cabin asked via the intercom whether the train should stop. The train driver thought he recognised the relevant level crossing and expected to see a speed sign shortly after the crossing indicating that the train should reduce speed to 40km/h. That sign was shown on the visual instructions that he had consulted just before that time. However, the sign did not follow. He then looked for a kilometre sign as a reference point but was also unable to locate that particular sign. Almost immediately after that, the train driver saw the end of the railway track further on and responded by instructing the vehicle operator to brake in German: '*Bremsen, bremsen, bremsen*'. The vehicle operator promptly initiated an emergency braking action, but by that time the distance to the buffer stop was too short to halt the train on time. However, the three men still managed to get out of their seats and move to the rear wall of the cabin. The train then crashed into the buffer stop.

Figure 8: Diagram showing the course of the transfer journey from Leeuwarden to Stavoren

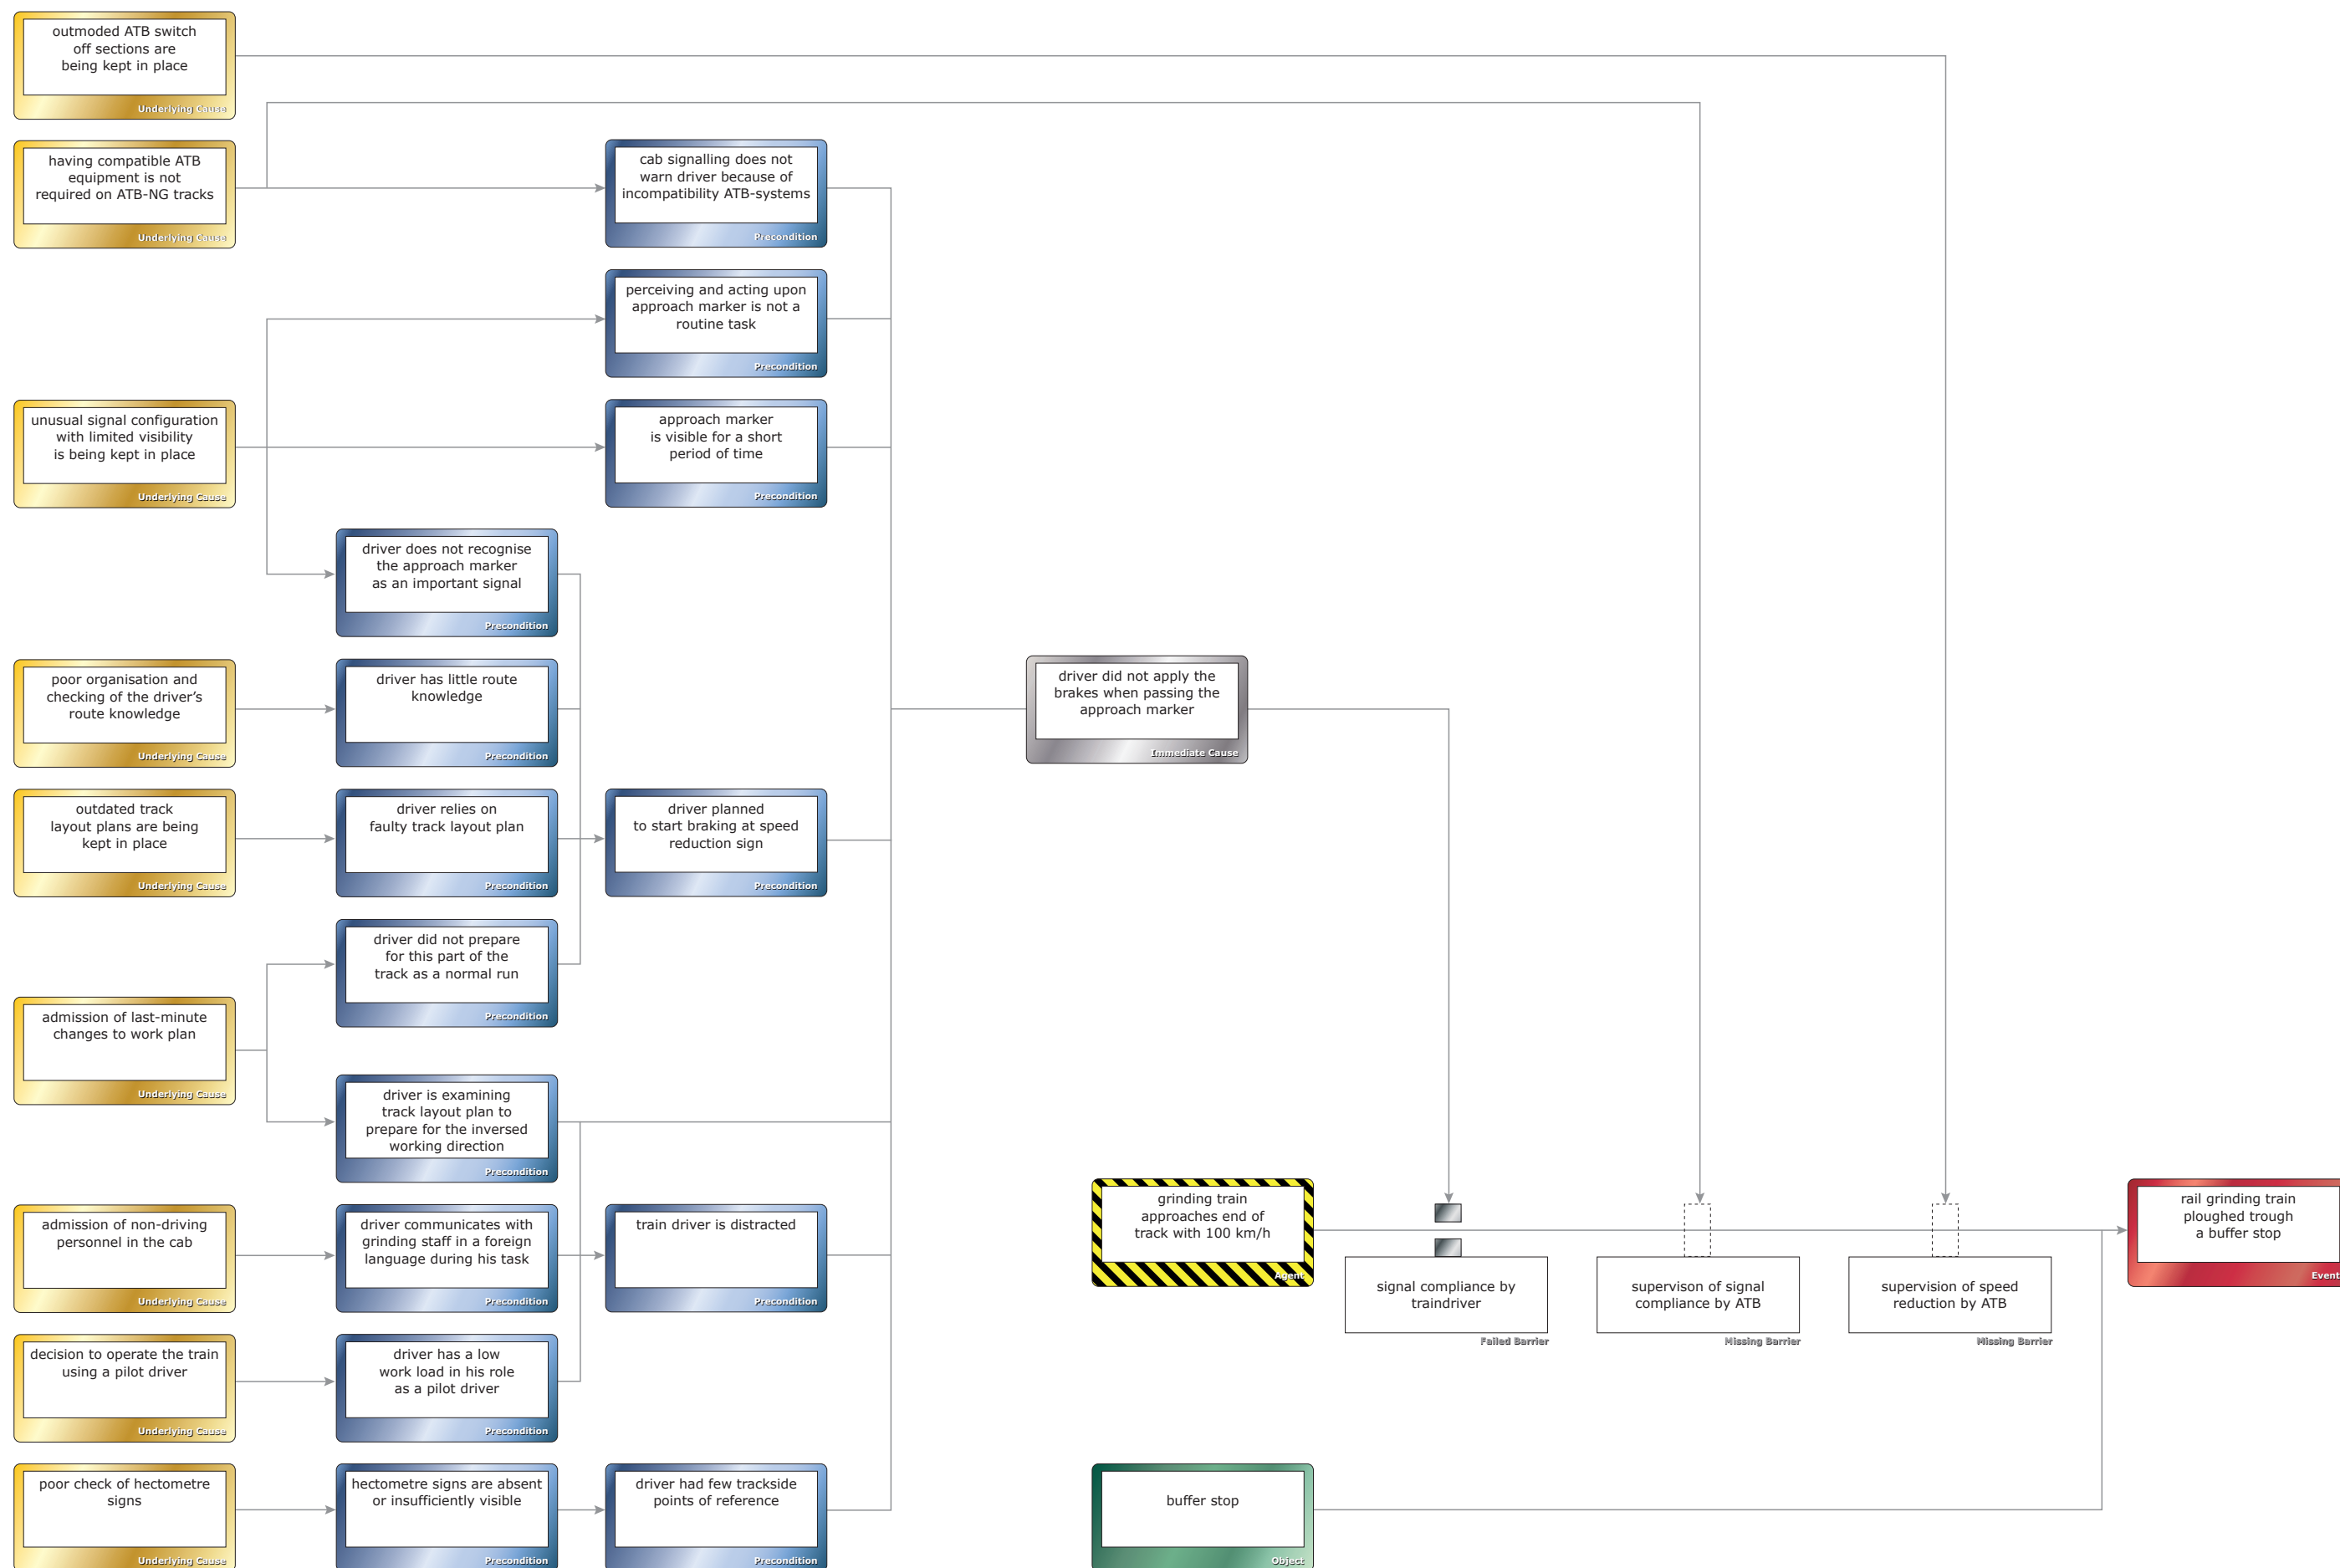
Figuur 15: Tripod Beta diagram.

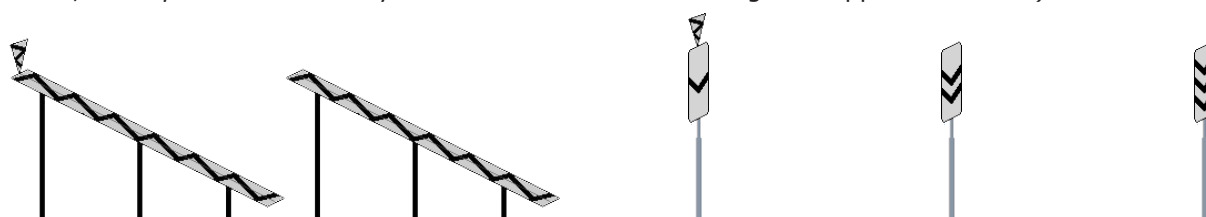
Figure 23: 'dual zigzag marker board' (left) and 'herringbone' approach marker (right).
(Source: www.klassiekebeveiliging.nl).

The zigzag or herringbone pattern shows the train driver that he has approached a main signal at braking distance. If the train driver cannot read the position of the accompanying warning signal (located at a distance which is shorter than braking distance from the main signal), for safety reasons he must apply the brakes at the location of the marker.
