DUTCH  
SAFETY BOARD

# Explosions MSPO2 Shell Moerdijk

*The Hague, July 2015*

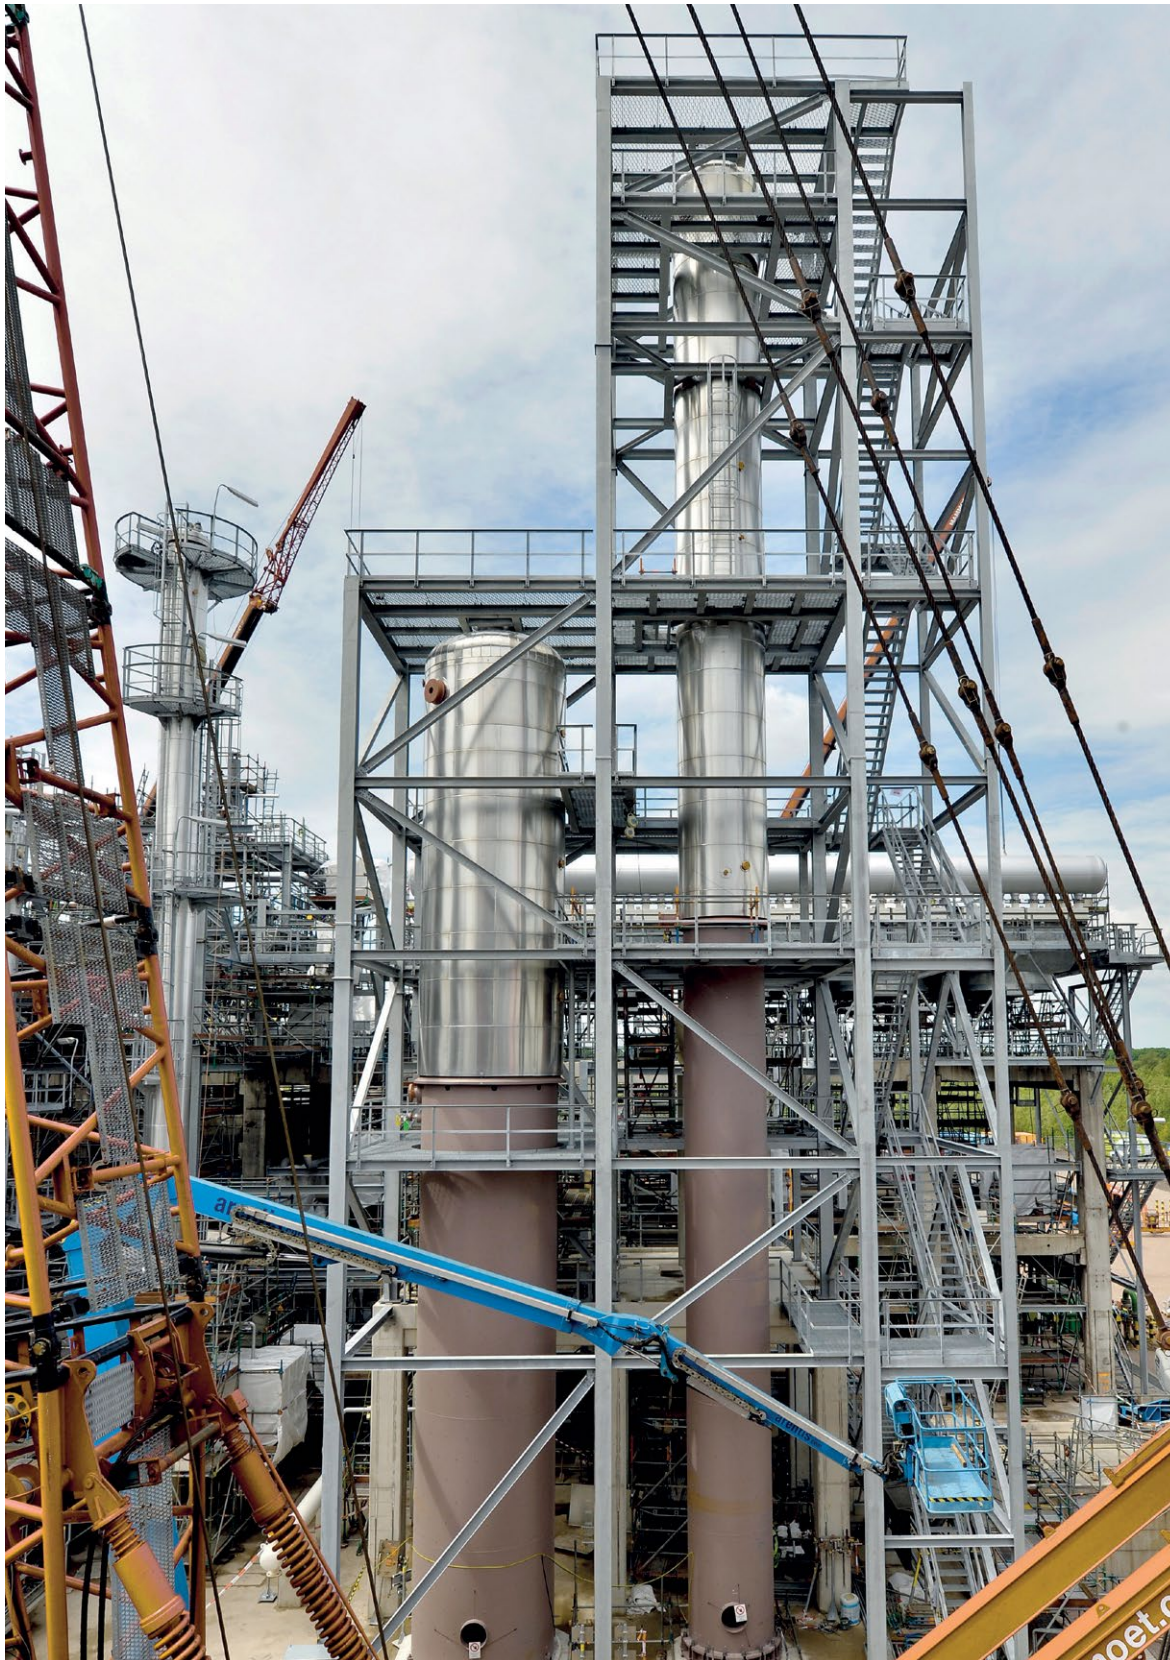
Figure 2.4: Unit 4800 before the explosion. (Source: Shell Photo)

The MSPO2 plant consists of a number of units. The explosions occurred in the hydrogenation unit; unit 4800 of the MSPO2 plant.

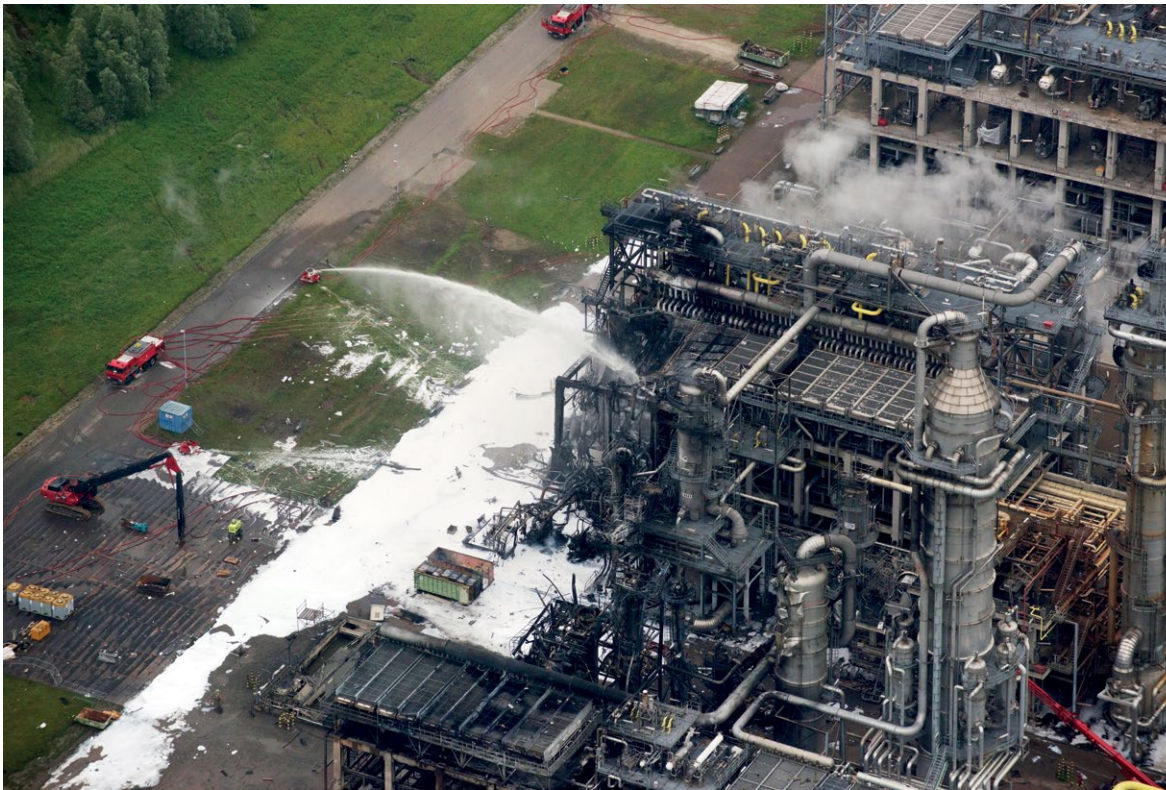
Figure 4.6: Damping down at the MSPO2 plant. (Source: ANP/B. van de Biezen)

From 03:00 hrs onwards the fire diminished and the fire brigade had it under control. Locally, various units were scaled down and sent back to their stations. However, the situation still required considerable attention. Additionally, the fire brigade wanted to assess by daylight whether adjacent parts of the plant had been damaged during the cooling operations. At 05:15 hrs the last seat of the fire was extinguished with foam and from 06:00 hrs onwards cooling was no longer required. On 4 June at 06:10 hrs the fire brigade issued the 'fire under control' signal.<sup>136</sup>

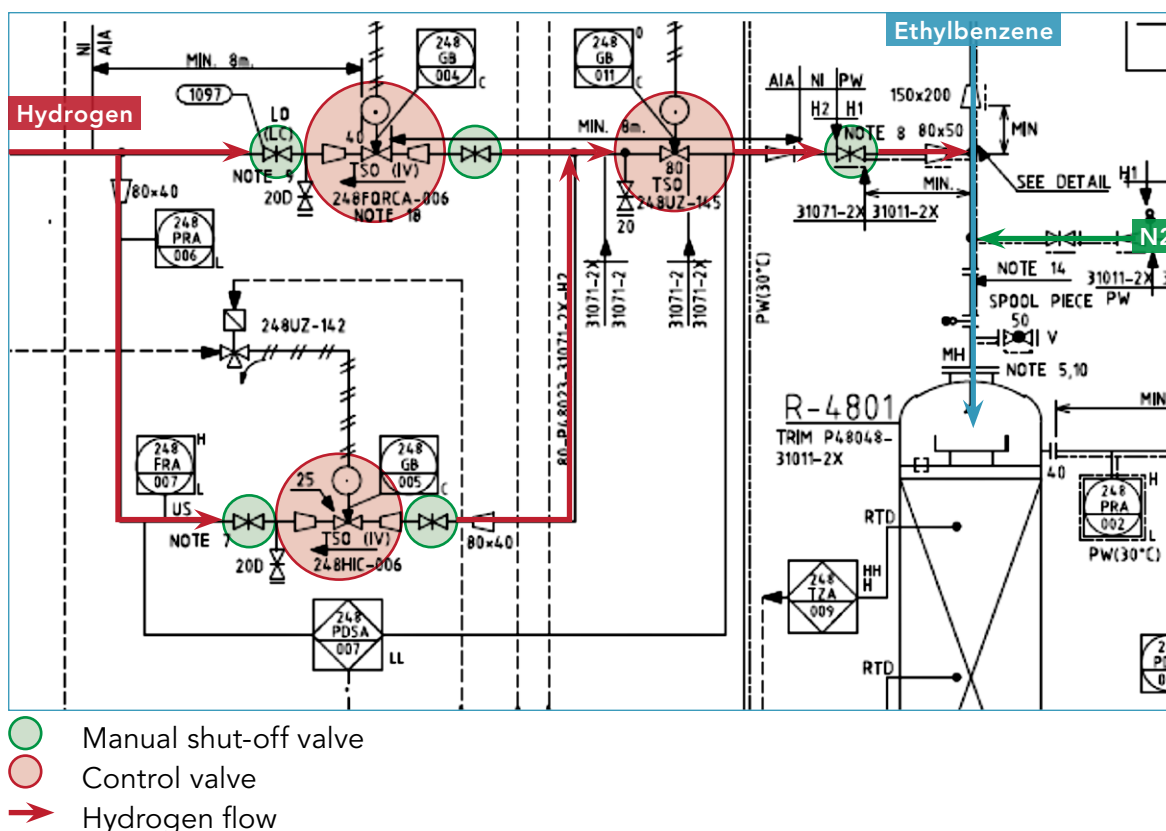
Figure B4.7: Hydrogen feed control system diagram. (Source: Shell Moerdijk)

The incident investigation (Shell Nanhai), revealed leakage of hydrogen into reactor 1 via a control valve as the direct cause of the runaway. According to the investigation team, this was possible because the hydrogen system was already aligned. This means that the control valves were closed and the manual shut-off valves were already opened. The fact that hydrogen was still able to flow into the reactor system was down to the fact that the pressure of the hydrogen was temporarily higher than the pressure in the ethylbenzene/nitrogen system (see Figure B4.7).

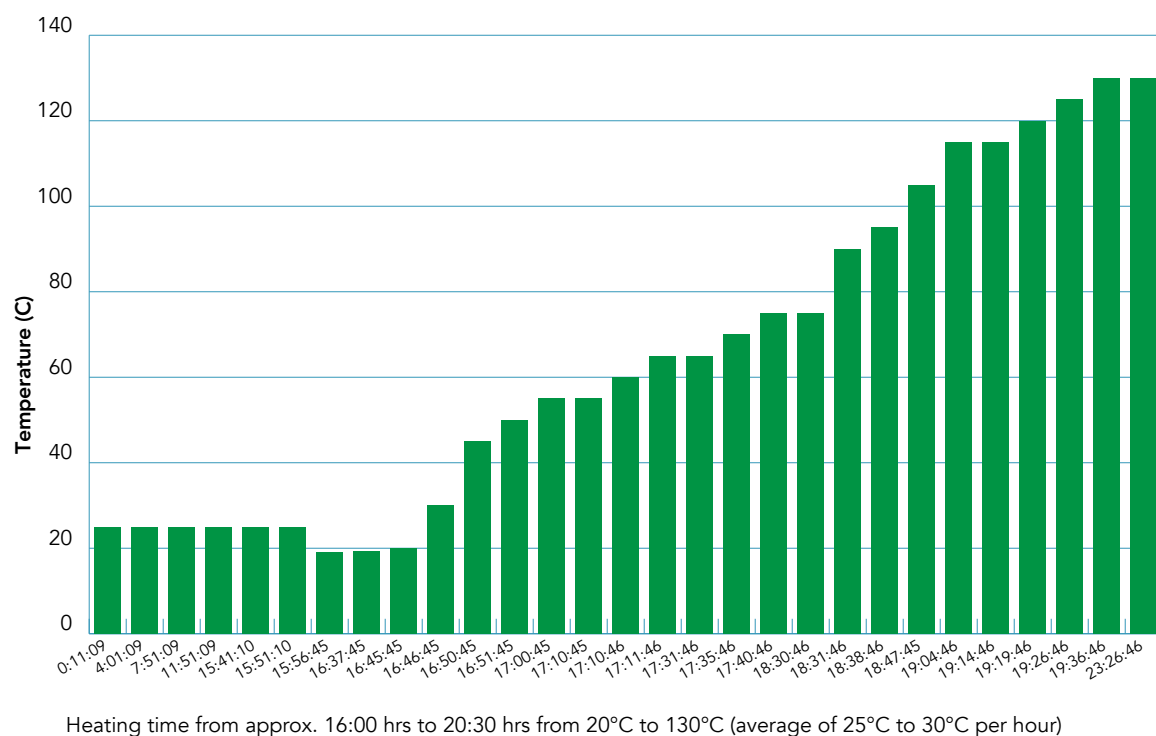
Figure B4.13: Heating rate of reactor 1 (2011).

In 2011 another catalyst change took place in the MSPO-2 plant whereby the hydrogenation section was loaded with the 'old' Cu-1808T catalyst. Although the cause remained unclear to the Safety Board, according to Shell this was sooner than expected. The planned production period was, after all, around six years. After the catalyst change, a turbulent start-up process followed. A runaway was not observed and/or had not occurred. In this case, 'turbulent' refers to that fact that means fines (fine particles broken off from the catalyst pellets) had caused blockages. The reactors were heated in small steps, with an average heating rate of approximately 25°C to 30°C per hour, as illustrated in figure B4.13 below.

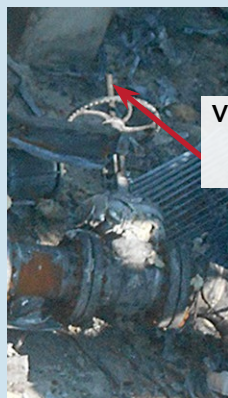
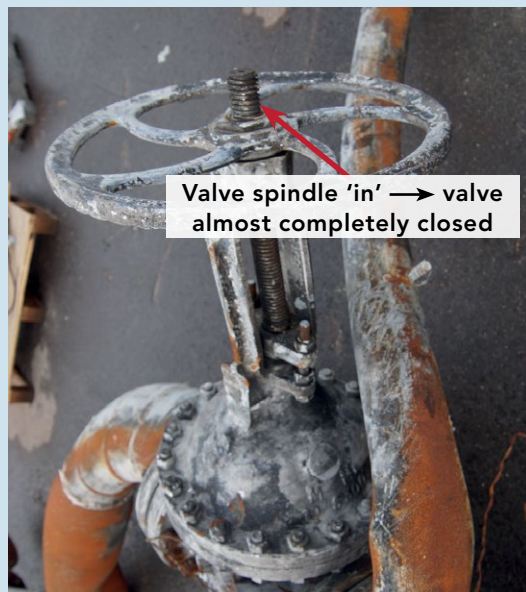
Figure B6.3: Photographs of valves in an almost completely open position (left) and an almost completely closed position (right). The photograph on the right is the bottom valve of the separation vessel of reactor 1.

After changing the catalyst, the unit 4800 is almost completely free of liquid and ultimately has to be filled with ethylbenzene. It is not easy to fill the unit with liquid and induce and maintain its circulation over two reactors using a single central pump. This is because, on the one hand, the pump may not run 'dry' (flow too low) and, on the other hand, because the capacity of the two separation vessels is relatively low in relation to the capacity of the central pump. When they are full, the separation vessel of reactor 1 has a capacity of approximately 10 cubic metres and the separation vessel of reactor 2 a capacity of approximately 15 cubic metres. In practice, the vessels will be partly full to between 28% and 72% of the liquid level. That amounts to 44% for the control band, which amounts to approximately 4.4 cubic metres for the separation vessel of reactor 1 and 6.6 cubic metres for the separation vessel of reactor 2. Both vessels are filled halfway for the phase of flushing out contamination (fines) and for the filling required for circulation. After filling, the unit 4800 contains approximately 20 to 35 cubic metres of ethylbenzene. The liquid is then located in the pipes, reactors and vessels. In order to counteract the emptying of the separation vessel of reactor 1 during circulation, the bottom valve under this vessel is almost completely closed (see Figure B6.3 on the right. A similar valve is shown on the left in Figure B6.3 which is almost completely open). This was also the case on 3 June 2014.

Valve spindle 'out' →  
valve almost  
completely open

Valve spindle 'in' → valve  
almost completely closed

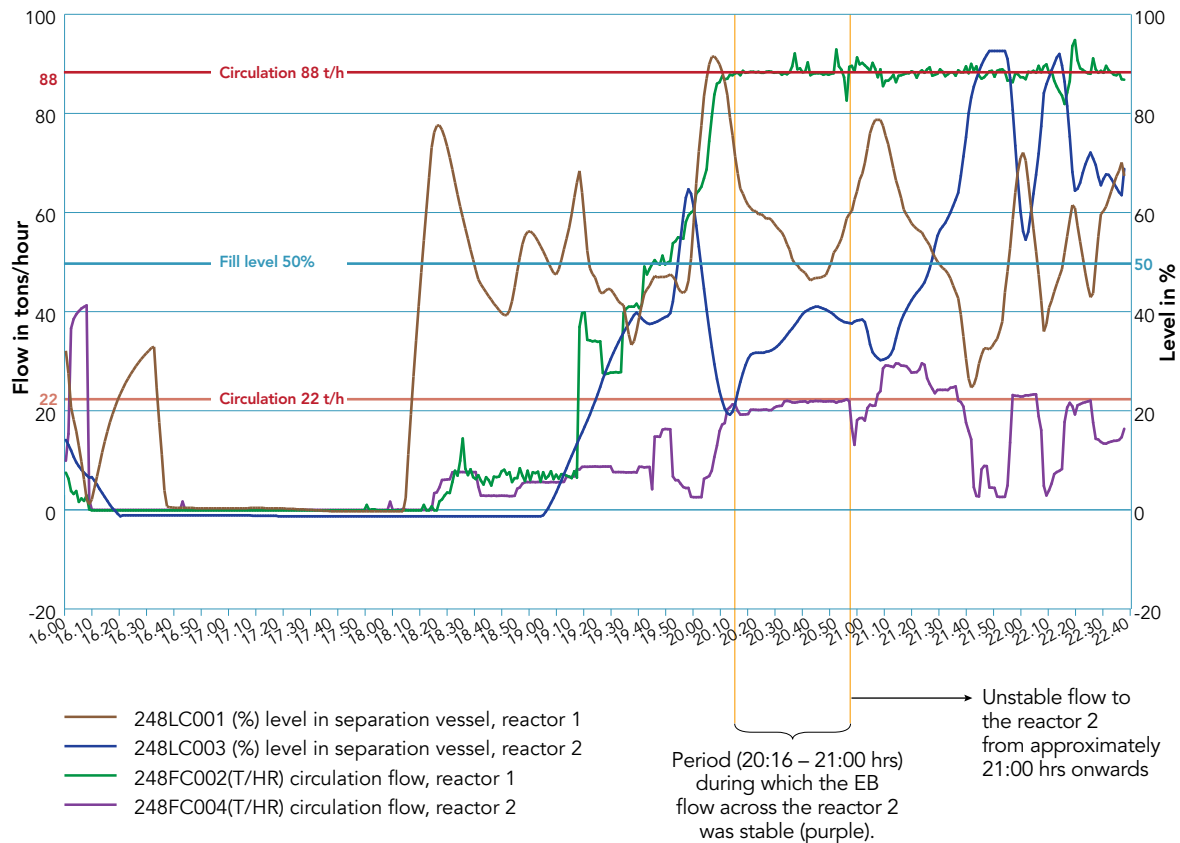
Figure B6.4: Graph showing ethylbenzene flow and level in the separation vessels.

The critical point during circulation was focused on preventing the central pump from stopping unintentionally. The graph in Figure B6.4 shows the unstable level (brown and blue lines) and the unstable flow to reactor 2 (purple) and the stable flow to reactor 1 (green line).

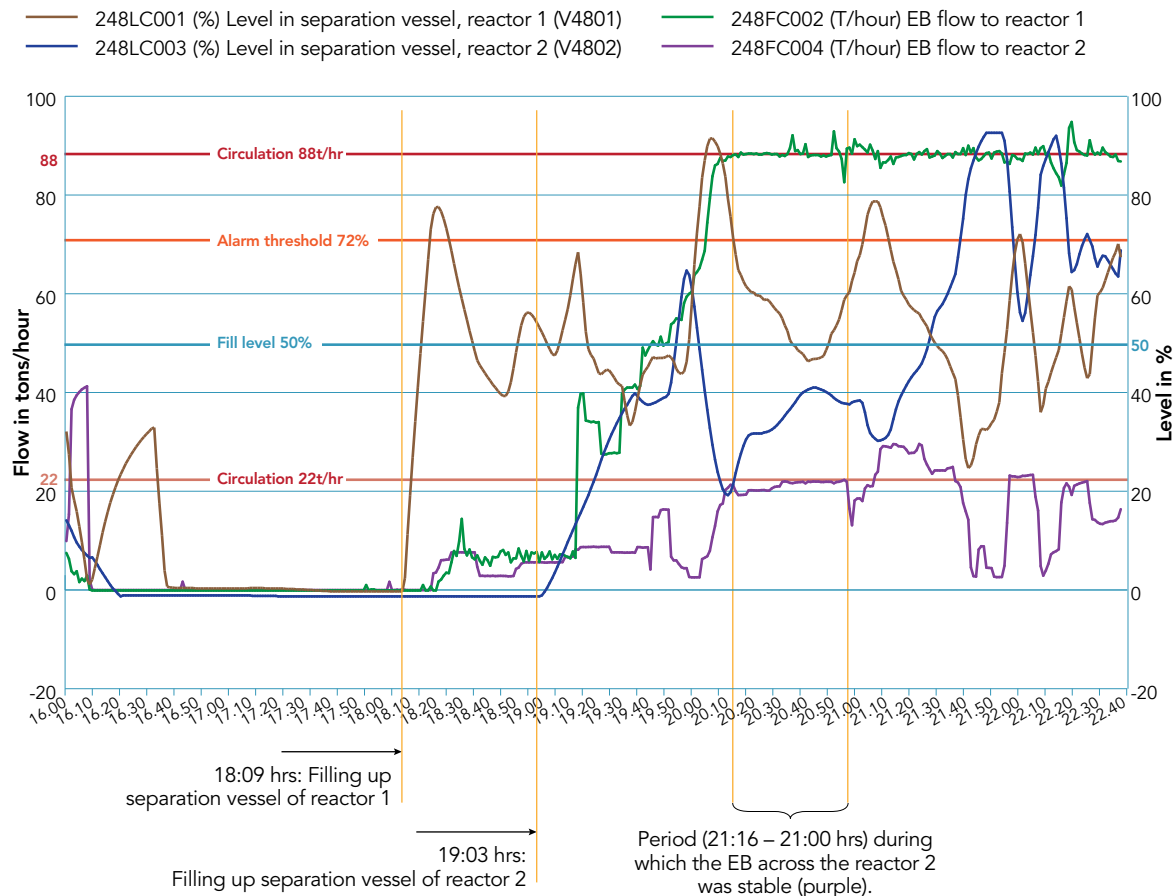
Figure B6.6: Filling the separation vessels.

The graph shows that the separation vessel of reactor 1 was filled to above the alarm threshold of 72%, whilst the instruction was to fill to 50%. A stable level was not achieved in either separation vessel. Circulation was started, as a variation in the level of the vessels around the level of 50% is inherent in initiating the flow/circulation flow. There was a short period during which the circulation flow to both reactors was stable, however the level was unstable.

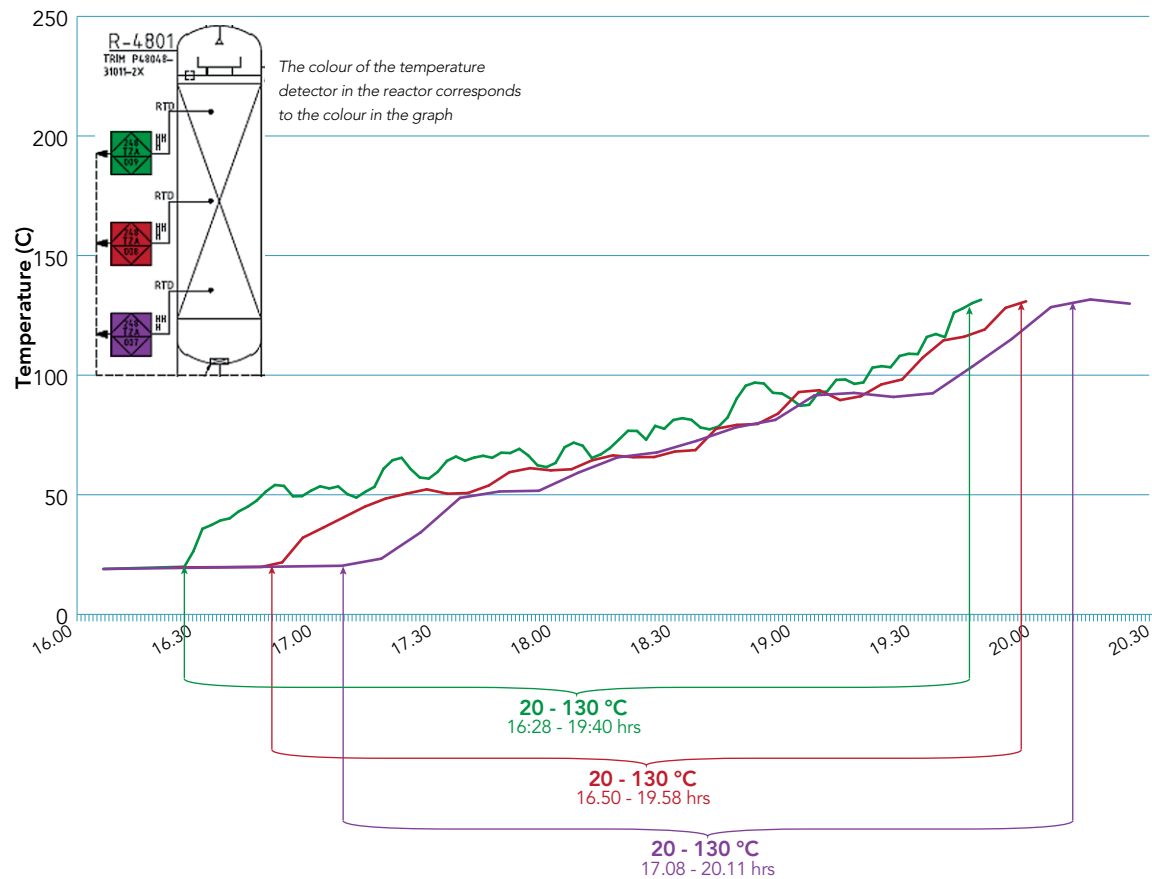
Figure B6.7: Temperature development of reactor 1 during 2011 start-up.

Figure B6.7 provides an impression of the heating process in 2011. The graph includes the temperature sensors of reactor 1. On average, the heating from approximately 20°C to approximately 130°C takes more than 3 hours. This amounts to a heating rate of around 35°C per hour.

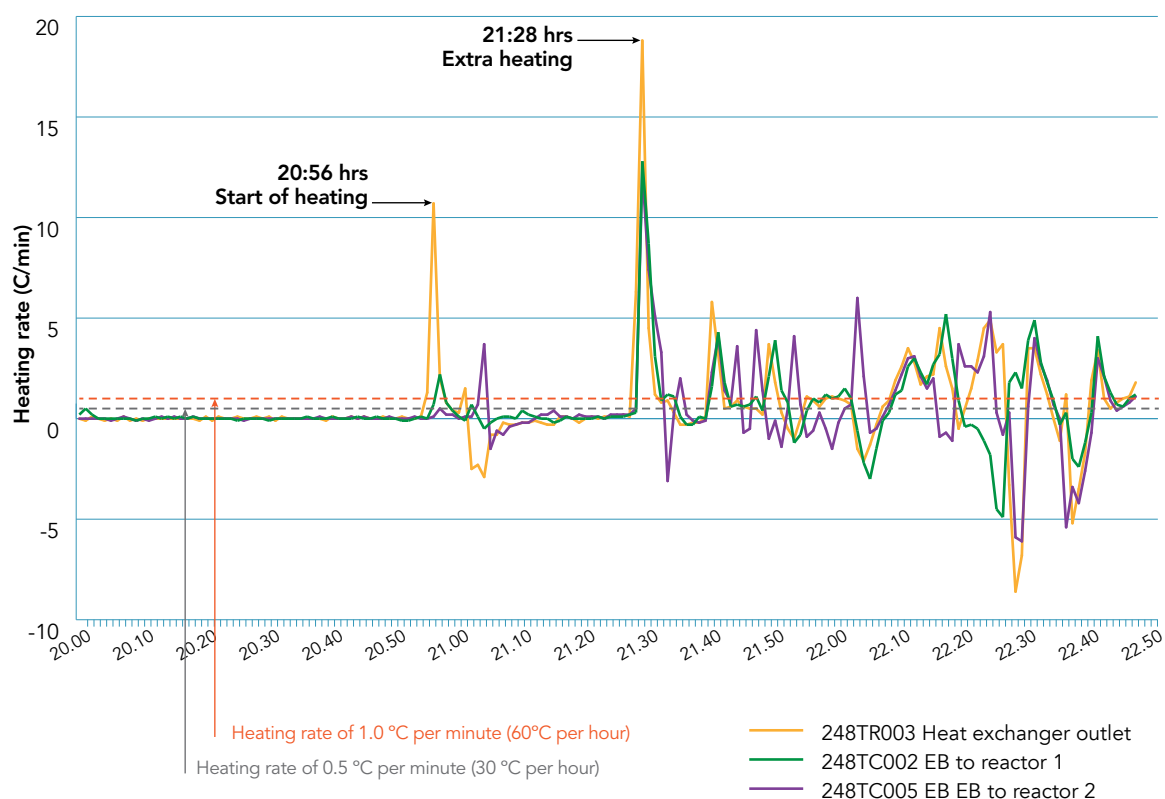
Figure B6.9: Heating rate of reactor 1 and 2.

This graph gives an impression (retrospectively) of the actual heating rate. This information was not available to the Panel Operator. In retrospect, the heating rate after opening the steam valve for the first time (at around 21:00 hrs) was already sufficient to increase the temperature of the ethylbenzene by 30°C per hour. The ethylbenzene circulation flow to reactor 2 was unstable after the steam valve was opened for the first time. Opening the steam valve further (at around 21:30 hrs), in combination with the manual temperature control, caused more process interruptions.

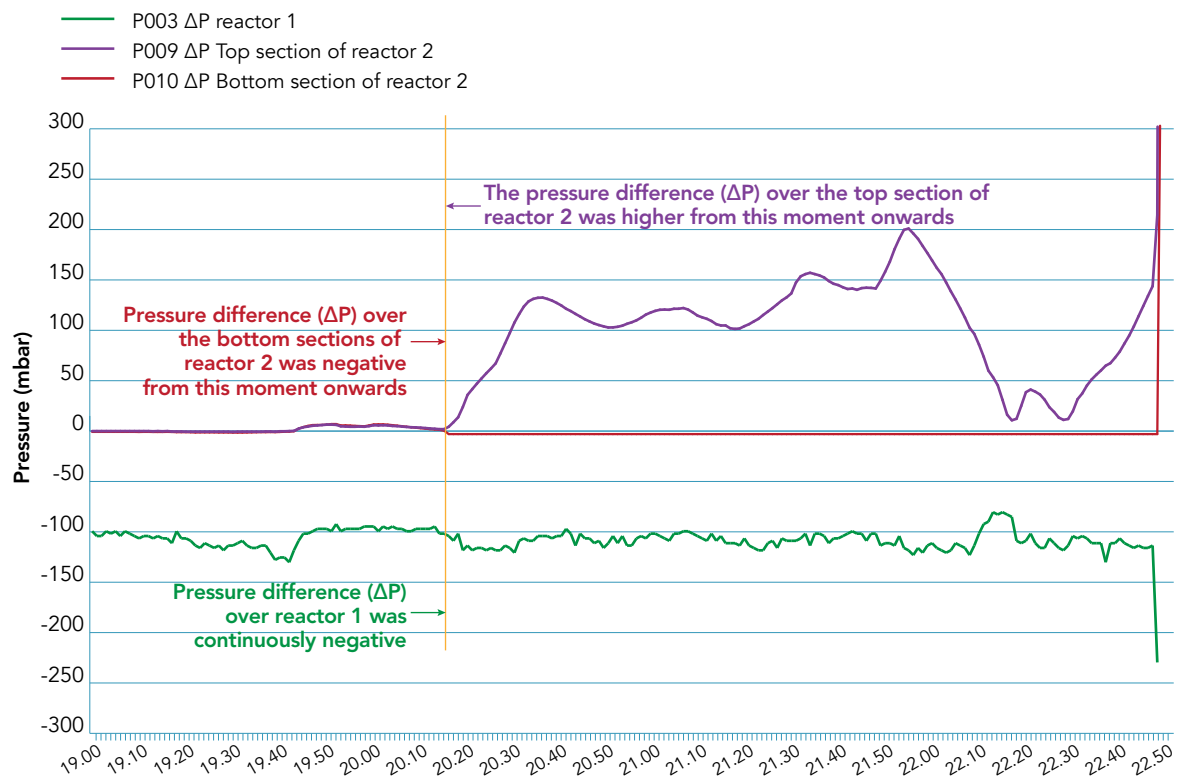
Figure B6.12: Pressure difference in reactor 1 and reactor 2.

On 3 June 2014 the three pressure difference measurements (P003, P009 and P010) showed different pressure differences. The colours in the diagram in Figure B6.11 correspond to those in the graph below.

At around 20:16 hrs the pressure difference over the top part of reactor 2 rapidly became more positive and the pressure difference over the bottom part of reactor 2 became negative. This can indicate an obstruction or a change in the flow through the reactor. The pressure difference over reactor 1 was almost continuously negative. It could be concluded from this that the pressure on the liquid/gas separator of reactor 1 (outlet pressure) was higher than the pressure in the top of the reactor (inlet pressure). This may have been due to the following:

- Faulty measuring instruments. These should have been repaired because the pressure difference over the reactor is also an important indicator during circulation and heating.
- Correct measuring instruments. In this case there may have been another pressure source or counter-pressure from reactor 2 which is also undesirable during circulation and heating (insufficient wetting of reactor 2).

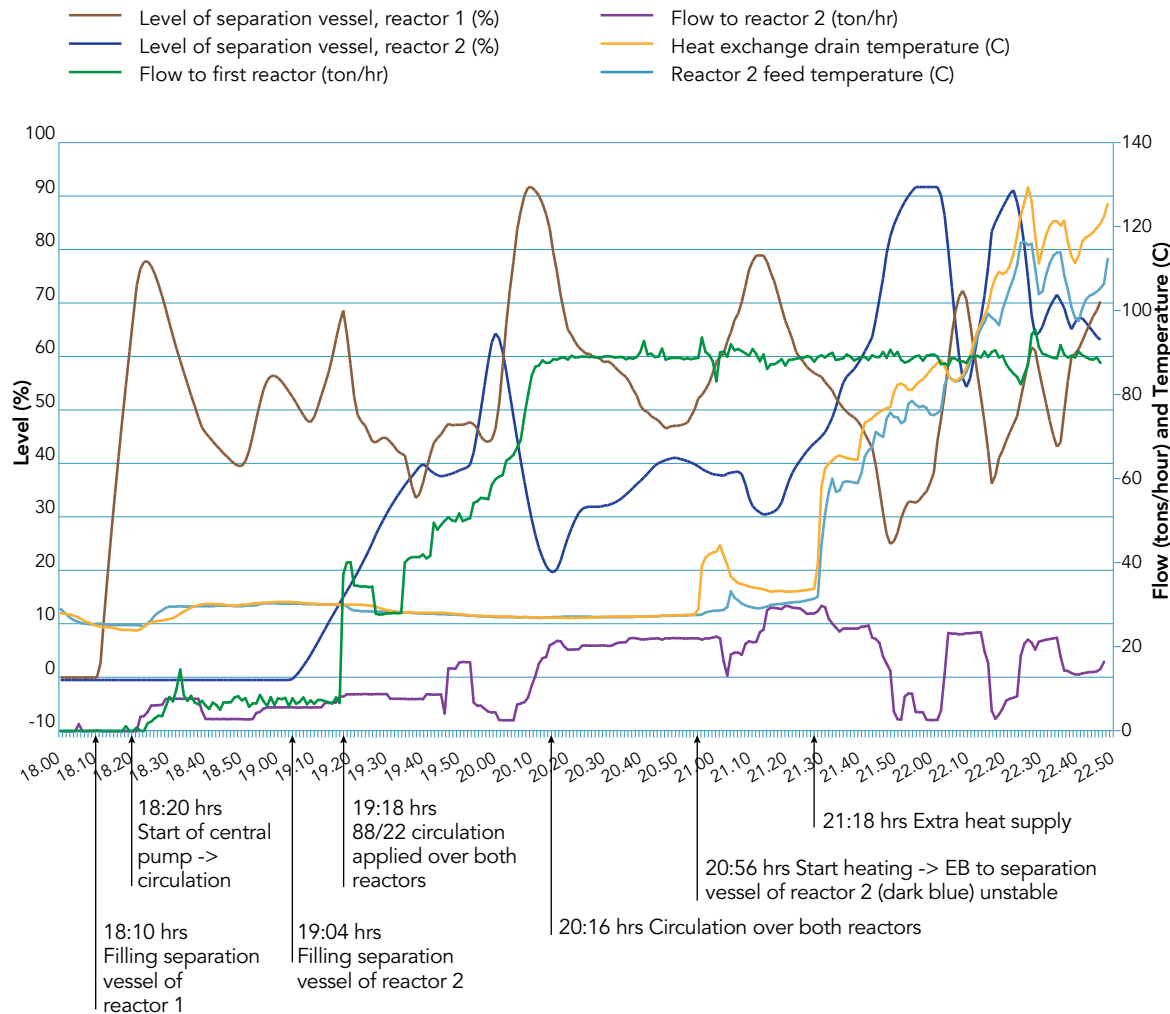
Figure B6.13: Full overview of measurements of flow/temperature of the ethylbenzene flow and levels in the separation vessels.

Once a stable situation is achieved, the unit is ready to start the circulation in the ratio of 88 tons per hour over reactor 1 to 22 tons per hour over reactor 2. Figure B6.13 shows that both separation vessels were filled shortly after each other. In the meantime, with the aid of the circulation pump, ethylbenzene circulation was started in the ratio of 88 to 22 tons per hour. At around 21:00 hrs heating was started whilst the situation was still unstable. Adequate wetting was not therefore achieved.

Because the central pump has a considerable pump capacity compared to the capacity of the separation vessels, work has to be performed with the shut-offs and valves almost closed. Shell was aware of this but took no further action. Furthermore, the job analysis does not provide clear instructions about how the filling and circulation has to be undertaken. The only clear instruction was that the central pump was not allowed to run 'dry'. Otherwise it would break. The design data and the system configuration of the process controls do not provide for this operating phase. This phase was not included in the start-up procedure for the unit 4800, either.

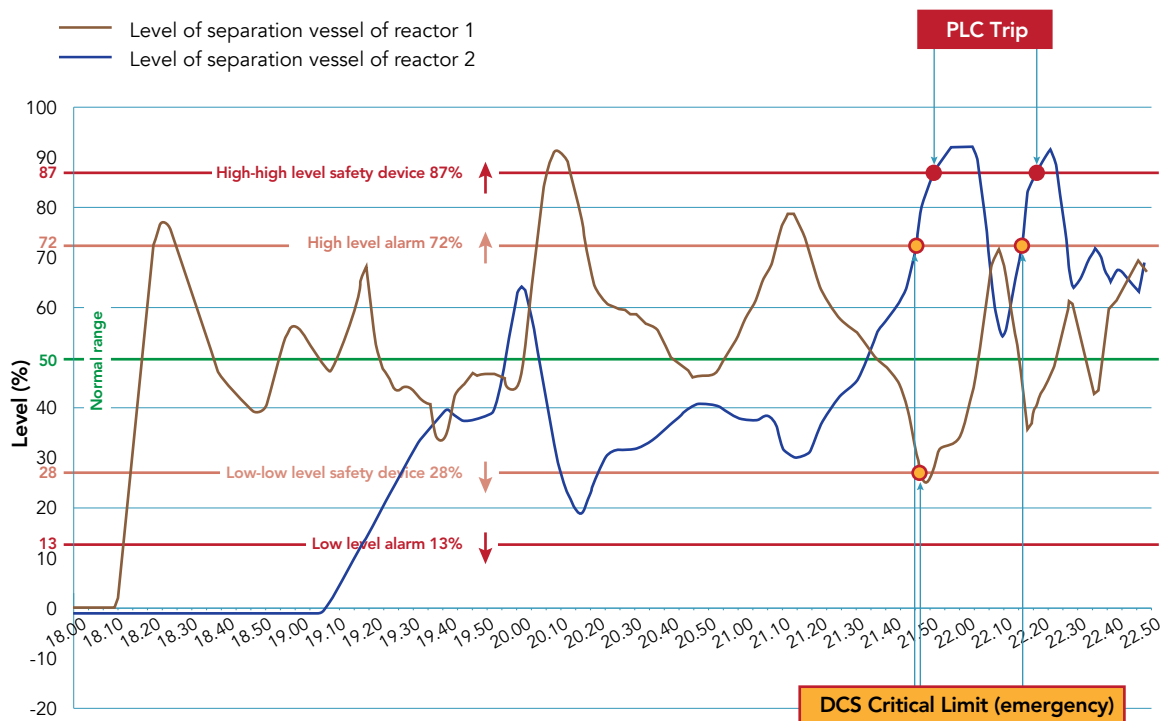
Figure B6.15: Level in the separation vessels.

Figure B6.15 has been included for illustration purposes. This figure demonstrates that on the evening of 3 June 2014, various possibilities arose which required adequate action be taken. In two situations, the safety device system (PLC trip) intervened. These are the situations that Shell attempted to prevent by means of the ESP programme.

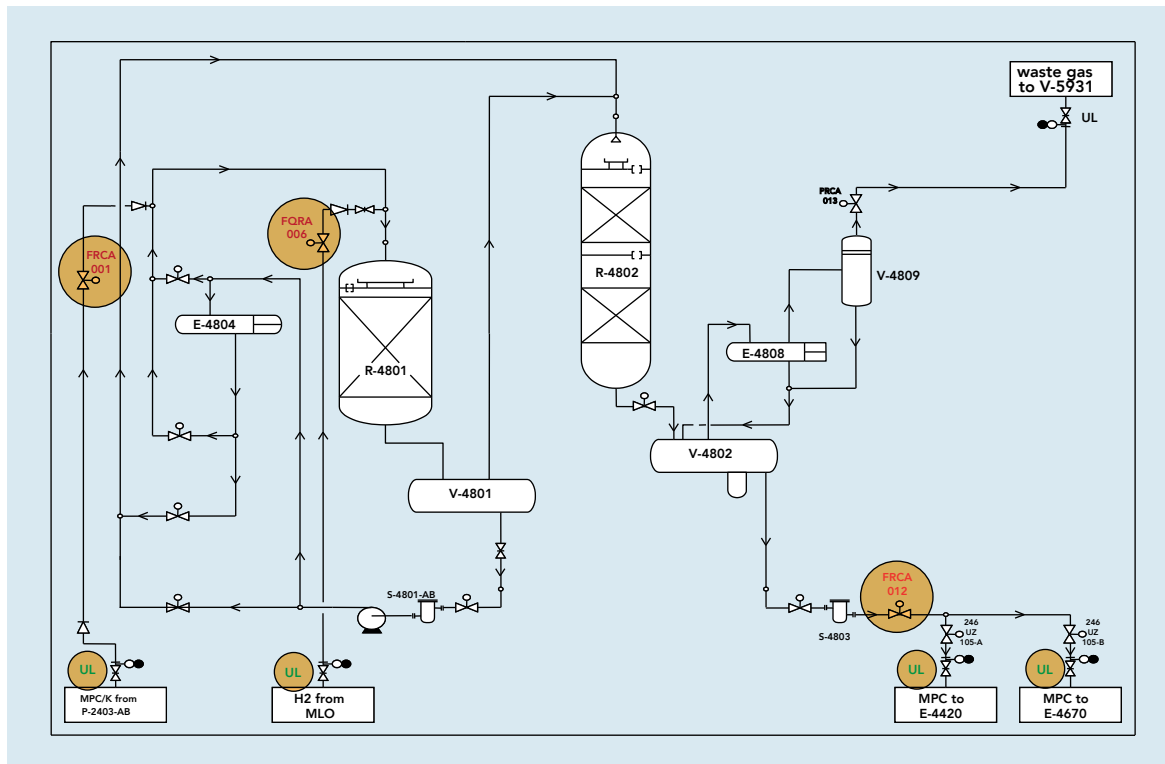
Figure B6.17: Containment system of the unit 4800. (Source: Shell BBS manual/MSPO work instructions 03.1147)

As a result of the explosions it was no longer possible to contain U4800 with the three valves. The alternative for Shell was to then use the unit limits (see circled UL in the figure) in order to contain the unit 4800. However, these valves cannot be remotely operated. In practice, the Operator has to operate them manually. Due to the intensity of the fire that had broken out and the risk of explosion it was not possible for these to be operated immediately. An initial attempt to contain the unit 4800 was made during the night of 4 June 2014, at around 02:30 hrs.

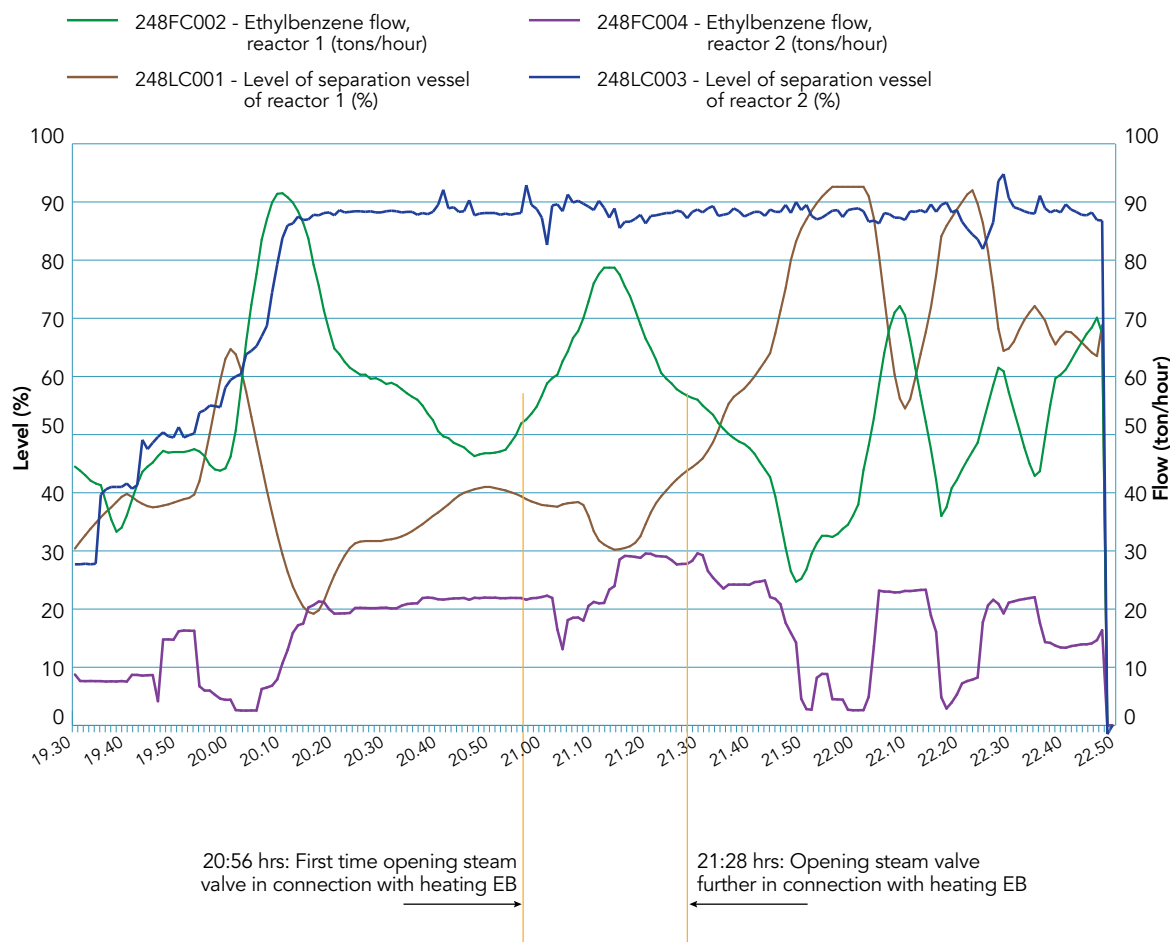
Figure B7.1: Ethylbenzene flow over the reactors and ethylbenzene levels in the separation vessels.

The ethylbenzene levels in the separation vessels varied constantly and substantially. Once the ethylbenzene flow was more or less kept constant, the level in the vessels varied from approximately 25 to 79% in the first vessel and from 30 to 93% in the second vessel.

The instability increased from the moment that the heating of the ethylbenzene began. For this purpose, the Outside Operator manually opened the steam supply valve to the heat exchanger further. Regulating the ethylbenzene flow and temperature is complex, because there is no separate pump or heat exchanger present for both reactors. The automatic process control was not properly configured for this phase. The Operators therefore believed that it was better to perform this manually.

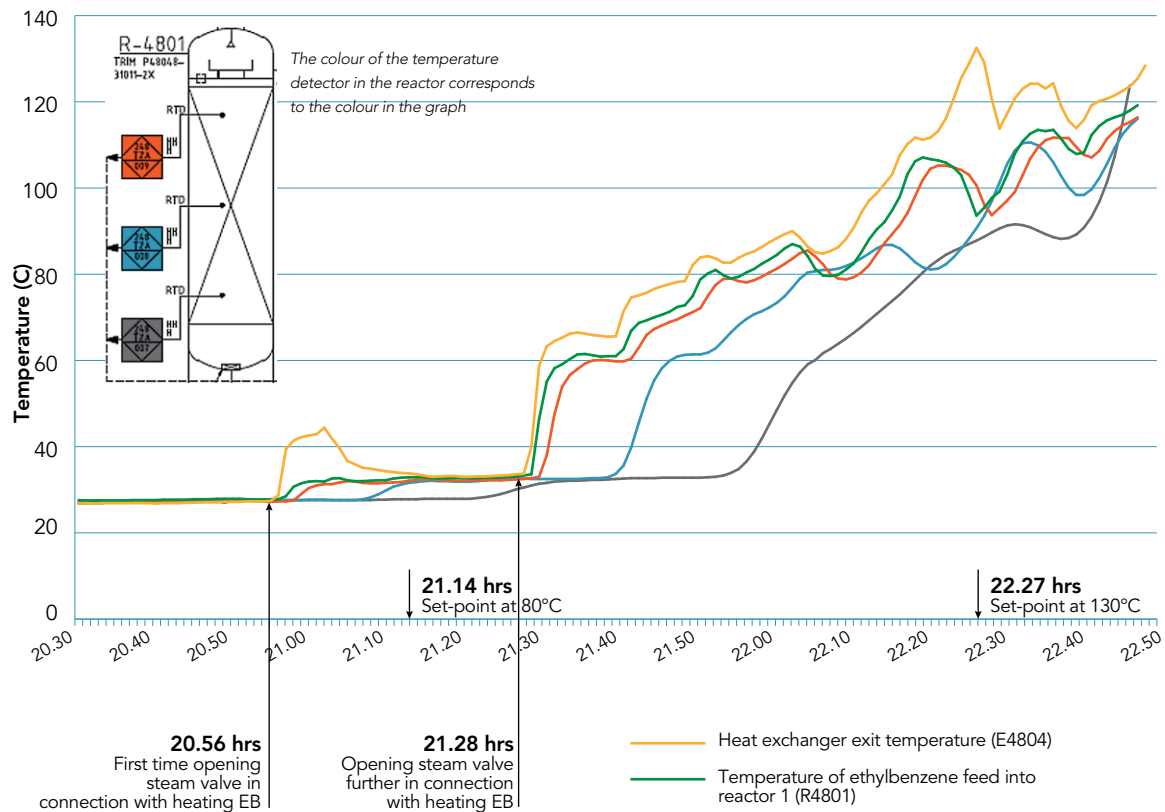
Figure B7.3: Temperature development: heat exchanger, ethylbenzene flow to reactor 1.

The temperature development of reactor 1 is shown in Figure B7.3. This corresponds to the picture that the Panel Operator could see on the computer screen. From approximately 22:40 hrs onwards the bottom temperature (248TI007) started to increase and shortly thereafter, at around 22:41 hrs the middle temperature (248TI008) also started to increase. Between 22:46 and 22:47 hrs the bottom temperature rose above the intake temperature. The runaway reaction 'then builds up'. However, by that time it is actually too late to intervene effectively.

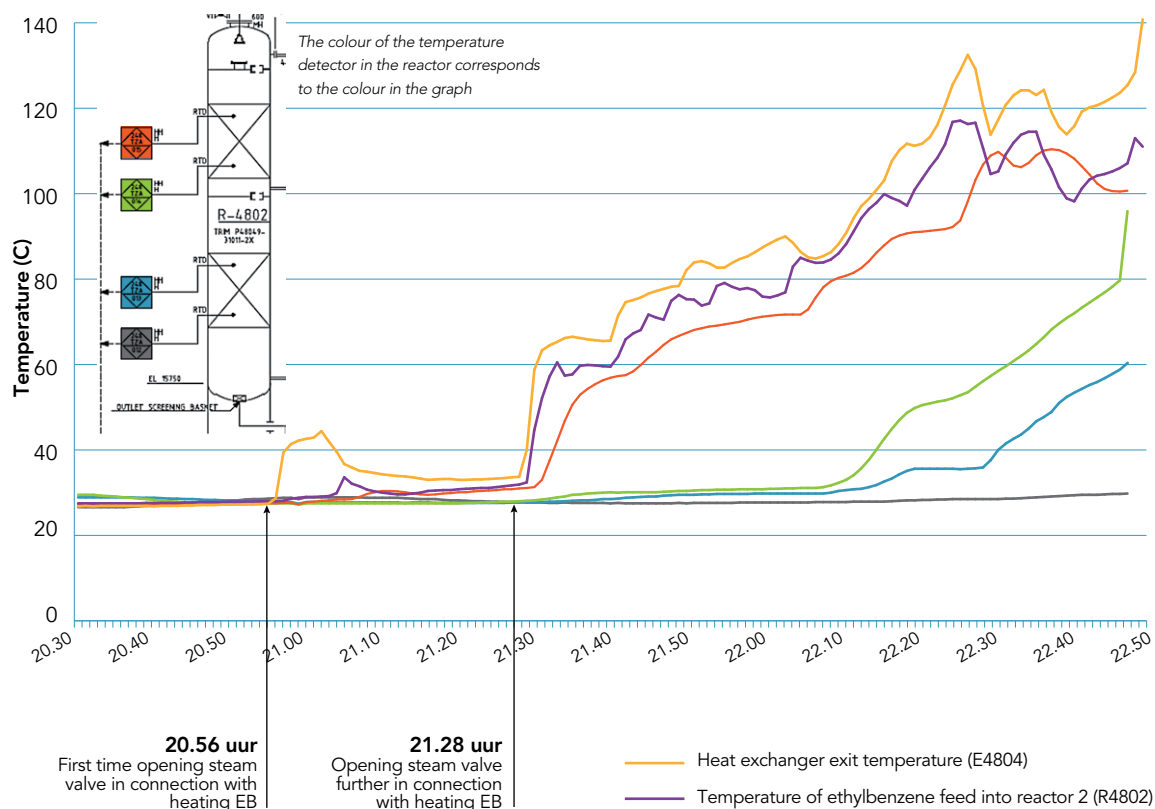
Figure B7.4: Temperature development: heat exchanger, ethylbenzene flow to reactor 2.

The temperature development of reactor 2 is shown in Figure B7.4. The Panel Operator could also see this on the computer screen. The temperature of the ethylbenzene flow to reactor 2 had a set-point of 80°C starting at 21:02 hrs. All reactor temperatures (top and bottom temperatures of the top and the bottom reactor sections) increased gradually. Only the bottom temperature of the bottom section remained low. Until 22:47 hrs the bottom temperature of the top section (248TI014) increased gradually. From that moment it rose sharply. As with reactor 1, effective intervention was no longer possible.

In neither reactor did the heating proceed at 30°C per hour as stated in the design book. The reactor 1 heated up at almost 68°C per hour and reactor 2 at 70°C per hour (see Table B7.5).

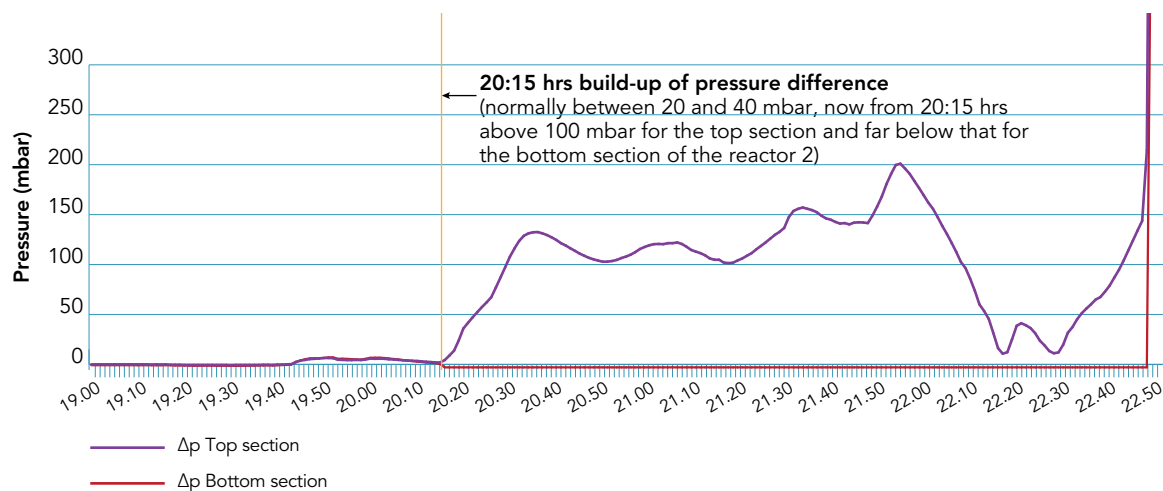
Figure B7.10: Pressure differences over the top and bottom sections of reactor 2.

The conspicuous pattern of pressure difference ( $\Delta p$ ) over reactor 2 that arose at around 20:15 hrs (see Figure B7.10) appears to indicate an obstruction in the catalyst bed (according to Shell's statement).  $\Delta p$  over the top section of the reactor reached values of 100 to 200 mbar. At the same time, the  $\Delta p$  over the bottom section became negative. The amount is unclear because a negative pressure difference, greater than -3 mbar, was apparently not recorded. This picture was clearly different during the 2011 turnaround and start-up (see Figure B7.11). In that case, the pressure difference over the top section of the reactor remained below 25 mbar. The Operator did not take any action in response to this conspicuous development in the pressure differences.
