APPENDICES

APPENDIX I: JUSTIFICATION OF THE INVESTIGATION

In the night of 26/27 October 2005, the Safety Board received reports from the media of a major fire at the Detention Centre Schiphol-Oost. During the night, a Safety Board investigator went to the site. In view of the criminal investigation being carried out by the Public Prosecutions Department (OM), the site was originally designated as a 'Crime Scene'. During this time, the Safety Board cooperated closely with the OM in investigating the site. When, in January 2006, the 'Crime Scene' status was lifted, and the site was allocated the status 'Incident Scene'. The Safety Board had sole access to the part of the detention centre where the fire had broken out up until the period in which the draft report was sent for comment to parties en persons involved in July 2006.

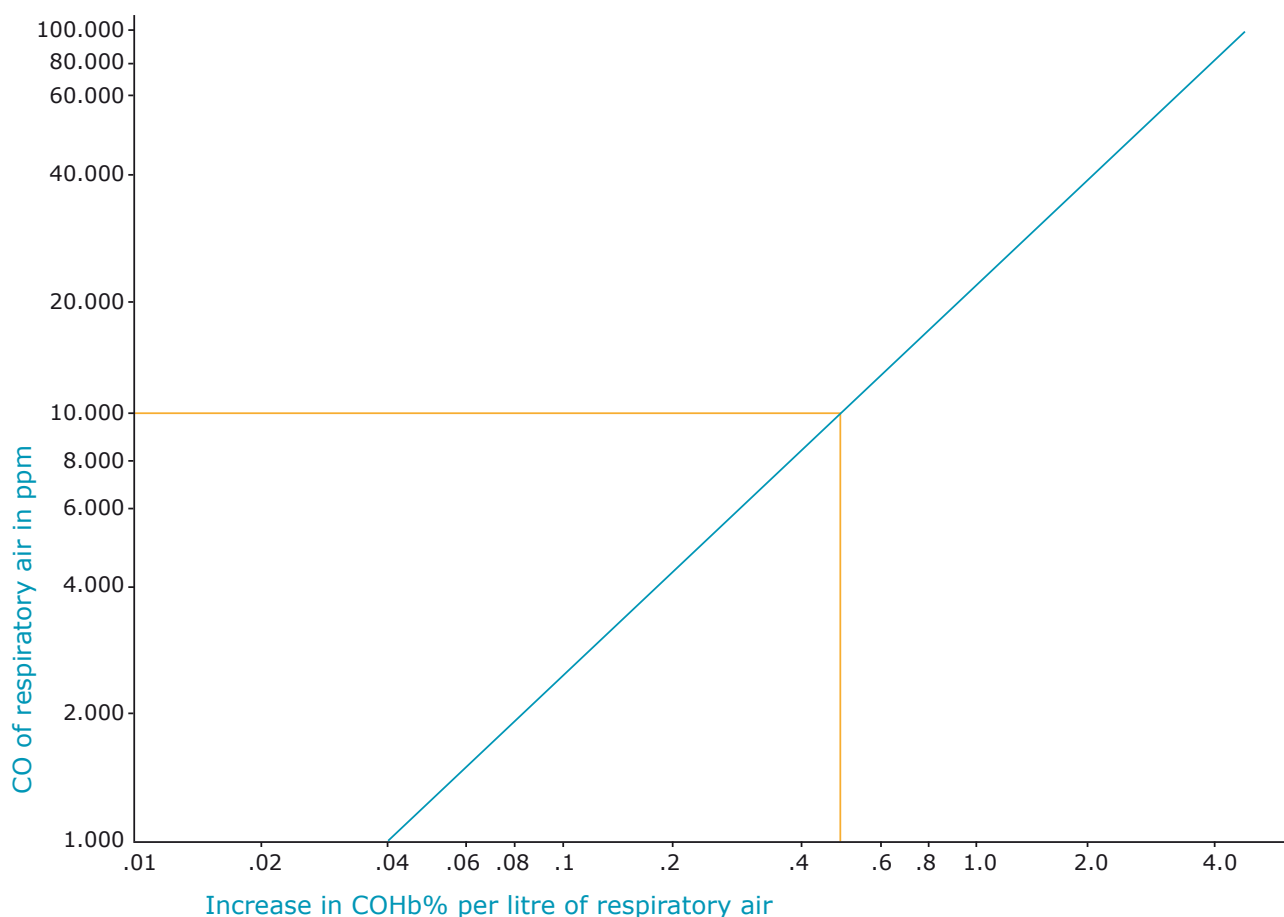
Figure 1: The relationship between the exposure to CO and the increase in COHb%

From the figure it may be concluded that inhaling one litre of oxygen with a [CO] content of 10,000 ppm, for example, results in an increase in the carboxyhemoglobin concentration (increase in COHb%) of 0.5. A person who finds themselves in this type of environment and maintains a calm rate of breathing of 8 l/min will develop a COHB% saturation of 40 within approximately 10 minutes which is more or less the level at which a person will lose consciousness (DeHaan, 2002).

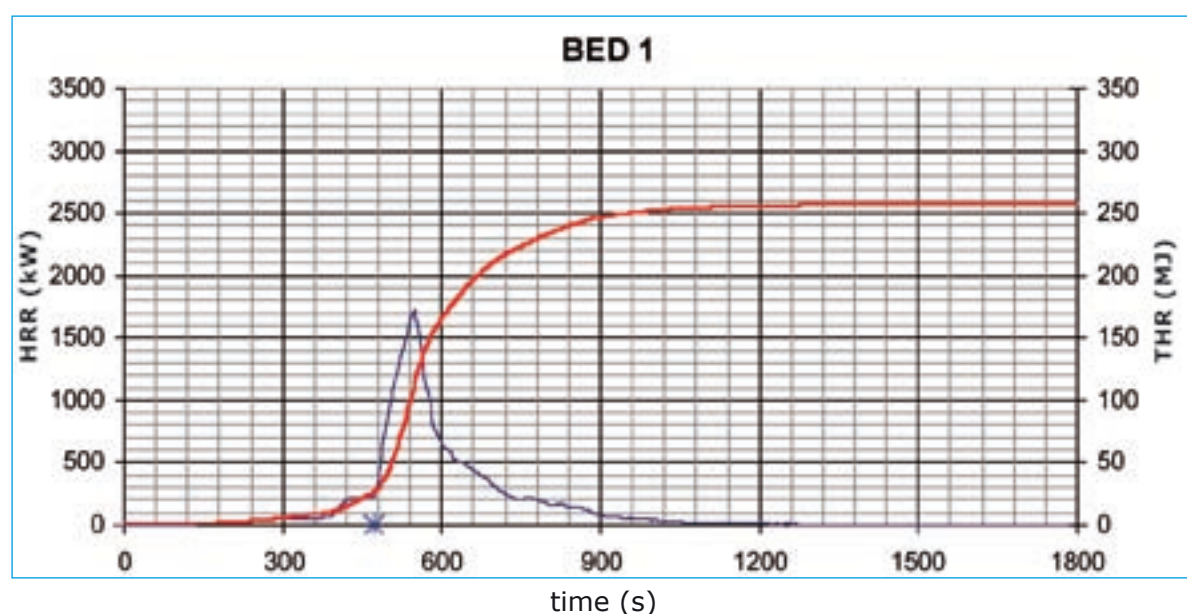
In order to test this process of sequential inflammable bed materials under experimental conditions, the Safety Board carried out a number of tests on cell beds, complete with the aforementioned mattresses, bedding and items of clothing. Figures 1 and 2 indicate the combustion heat generated in two tests in relation to time elapsed from the moment of ignition. Figure 1 shows the heat release during the first bed test, where the materials in and on the bunk bed were arranged in much the same way as described by the occupant of cell 11. The bedding on the lower mattress was not made up (i.e. open) for this test set-up. The fire was ignited at the toilet paper at the foot end of the mattress on the lower bunk. The sheet, blanket, lower mattress flared up in succession, followed by the mattress on the upper bunk, after which a peak heat release of 1.7 MW was attained.

Figure 1: First integrated bed test – heat release of the burning bunk bed. Ignition at $t = 0$.

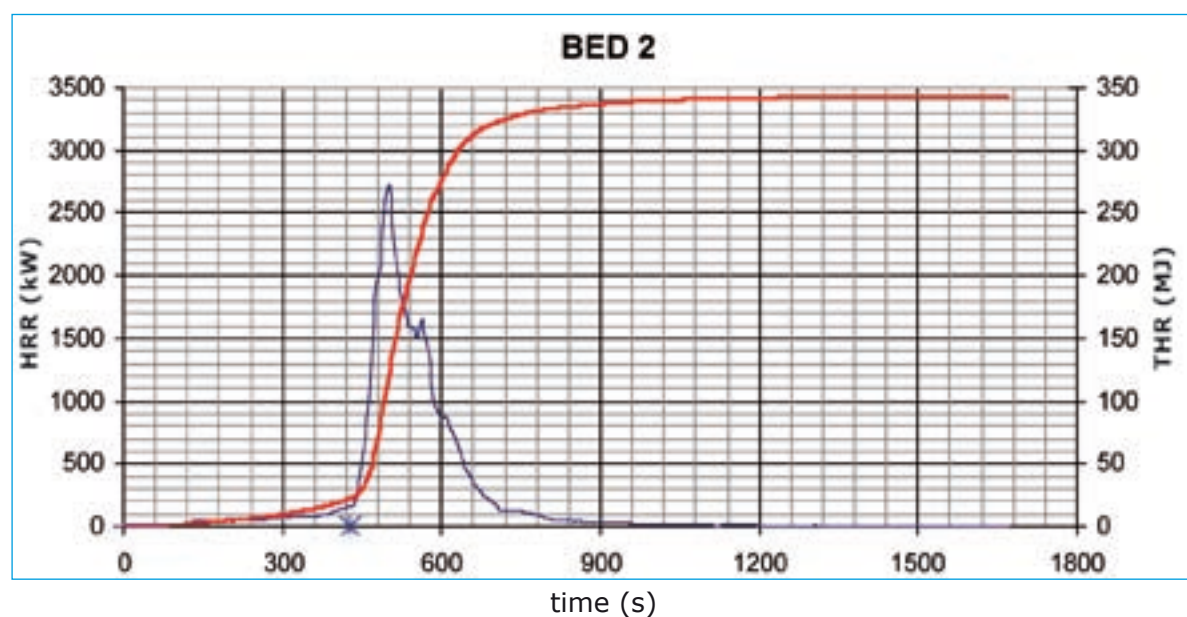
Figure 2: Second integrated bed test – heat release of the burning bunk bed. Ignition at $t = 0$.

The second bed test was carried out with the same set-up as that used for the first test, the only difference being that the bedding this time was made, instead of open. Likewise, this bed test (figure 2) showed that the successive combustion of the toilet paper, sheet, blanket, lower mattress and upper mattress can explain the initial development of the fire. The final peak heat release of the burning bed was even higher than in the first test, namely 2.7 MW. Likewise, total heat release (THR) for the second test (340 MJ) was higher than for the first (260 MJ). This difference can be explained by the presence of plasterboard, which was placed under the bunk bed in the second test to provide protection for the floor of the lab. A burning puddle of polyurethane caused by the smouldering mattress formed on this plasterboard. In the first test too, a puddle of polyurethane likewise formed, but since in this case, the bunk bed was positioned on a cold stone floor, the puddle cooled so that the melted polyurethane did not make any further contribution to the fire. The difference between the two tests therefore is that only part of the polyurethane burned in the first test, and all of it in the second test, so that the second test provided the most representative outcome for the maximum heat release from the bed. The 2.7 MW for the two mattresses, bedding and clothing would seem to correspond well to the previous estimate of 1 MW for the combustion of a single mattress.

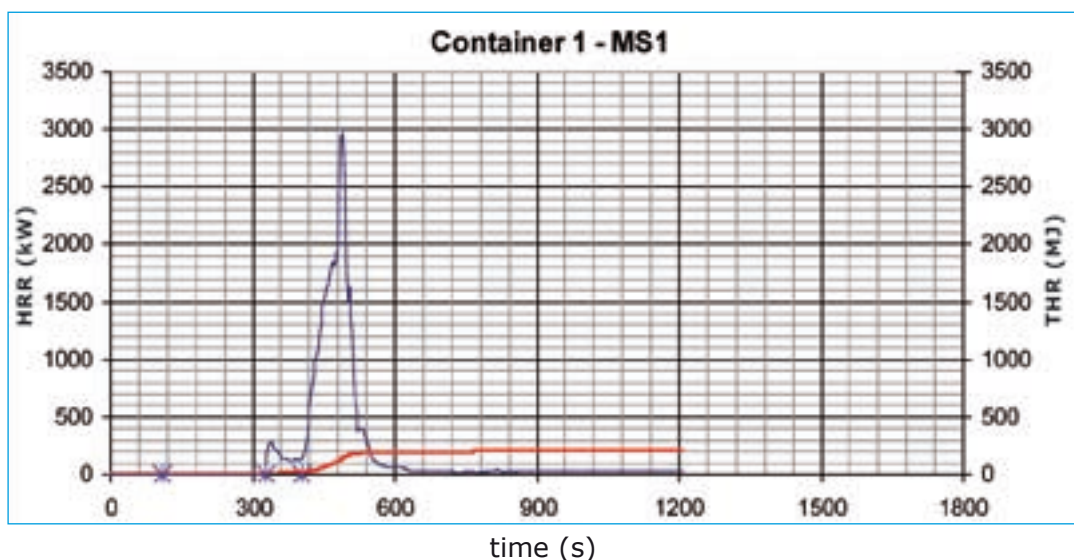
The next series of experiments consisted of simulating a fire in fully furnished cell containers, consisting of the standard fixtures and fittings, plus the personal belongings of the cell occupant. Figure 6 and 7 indicate the heat release for two of the three cell fire tests carried out. For purposes of clarity, it should be mentioned that the first cell fire test was discontinued shortly after the flashover; for the last test, the fire was put out after half an hour.

Figure 6: First integrated cell fire test – heat release of burning cell.

In figures 6 and 7, three asterisks have been placed on the x-axis, the first two of which indicate the triggering of the fire alarm and the opening of the cell door respectively. The third asterisk indicates the point at which the underside of the upper mattress caught fire. In the cell fire tests, this takes place around a minute earlier than in the integrated bed tests, which might be explained by the temperature in the cell containers developing more quickly in view of the fact that it is more difficult for the heat to escape.

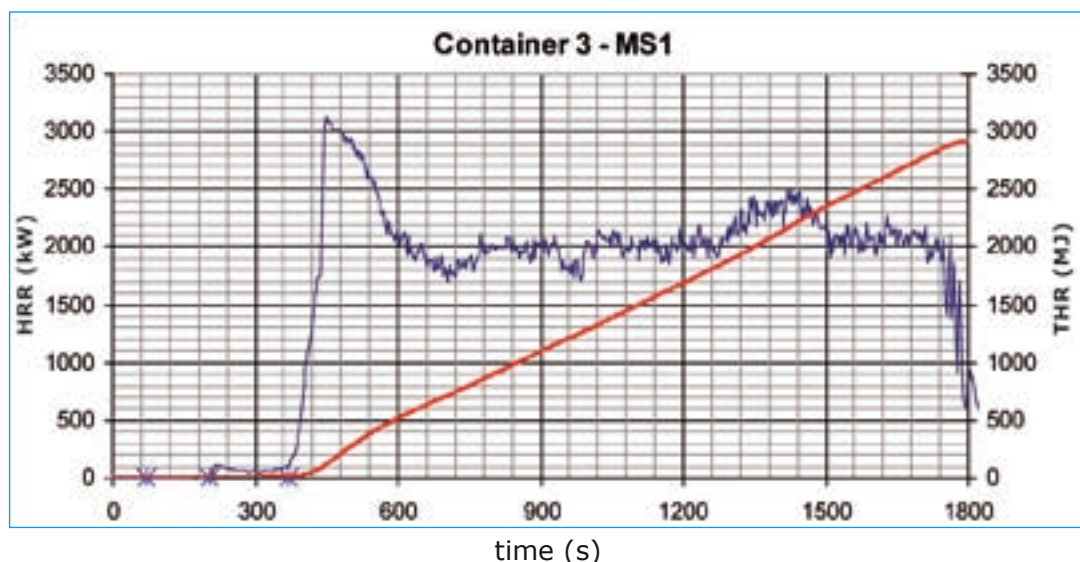
Figure 7: Third integrated cell fire test – heat release of burning cell.

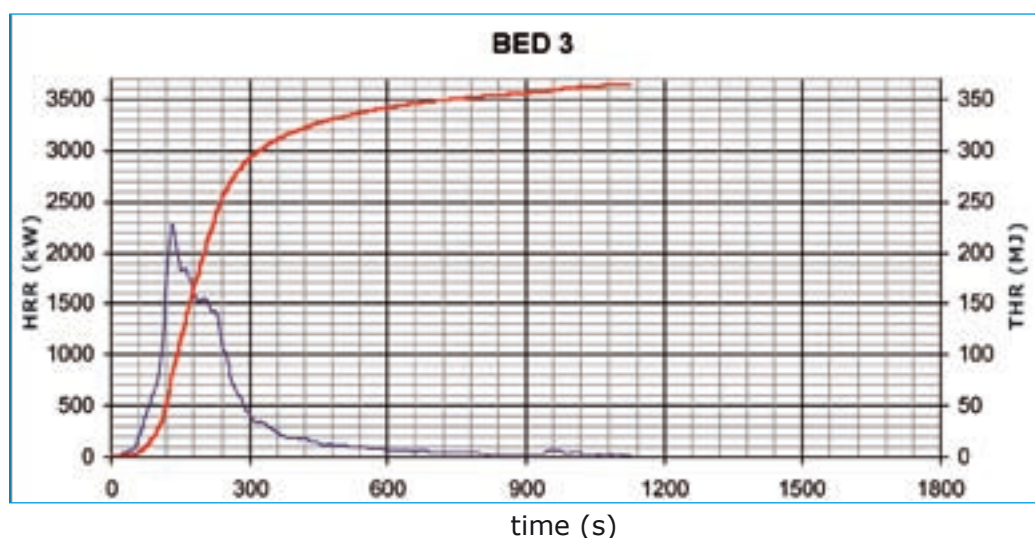
In parallel with the fire tests described above, in which an accidental scenario was simulated for the development of the fire, both the integrated bed test and the cell fire test were carried out for the 'intentional' scenario. For the purposes of these tests, the lower bed was not made up in the normal way, but the mattress was 'rolled up', where the mattress roll was positioned vertically and filled with blanket, sheets and two unrolled rolls of toilet paper. The reason for this arrangement was that an arsonist would reasonably be expected to collect together as much flammable material as possible in order to cause an effective fire.

Figure 8: Integrated bed fire test for the 'intentional' scenario.

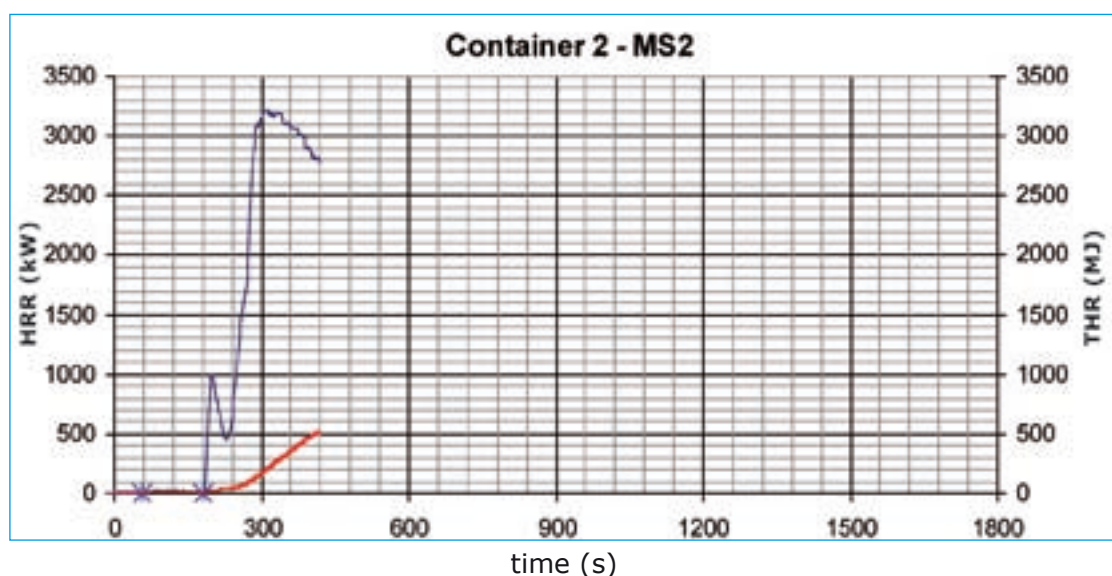
Figure 9: Cell fire test for the 'intentional' scenario.

N.B.: After 7 minutes a technical defect occurred in the registration equipment.

At the point when the cell door is opened, the fire has fully subsided for over half a minute. It takes some time before the fires sets hold again. However, when the flames begin to conflagrate again half a minute after the door is opened, there is a rapid development of fire which results in the polycarbonate³² inner pane giving way half a minute later, and fifteen seconds later, flames emerge from the doorway.

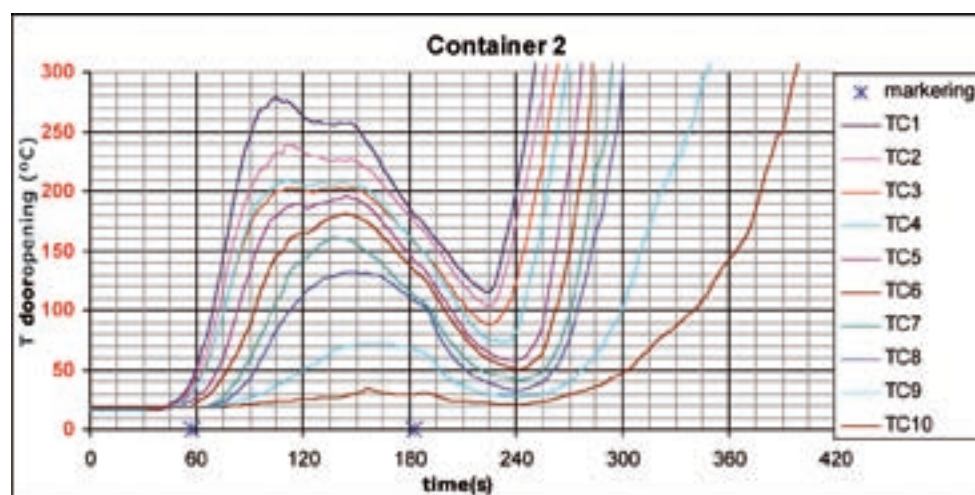
Figure 10: Temperature development in the doorway during the first few minutes of the container test for the 'intentional' scenario. First asterisk on the x-axis: fire alarm. Second asterisk: opening of door.

alarm, when the cell occupant pressed the call button for assistance in the actual fire, in the test cell, the heat has reached such high temperatures (see figure 10) that it would be expected that the cell occupant would have more than just localized burns.

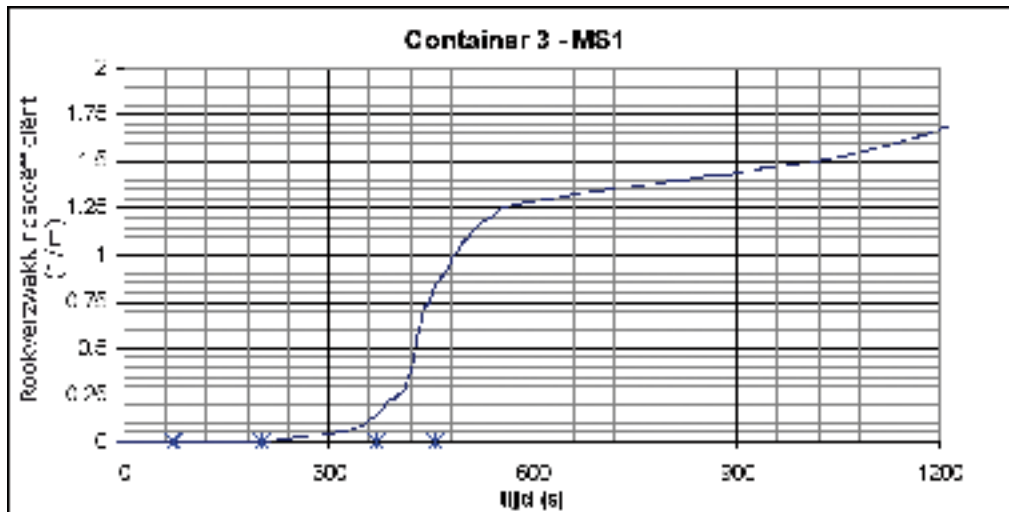
Figure 1: Development of extinction coefficient in cell fire test 3

1st asterisk: automatic fire alarm
 2nd asterisk: opening of cell door
 3rd asterisk: mattress on top bunk ignites
 4th asterisk: flames egress through door opening
 The flashover takes place between the 3rd and 4th asterisk.

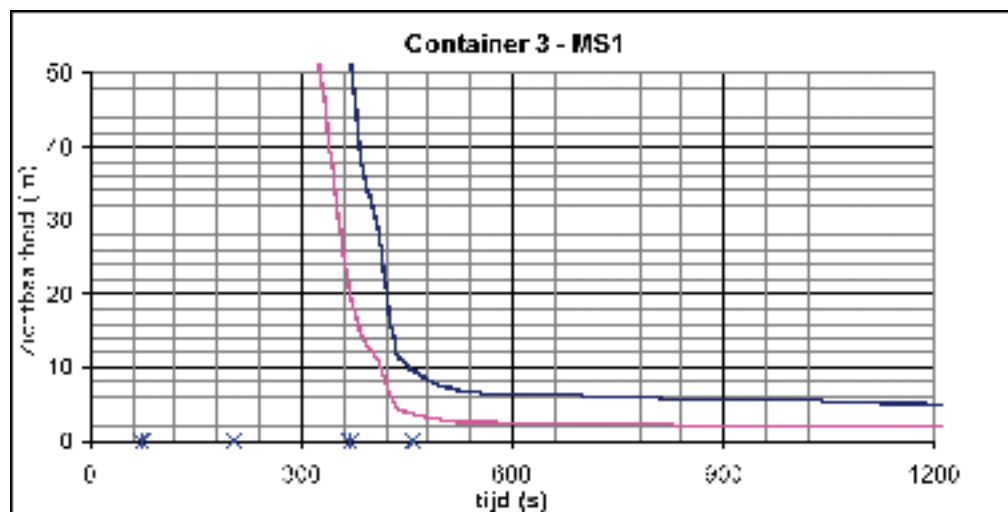
Likewise, the visibility in the smoke-filled corridor reduces rapidly after the flashover. Figure 2 shows that, at the point when the first flames move out of the burning cell in cell fire test 3, the criterion 'visibility of light-giving pictograms' has decreased to less than 10 metres; for the criterion 'visibility of light-reflecting pictograms', the value has decreased to less than 4 metres. During the Schiphol fire, at the time the flames egress from cell 11 occurred, two of the guards acting to save the cell occupants, were still busy opening the cell doors. For cell fire tests 1 and 2, visibility became restricted at a faster rate than for cell fire test 3.

Figure 2: Visibility for light reflecting (pink) and light-giving (blue) pictograms. For explanation of asterisks: see figure 1.

Although these calculations do not take into account the open cell doors, which meant that some of the smoke could disappear into the cells that had been evacuated, the results do clearly demonstrate that the spread of smoke in the corridor seriously impeded any attendance there. The calculations confirm that the statements of the two guards, that the development of smoke rendered it impossible for them to open all of the cell doors on K Wing.

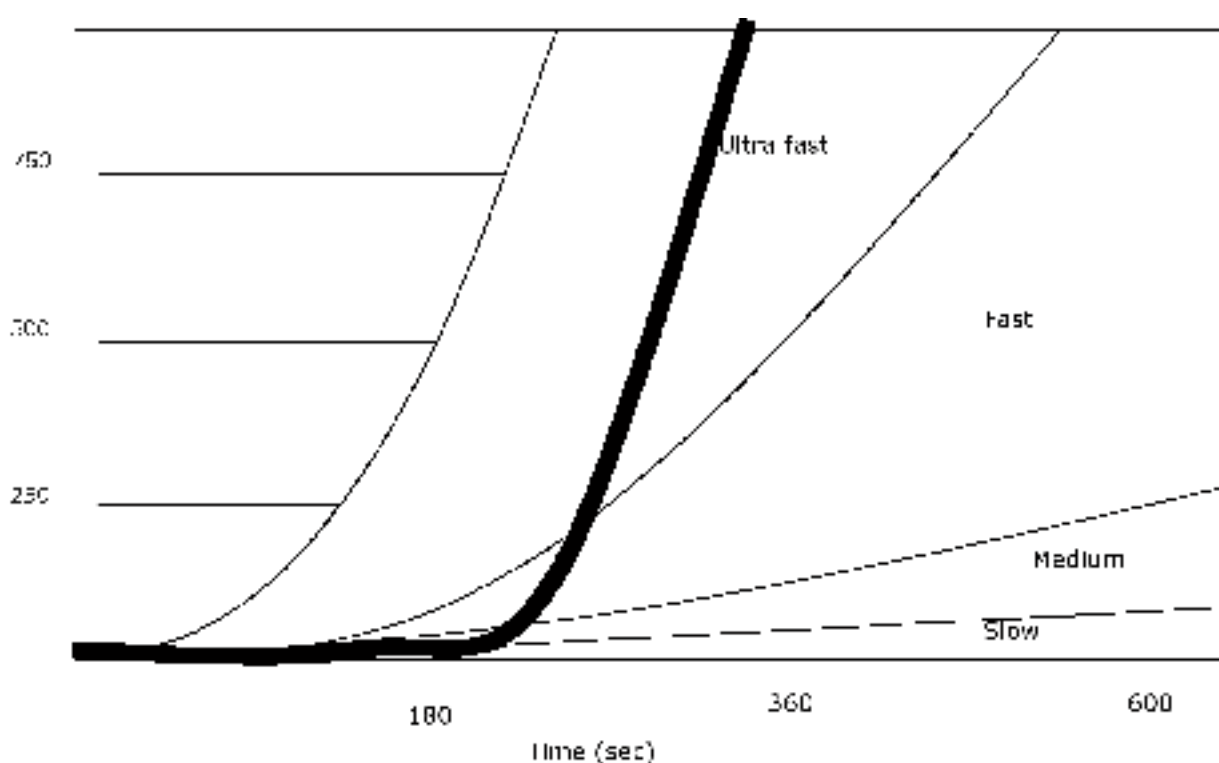
The broad line in the diagram indicates the development of the combustion heat as measured during the third cell fire test carried out by the Safety Board. This shows how the cell fire, after acceleration in the fourth minute after ignition, developed into the 'ultra-fast fire growth' category.

Figure 1: 'Fire growth rates' according to the NFPA
Broad line: combustion heat curve for cell fire test 3
