DUTCH
SAFETY BOARD

Capsizing and sinking of fishing vessels

Lessons learned from the occurrences
involving the UK-165 Lummetje and
the UK-171 Spes Salutis

The Hague, June 2021

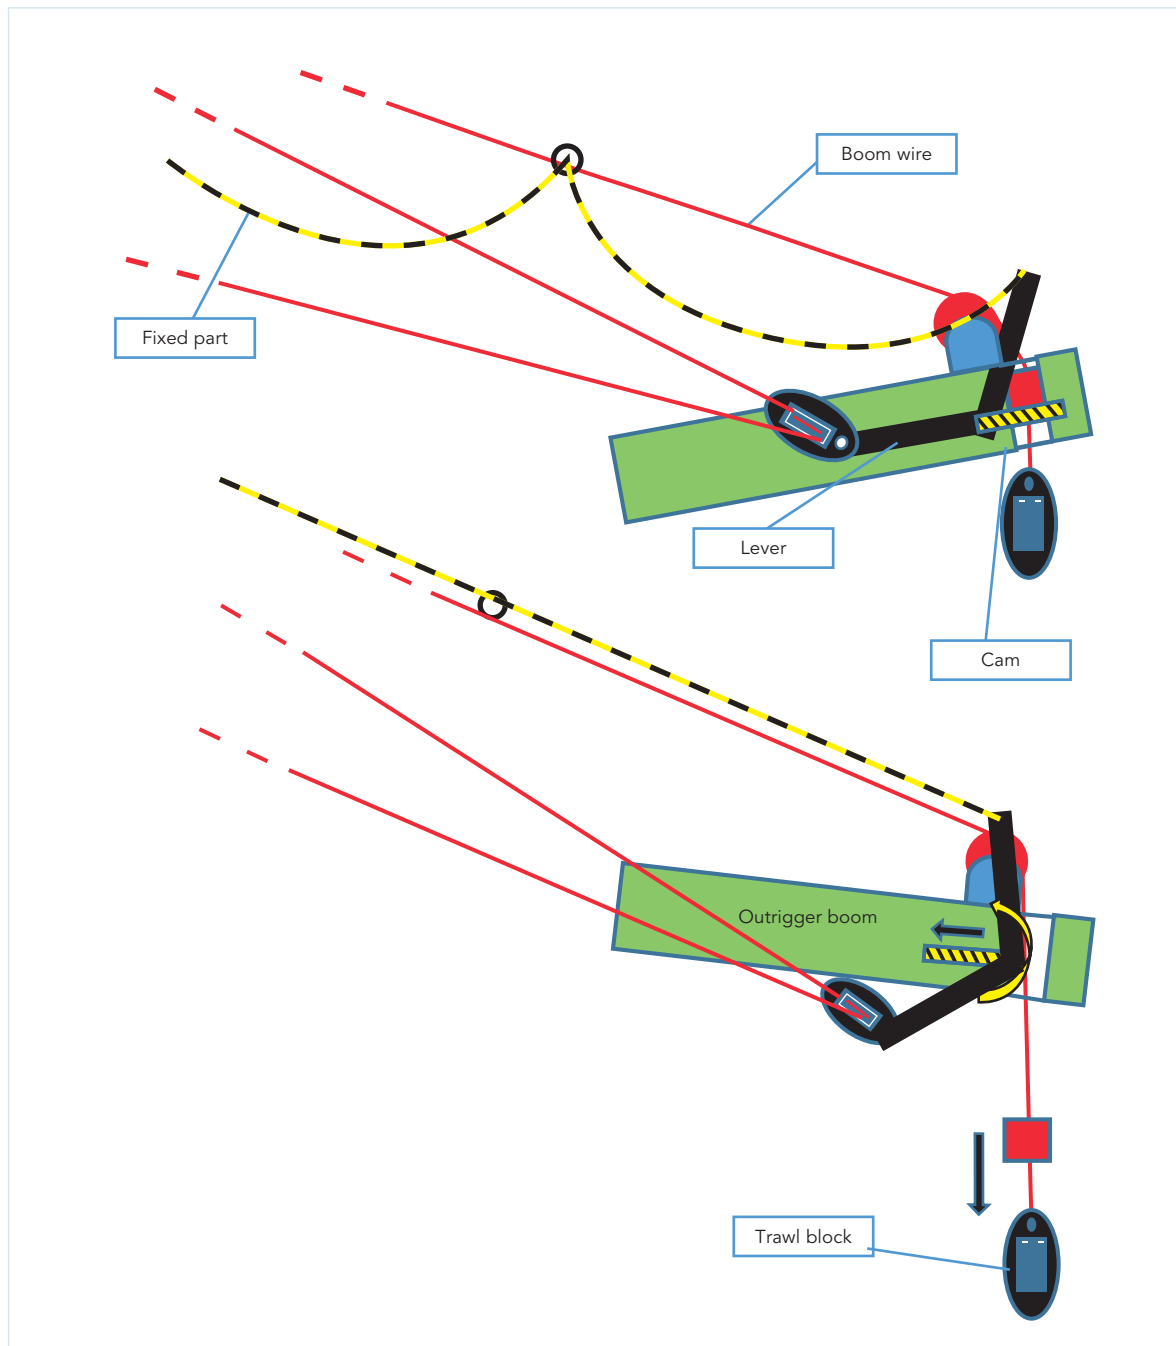
Figure 24: Diagrammatic representation of trawl block slip construction (Source: Dutch Safety Board)

As shown in Figure 24, the boom wire was not fixed to the end of the boom. The wire ran through the boom to the trawl block. The boom wire was clamped against the boom via a cam in the end of the boom. This construction enabled the boom to be raised and lowered, while the trawl block remained suspended just below the boom. This cam was operated by the lever referred to above, and held firmly in place by the tension from the boom wire on the block at the underside of the lever.

If the boom was lowered so far that the fixed part was pulled taut, then the lever was activated. This in turn shifted the cam, so that the boom wire was no longer clamped in position. This enabled the trawl block to be paid out further, while the boom remained suspended in the fixed part. In other words, the trawl block could be *slipped*.
