# Mortar Accident Mali

*The Hague, December 2017*

On 6 July 2016, members of a mortar squad from the Airmobile Brigade were conducting an exercise firing 60 mm mortar rounds. During the exercise one of the rounds exploded in the mortar. As a result, the two members of the mortar squad operating the mortar lost their lives and a third one was seriously wounded. The exercise took place near the UN camp in Kidal, Mali, where the Netherlands is participating in the UN Multidimensional Integrated Stabilization Mission in Mali (MINUSMA).

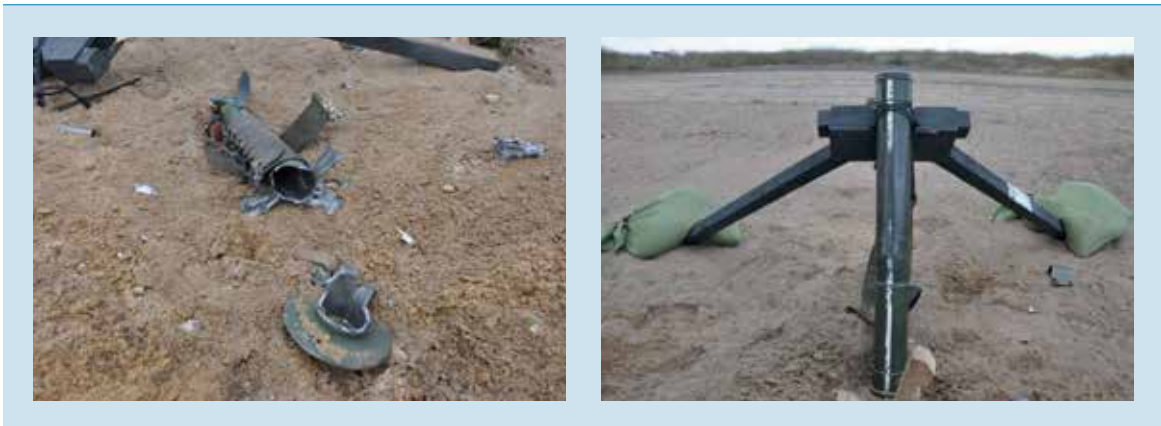
Figure 7: Mortar after an internal detonation (left) and deflagration (right) of a 60 mm mortar round based on reference tests by KCW&M. (Pictures: KCW&M)

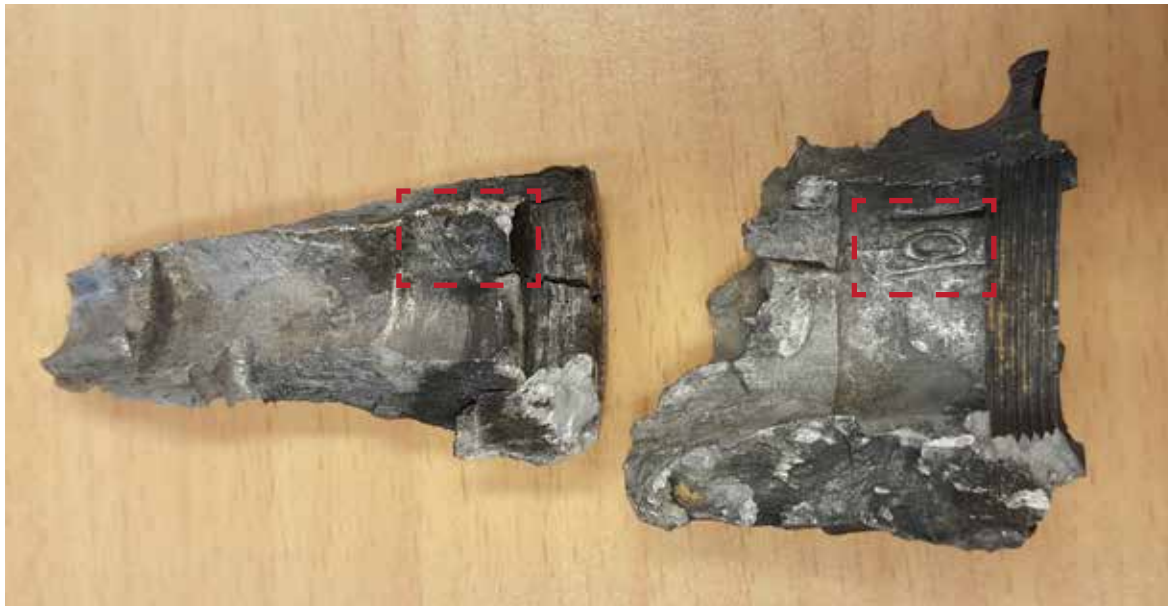
A prominent imprint of the slider and slider spring is visible on the inner wall of the fuze from the round involved in the accident. The slider and slider spring also made an imprint on the inner wall of the fuze tested in armed position, but it is less prominent than that of the fuze from the accident, see Figure 9.

*Figure 9: Imprint of the slider and slider spring on the inner wall of the fuze tested in armed position (left) and on the inner wall of the fuze from the round involved in the accident (right). (Pictures: TNO)*

The difference between the two imprints can be explained with Figure 10. When the detonator fires, the slider breaks into two parts: the part on the left of the detonator is accelerated to the left and the part on the right of the detonator is accelerated to the right. Since in armed position the slider and slider spring are positioned at some distance from the inner wall of the fuze (Figure 10, left), firing of the detonator leaves an imprint on the inner wall that is less prominent than in safe position, where the slider and slider spring are already in contact with the inner wall (Figure 10 right). Accordingly, this is a strong indication that the accident round detonated in safe position.

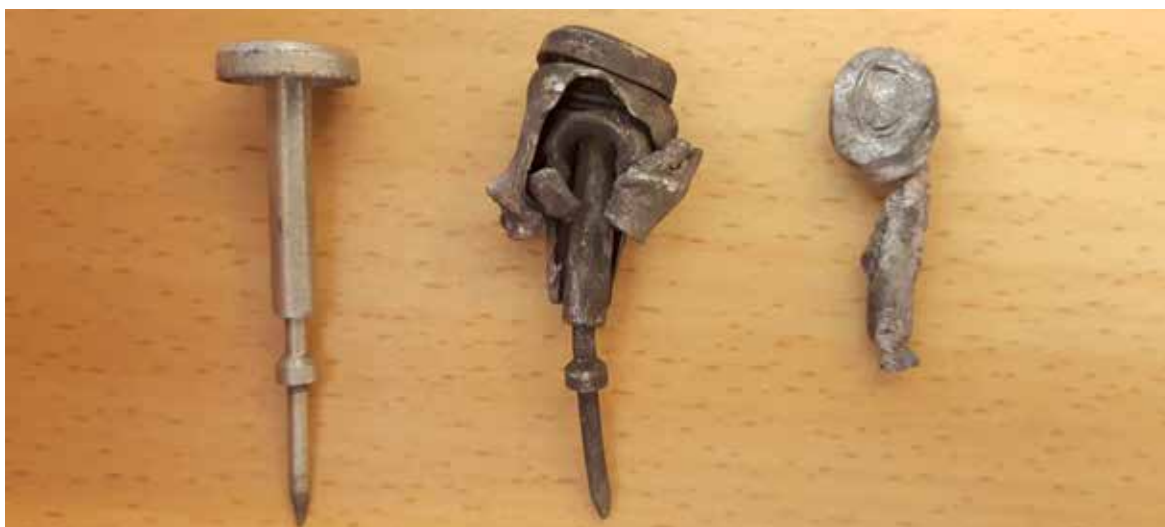
When the detonator fires in safe position (right in Figure 10) the section of the slider with the recess for the firing pin is accelerated to the left. The firing pin will significantly deform or shear off because its tip resides in the recess of the slider. Figure 11 shows three firing pins, an unused firing pin (left), the firing pin from the test in armed position (centre) and the firing pin from the accident round (right). The latter has sheared off just below the lower thickened section. This is a strong indication that the accident round detonated in safe position.

Figure 11: Different firing pins: left an unused firing pin, in the centre a firing pin from the test in armed position and right the firing pin from the accident. (Picture: TNO)

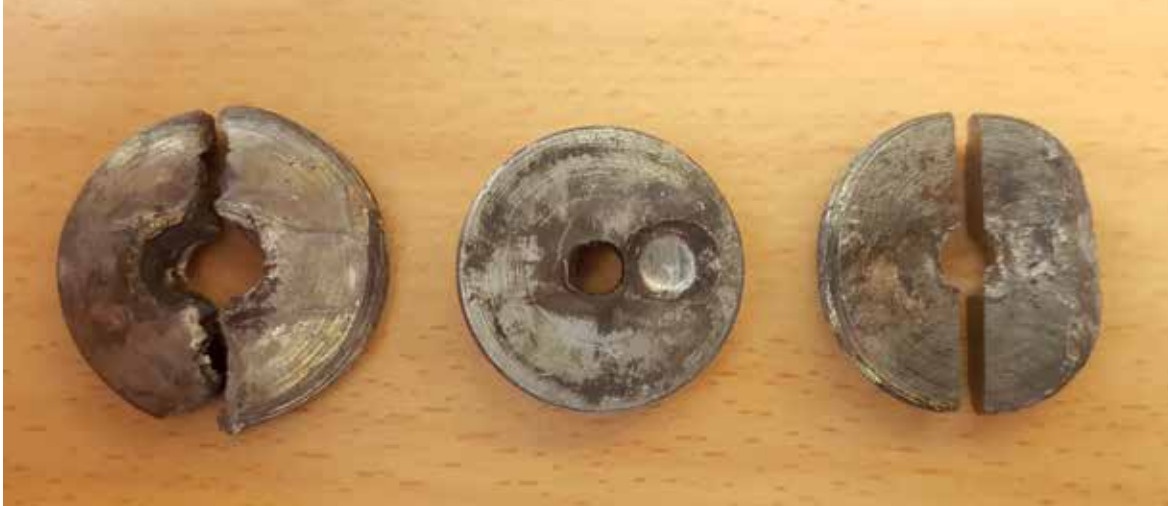
The effect of a detonation of the detonator on the barrier (explosive train interrupter) depends on the position of the detonator at the moment of detonation. In armed position the detonator has moved to the centre of the barrier and is in line with the lead charge (see Figure 10, left). The shock from the detonator propagates through the barrier and initiates the lead charge, creating a large central hole in the barrier, see Figure 13 (left). In safe position the detonator is positioned eccentric on the barrier (see Figure 10, right). When the detonator fires this leaves an imprint in the top of the barrier. As a result of inadvertent transfer through the barrier the lead charge reacts and the thin metal layer covering the lead charge is blown away. This also creates a central hole, which is however smaller than that in armed position. The imprint and relatively small central hole are observed in an explosive transfer test in safe position (Figure 13, centre) during which the lead charge reacted without initiating the booster. A similar imprint and small central hole were also observed in the barrier of the accident round (Figure 13, right).

Figure 13: Different appearances of the top of a barrier: from the test in armed position (left), from the test in safe position (centre) and from the accident (right). The barrier from the accident was recovered in one piece, but was cut in half for further examination. (Picture: TNO)

The presence of an imprint adjacent to the centre and the absence of a large central hole in the centre of the barrier, show that the accident round was in safe position when it was launched.

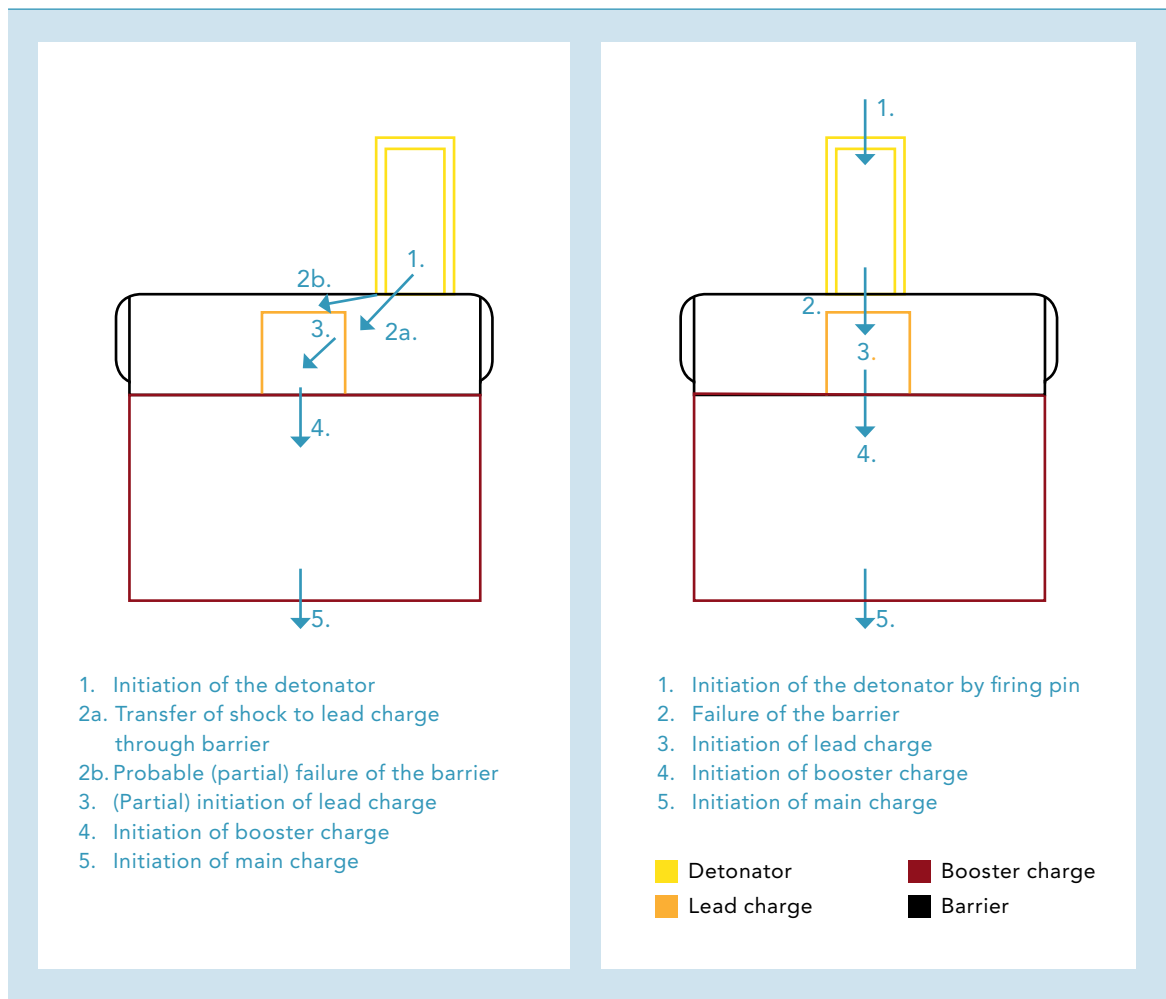
Figure 17 displays the explosive trains for a fuse in unarmed (left) and in armed position (right), occurring, respectively, before and after the launch of the mortar round.

Figure 17: Explosive train for an unarmed fuze (left) and an armed fuze (right). (Source: TNO)

The second conclusion is that the barrier of the fuze failed to function as intended, namely as an explosive train interrupter that should have separated the detonation of the detonator from the rest of the explosive train when the fuze is in safe position. The shock wave created by the initiation of the detonator propagated through the metal of the barrier (Figure 17, left). This set off the lead charge, booster and main charge of the round.

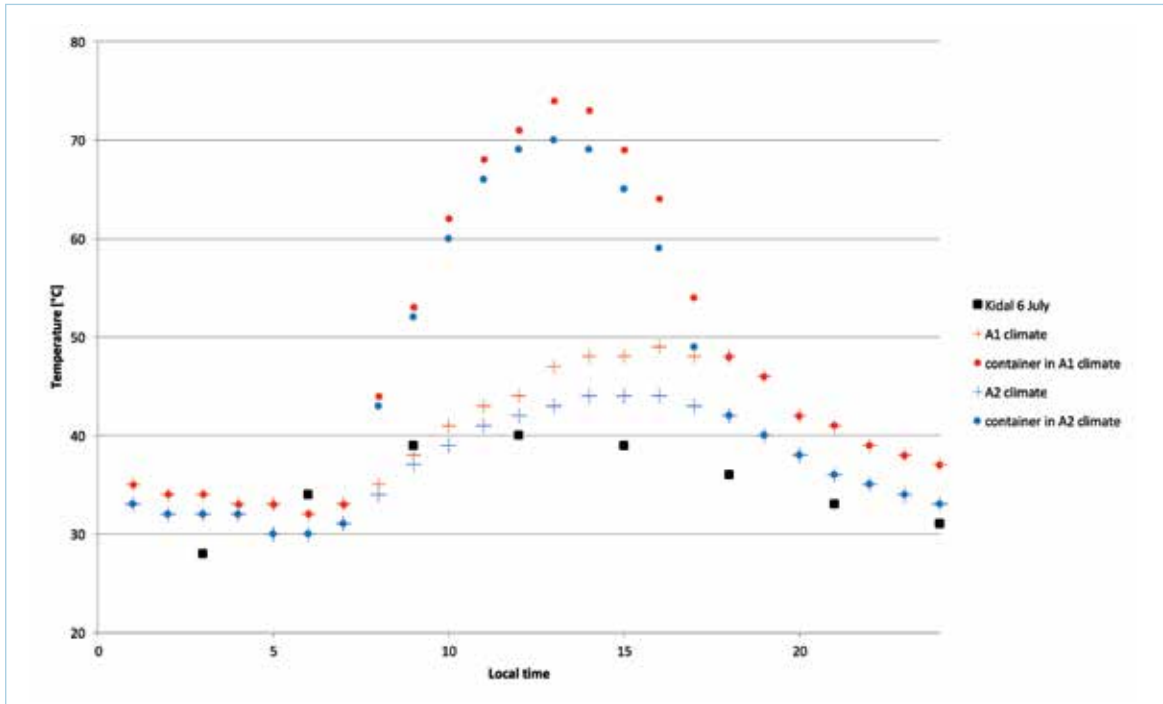
Figure 20 shows the daily ambient temperature profile and, as calculated using the TNO climate tool, the temperature inside the shipping container at the time of the accident. (Source: TNO)

Figure 20: Expected temperature profile in the container during the days around 6 July 2016. (Source: TNO)

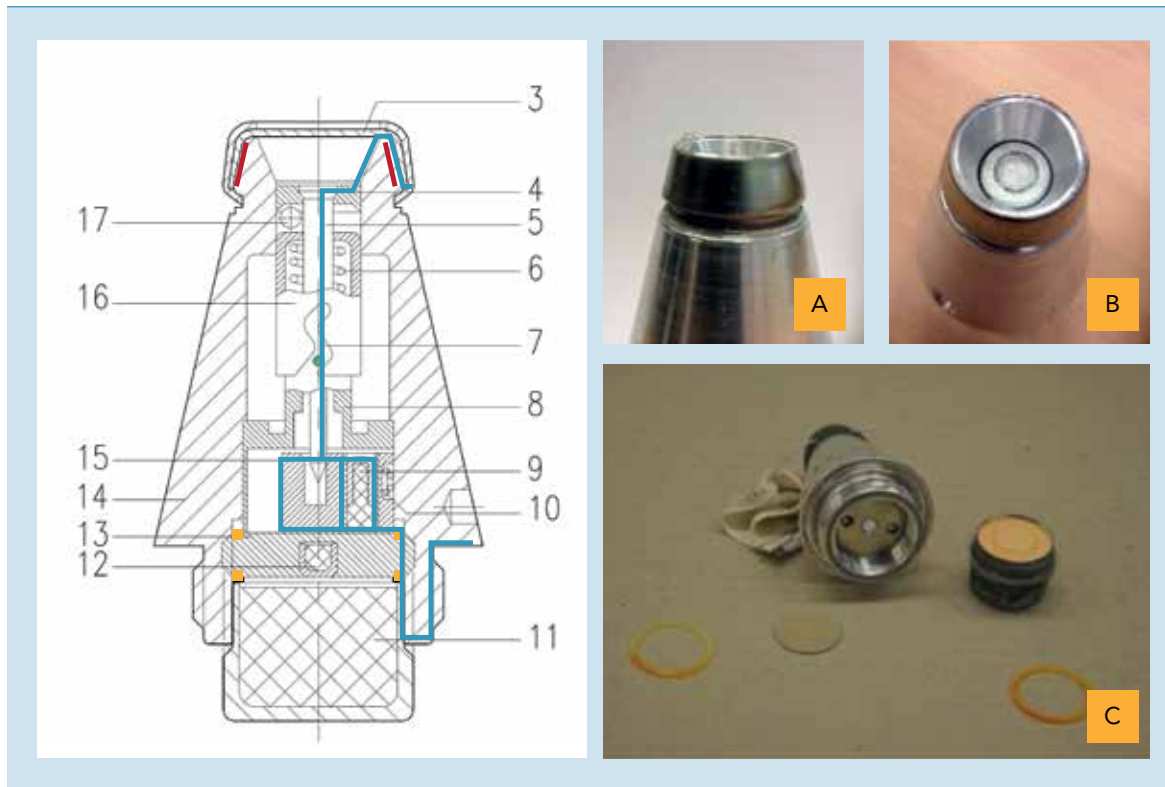
Based on these observations it is likely that there have been mortar rounds that were exposed to moisture at some point in time - it is impossible to establish when and where - and that the moisture is able to reach the primer inside the detonator. The most likely route for moisture to penetrate is through the tip of the fuze; here the barrier consists of the adhesive layer in between the membrane and fuze body (the transport safety cap is a loose part and does not act as a moisture barrier). Due to the many barriers it is less likely that moisture penetrated via the screw thread of the fuze, the screw thread of the booster, the screw thread of the barrier and the two rubber sealing rings. Both routes are displayed in Figure 21 (on the left).

Figure 21: Cross section of the fuze with potential routes (blue) for moisture penetration via the adhesive layer (red) and sealing rings (yellow). Picture A: adhesive layer for the membrane, picture B: opening between the firing pin and the housing and picture C: underside of the housing with the barrier, booster with cardboard disk and two rubber rings. (Source: TNO)

Although adhesive and rubber rings are both permeable, moisture penetration through a layer of adhesive is easier than along three screw threads and two sealing rings. Two simple leak tests were performed for confirmation. First, five empty fuzes were positioned with their nose facing down and filled with water; they were all watertight, despite the fact that KCW&M exposed them to environmental loads to which they can be subjected during their life cycle. The five fuzes were subsequently mounted on an inert shell body, and subjected to five drop tests from a height of about one metre with a random orientation upon impact with the ground. After removal from the shell body the fuzes were again filled with water; the adhesive layer of one of the five fuzes was found to be leaking, see Figure 22. It is possible that the preloading of the fuzes contributed to the leakage.

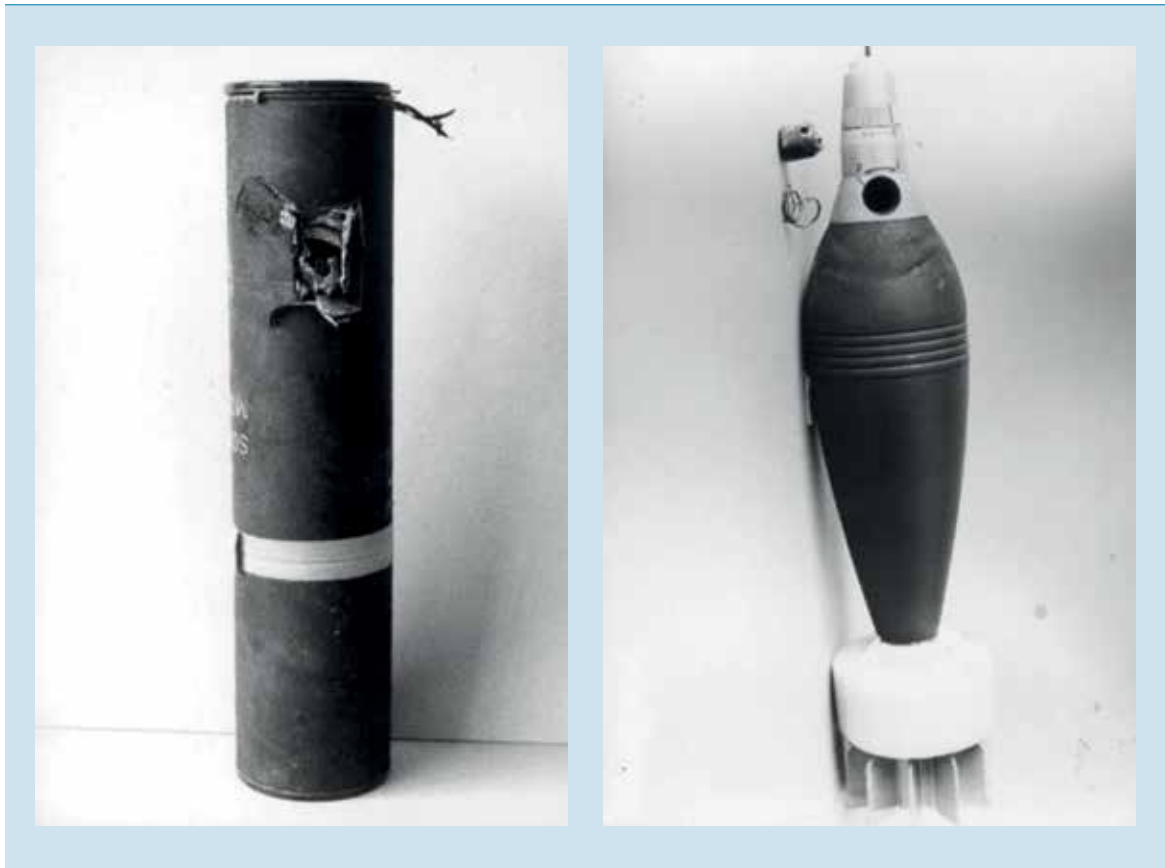
The referenced ammunition had arrived in Den Helder after a stay in the Antilles.<sup>38</sup> The rotor that ensures arming after leaving the launch tube (part of the safety and arming mechanism) had projected through the cardboard packaging for a number of rounds (see Figure 23). The investigation revealed that the detonators of the fuzes were corroded, resulting in the formation of copper azide. It was concluded that the brass<sup>39</sup> components around the detonator had reacted with the lead azide in the aluminium detonator. As a result of internal friction, probably caused by vibration during transport, the copper azide reacted, leading to the initiation of the primer charge in the detonator causing the rotor, which ensures safe arming distance, to project through the packaging. The main charge was not activated because the fuzes were in safe position. In contrast to the accident round in Mali, the safety mechanism of these fuzes did function.

*Figure 23: Perforated packaging and projected rotor of the arming and safety mechanism of an 81 mm round (Pictures: TNO).*

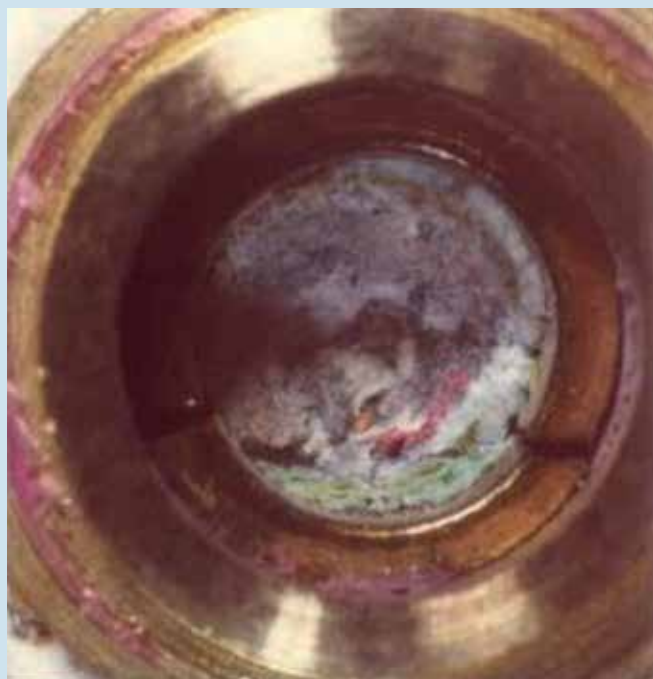
The ammunition was on board of a ship of the Royal Dutch Navy located at the Antilles for 18 months. The prevailing high temperature and humidity caused the reaction of the lead azide with water vapour in the atmosphere. The reaction is seen on the top view of the detonator in the brass casing in Figure 24. Traces of the primer are visible as grey and white crystals, possibly mixed with aluminium compounds from the detonator. Traces of the red lacquer (sealant) are also visible. The green crystals indicate copper compounds including the highly sensitive copper azide and the non-explosive copper hydroxide and copper oxide.

Figure 24: Top view of the aluminium detonator in the brass casing from fuze type V-19. (Picture: TNO)

The investigation conducted at the time concluded that there was a major risk when handling the 81 mm rounds affected by corrosion and that the presence of copper in the immediate vicinity of lead azide must be considered unacceptable.<sup>40</sup>

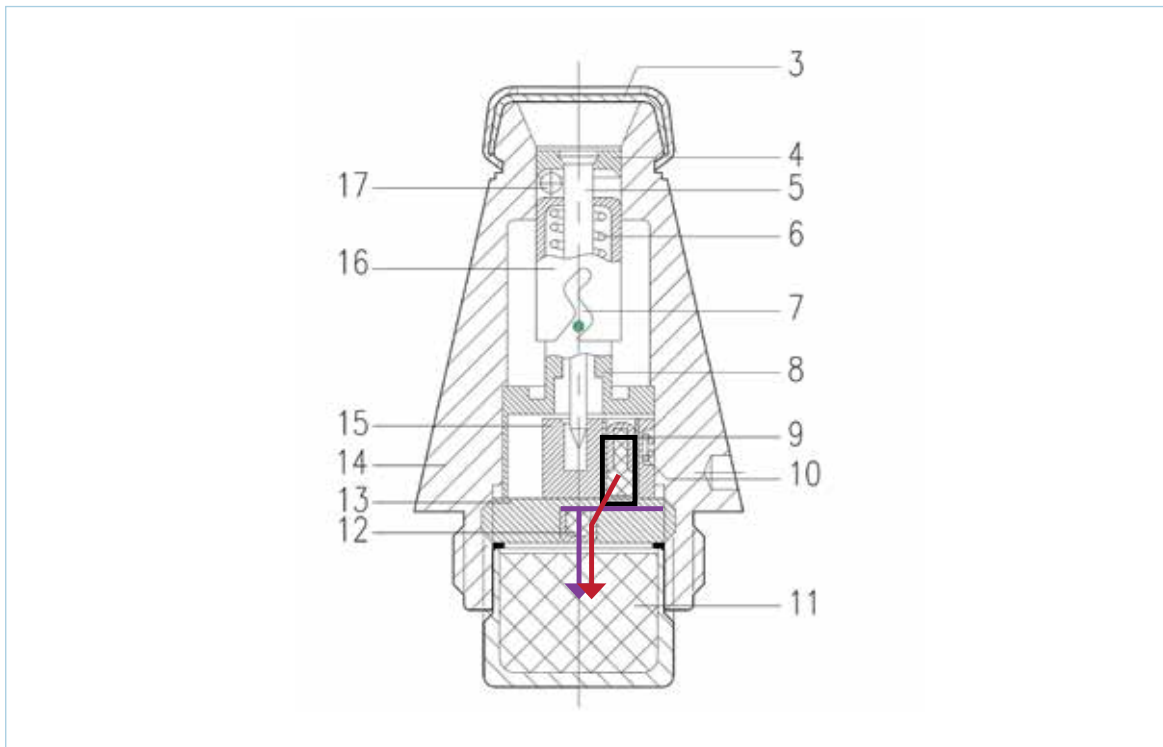
Figure 25 illustrates the two hypothetical reaction transfer routes from the detonator to the lead charge: straight through the slider, or along a 'bridge' of copper azide (and possibly tetrazene and/or the compounds exuded from the shell body) between the primer and lead charge, both with the fuze in safe position. In both cases the reaction transfer leads to the detonation of the booster and of the main charge.

Figure 25: The detonation of the copper azide when the mortar round is launched detonates the primer (red) or detonates the primer and the 'bridge' of copper azide (and possibly tetrazene) between the detonator and the lead charge (purple). (Source: TNO)

Laboratory tests performed by TNO (at circa 12°C) show transfer of reaction of the primer to the lead charge with the fuze in unarmed position (five tests). The steel disc that should form a barrier between the detonator and the lead charge, appeared not to function as such in these tests. However, there was no transfer of reaction to the booster charge (two tests); see Appendix I.<sup>42</sup> Because transfer of reaction to the lead charge in safe position is not allowed<sup>43</sup>, the design of the fuze does not comply with NATO standard.

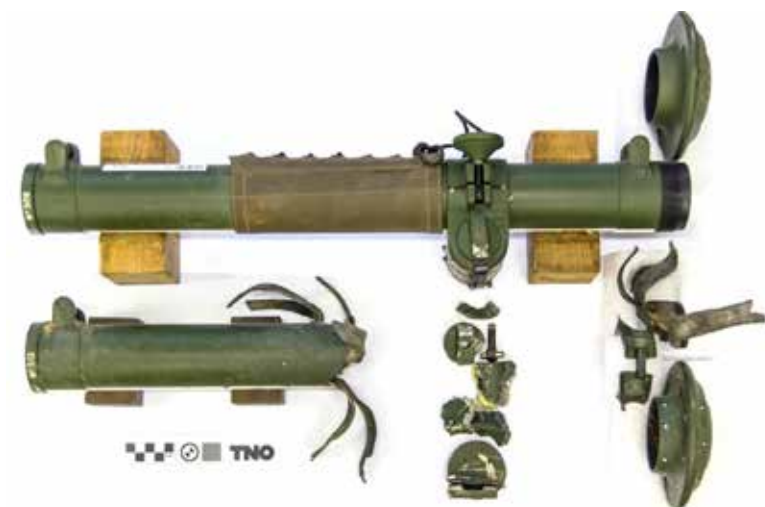
Based on an analysis of the recovered debris a reconstruction was made of the damaged mortar. In Figure 1 this reconstruction is positioned next to an intact mortar. The reconstruction reveals a similar damage pattern to the muzzle end and to the baseplate end of the launch tube (at both sides of the sight unit). The largest missing part of the tube corresponds to the original location of the sight unit. The absence of these parts is an indication of the level of fragmentation of this tube section. The fragmented, smaller parts of the tube are harder to find and were therefore probably not recovered during the search at the site of the accident. It is also possible that smaller fragments from the tube are still in the body armour or among the remaining, smaller fragments that were recovered from the bodies of the victims. Large parts of the sight unit are also missing. Figure 1 shows a reconstruction of the recovered parts of the mortar. As a reference an intact mortar is also displayed.

Figure 1 Reconstruction of the recovered parts of mortar No. 513 (bottom) and an intact mortar No. 500 (top).

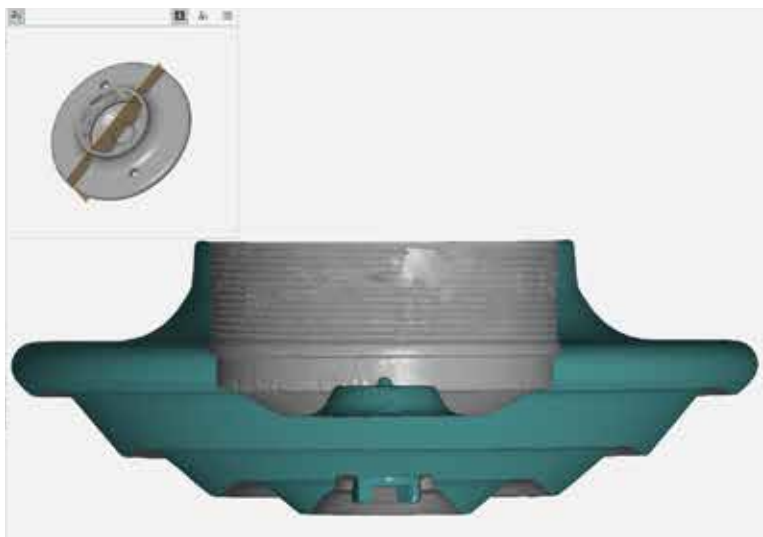
The 3D scan of the base plate was used to produce a cross-section over the centreline of the base plate and the firing pin. The firing pin is screwed into the base plate; the cross-section in Figure 3 shows how far the firing pin extends from the central plateau, namely 1.73 mm. The firing pin must extend 1.5 - 1.8 mm from the central plateau [ref. 1].

Figure 3 Cross-section of the base plate over its centreline.

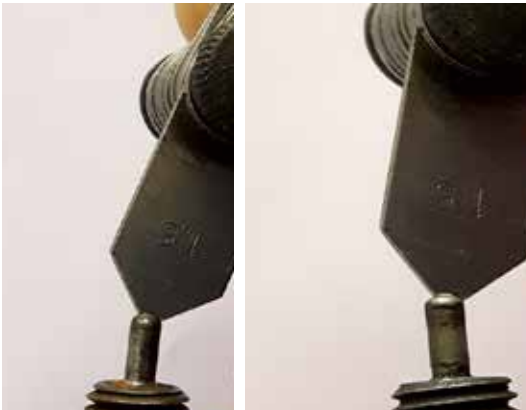
The firing pins are both straight with respect to the screw thread, but a difference is observed between the shape of the tip of both firing pins; the firing pin from the reference weapon is flattened compared to the tip of the firing pin from the damaged mortar; see Figure 4 and Figure 5. It is assumed that the tip of the firing pin flattens with the number of rounds fired. Therefore it is likely that more rounds were fired with the firing pin from the reference mortar than with the firing pin from the mortar involved in the accident. The dimensions of both firing pins were mapped and the measurements are given in Table 1.

Figure 5 Measured dimensions of the firing pin from the mortar involved in the accident (left) and from the reference mortar (right).

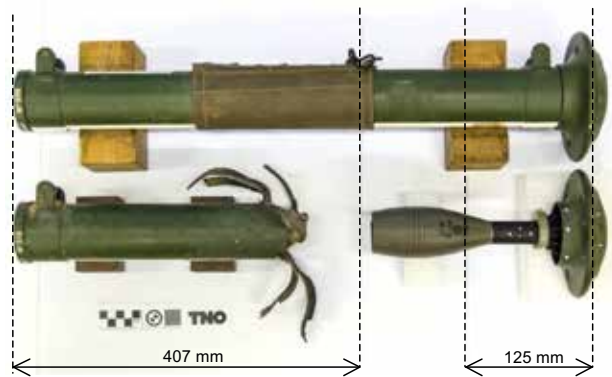
A reconstruction was made of the possible position of the mortar round at the moment of the accident; see Figures 8a and 8b. In Figure 8a, the damaged upper section of the launch tube and base plate of mortar No. 513 are aligned with the muzzle end and base plate of the reference mortar No. 500. In Figure 8b, both the damaged upper and lower section of the launch tube of mortar No. 513 are aligned. A 60 mm mortar round without a fuze is shown in both figures with the base of the tail assembly placed against the bottom of the tube.

The dotted lines in Figures 8a and 8b mark the positions to which the metal strips would extend in their unbent state. In between these dotted lines the reaction has occurred. As this reconstruction also shows the mortar round, it is seen that the shell body with the main charge of the round (olive green) for the larger part is situated in between these lines. In Figures 8a and 8b, the tail assembly is at the bottom of the launch tube and the shell body is slightly to the right of the dotted lines. It is not possible to conclude with certainty that the main charge detonated in this position. It is also possible that the mortar round was already accelerating (towards the muzzle end of the mortar) when the reaction of the main charge occurred; the upper and lower side of the main charge may therefore also correspond to the dotted lines in Figures 8a and 8b. In other words: the dotted lines provide an indication of the potential position of the main charge of the round at the time of the reaction.

Figure 8a Position of the mortar round with the tail assembly situated against the base plate and relative to the upper part of the damaged mortar No. 513. For comparison the intact mortar No. 500 is placed next to the reconstructed mortar. The dimensions are given relative to the upper and lower side of the mortars.

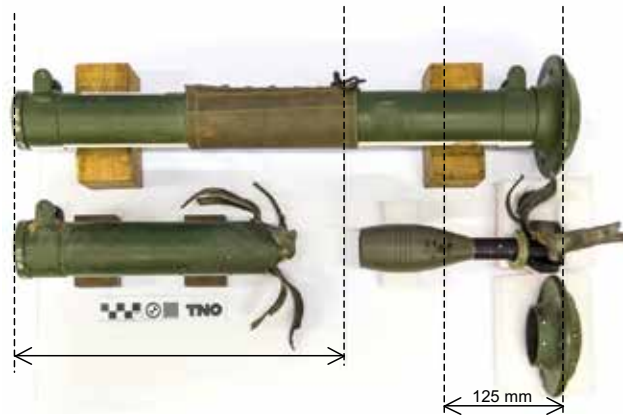
Figure 8b Position of the mortar round with the tail assembly aligned with the damaged lower section of the launch tube and base plate and relative to the upper part of the damaged mortar No. 513. For comparison the intact mortar No. 500 is placed next to the reconstructed mortar. The dimensions are given relative to the upper and lower side of the mortars.

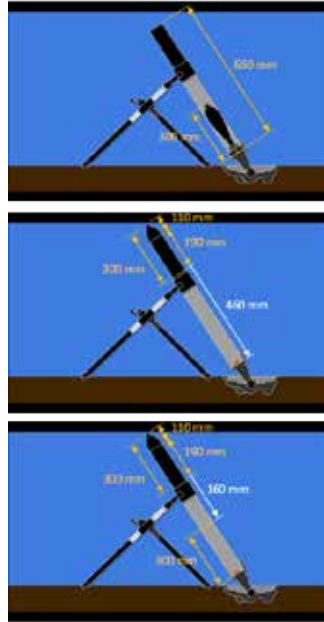
In case another round was already present inside the tube, the distance to cover is only 160 mm, because the length of a round equals 300 mm. The travel distance in case of double loading measures only one third of the normal distance.

Figure 10 Dimensions of the launch tube and mortar round (top image) and distance travelled (in white) by the round in the tube for a single loading (center image) and double loading (lower image).

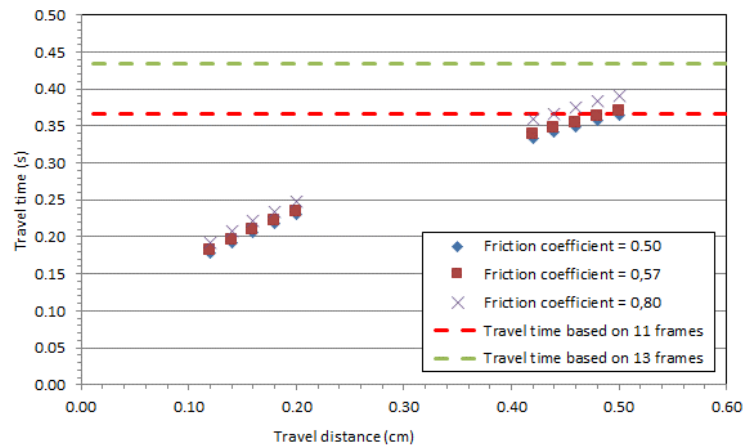
For the calculation a dynamic friction coefficient of 0.57 is used and it is assumed that the round was 190 mm inserted in the barrel at the moment of release. A sensitivity analysis was applied to the calculation to ensure that variation in these assumptions does not result in an overlap with the travel time for double loading. See Figure 12; because literature reports a (static) friction coefficient for steel on steel between 0.5 and 0.8, the calculation is repeated for these values, also including a variation of 50 mm on the travel distance. As Figure 12 shows, the corresponding travel time for double loading is between 0.18 and 0.25 s, and between 0.33 and 0.39 s for single loading. Only the latter corresponds with the time derived from the video footage.

Figure 12 Sensitivity analysis of the travel time versus the travel distance for single loading (around 46 cm) and double loading (around 16 cm).

This analysis demonstrates that double loading has not occurred and that the mortar round that is dropped into the mortar as seen in the video footage, was the cause of the observed effects.

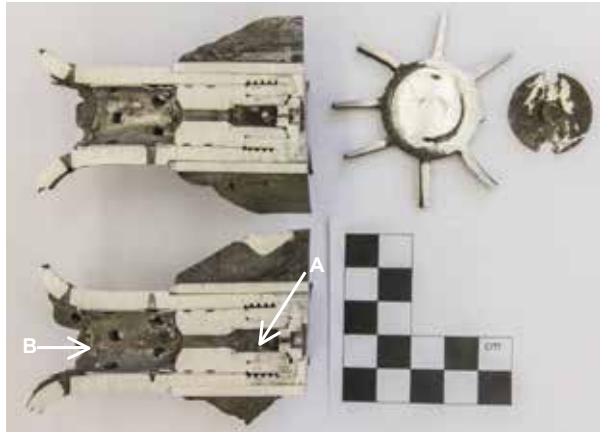
Figure 13 Cross-section photo of the tail assembly.

A cross-section was made of the recovered tail assembly; see Figure 13. No intact powder was discovered on the inside of the tail assembly. Combustion products were however present inside the combustion chamber in the tail assembly ('A' in Figure 13). It is not possible to determine whether the powder burned as a result of the normal initiation route via the percussion primer or as a result of the heat released by a reaction of the main charge.

The top of the inner cartridge casing ('B' in Figure 13) displays plastic deformation, which indicates that stress was applied from the forward end of the tail assembly. This deformation is probably caused by the shock wave resulting from the detonation of the main charge.

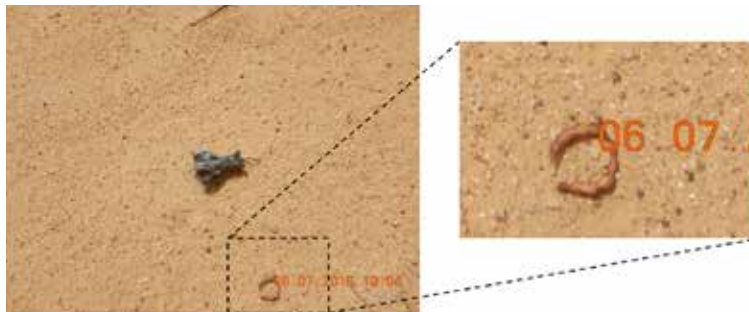
On one of the pictures taken after the accident (ref. DSCN2971.JPG) an object is seen with a similar shape as an augmenting charge. Figure 14 shows an intact augmenting charge and Figure 15 shows the object in the immediate vicinity of the remnant of the mortar round tail assembly, as found after the accident. It is possible that this object is the remnant of an augmenting charge. For a normal ignition process it is unlikely that remnants of the augmenting charge are found because it is completely consumed. If this object is the actual remnant of an augmenting charge it implies that the combustion process was incomplete during the accident; i.e. that the ignition process was disturbed or interrupted by the reaction of the main charge.

Figure 15 Object near the remnant of the tail assembly, found after the accident.

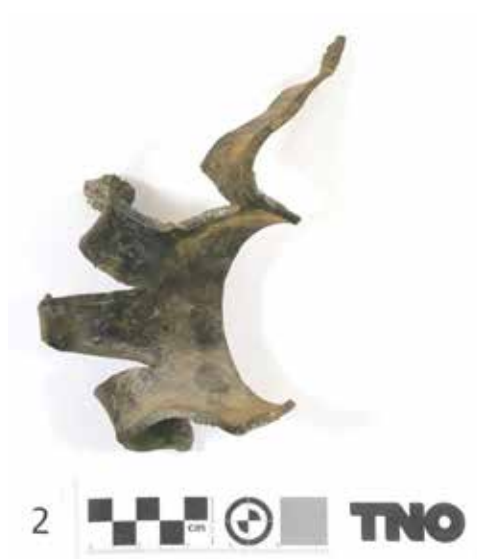
The recovered baseplate end of the launch tube consists of a part, including screw thread, which connects the launch tube to the base plate. Three elongated metal strips are still attached to the part with the screw thread; see Figure 17.

Figure 17 Recovered base plate end of the launch tube.

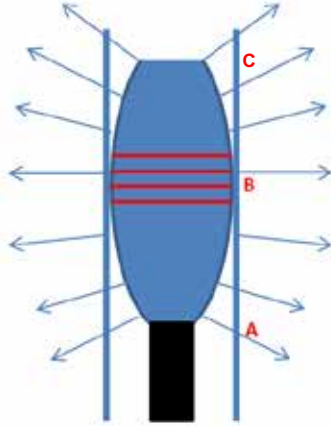
Figure 19 schematically illustrates how the fragments from the shell casing are accelerated in different directions and subsequently strike the inner side of the launch tube; see point A in Figure 19. At this point there is a free path for the shell casing to expand, fragment, accelerate and impact the inside wall of the tube at high speed due to the reaction of the explosive charge.

It should be noted that the typical damage shown in Figure 18 is not found on the metal strips that are still attached to the remnants of the *muzzle end* of the launch tube (point C in Figure 19). This difference is probably caused by the larger amount of explosive present at the forward end of the mortar round; at point C, the launch tube is fragmented into smaller pieces, as a result of which the pieces with this typical damage are no longer attached to the remnants of the muzzle end of the launch tube.

The amount of explosive is less at point A in Figure 19 as a result of which the metal strips with this typical impact damage at their ends, are still attached to the remnants of the baseplate end of the mortar.

Figure 19 Expansion of the main charge and fragment directions.

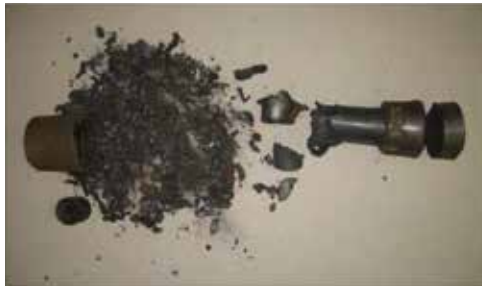
In 2016 TNO performed a series of tests to investigate how a controlled deflagration can be achieved in a sealed steel tube filled with a Plastic Bonded Explosive (PBX) [ref. 5]. These tests demonstrated that a contained explosive can be set off to a full detonation, a partial detonation and a deflagration. Figure 20 is reproduced from ref. 5; it shows the damage to the tube after a detonation and deflagration. The explosive is initiated with a pyrotechnic charge on the right side of the tube, after which the left side was initiated with an explosive shock from a detonator. As a consequence, the explosive deflagrated on the right side, and detonated on the left side. Figure 20 shows that only the left side of the tube fragmented as a result of a detonation.

The launch tube from the accident has fragmented at the location of the main charge of the mortar round. The information from [ref. 5] supports the conclusion that the main charge detonated instead of deflagrated.

Figure 20 Damage to a sealed tube following a detonation (left) and deflagration (right).

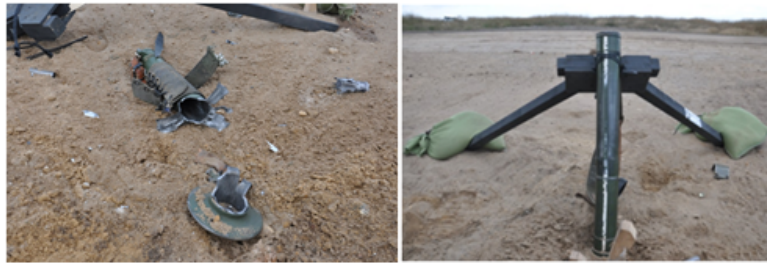
Reference tests, performed by the Knowledge Centre for Weapons Systems and Ammunition (KW&M), substantiate that only a detonating round can cause this kind of damage pattern [ref. 10]. Figure 21 shows on the left, the remnants of a mortar which is blown apart by the detonation of a 60 mm mortar round. Because the round was released (remotely) into the mortar with its fuze in armed position, the round detonated at the bottom of the launch tube at the moment the primary cartridge hit the firing pin. On the right in Figure 21, a mortar is shown in which a mortar round has deflagrated. The deflagration was enabled by drilling a 5 mm diameter hole in the casing of the shell. When the round is fired (with its fuze in unarmed position) the flames and gas pressure from the ignited powder charge reach the main explosive charge through this hole in the casing, causing the main charge to burn while still in the launch tube. The launch tube bulges due to the build-up of the internal pressure and the sight unit is blown away, but the launch tube does not fragment.

Figure 21 Mortar after an internal detonation (left) and deflagration (right) of a 60 mm mortar round [ref. 10].

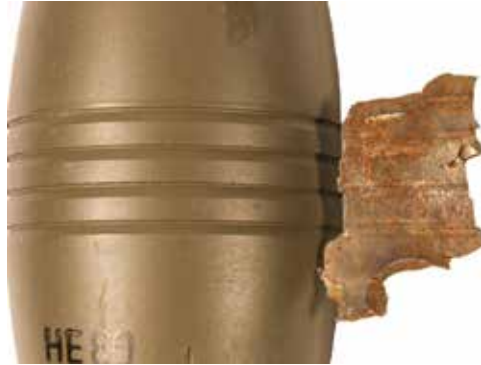
The recovered debris also includes a fragment that features a number of parallel lines in the metal. This fragment was removed from the body of one of the victims following the accident. It is a fragment measuring approximately 3 x 5 cm and with a thickness corresponding to the thickness of the wall of the launch tube. Based on the thickness, colour and the surface texture<sup>5</sup> it is concluded that this fragment originates from the section of the launch tube that severely fragmented. The lines of the imprint (with barely tangible relief) on the fragment have a spacing of about 6.3 mm. This spacing corresponds with that of the grooves on the exterior of the shell casing<sup>6</sup>, see Figure 22.

At the moment the main charge explodes, the exterior of the shell casing strikes the interior of the launch tube and leaves an imprint with four grooves. This location is marked as 'B' in Figure 19. At location B, the space between the main charge and the inside of the launch tube is very small (in contrast to location A). At the moment of impact, the shell casing of the main charge has not yet fragmented, but it expands elastic-plastically due to the reaction of the explosive compound. For this reason the damage pattern due to fragment impact of the casing on the inside of the tube, as shown in Figure 18, is absent on this fragment of the tube.

Figure 22 Imprint on the fragment of the launch tube, originating from the grooves on the shell casing when the main charge explodes.

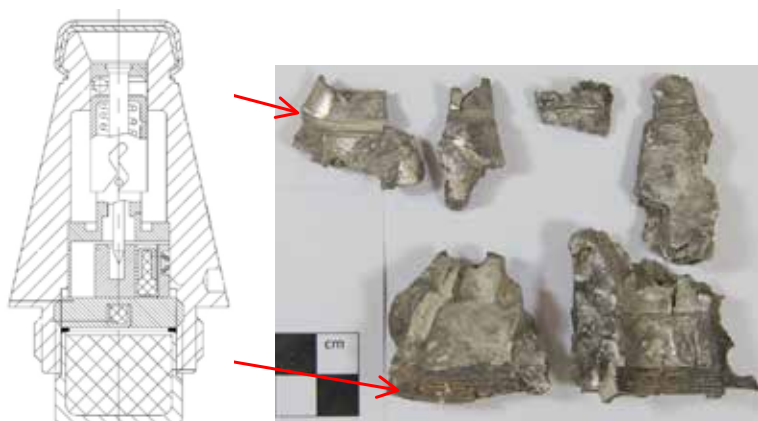
Relatively large aluminium fragments were found in the body armour of the victims. The body of the fuze is made of a cone-shaped aluminium part. Several fragments are identified as being parts of the fuze body, see Figure 25. Especially the screw thread (Figure 25, two lower parts) and a groove on some of the other parts (Figure 25, top four parts) are characteristic for the fuze.

Figure 25 Aluminium fragments originating from the fuze.

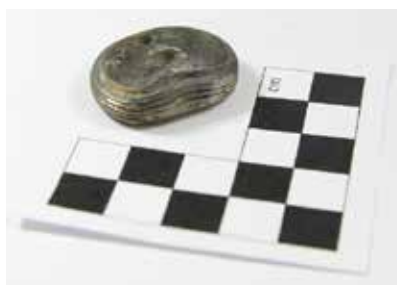
<sup>7</sup> It is impossible that this component (Figure 26) stems from the remaining mortar rounds that were destroyed since it was recovered from the body armour of one of the victims. If the presumption is confirmed that this is the metal barrier of the fuze, the hypothesis is that the lead charge in the metal barrier has functioned, since the metal above it has disappeared (blown away by the lead charge).

Figure 26 Presumed explosive train interrupter from the fuze.

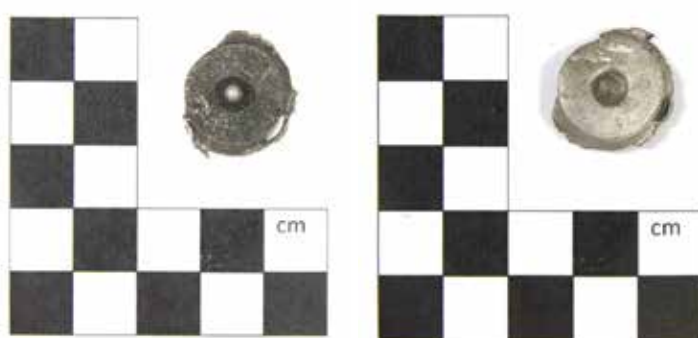
Two components were also recovered, see Figure 26 and Figure 27, which possibly originate from the fuze. The confirmation that these parts respectively represent the explosive train interrupter<sup>7</sup> (metal barrier) and cover plate<sup>8</sup> of the booster, can be obtained by making a direct comparison with an original fuze. This comparison is not possible since no (inert) original fuze is available to TNO at the time of writing of this report.

<sup>8</sup> If the presumption is confirmed that this is the cover plate of the booster (Figure 27), the hypothesis is that the lead charge has initiated the booster. Because it is unlikely that the plate originates from one of the mortar rounds destroyed after the accident. In that case the detonation shock front (which causes the deformation) comes in from the main charge and not from the lead charge.

Figure 27 Presumed booster cover plate from the fuze, photographed from two sides.

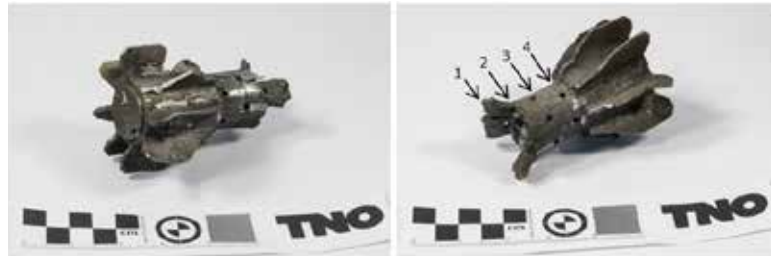
The recovered remnants of the tail assembly of the mortar round shows different types of damage; see Figure 28.

Nearly the entire outer metal surface is affected by the explosive reaction. The released heat and combustion gases have affected the surface and resulted in a dark grey layer of oxide.

Figure 28 Remnants of the mortar round tail assembly.

Moreover, there are several localised deformations of the fins and central section of the tail assembly. These are caused by impact with other metal parts (such as the launch tube in which the shell was dropped and the base plate), probably immediately following the reaction and the dispersal of the fragments of the launch tube, the sight unit and the shell.

A distinct damage pattern was found on the forward end of the tail assembly (towards the main charge). On the forward end a section of the tail assembly is missing. For indicative purposes: an intact tail assembly has a total of four rings with perforations (flash holes) one above the other, see Figure 29. The section of the tail assembly between the second ring with flash holes and the shell body is missing, with the exception of three petalled strips of steel between the first and second ring with flash holes. The tail assembly is partially sheared off at the first ring and partially at the second ring.

During production, a short screw thread is machined at the bottom end of the shell body<sup>9</sup>. The tail assembly is screwed to the shell body using this thread. When the main charge detonates a shock wave travels through this connection. Rarefaction waves (reflected shock waves) will cause fracture and fragmentation. The flash holes represent weak points in the tail and are therefore vulnerable to crack initiation and fracturing. Due to the rarefaction wave the tail failed at the flash holes.

The combination of the damages to the tail assembly can be explained by a reaction of the main charge. This reaction resulted in a shock wave, heat and combustion gases, the dispersal of fragments and the failing and the deformation at the forward end of the tail assembly.

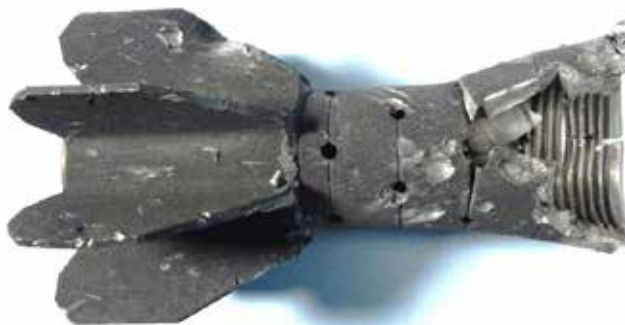
In 2012, TNO performed experiments [ref. 8] with the HE80 60 mm mortar round without a fuze. In these experiments the main charge was detonated using a plastic bonded explosive (at the location of the booster) and a detonator. The experiments were carried out in bunkers, which allowed for easy recovery of the fragments. The tail assemblies of the rounds were recovered after the experiments. These assemblies display damage patterns (see Figure 30) similar to the tail assembly recovered after the accident (see Figure 28); also in these experiments the tail failed at the first and second row of flash holes<sup>10</sup>.

This confirms that the damage to the recovered tail assembly is caused by a detonation of the main charge.

Figure 30 Recovered tail assembly of the HE80 mortar round after a TNO experiment in 2012.

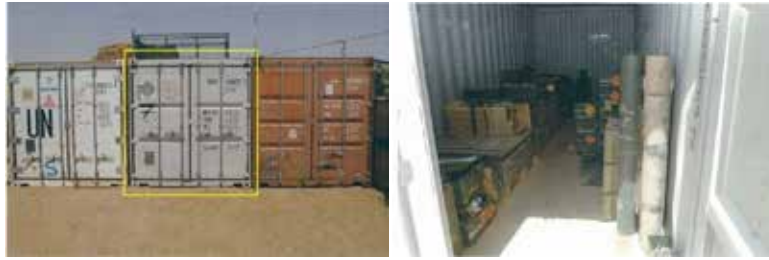
Figure 1 Ammunition storage in a shipping container in Kidal, Mali. The container with the mortar rounds is positioned in between two other shipping containers [KMAR, 2016].

The wind on the days before and on 6 July, is known to have been very calm around Kidal. The localised wind across the roof of the container is not known. This is a very important detail as wind dissipates heat very effectively. As an example: if the wind is relatively moderate - three on the Beaufort scale - the convective heat transfer coefficient doubles and the temperature inside the container would be reduced from 26°C higher than the outside ambient temperature to 16°C higher than the outside ambient temperature. A moderate wind of 4 m/s would be able to reduce the temperature in the storage container to 56 - 59°C during the week of 6 July. As mentioned above, there was little wind, so it seems likely that the specified temperature for storage and transport was exceeded inside the container.

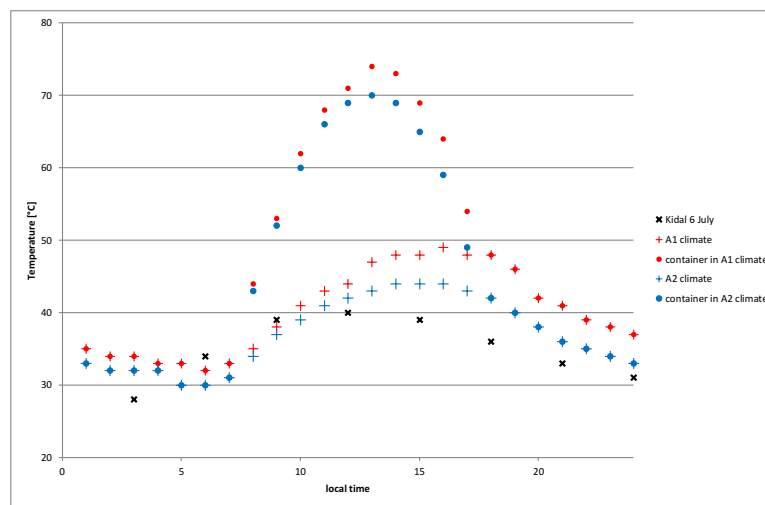
Figure 5 displays the expected daily temperature profiles. The profile for 6 July 2016 is presented with three hour time steps. The ambient temperature peaked at 40°C. Figure 5 also shows the profiles for the AECTP climates A1 and A2. Kidal has an A1 climate according to the Leaflet series. However, the A2 climate seems more representative, especially when based on the maximum temperatures.

The temperature difference between the container and the ambient air is calculated for every hour of the day and added to the daily temperature profile of the A1 and A2 climates. At the beginning and end of the day the insolation is too weak (or absent) to increase the temperature inside the container. Around noon the temperature difference increases to a maximum of 26°C. The time frame during which the specified maximum temperature of 63°C for transport/storage and operation is reached, measures approximately five hours (from 11:00 to 16:00), for both climates A1 and A2. Within this time frame the temperature peaks at 70°C for climate A2 and 73°C for A1 climate A1. Its duration is likely sufficient to heat up the mortar rounds to over 60°C. Since the A2 climate in Figure 5 is representative for the days immediately before and after 6 July heating to over 60°C occurred regularly.

Figure 5 Expected daily temperature profile inside the container plotted for 6 July 2016.

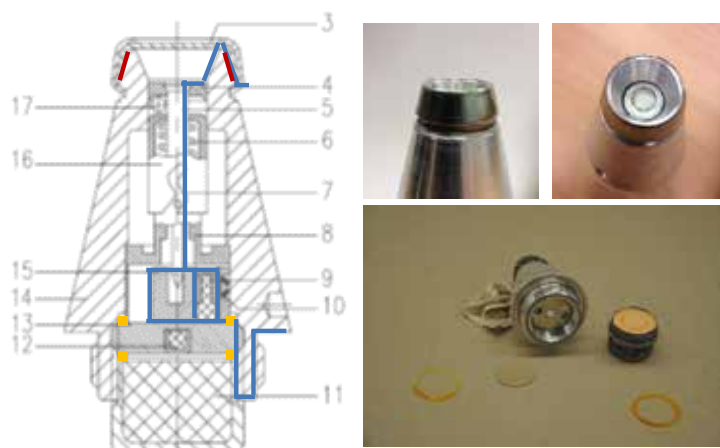
The most likely route for moisture to penetrate and reach the detonator is through the tip of the round; here the barrier consists of the adhesive layer in between the membrane and fuze body (the transport safety cap is a loose part and does not act as a moisture barrier). Less likely is the penetration of moisture via the screw threads between the fuze and the shell body, booster and explosive train interrupter (metal barrier) and the two rubber sealing rings. Both routes are shown in Figure 7.

Figure 7 Cross-section of the fuze with potential routes (blue) for moisture penetration via the adhesive layer (red) and sealing rings (yellow) (left), adhesive layer for the membrane (top centre), the opening between the firing pin and the fuze body (top right) and underside of the fuze body with metal barrier (disk), booster with cardboard insert and two rubber rings (bottom right).

Although adhesive and rubber rings are both permeable, moisture penetration through a layer of adhesive is much easier than along three screw threads and two sealing rings. Two simple leak tests were performed for confirmation. First, five empty fuzes were positioned with their nose facing down and filled with water; they were all watertight. The five fuzes were subsequently mounted one by one on an inert shell body, and subjected to five drop tests from a height of about one meter with a random orientation upon impact with the ground. After removal from the shell body the fuzes were again filled with water; the adhesive layer of one of the five fuzes was observed to be leaking; see Figure 8.
